The information in this report is preliminary and may be supplemented or corrected.

On July 18, 2013, CSX train no. Q704-19, consisting of two locomotives and 24 loaded flat cars carrying municipal waste, derailed at milepost 9.99 on Metro-North's Hudson Division in the Bronx New York while traveling northbound towards Spuyten Duyvil station, Figure 1.

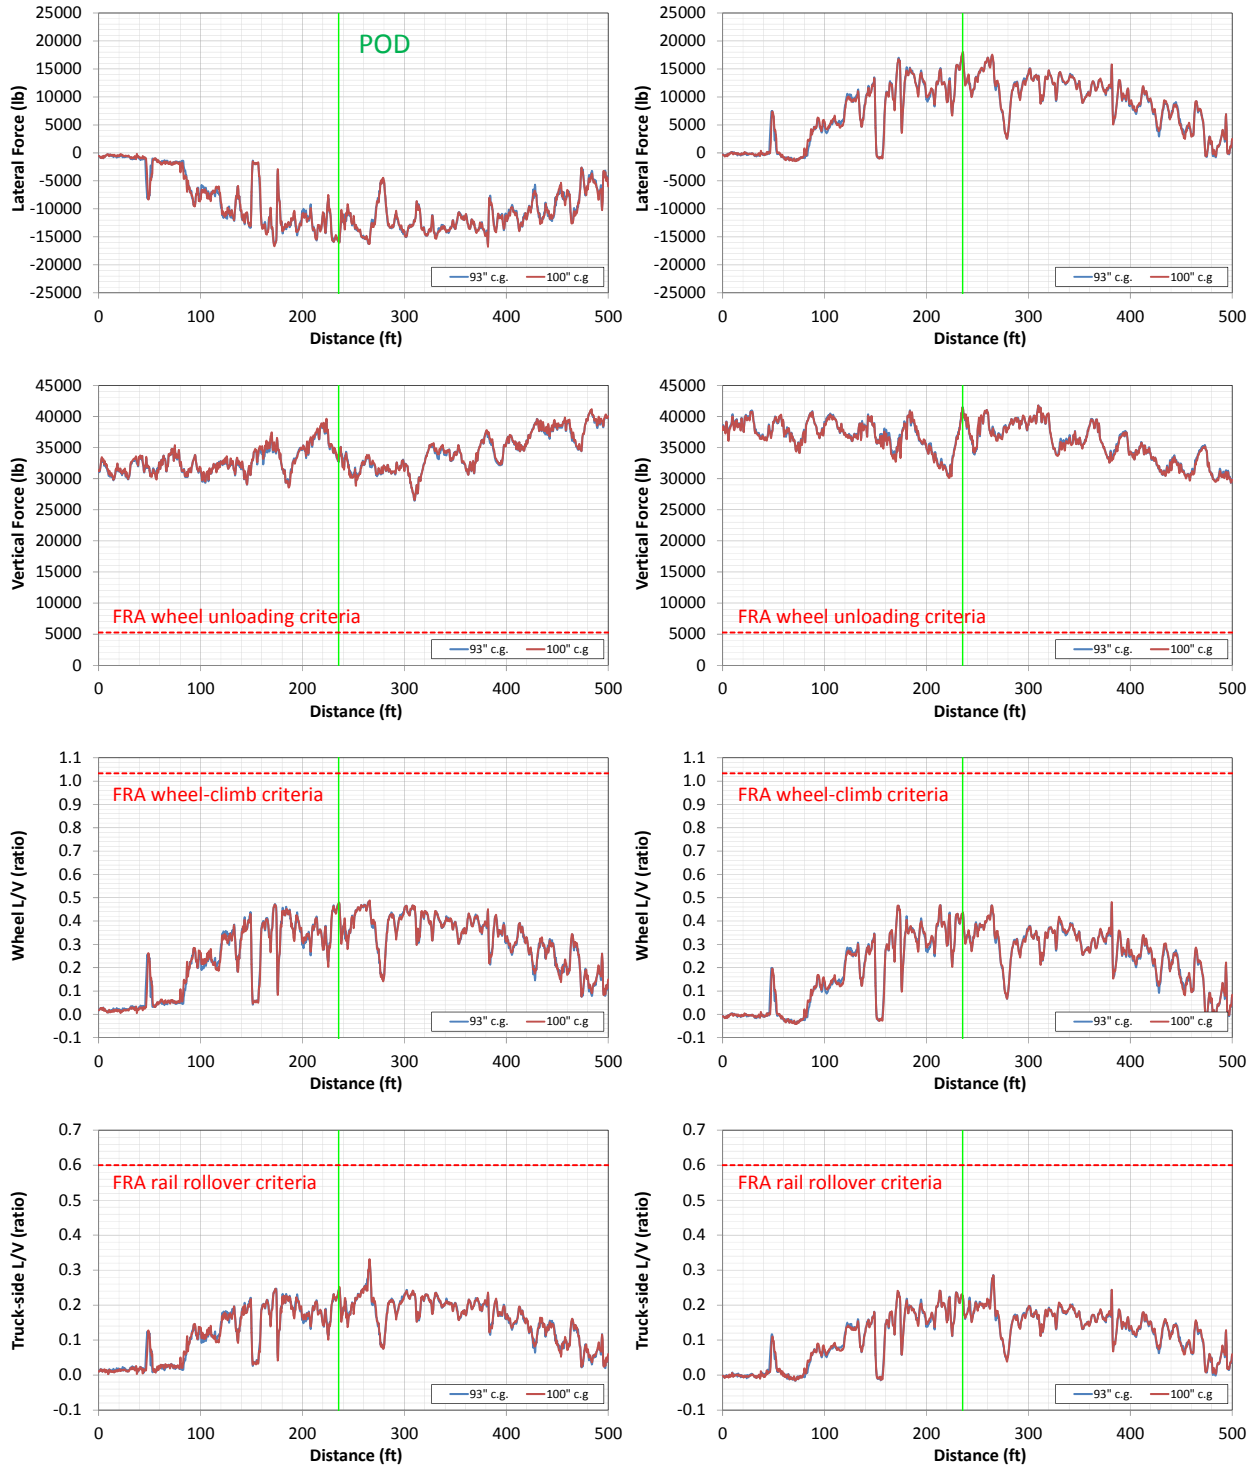
Figure C2: Axle 1 predicted wheel-rail forces in derailment curve, effect of center of gravity: comparison of baseline car with center of gravity of 93 inches and car center of gravity of 100 inches, weight of 280 kips.

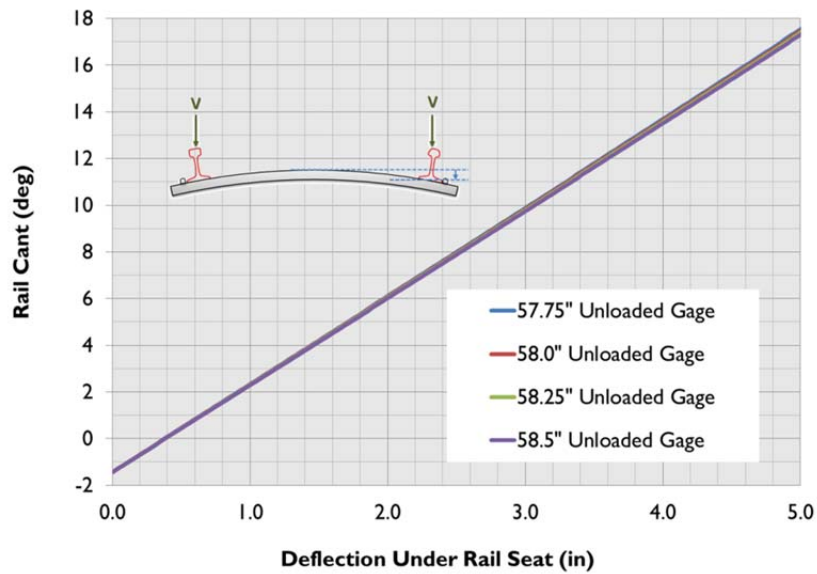
Figure D1: Rail cant for a given crosstie deflection – single center-bound crosstie.

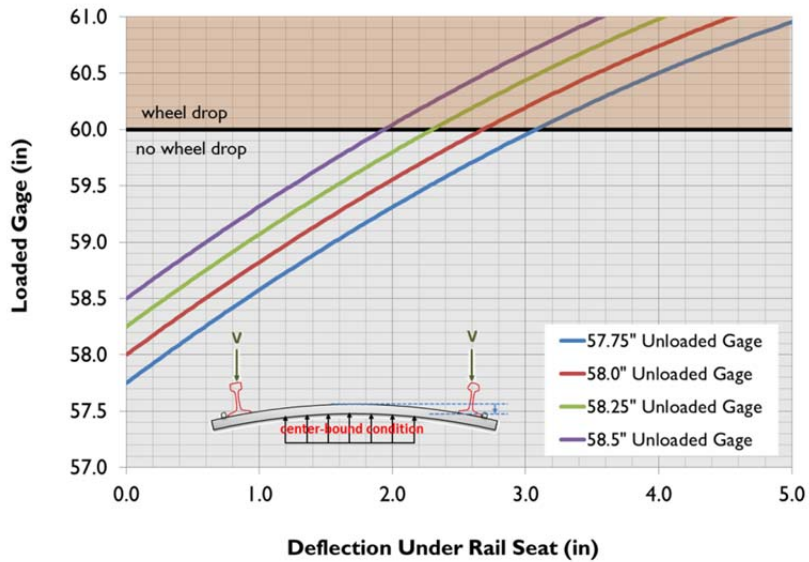
Figure D2: Loaded gage for given crosstie deflection – center-bound crosstie.

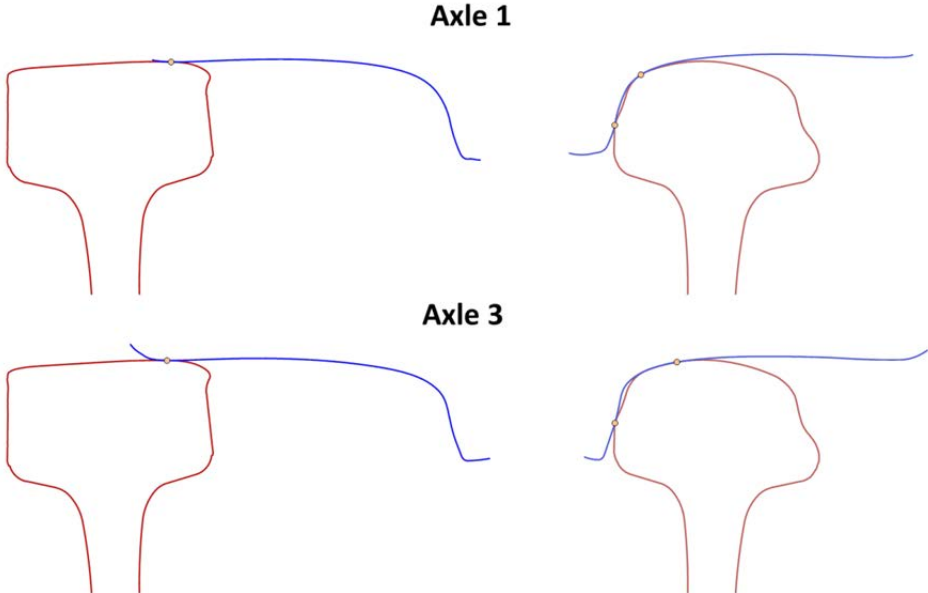
Car 10 (USWX40113) – with rail cant

Figure D3: Wheel-rail contact geometry for car 10 axles 1 and 3 (lead truck axles) on canted rails.

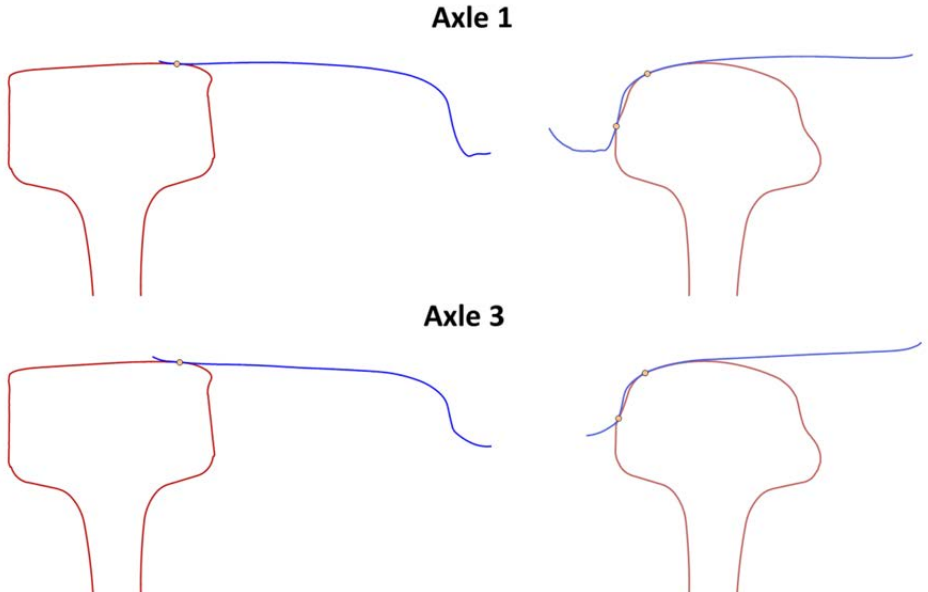
Car 11 (USWX638345) – with rail cant

Figure D4: Wheel-rail contact geometry for car 11 axles 1 and 3 (lead truck axles) on canted rails.

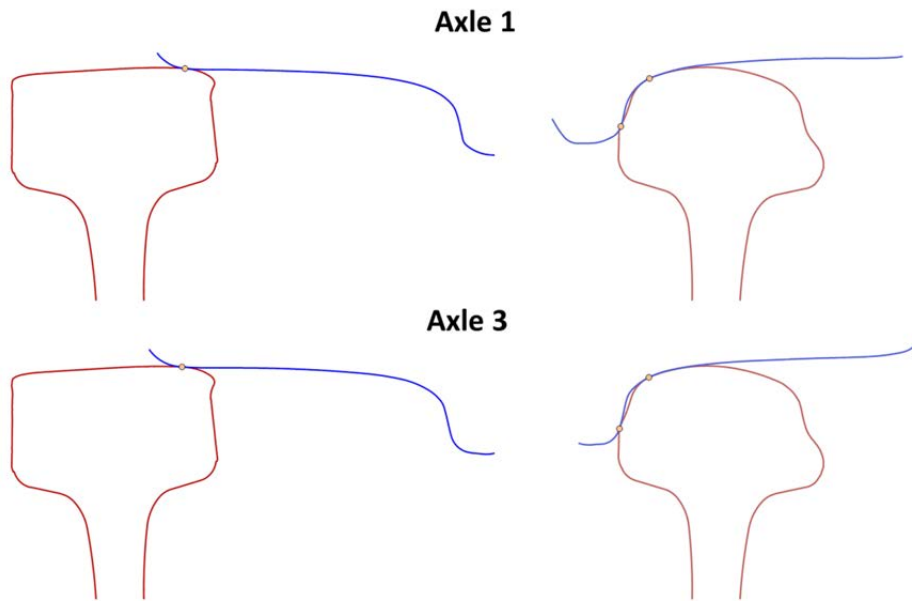
Car 12 (USWX638391) – with rail cant

Figure D5: Wheel-rail contact geometry for car 12 axles 1 and 3 (lead truck axles) on canted rails.
