**BUILDING EXPLOSION AND FIRE  
8701 ARLISS STREET  
SILVER SPRING, MARYLAND  
ACCIDENT NUMBER – DCA16FP003**

**PREPARED BY:  
WASHINGTON GAS  
SUBMITTED TO:  
NATIONAL TRANSPORTATION SAFETY BOARD (NTSB)**

**JUNE 7, 2017**

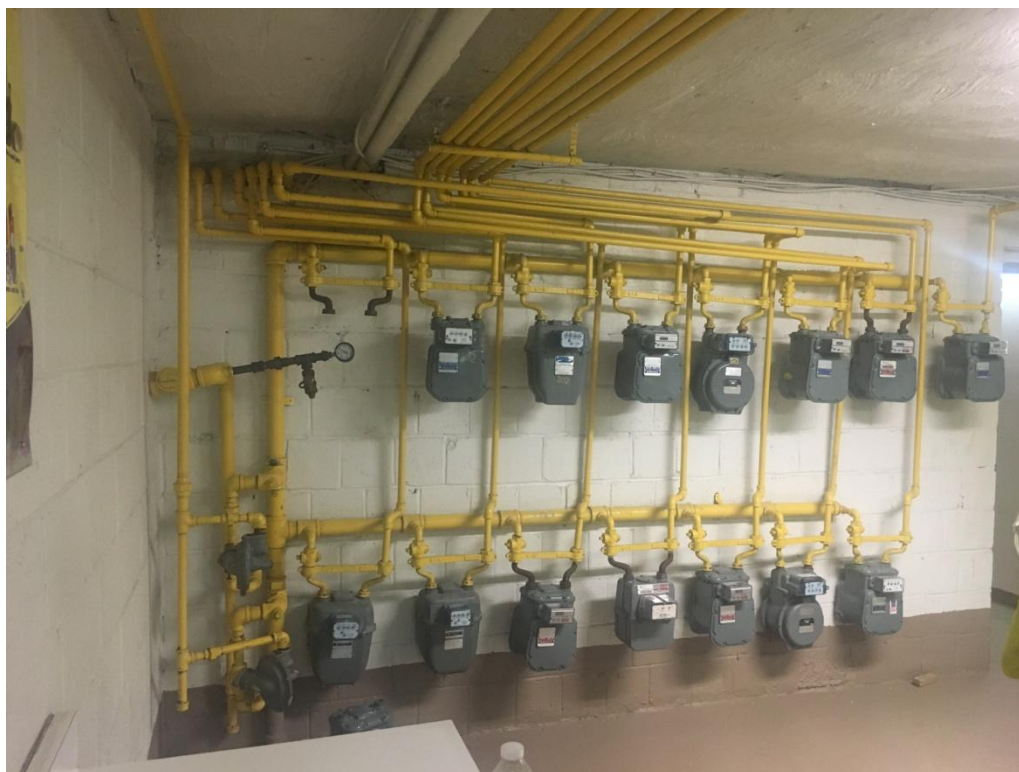
**Figure 1: Exemplar meter and regulator assembly; located in Flower Branch Apartment complex**

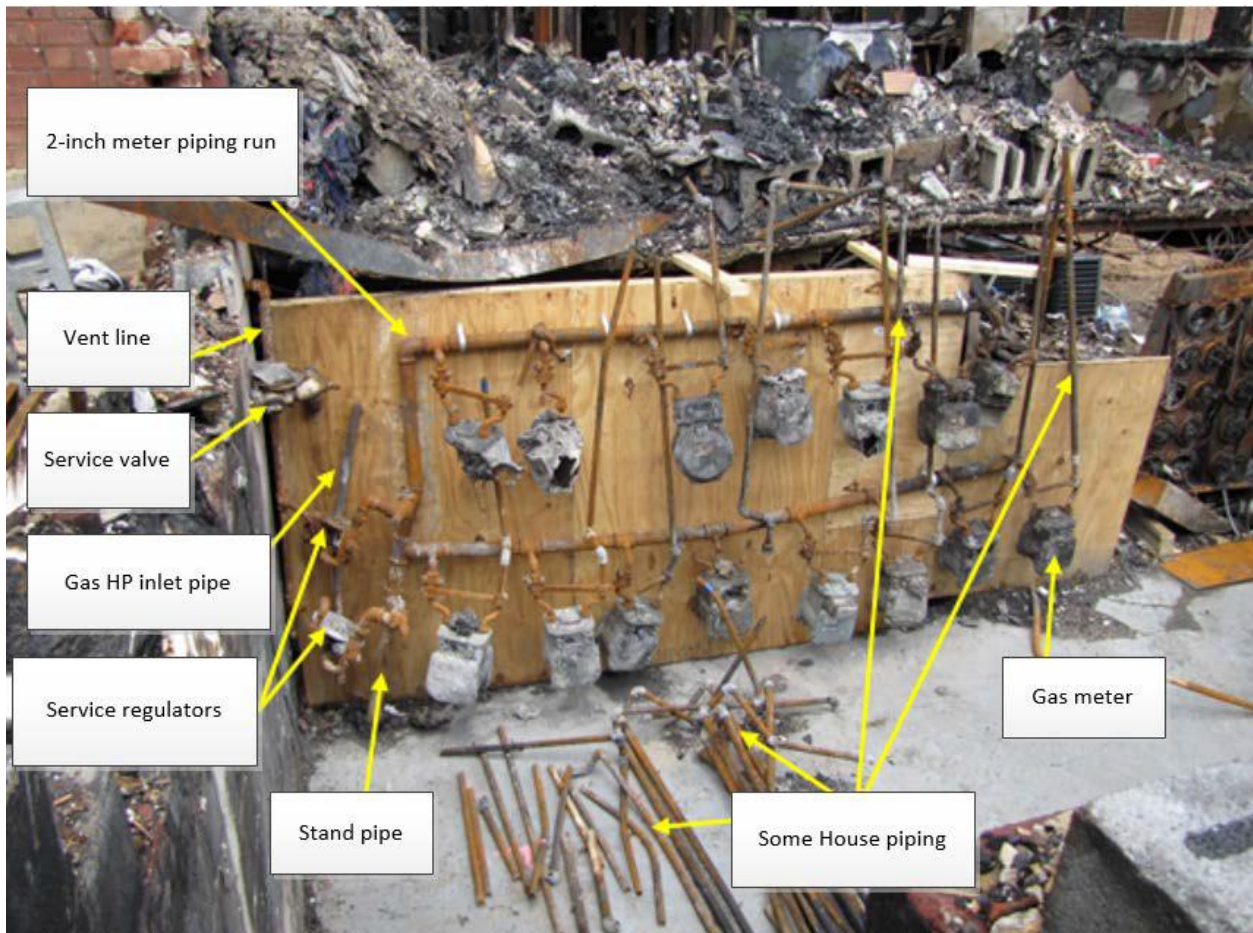
**Figure 9: Meter set and house piping as reconstructed by ATF post accident clean up.**

**Conclusion:** When considered together with all the developed observations and data, as well as the testing and analysis conducted, these facts are consistent with the union fitting on the vent pipe being connected prior to the explosion and the ensuing building collapse. The fact that the union was found separated post-accident, as were numerous other fittings as shown in Figure 9, is a result of the forces associated with the collapsing building and meter set acting on a threaded union fitting with minimal thread engagement due to a difference in size between the male and female components.

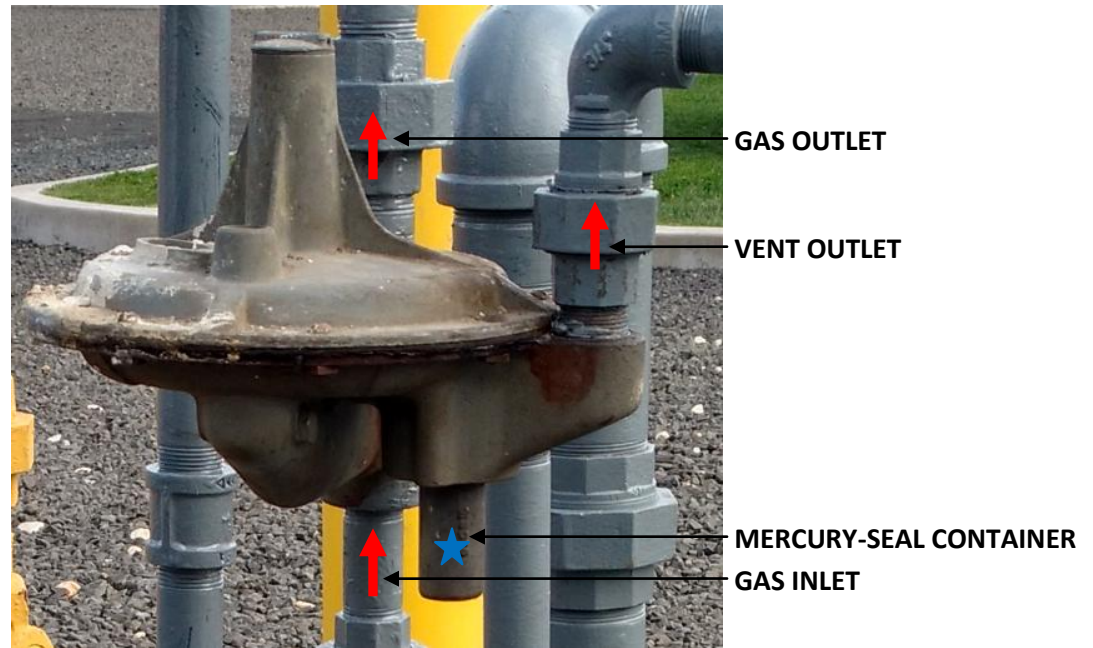
**Figure 10: Mercury-Sealed Regulator**

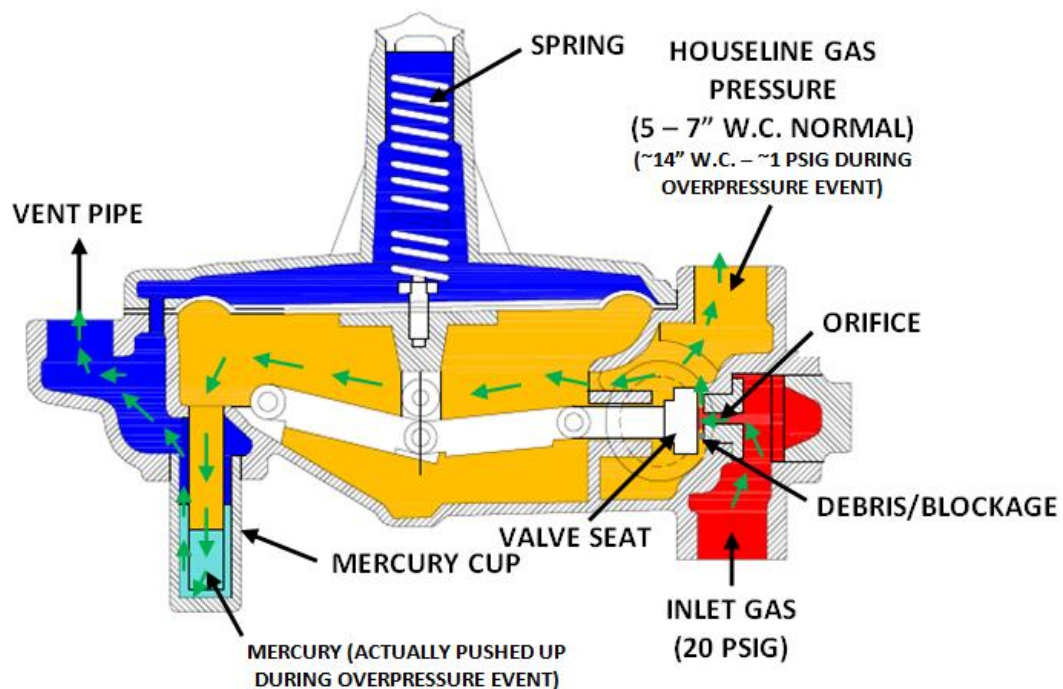
In this situation, the valve seat does not create a gas tight seal with the orifice, allowing the gas to flow through the regulator, exceeding the customer's appliance consumption downstream. In this case, the pressure will slowly rise until it overcomes the weight of the column of mercury in the mercury cup and gas bubbles through the mercury and out of the relief vent. The mercury in the mercury cup is typically filled to a level that equates to 14 in. w.c. of weight (equivalent to approximately 0.5 psig). The downstream pressure in the customer's house piping will be maintained at or below the

pressure of the relief setting (14 in. w.c. in this case; 0.5 psig). See Figure 13 for an illustration of this failure mode (gas flow indicated by green arrows). This was demonstrated during the field test held at the Washington Gas Springfield Training Center on May 31, 2017, detailed in Appendix 5, in which gas escaped through the vent at approximately 165 SCFH. During testing, the relief capacity of a single regulator was adequate to limit the houseline pressure to a maximum of 8.5 in. w.c. (0.3 psig) in this failure mode.

**Figure 13: Orifice Blockage or Valve Seat Wear Schematic**

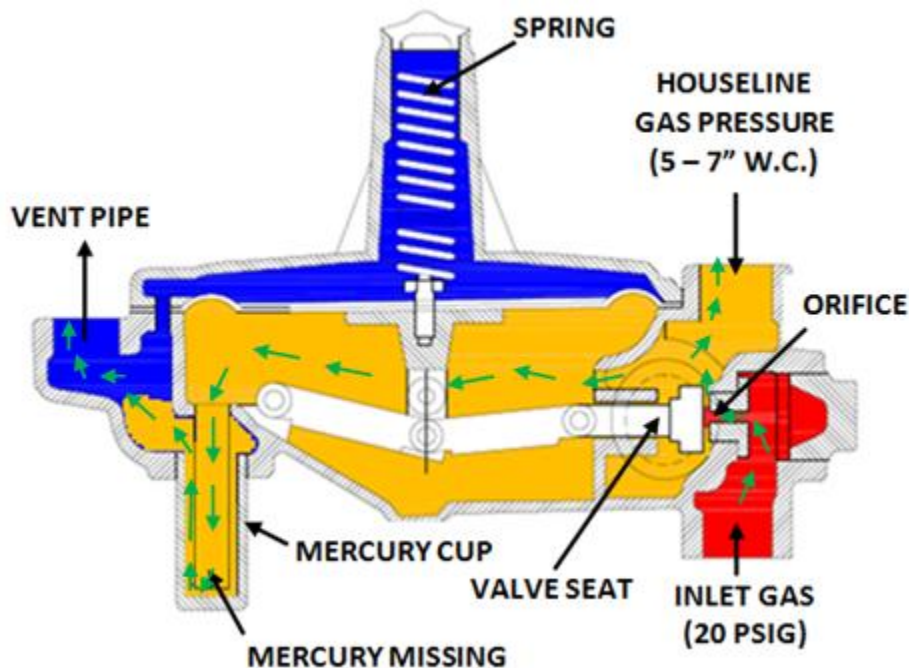
The circumstance of mercury being displaced is caused by individuals (HVAC Contractors/homeowners) unfamiliar with the intricacies of the mercury regulator who (a) modify the regulator installation and tilt it or, (b) shut off gas to the regulator, then reintroduce gas too quickly, both of which force mercury out of the cup. In these cases,

the regulator continues to operate and control the pressure to its set point (5 to 7 in. w.c.; 0.2 psig), supplying gas to customers' appliances while gas vents out through the relief vent due to the lack of mercury to retain it. This was demonstrated during the field test held at the Washington Gas Springfield Training Center on October 12, 2016, as detailed in Appendix 4, in which gas escaped through the vent at approximately 330 SCFH. See Figure 14 for an illustration of this failure mode (gas flow indicated by green arrows).

Figure 14: Missing Mercury Schematic

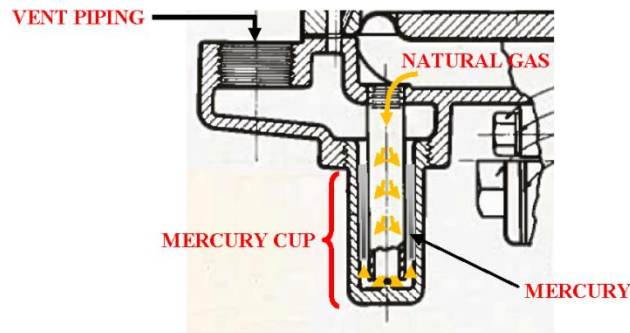
2.3 Mercury Content Measurement. Mercury (liquid) forms a seal between gas within the regulator body and the vent line. A column of mercury is exposed to downstream, or houseline, pressure. The mercury column is located within the regulator's "mercury cup", which includes a small diptube. When the houseline pressure is higher than the pressure provided by the height of the mercury column, the mercury is driven into a reservoir above the cup. At this point, gas is allowed to escape through the vent piping. This scenario is shown below in Figure 2.

Mercury Column (silver) being Driven Upwards  
within Cup by High House Line Pressure

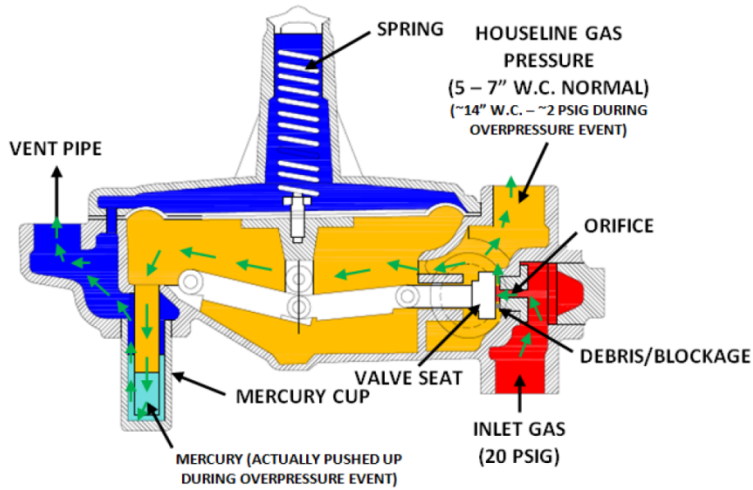
A disruption of the seal between the valve seat and the orifice (small amount of valve seat deterioration, orifice scoring, or foreign material between the orifice and valve seat) will result in the houseline pressure slowly rising until it overcomes the relief setting of the regulator. As downstream pressure builds to overcome the relief setpoint, gas will travel through the vent line and exit through the vent outlet, outdoors. In order to model this phenomenon, a small needle will be taped across the valve seat. This will prevent the seat from sealing against the orifice. This action should cause the houseline pressure to rise from ~5.5 – 6.0” w.c. to the relief setting. The small flow of gas that will vent through the relief device should mirror the small amount of gas flowing past a disrupted valve seat-orifice seal. The houseline pressure and vent flow rate will be measured Both a no-flow condition (“no houseline demand”) and a low-load condition will be modeled. The houseline will initially be “shut-in”, meaning there will be no demand or flow within the houseline. A small gas demand will then be placed on the houseline to demonstrate the effect of flow. A “low-load” representative of a small 50,000 Btu furnace will be placed on the houseline by opening up a small passageway equivalent to the size of a #34 drill bit. A single regulator will be used for the test. See Figure 2 for a schematic of this failure mode. The following data will be collected:

**Figure 2. Disruption of seal between the valve seat and orifice – gas flow indicated by green arrows.**

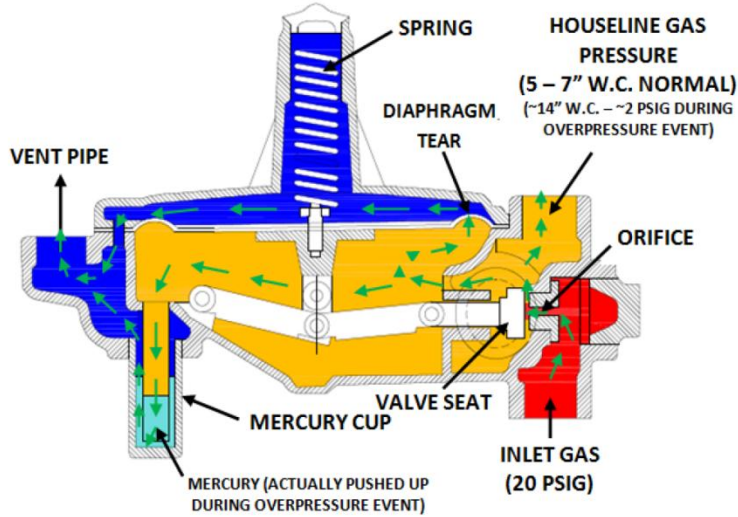
A ruptured, or torn, regulator diaphragm may result in the regulator spring forcing the linkages connected to the valve seat to move the valve seat away from the orifice, leaving a gap for gas to flow into the regulator and house piping, resulting in an increase in the downstream pressure. The tear would have to be significant enough so that the increased force above the diaphragm – due to pressure from gas travelling into the chamber above the diaphragm – combined with the force of the spring, exceeds that of the houseline pressure. The downstream pressure may increase until the relief vents of one, or both, of the regulators activate (at approximately 14” wc) and then will stabilize at a pressure where the volume of gas entering the regulator is equal to the volume forced out through the vent plus any demand for gas. This will be demonstrated by removing the cover from one of the regulators and then cutting a 1” long slit through the diaphragm. The response of each regulator’s vent line and the houseline pressures will be measured with both no demand on the houseline and a low-load, analogous to the test described in subsection 2.2. See Figure 3 for a schematic of this failure mode. The following data will be collected:

**Figure 3. Diaphragm Tear – potential gas flow indicated by green arrows.**
