**From:** Eick Donald  
**Sent:** Thursday, July 19, 2012 6:28 AM  
**To:** Jones Patrick  
**Cc:** Lawrence David; Lawrence David; Soper Brian  
**Subject:** WPR12FA305 - Richfield, UT, SR22 accident, N86AA  
**Attachments:** WPR12FA305-IR1730Z.GIF; WPR12FA305-VIS1730Z.GIF; KICX 0.5deg base reflectivity at 1727Z.png

### Weather on July 14, 2012 - WPR12FA305

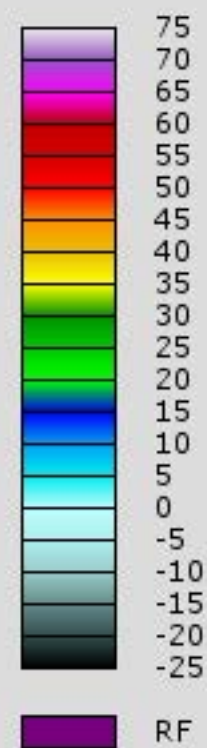
REFLECTIVITY  
ELEV ANGLE: 0.47

The radar and satellite imagery depicted convective clouds over the route and the accident site with tops to 27,500 feet, with conditions very similar to what was observed over Bryce Canyon. The radar imagery from Cedar City (KICX), UY, 0.5 degree base reflectivity image was centered at 22,600 feet and depicted very light intensity echoes over the accident site and implied cumulus congestus clouds capable of producing rain showers and reduced visibility.
