3.0 2021 Tesla Model 3 Vehicle Inspection

The Tesla was impounded at Downtown Towing, located at 1101 SW 69th Ave Miami, FL. The NTSB investigators inspected the vehicle on September 20 through 23, 2021. The Tesla had VIN: 5YJ3E1EB2MF037962.

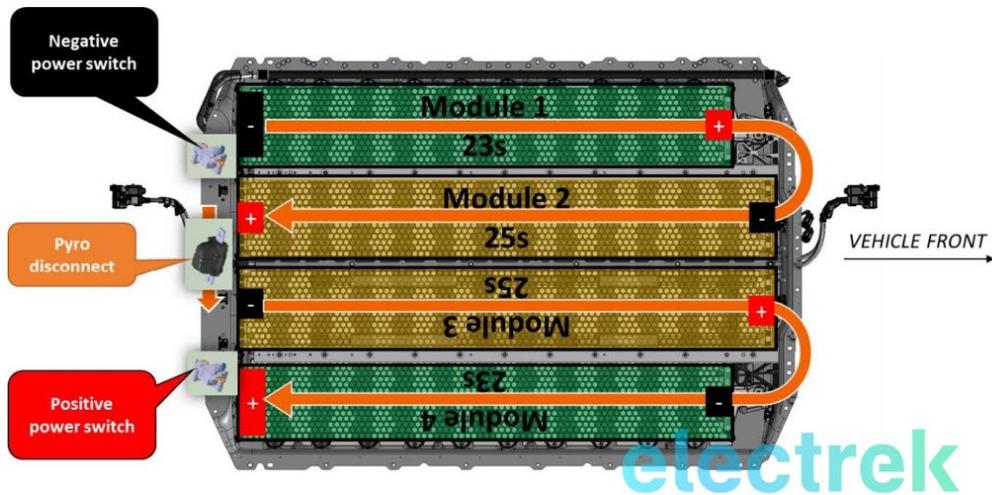
Figure 8: Diagram of a Tesla Model 3 battery pack. Source: electrek

The Tesla Model 3 HV battery pack consists of 4 modules, each containing approximately 1,000 cells, as shown in Figure 1.¹⁵

The battery pack sustained severe damage to the entire right side of the battery, which breached the case and exposed cells. A large number (hundreds) of individual cells were displaced and scattered in the wreckage and on the ground. Module 4 exhibited the most damage and displacement of cells.
