# National Transportation Safety Board

HWY23MH006

## **SURVIVAL FACTORS**

Group Chair's Factual Report

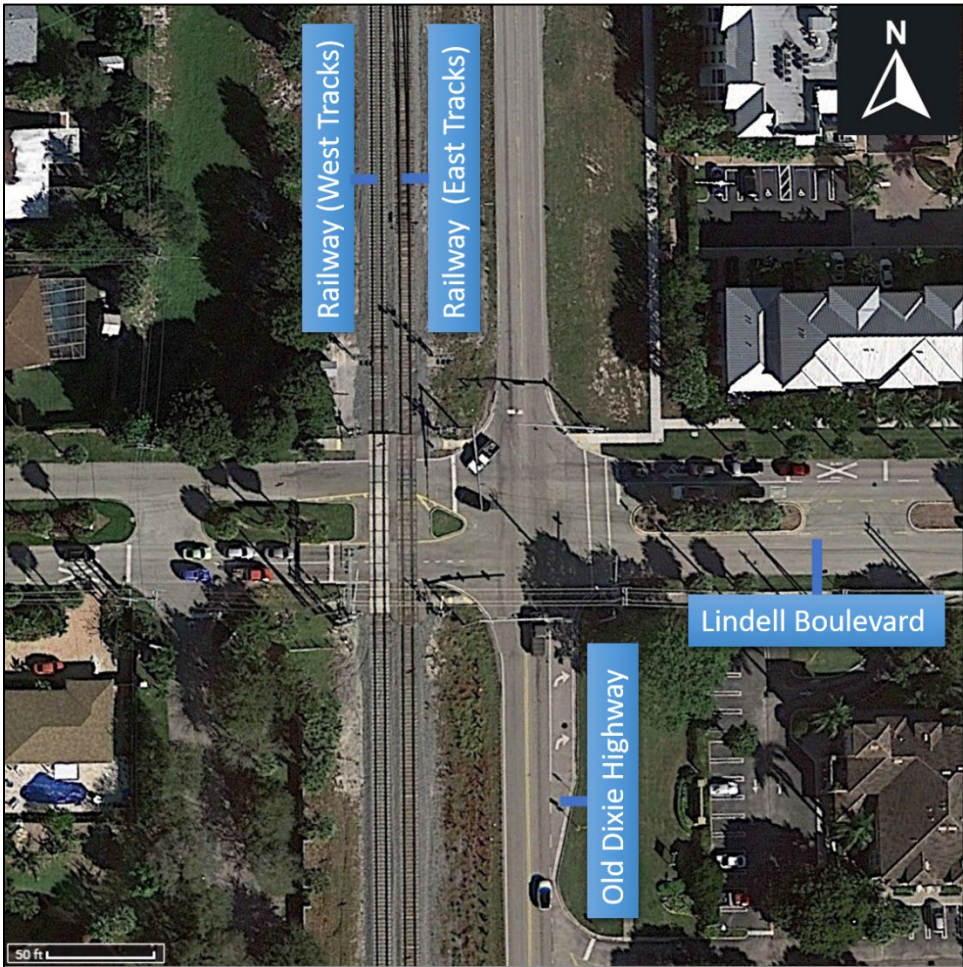
**Figure 1: Aerial View of Lindell Boulevard and Old Dixie Highway**

A daytime inspection of the scene was conducted on February 11-13, 2023. The scene was located west of the intersection of Old Dixie Highway and Lindell Boulevard, as observed in Figure 1. The collision occurred in the westbound lanes of Lindell Boulevard and the eastmost Florida East Coast Railway (FECR) track (Track #1), in the city of Delray Beach, Palm Beach County, Florida. The collision involved a 2015 Nissan Rouge SV (Nissan) and a Brightline train (train). A northbound Acura TLX (Acura) was struck by debris from the collision.

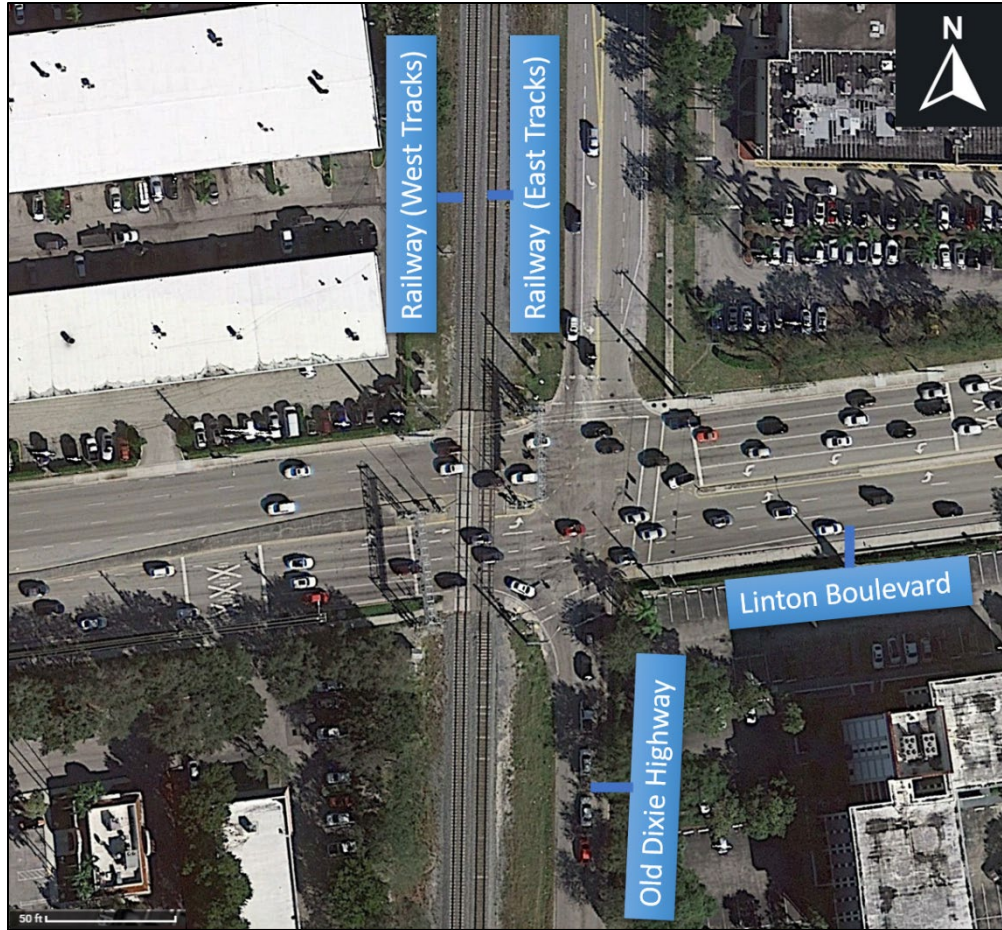
**Figure 4: Aerial View of Linton Boulevard and Old Dixie Highway**

The crossing located north of the subject crossing was inspected. A daytime inspection of the adjacent north crossing was conducted on February 13, 2023. The adjacent north crossing was located just west from the intersection of Old Dixie Highway and Linton Boulevard, as observed in Figure 4. The DOT crossing inventory number for this crossing was 272497S.

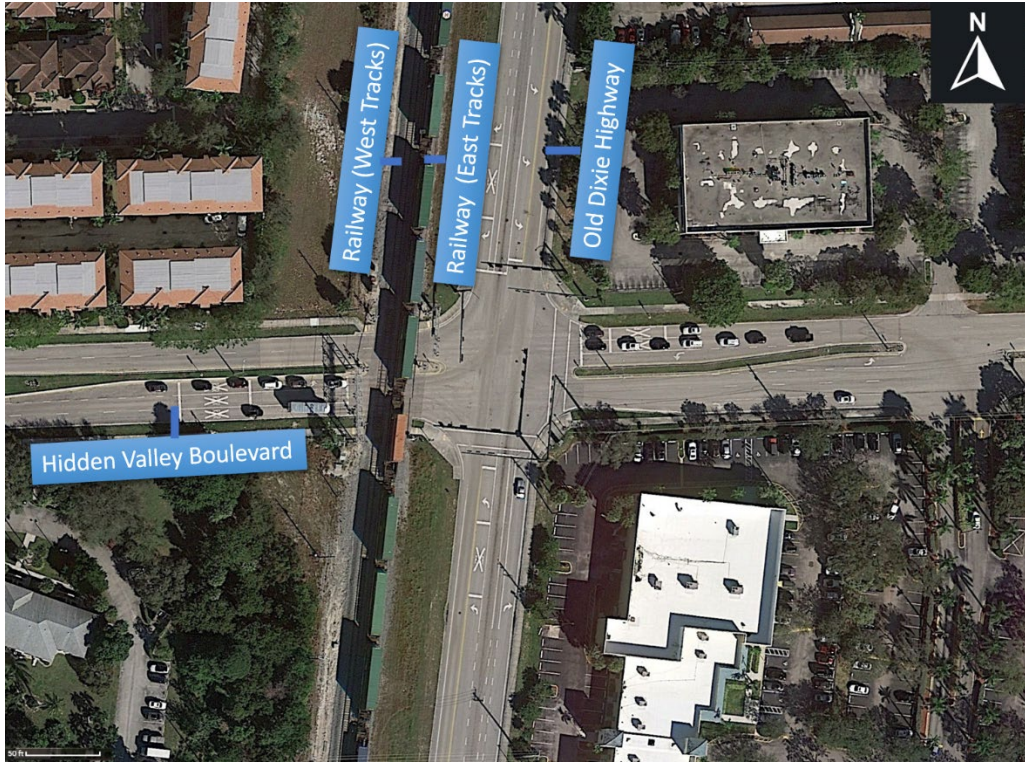
**Figure 6: Aerial View of Hidden Valley Boulevard and Old Dixie Highway**  
Source: Google Earth (Modified)

The crossing located south of the subject crossing was inspected. A daytime inspection of the scene was conducted on February 13, 2023. The adjacent south crossing was located just west from where Old Dixie Highway intersects Hidden Valley Boulevard, as observed in Figure 6. The DOT crossing inventory number for this crossing was 272499F.
