National Transportation Safety Board

HWY23MH006

TECHNICAL RECONSTRUCTION

Group Chair's Factual Report

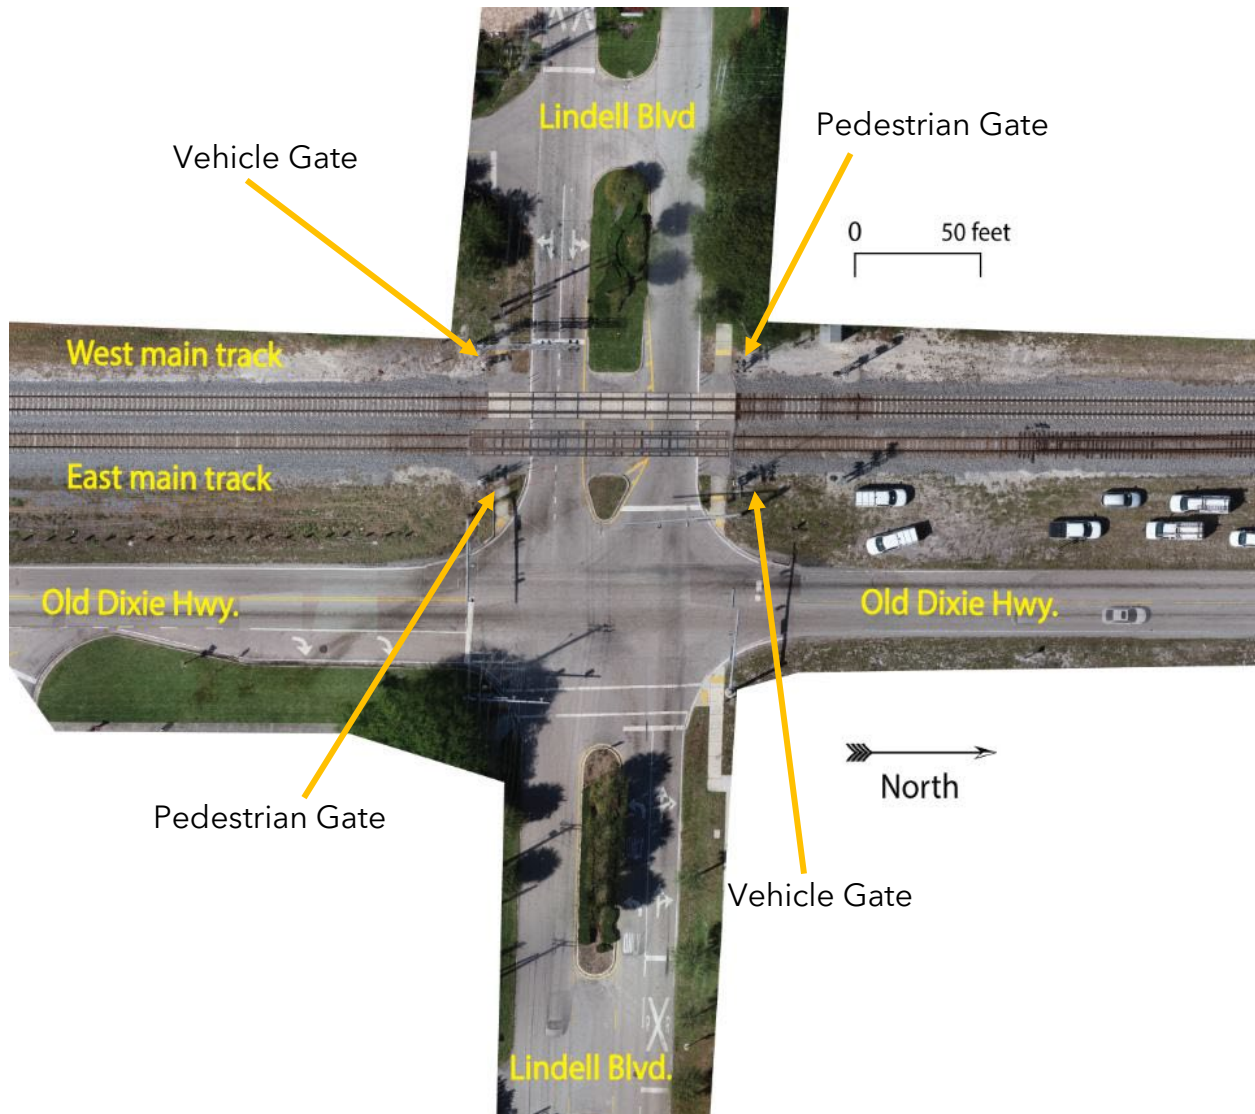
Sidewalks were contiguous with Lindell Boulevard west of Old Dixie Highway on the north and south sides. The sidewalks measured approximately 18 feet in length and 6 feet in width. As previously discussed, the grade crossing warning system included a pedestrian warning system. When the grade crossing warning activated, the pedestrian gate arms lowered simultaneously to prevent pedestrian traffic from crossing the tracks.³ **Figure 2** is the orthomosaic image of the grade crossing as it was on February 10th, 2023.

Figure 2. Orthomosaic of the grade crossing with the roadways and main tracks labeled.

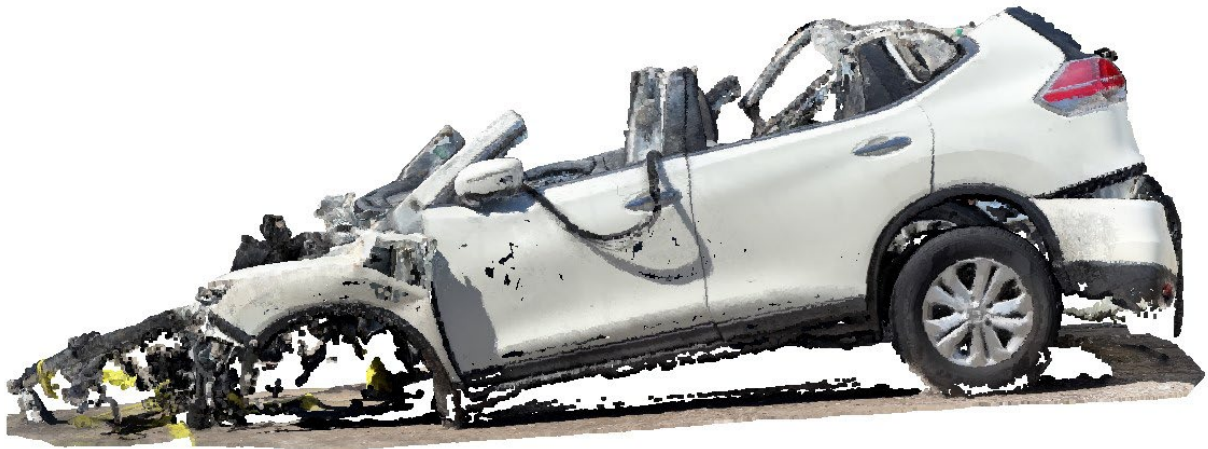
At its position of final rest, the Nissan was on its right-side facing southeastward, positioned about 70 feet southeast of the area of impact and just over 15 feet off the roadway. **Figures 7** and **8** depict images of the three-dimensional point cloud from the scanning of the Nissan. **Table 1** provides a sampling of dimensional data for the Nissan.⁴

Figure 8. Screen capture image showing the 3D point cloud of the Nissan as viewed from the left-side of the vehicle.
