# National Transportation Safety Board

HWY24FH002

## **FACTUAL REPORT OF INVESTIGATION**

Group Chair's Factual Report

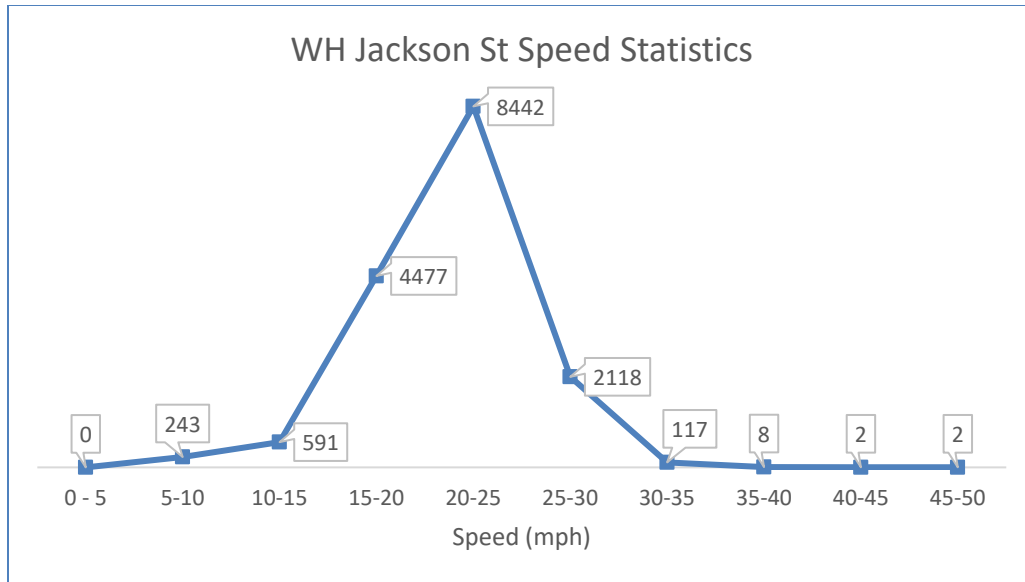
**Figure 4.** Chart depicting the number of vehicles in each speed range.

The most recent speed study on WH Jackson Street prior to the crash occurred between May 23, 2017, and June 8, 2017. The speed study was conducted at the intersection of Grant Street and WH Jackson Street and included all classes of vehicles. Figure 4 is a chart showing the number of vehicles within each speed range during the speed study. The maximum and minimum reported speeds were 49 and 5.1 mph respectively.<sup>11</sup>

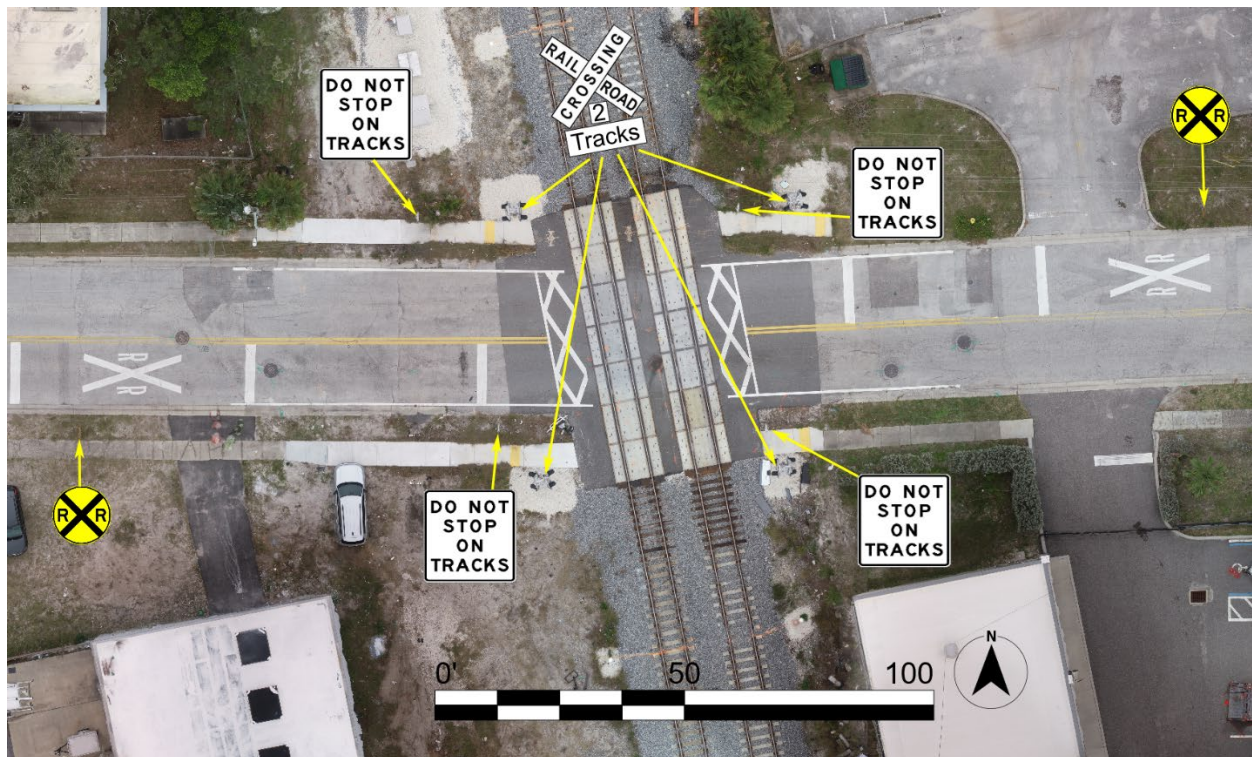
**Figure 5.** WH Jackson highway-rail grade crossing related signage.

Along both the east and westbound approaches approximately 97-feet prior to the highway-rail grade crossing were W10-1 Grade Crossing Advanced Warning signs. There were four, R8-8, Do Not Stop on Tracks signs were posted on the right-hand side of each travel lane on both the near and far sides of the highway-rail grade crossing.

Grade crossing pavement-marking symbols were located on the roadway in the eastbound and westbound travel lanes. Each pavement marking was located approximately 97 feet from the nearest rail. There were two 24-inch-wide white stop lines for each approach (east, west) located approximately 25-feet and 32-feet respectively, from the nearest rail. Additionally, two 4-inch-wide white lines extended across the roadway on each side of the highway-rail grade crossing identifying the dynamic envelope.<sup>14</sup> The markings were located approximately 10-feet from the nearest rail and contained transverse markings. Figure 5 is an overhead image of the WH Jackson grade crossing depicting the signage and pavement markings.

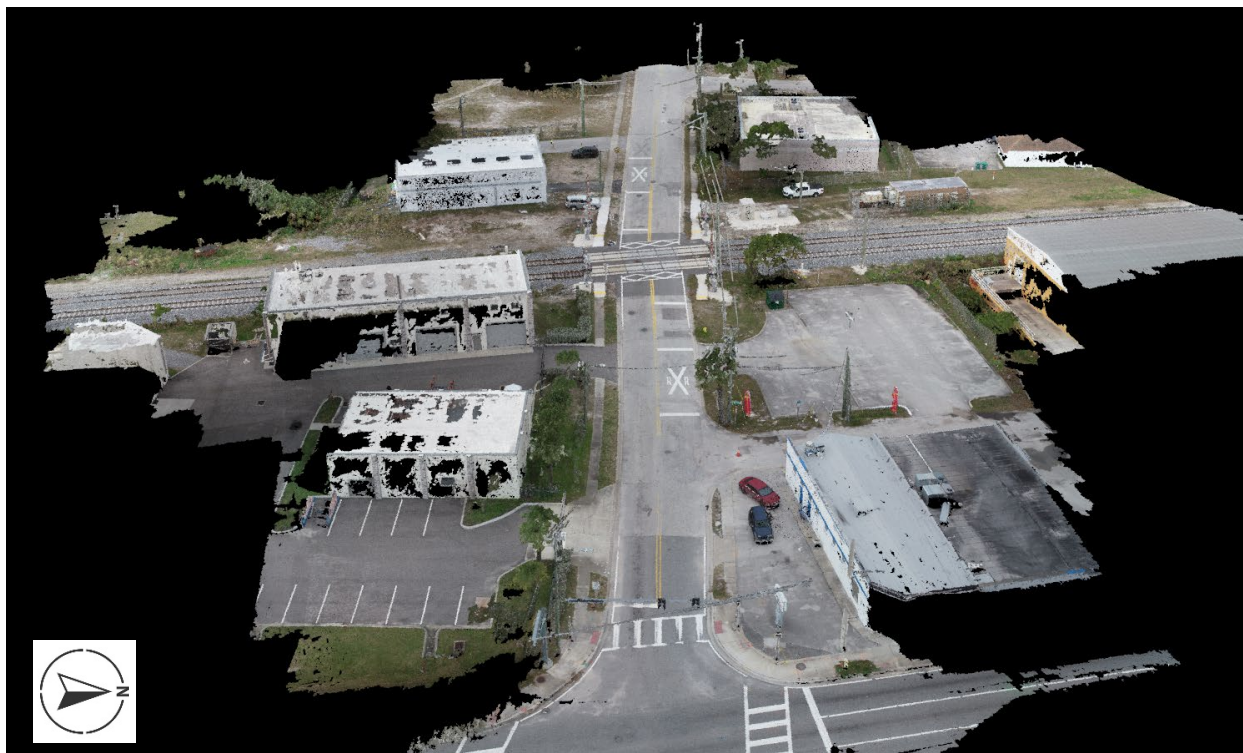
**Figure 7.** Image of the generated point cloud depicting WH Jackson Street and the highway-rail grade crossing.

The UAS captured 438 high resolution, georeferenced photographs of the crash scene suitable for processing in the Pix4D photogrammetry software.<sup>16</sup> An additional 19 perspective photographs were taken capturing a 360-degree view of the crash scene and were not included in the photogrammetry processing. Figure 7 is an image of the generated point cloud showing the highway-rail grade crossing. The view is looking westbound along WH Jackson Street.
