**METALLURGICAL ASSESMENT OF OWINGSVILLE LINE 15
FOR HARD SPOTS**

NOVEMBER 10, 2004

**PREPARED BY:
Gary Vervake
Sr. Metallurgical Engineer
Metallurgical Services & QA**

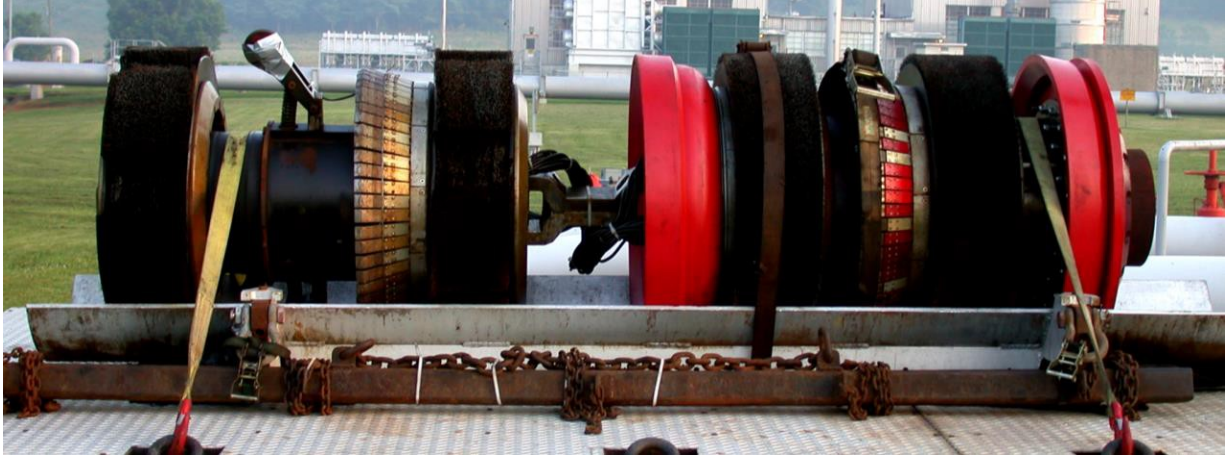
Figure 1. The Tuboscope hard spot tool prior to inspection.

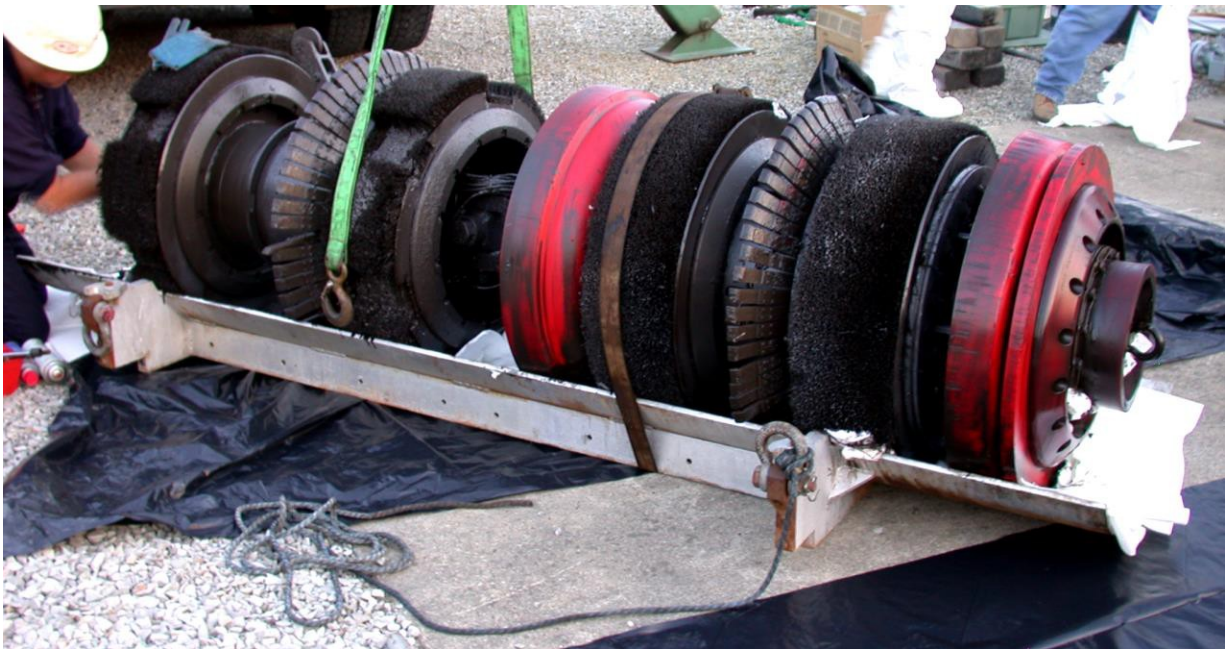
Figure 2. A view of the hard spot tool after the inspection operation.

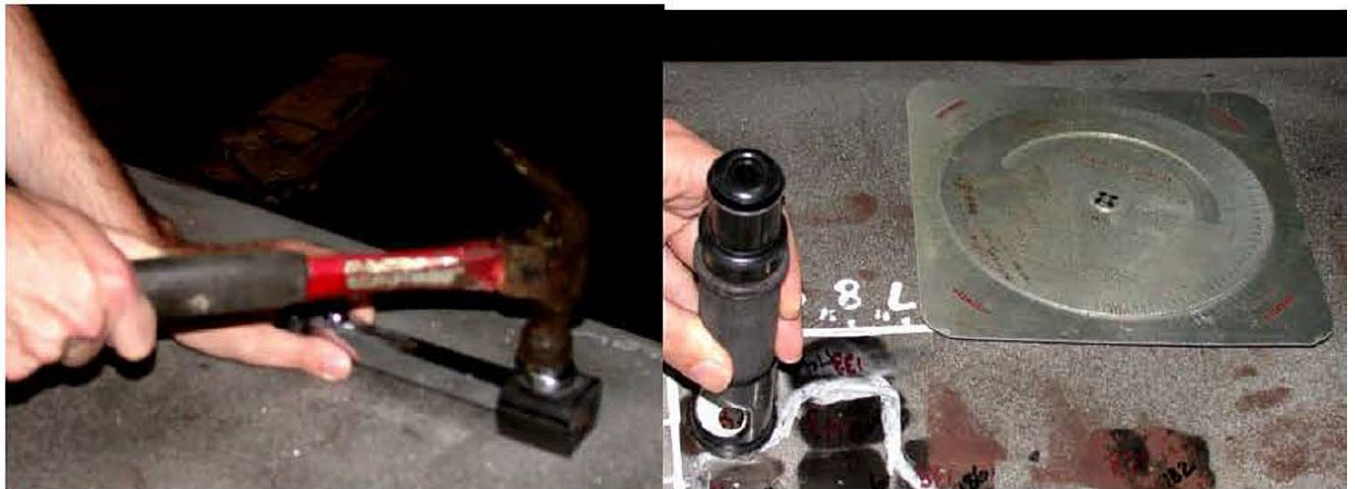
Figure 4. A view of the Telebrineller hardness test equipment. The image on the left shows the bar holder which contains the steel bar of known hardness (280 Brinell), and hammer. The bar holder has a hardened steel ball that creates simultaneous impressions in the pipe and steel bar when the holder is struck with the hammer. The image on the right shows the optical viewer that is used to measure the diameter of the impressions in the bar and in the pipe surface. The calculator is also shown in this image.

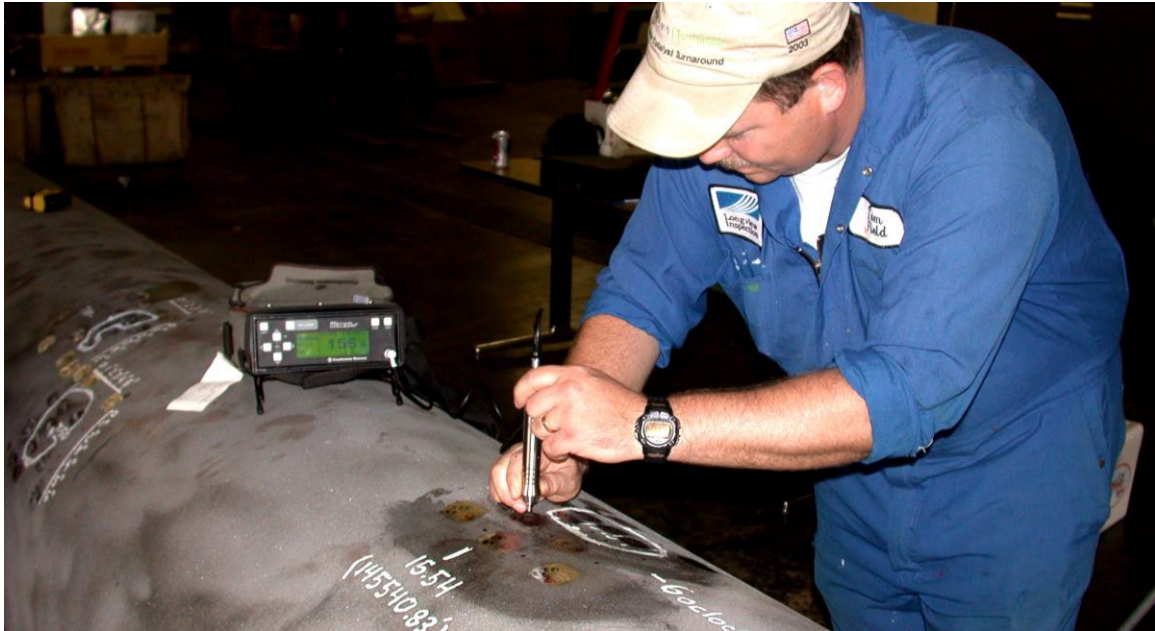
Figure 5. Microdur hardness testing. This method involves ultrasonic contact impedance principles that related the shift in longitudinal oscillation frequency to a Vickers hardness which was converted to Brinell hardness.
