### Federal Railroad Administration Tank Car Damage Assessment Form

Reporting Marks	UTLX 665072		Car Location City/State	Reed Point, MT
Date inspected	6/28/23	Railroad	MRL	DOT Specification
Last Contained	UN3257		Was product released?	Yes
(Jacket thickness)	Jacket 1196	Non-jacketed	Does car contain product	Yes
Car builder	Union Tank	Stub Sill Design	UTLZBG	Built Date 6/1/01
Capacity (GAL)	23,590		LD Limit (LB)	190,800

Tank car breached and was located in the river.

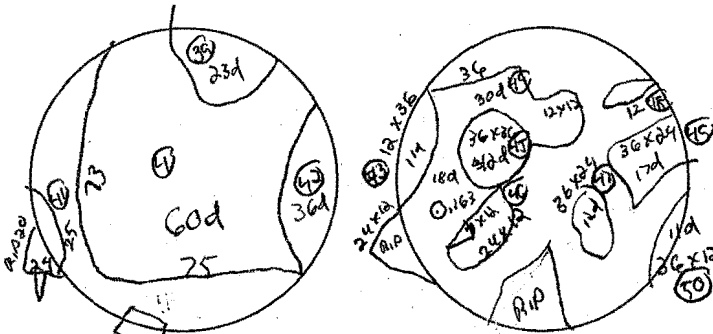
1.	Affected?	Jacket/Tank	Location?	Bottom A End	Dimensions:	Length	Width	Depth	11
-	Defect type?	Dent/breach	Shape?	Circle	Possible Cause?	Derailment/bridge failure/ head impact			
2	Affected?	Jacket	Location?	Bottom A End	Dimensions:	Length 36	Width 16	Depth 28

-	Defect type?	Dent	Shape?	Oval	Possible Cause?	Derailment/bridge failure			
3	Affected?	Jacket	Location?	Bottom B end	Dimensions:	Length 24	Width 24	Depth 2

-	Defect type?	Dent	Shape?	Semicircle	Possible Cause?	Derailment/bridge failure			
4	Affected?	Jacket	Location?	Bottom B end	Dimensions:	Length 36	Width 9	Depth 3

-	Defect type?	Scrape	Shape?	lines	Possible Cause?	Derailment/bridge failure			
5	Affected?	Jacket/Tank	Location?	Bottom B end	Dimensions:	Length 87	Width 64	Depth 36

-	Defect type?	Buckle	Shape?	Semicircle	Possible Cause?	Derailment/bridge failure			
6	Affected?	Jacket/Tank	Location?	Bottom B end	Dimensions:	Length 87	Width 64	Depth 36

-	Defect type?	Buckle	Shape?	Semicircle	Possible Cause?	Derailment/bridge failure			
7	Affected?	Jacket/Tank	Location?	Right B end	Dimensions:	Length 31	Width 96	Depth 31

-	Defect type?	Buckle	Shape?	Semicircle	Possible Cause?	Derailment/bridge failure			
8	Affected?	Jacket/Tank	Location?	Right B end	Dimensions:	Length 17	Width 96	Depth

-	Defect type?		Shape?	rectangle	Possible Cause?	Derailment/bridge failure
