Federal Railroad Administration  
Tank Car Damage Assessment Form

| Reporting Marks | UTLX 644827 | | Car Location City/State | Reed Point, MT | |
| Date inspected | 7/6/23 | Railroad | MRL | DOT Specification | 111A100W1 |

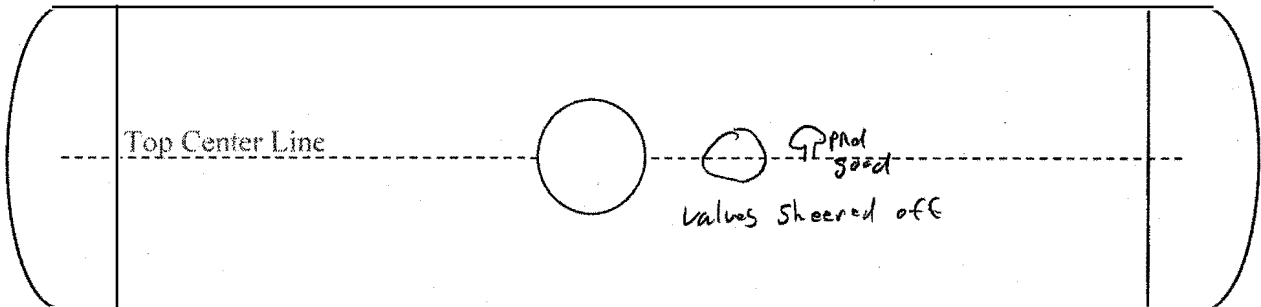
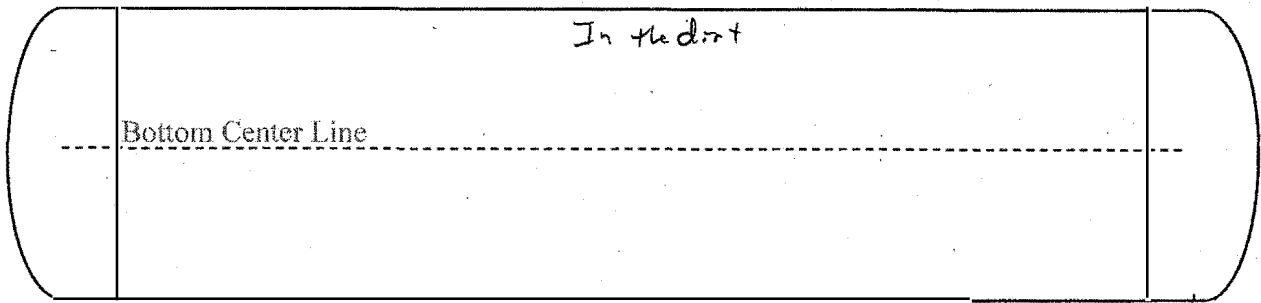
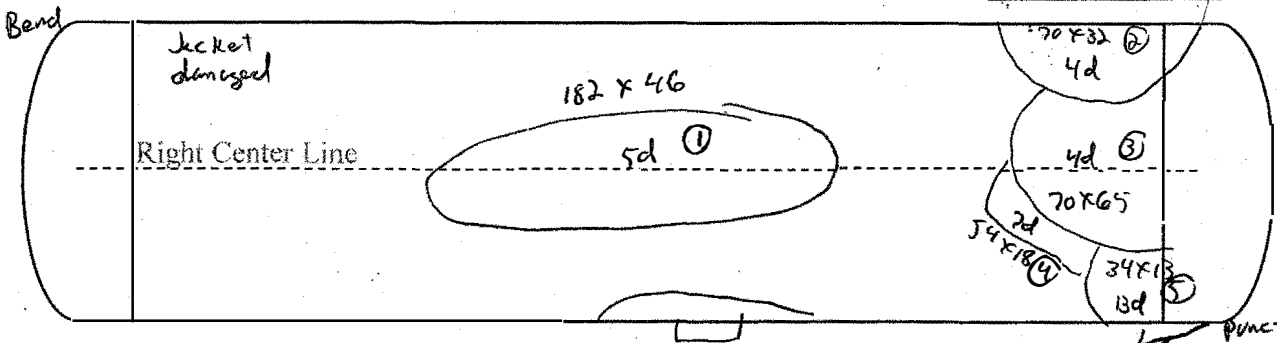
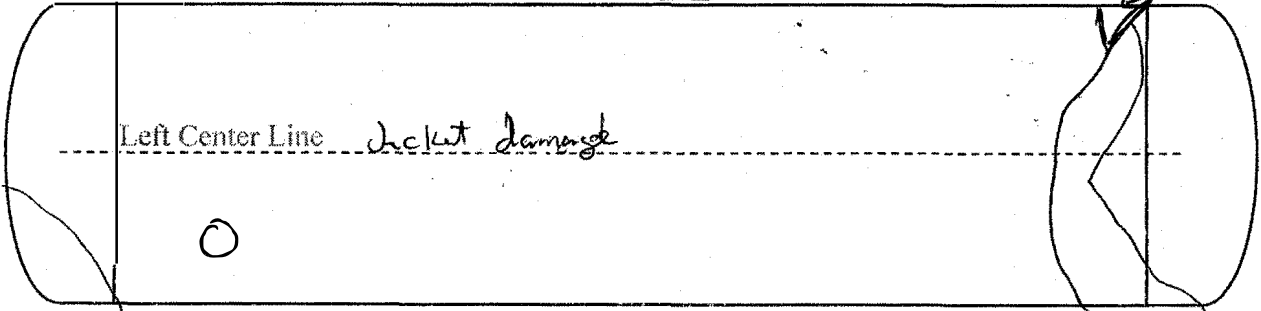
Indicate number on figures below within damaged areas. (sketched in by inspector)

| - | Defect type? | Dent | Shape? | Oval | Possible Cause? | Derailment/Bridge collapse | | | | | |
| - | Defect type? | Dent | Shape? | Semicir | Possible Cause? | Derailment/Bridge collapse | | | | | |
| - | Defect type? | Dent | Shape? | Rectang | Possible Cause? | Derailment/Bridge collapse | | | | | |
| - | Defect type? | Dent | Shape? | Circle | Possible Cause? | Derailment/Bridge collapse | | | | | |
| - | Defect type? | Dent | Shape? | Triangle | Possible Cause? | Derailment/Bridge collapse | | | | | |

Tank punctured on left side towards B head.  
Jacket missing of left side, B head and A head.
