Federal Railroad Administration  
Tank Car Damage Assessment Form

Reporting Marks	UTLY 641341		Car Location City/State	Reed point, Montana	
Date inspected	6/27/83	Railroad	MAL	DOT Specification	111A 100W3
Last Contained	UN3257 Class 9		Was product released?	Yes	
(Jacket thickness)	Jacket 0.1192	Non-jacketed	Does car contain product	Yes	
Car builder	Union Tank	Stub Sill Design	UTL2BN	Built Date	7/1/1989
Capacity (GAL)	23508		LD Limit (LB)	190500

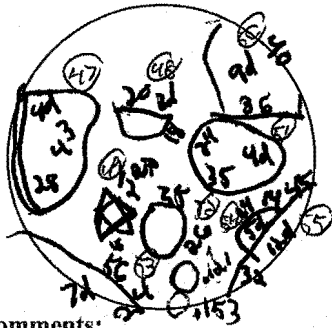
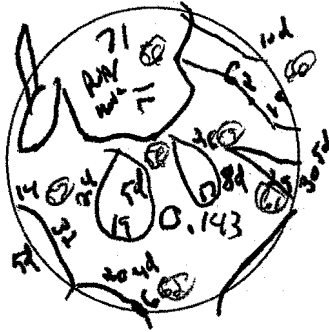
1.	Affected?	Jacket/Tank	Location?	Top A End	Dimensions:	Length	71	Width	70	Depth	
-	Defect type?	Breach	Shape?	Oval	Possible Cause?	Derailment into river.

2.	Affected?	Jacket/Tank	Location?	Top A End	Dimensions:	Length	24	Width	24	Depth	2
-	Defect type?	Dent	Shape?	Oval	Possible Cause?	Derailment into river.					
3	Affected?	Jacket/Tank	Location?	Top Center	Dimensions:	Length	36	Width	24	Depth	6

-	Defect type?	Dent	Shape?	Oval	Possible Cause?	Derailment into river.					
4	Affected?	Jacket/Tank	Location?	Top Center	Dimensions:	Length	36	Width	16	Depth	4

-	Defect type?	Dent	Shape?	Oval	Possible Cause?	Derailment into river.					
5	Affected?	Jacket/Tank	Location?	Top Center	Dimensions:	Length	36	Width	24	Depth	5

-	Defect type?	Dent	Shape?	Oval	Possible Cause?	Derailment into river.					
6	Affected?	Jacket/Tank	Location?	Top Center	Dimensions:	Length	24	Width	24	Depth	3

-	Defect type?	Dent	Shape?	Oval	Possible Cause?	Derailment into river.					
7	Affected?	Jacket/Tank	Location?	Top Center	Dimensions:	Length	24	Width	16	Depth	5

-	Defect type?	Dent	Shape?	Oval	Possible Cause?	Derailment into river.					
8	Affected?	Jacket/Tank	Location?	Top Center	Dimensions:	Length	36	Width	24	Depth	6

-	Defect type?	Dent	Shape?	Oval	Possible Cause?	Derailment into river.

9	Affected?	Jacket/Tank	Location?	Top B end	Dimensions:	Length	26	Width	18	Depth	6
-	Defect type?	Dent	Shape?	Oval	Possible Cause?	Derailment into river.					
10	Affected?	Jacket/Tank	Location?	Top B end	Dimensions:	Length	18	Width	36	Depth	8

-	Defect type?	Dent	Shape?	Oval	Possible Cause?	Derailment into river.					
11	Affected?	Jacket/Tank	Location?	Top B end	Dimensions:	Length	36	Width	8	Depth	6

-	Defect type?	Dent	Shape?	Oval	Possible Cause?	Derailment into river.					
12	Affected?	Jacket/Tank	Location?	Top B end	Dimensions:	Length	20	Width	18	Depth	2

-	Defect type?	Dent	Shape?	Oval	Possible Cause?	Derailment into river.					
13	Affected?	Jacket/Tank	Location?	Top B end	Dimensions:	Length	35	Width	28	Depth	4

-	Defect type?	Dent	Shape?	Oval	Possible Cause?	Derailment into river.					
14	Affected?	Jacket/Tank	Location?	Top B end	Dimensions:	Length	36	Width	24	Depth	5

15	Affected?	Jacket/Tank	Location?	Top B end	Dimensions:	Length	24	Width	12	Depth	6
-	Defect type?	Dent	Shape?	Oval	Possible Cause?	Derailment into river.					
16	Affected?	Jacket/Tank	Location?	Bottom center	Dimensions:	Length	10	Width	15	Depth	5

-	Defect type?	Dent	Shape?	Oval	Possible Cause?	Derailment into river.					
17	Affected?	Jacket/Tank	Location?	Bottom center	Dimensions:	Length	96	Width	35	Depth	4

-	Defect type?	Dent	Shape?	Oval	Possible Cause?	Derailment into river.					
18	Affected?	Jacket/Tank	Location?	Bottom center	Dimensions:	Length	24	Width	12	Depth	5

-	Defect type?	Dent	Shape?	Oval	Possible Cause?	Derailment into river.					
19	Affected?	Jacket/Tank	Location?	Bottom center	Dimensions:	Length	128	Width	84	Depth	26

-	Defect type?	Dent	Shape?	Oval	Possible Cause?	Derailment into river.					
20	Affected?	Jacket/Tank	Location?	Bottom center	Dimensions:	Length	158	Width	108	Depth	8

-	Defect type?	Dent	Shape?	Oval	Possible Cause?	Derailment into river.					
21	Affected?	Jacket/Tank	Location?	Right B end	Dimensions:	Length	22	Width	52	Depth	8
