Federal Railroad Administration Tank Car Damage Assessment Form

| Reporting Marks | CGTX 13864 | | Car Location City/State | Reed Point, Montana | |
| Date inspected | 6/29/23 | Railroad | MRL | DOT Specification | DOT 111AL00W1 |

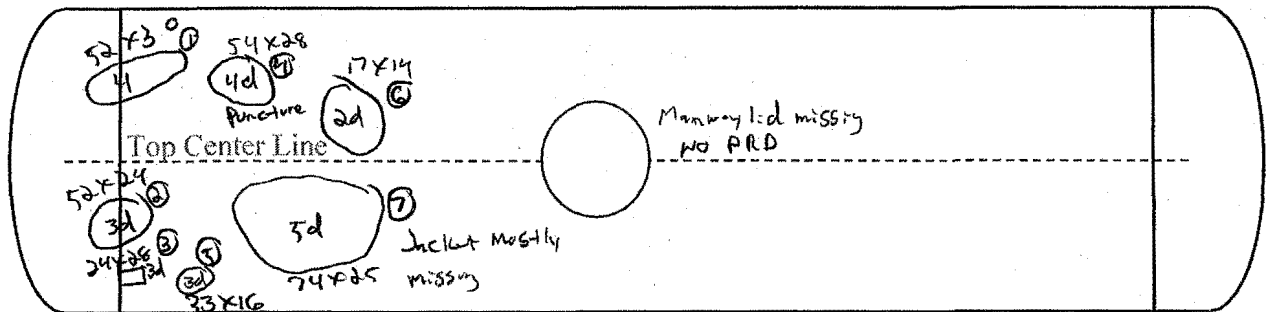
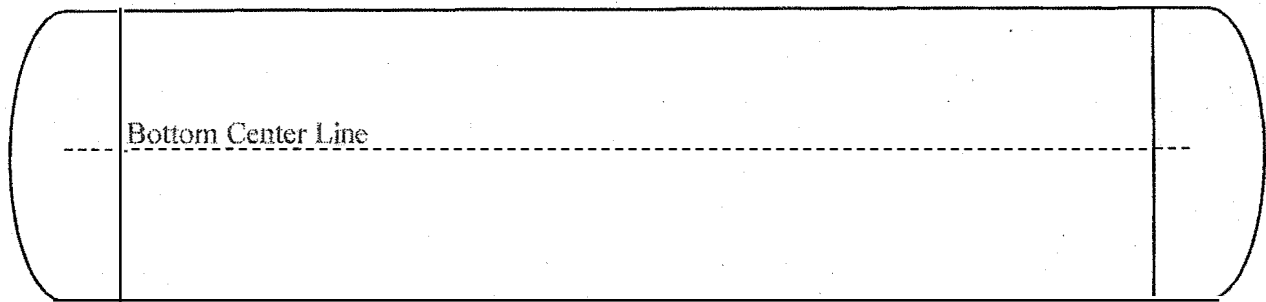
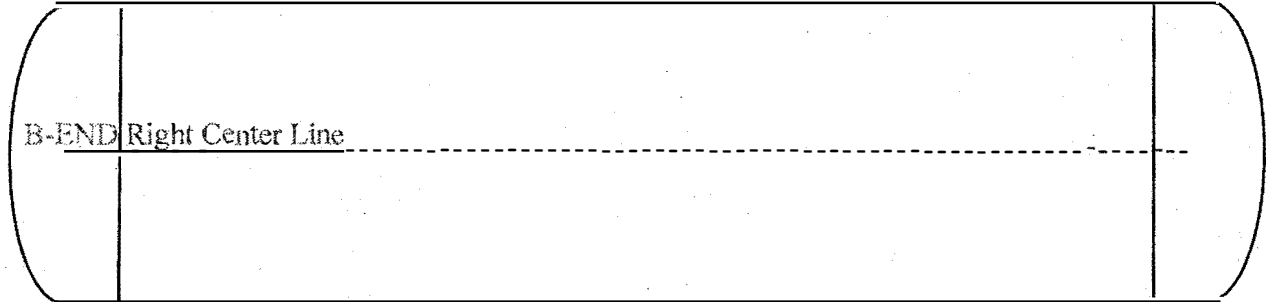
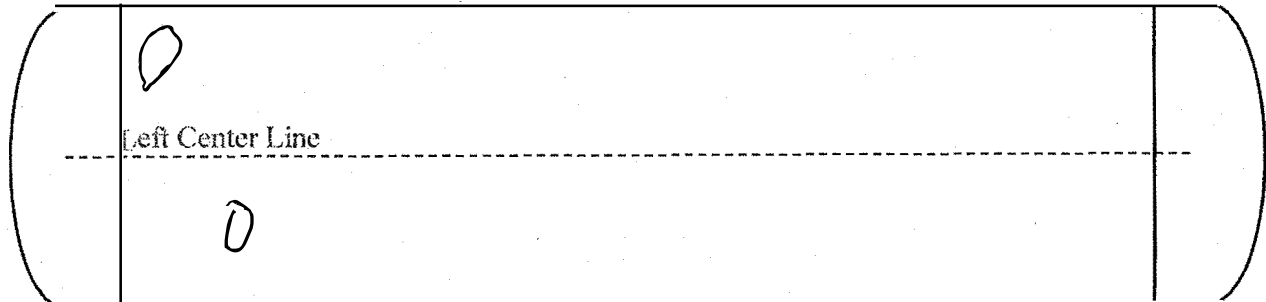
Indicate number on figures below within damaged areas. (Sketched in by inspector.)

Manway and PRD missing. A head punctured.

| 1 | Affected? | Jacket | Location? | Top, A end | Dimensions: | Length | 52 | Width | | Depth | 4 |
| - | Defect type? | Dent | Shape? | Oval | Possible Cause? | Derailment off a bridge into river. | | | | | |
| 2 | Affected? | Jacket | Location? | Top, A end | Dimensions: | Length | 52 | Width | 24 | Depth | 3 |
| - | Defect type? | Dent | Shape? | Circle | Possible Cause? | Derailment off a bridge into river. | | | | | |
