# National Transportation Safety Board

HWY23FH008

## **CONSOLIDATED FACTUAL REPORT**

Goodyear, Arizona Group Chair's Factual Report

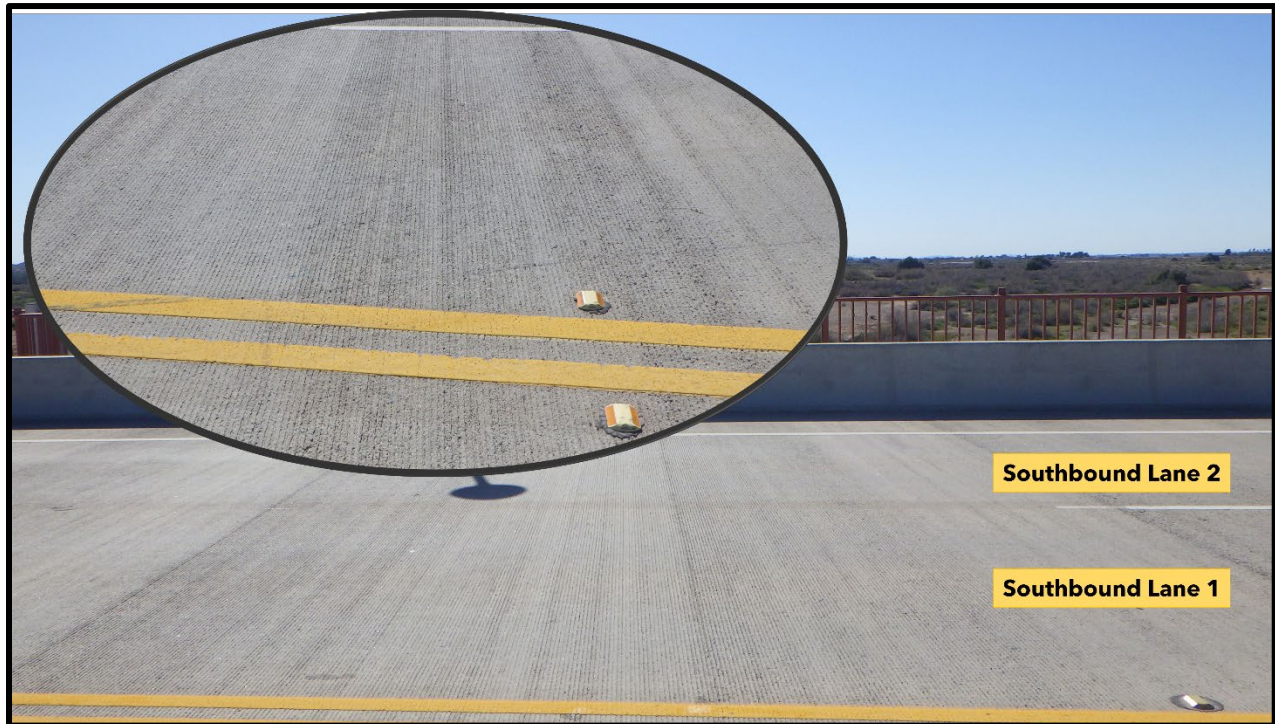
**Figure 3: Concrete surface on Cotton Lane Bridge**

The 8-inch-thick deck was poured concrete with transverse grooves on the surface (transverse tining), as shown in Figure 3. Further outside the concrete barrier were sidewalks extending along the entire length of the bridge. The concrete barrier protected pedestrians walking on the bridge, redirected vehicles toward the path of

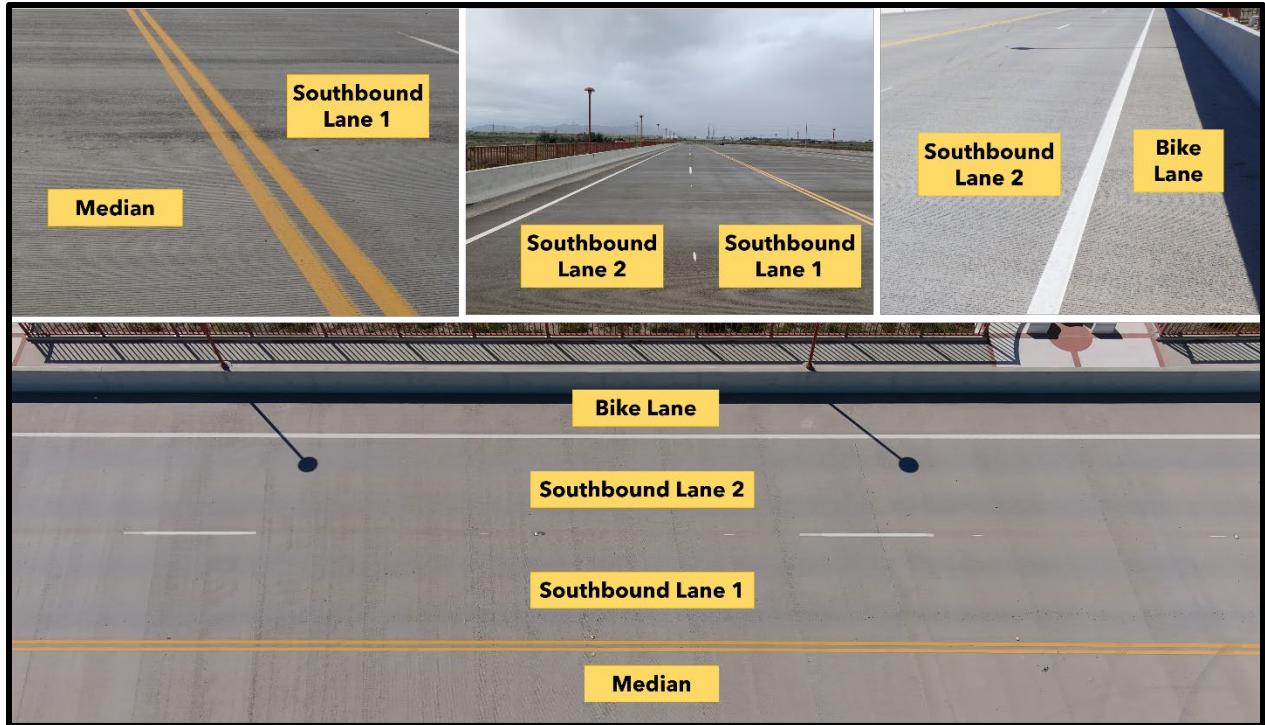
**Figure 4: Pavement marking on the Cotton Lane Bridge**  
(lower picture source GPD)

Highway measurements were obtained at a cross-section of the bridge south of the tire marks on the concrete barrier. The dimensions of the road are summarized in Table 1. The pavement markings on the Cotton Lane Bridge were clear and in good condition. This included the solid double yellow lines between the median and Lane 1, the broken white lane lines between Lane 1 and Lane 2, and the solid white fog line between Lane 2 and the bicycle lane (see Figure 4).

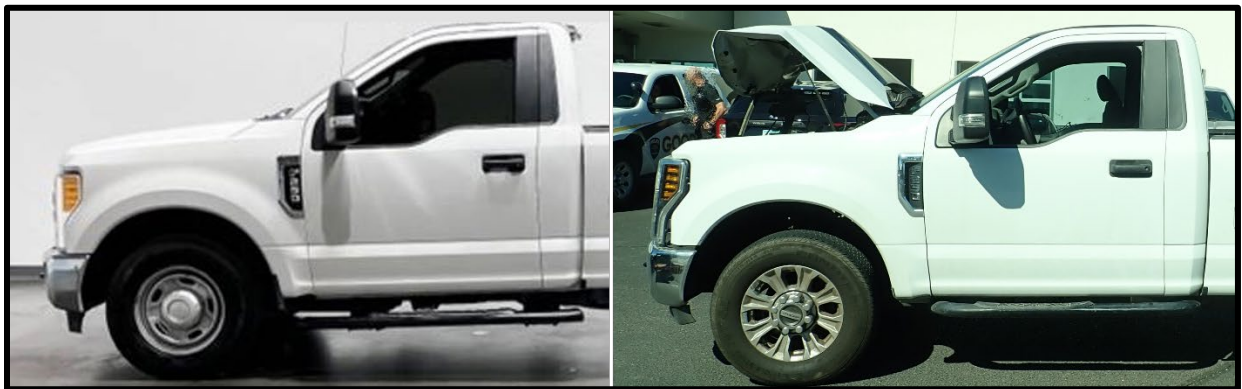
**Figure 15: Left side view of the subject pickup with exemplar.**

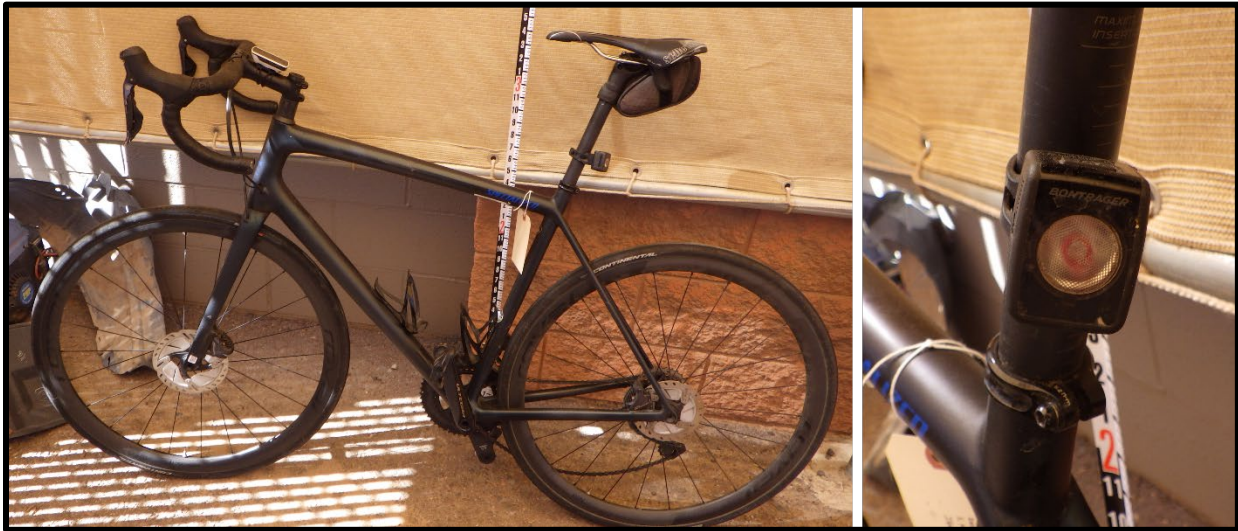
Figure 24: Inspection photos of Specialized Aethos bicycle.

<b>Brand</b>	Specialized
<b>Model</b>	Aethos
<b>Serial Number</b>	WSBC004419773R
<b>Owner</b>	B04
<b>Rear reflector/light present</b>	Bontrager light
<b>Seat height from the ground</b>	107.5 cm
<b>Notes</b>	Front and rear tires rotated freely.

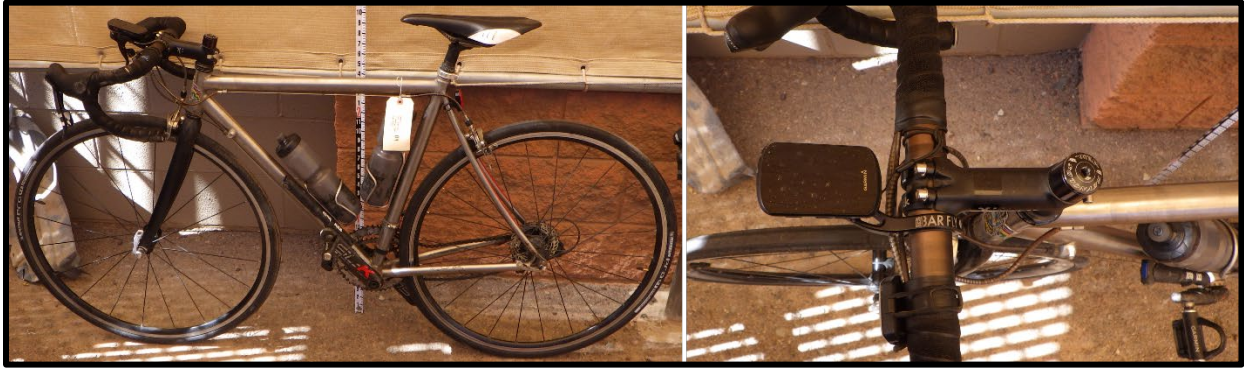
Figure 25: Inspection photos of Litespeed bicycle.

<b>Brand</b>	Litespeed
<b>Model</b>	Unknown
<b>Serial Number</b>	Unknown
<b>Owner</b>	B05
<b>Rear reflector/light present</b>	Reflector
<b>Seat height from the ground</b>	92 cm
<b>Notes</b>	The front tire was locked; the rear tire rotated freely.

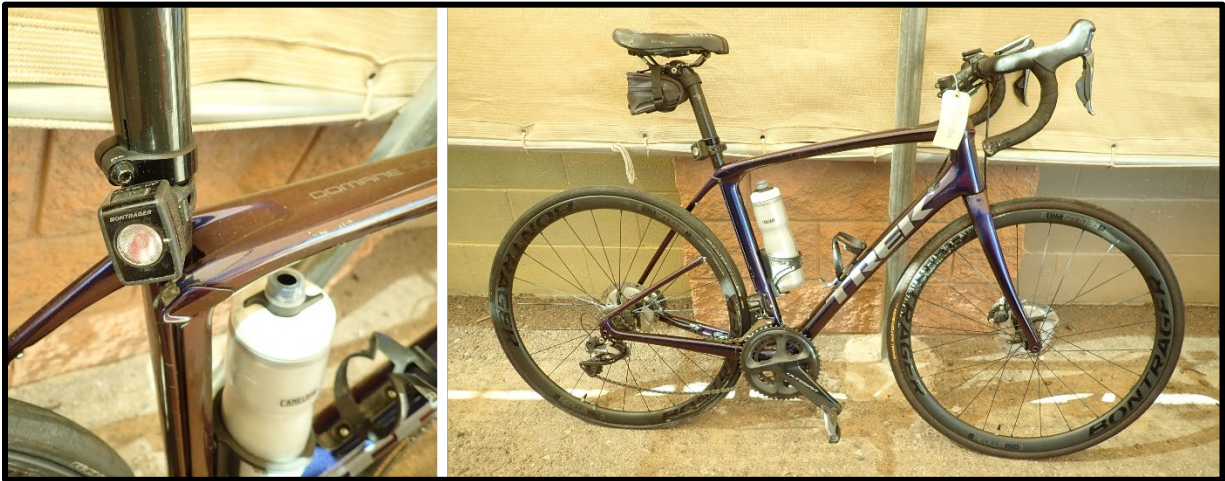
**Figure 33: Inspection photos of Trek Domane SLR bicycle.**

<b>Brand</b>	Trek
<b>Model</b>	Domane SLR
<b>Serial Number</b>	WTU092T0014P
<b>Owner</b>	B14
<b>Rear reflector/light present</b>	Bontrager Rear Light
<b>Seat height from the ground</b>	Not measured
<b>Notes</b>	None

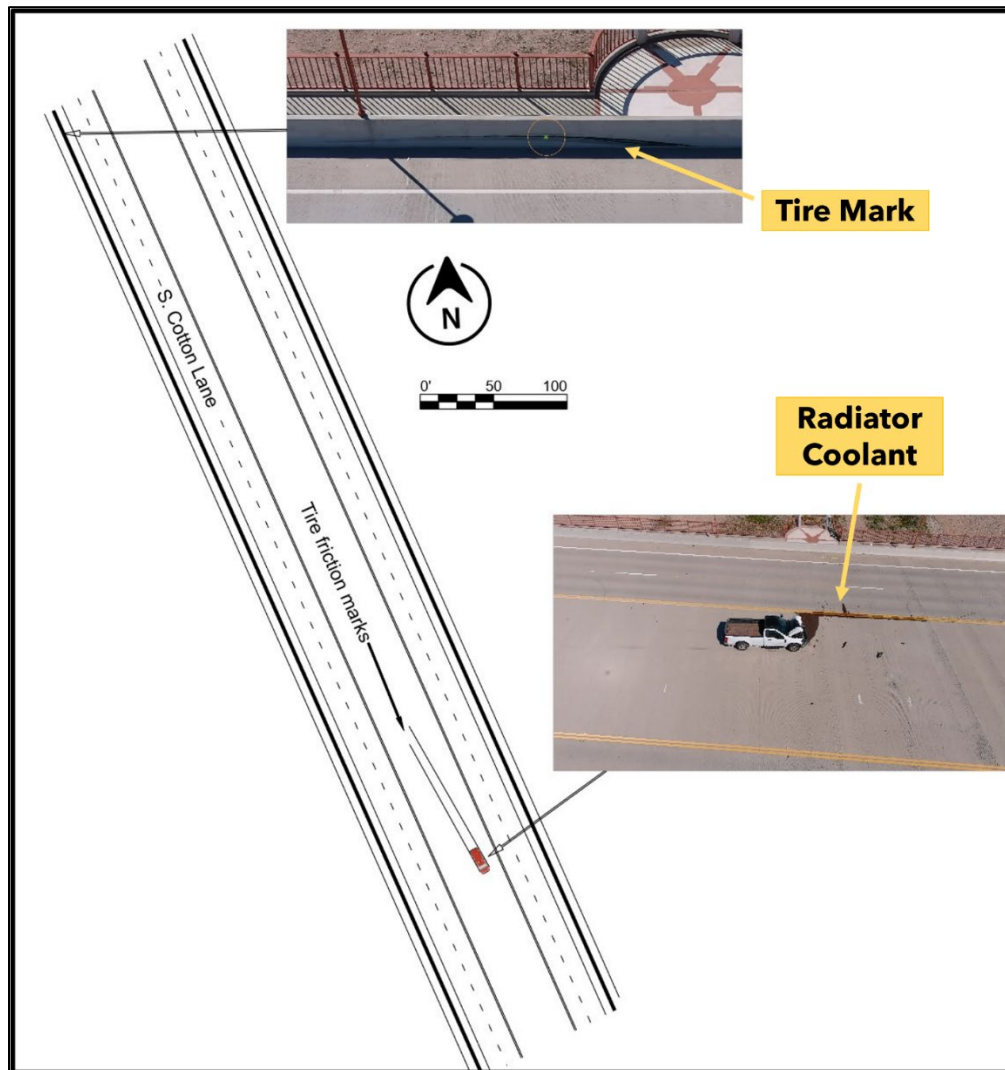
**Figure 38: Scaled diagram of crash scene**  
(source GPD)

Two additional tire friction marks were identified and documented by GPD. The two marks terminated at the right front and left front of the pickup. The tire mark associated with the right front measured approximately 99-feet and the left front measured about 110-feet. These two parallel tire marks started approximately in the center of the median and angled southeast to the spot of the pickup's final rest. Each friction mark had an intermittent pattern between light and dark areas. Between the tire mark on the concrete barrier and the final rest of the pickup were numerous bicycle component debris coupled with surface scrapes and narrow rubber smears. Figure 38 is an image of the scaled diagram showing the location of the initial tire mark on the barrier, the tire friction marks, and the final rest of the pickup. The top inset photograph is an image from the three-dimensional point cloud depicting the mark on the barrier. The lower inset photograph is an aerial photograph showing the final rest of the pickup. The fluid on the ground next to the pickup is radiator coolant that leaked out of the vehicle after the crash.
