National Transportation Safety Board

HWY23FH013

SURVIVAL FACTORS AND HUMAN PERFORMANCE

Group Chair's Factual Report

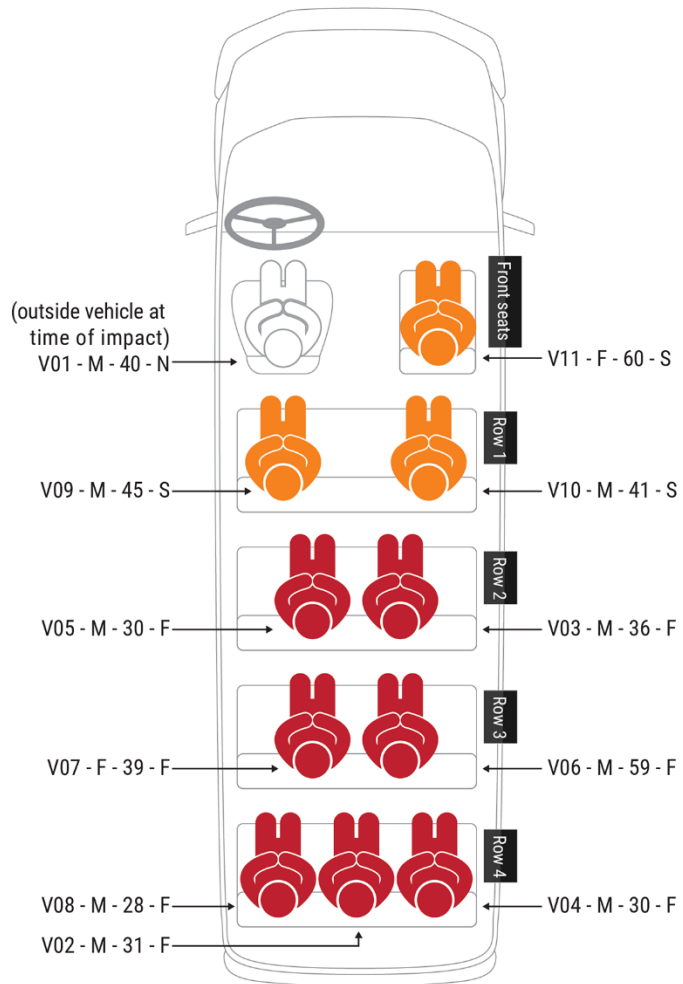
Figure 9: Van Seating Diagram.

Before the crash, the van's driver (V01) was outside the vehicle fixing an issue with the utility trailer and ran out of the way when he saw the 2018 truck approaching their vehicle. The other ten occupants were in the van. A summary of the occupants is given in Table 3. Note that the autopsy reports were not released to the NTSB. Therefore, the injuries to the fatalities are unknown. A seating diagram of the occupants is shown in Figure 9.

⁵ NTSB inspection photos of the Row 1 bench seat showed the lap belts on the vehicle's floor. This was confirmed with OSP photos of the vehicle before the deceased were removed. These occupants (V09 and V10) were considered unbelted. The driver (V01) reported seeing V11 after the crash, and she was wearing her seat belt. The other occupants were likely unrestrained. However, this could not be confirmed as the NTSB was not allowed to inspect the interior of the vehicle.

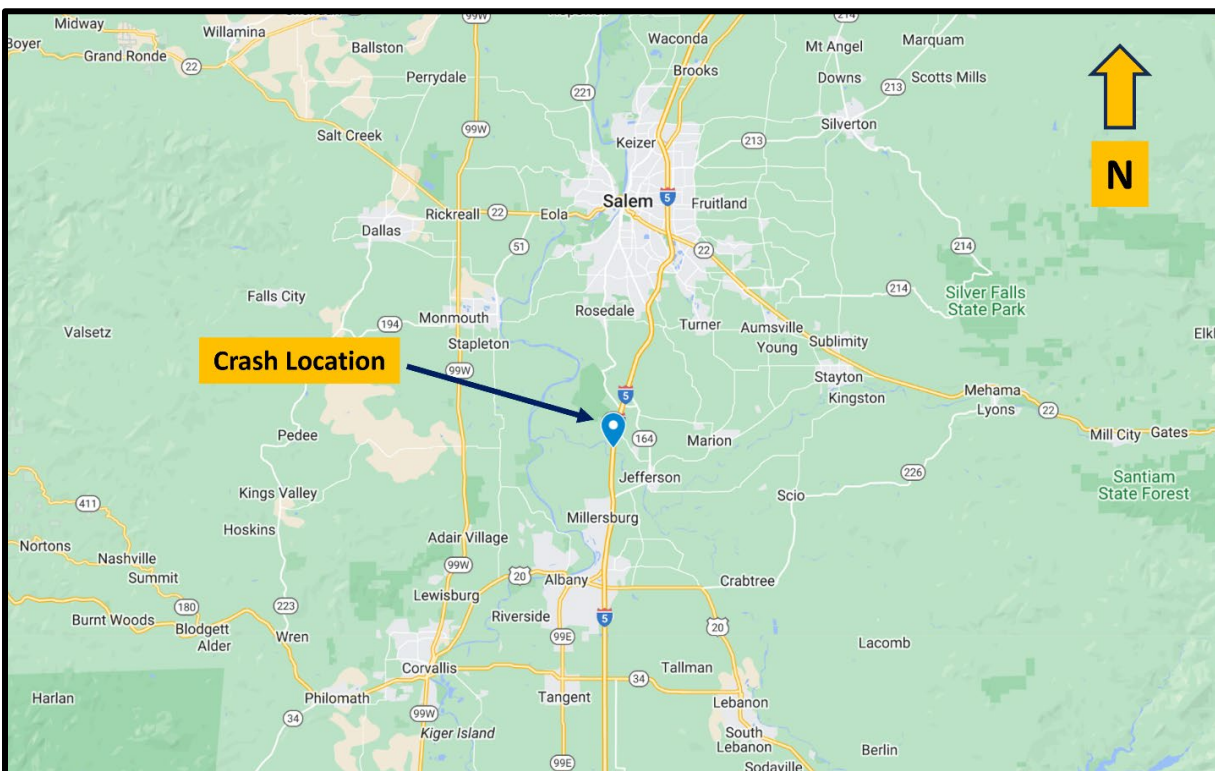
Figure 12: Crash location on I-5

NTSB investigators visited the crash location on May 22, 2023 (Figure 12). The scene was on the northbound side of Interstate 5 (I-5) near mile marker 241 in Marion County, OR (44.74184 degrees north latitude and 123.05193 degrees west latitude).

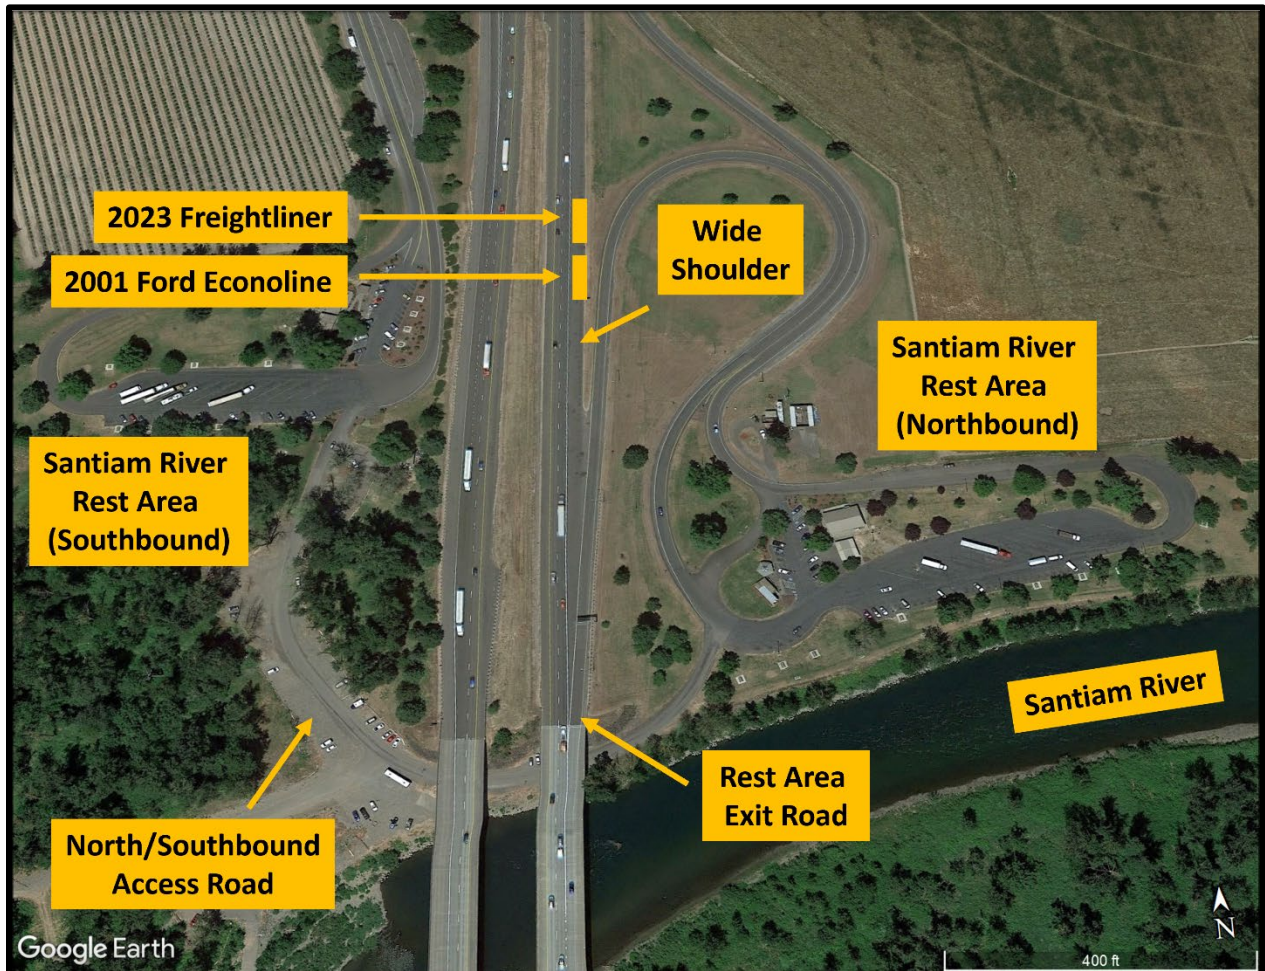
Figure 13: Santiam rest area.
(Source annotated Google Earth)

I-5 had two travel lanes in each direction, separated by an earthen median and a semi-rigid W-beam median barrier. The crash occurred north of the Santiam River Rest Area exit on an 18-foot-wide shoulder. After the gore point, the exit lane branched off the right travel lane, and the area in between transitioned to the wide shoulder (see Figure 13).

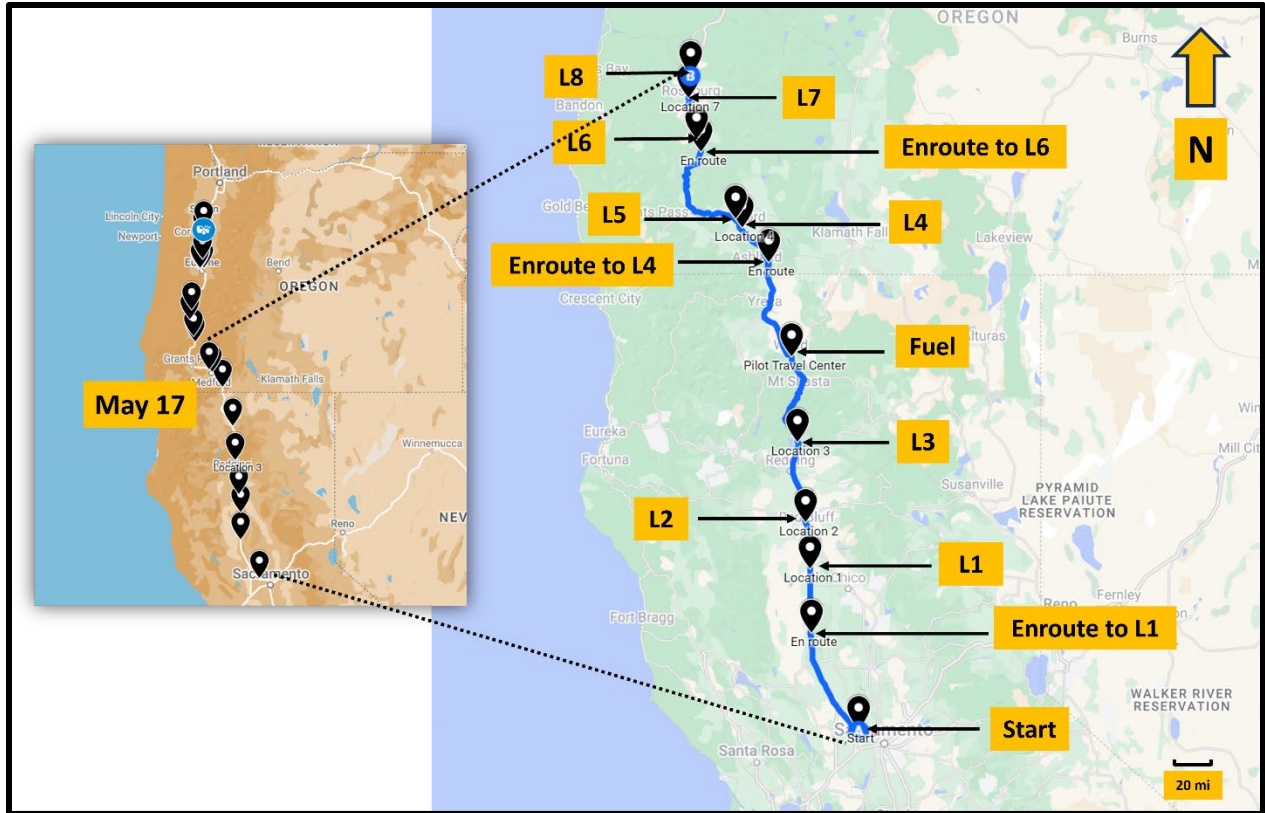
Figure 14: 2018 truck travel on the day before the crash
 (Source: annotated Google Maps)

The 2018 truck ELD was analyzed for his trip from California to Oregon. The trip details for the first day (May 17) are shown in Figure 14 and Table 12 and the second day (the day of the crash) in Figure 15 and Table 13. He started driving at 3:14 a.m. on May 17th and covered 417 miles. He made eight stops, and most of the driving was completed by 7:53 p.m. On the day of the crash, he started at 7:22 a.m. and drove 135 miles until the crash at 2:05 p.m. He made six stops before the crash.
