**NATIONAL TRANSPORTATION SAFETY BOARD  
OFFICE OF HIGHWAY SAFETY  
WASHINGTON, D.C.**

**TECHNICAL RECONSTRUCTION GROUP CHAIRMAN'S  
FACTUAL REPORT**

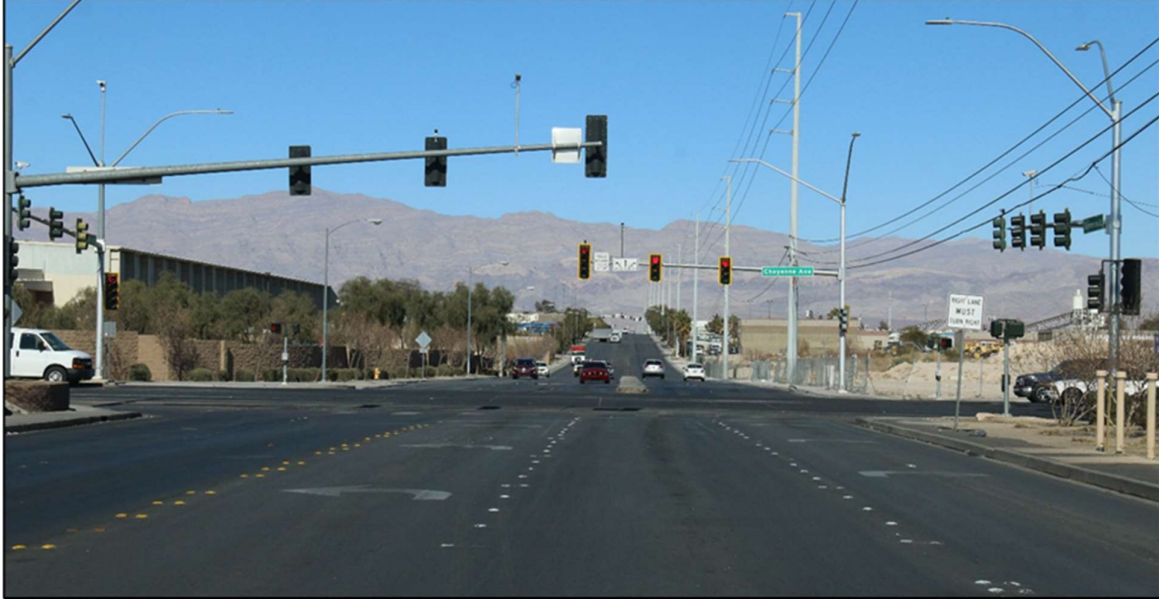
Raised pavement markers (RPMs) are used for lane delineation<sup>9</sup>. RPM colors included yellow for centerline features and white for same-direction lane delineation. Painted pavement markings included stop lines, crosswalks and turn lane direction arrows.<sup>10</sup> Painted pavement markings appeared somewhat faded but were otherwise visible. **Figure 4** is a photograph depicting the northbound approach to the Cheyenne Ave intersection.

**Figure 4:** Photograph depicting immediate northbound N. Commerce Street approach to the intersection with Cheyenne Ave.

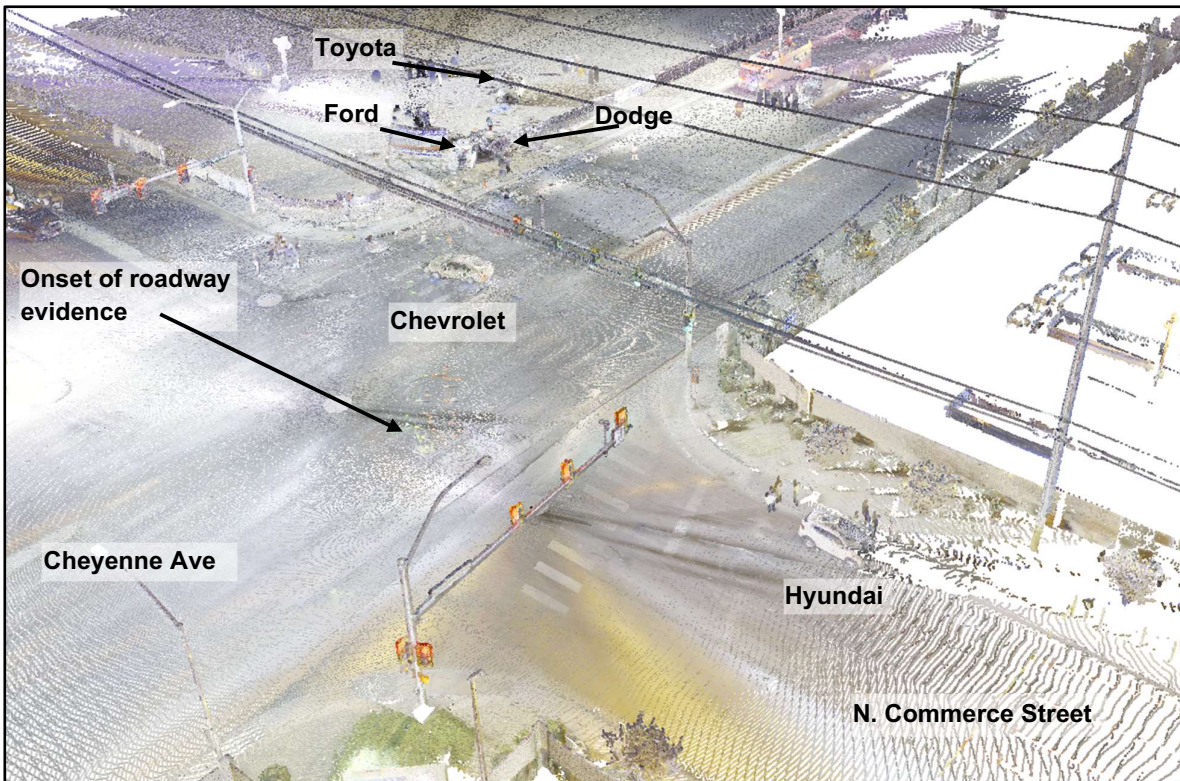
The post-collision positions of rest for the vehicles involved in the collision were identified through photographs and a terrestrial three-dimensional scan project provided by police investigators. **Figure 6** depicts a screen capture of the 3D point cloud of the intersection as viewed from the southwest corner at an oblique angle. **Figure 7** represents a two-dimensional diagram of the intersection depicting the final positions of rest for the involved vehicles.

**Figure 6:** Unmodified screen capture image (to be replaced with 2D diagram) of intersection post-crash as viewed at an oblique angle from the southwest corner.
