MDTA 2023 Bridge Inspection Report (S17-S19)

MARYLAND TRANSPORTATION AUTHORITY
FSK-Francis Scott Key Bridge
Bridge - Biennial
FOR
STRUCTURE No. BCZ472001(S17-S19)
IS 695 OVER PATAPSCO RIVER

BIN: BCZ472001(S17-S19)

Date: 01/09/2023

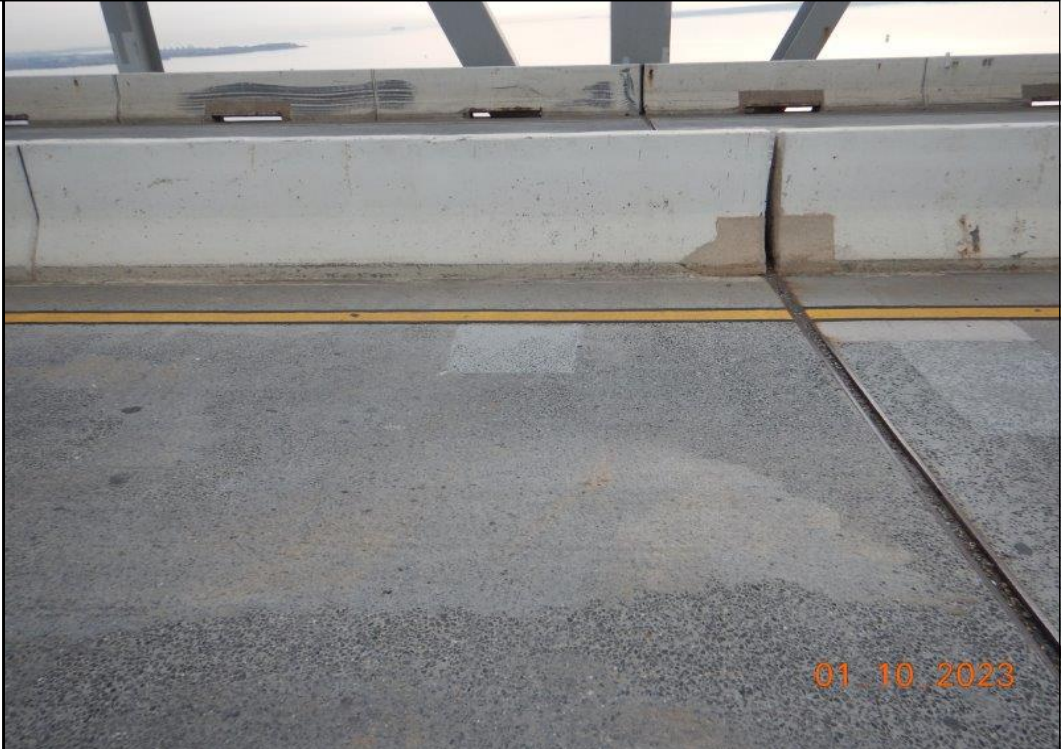
Photos	
<p>PHOTO NO.: 1</p> <p>Location: Span 17, Southbound Left Lane, 4'-0" north of PP21, along the left wheel line.</p> <p>Direction: East</p> <p>Description: There is a 1'-6" long x 1'-3" wide x up to 2" deep spall. FY 2023 Inspection: This defect has been repaired. Repair status changed to CLOSE-CONSULTANT.</p> <p>Element #: 58.01 - Wearing Surface</p> <p>Rating #: 5</p> <p>MDTA Repair: 2 Repair Id: 2021-BCZ472001(S17-S19)-00043</p>

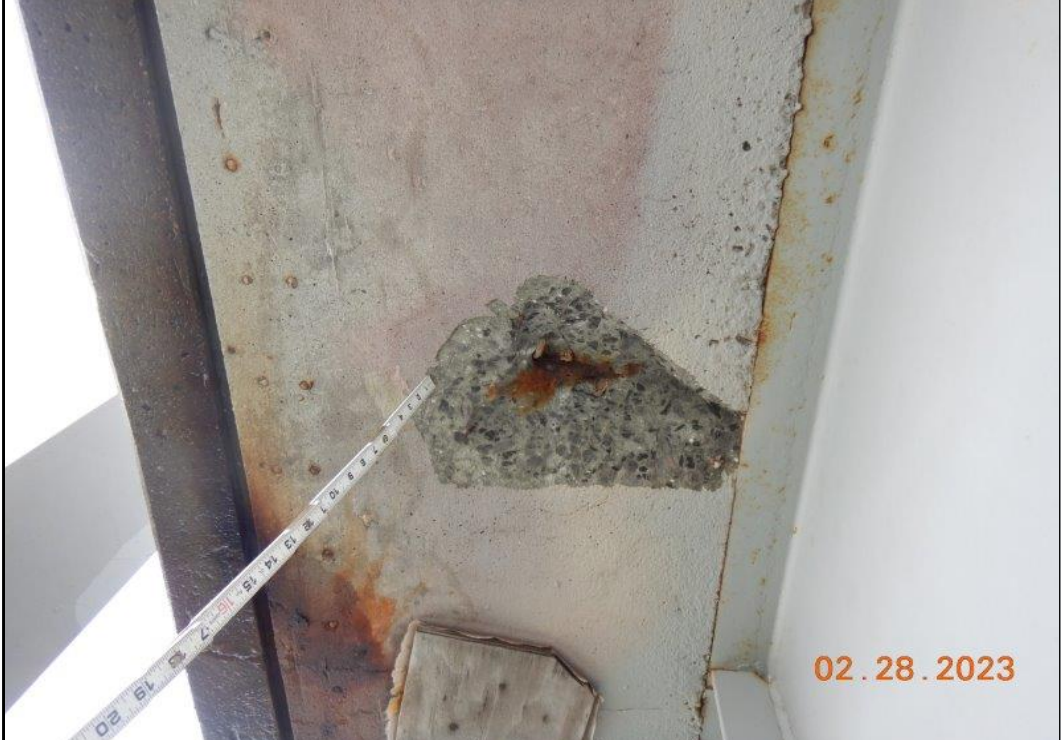
<p>PHOTO NO.: 2</p> <p>Location: Span 17, West Fascia, underside of overhang, over L6</p> <p>Direction: North</p> <p>Description: There is a 1'-0" diameter x 2 1/2" deep spall with exposed reinforcement.</p> <p>Element #: 58.03 - Fascias</p> <p>Rating #: 5</p> <p>MDTA Repair: 3 Repair Id: 2019-BCZ472001(S17-S19)-00427</p>

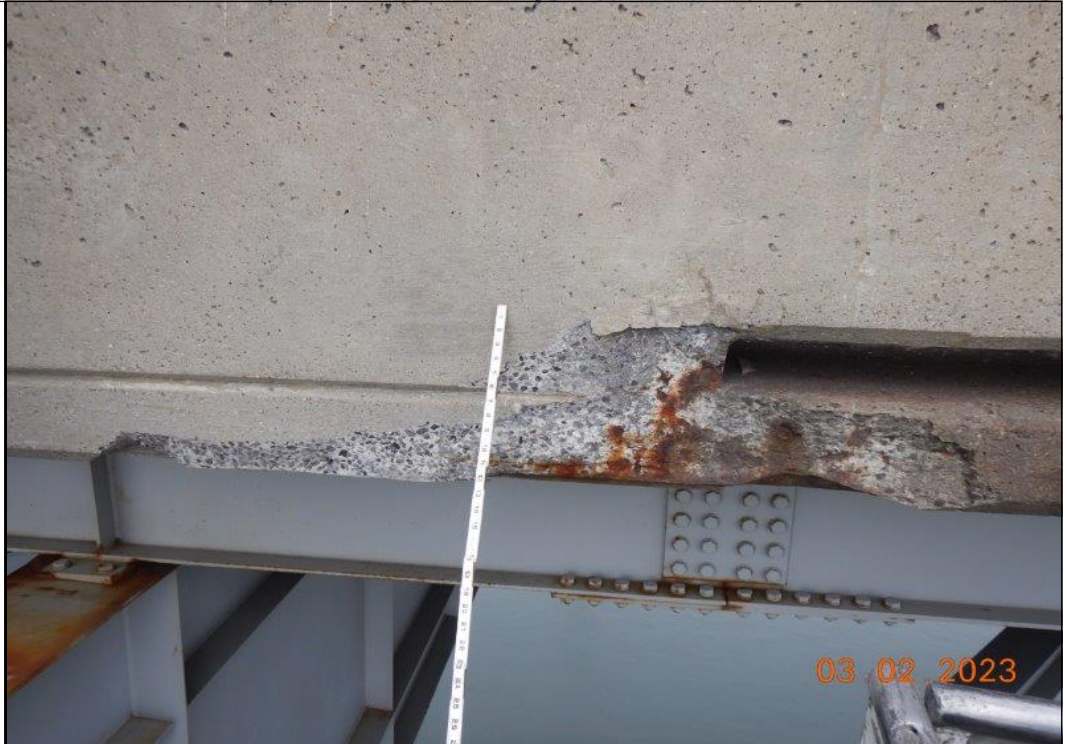
PHOTO NO.: 5
Location: Span 17, East Fascia, 2'-0" north of PP8
Direction: West
Description: There is a 5'-0" long x 1'-0" high x up to 3" deep spall with exposed and corroded reinforcement.
Element #: 58.03 - Fascias
Rating #: 5
MDTA Repair: 3
Repair Id: 2021-BCZ472001(S17-S19)-00002

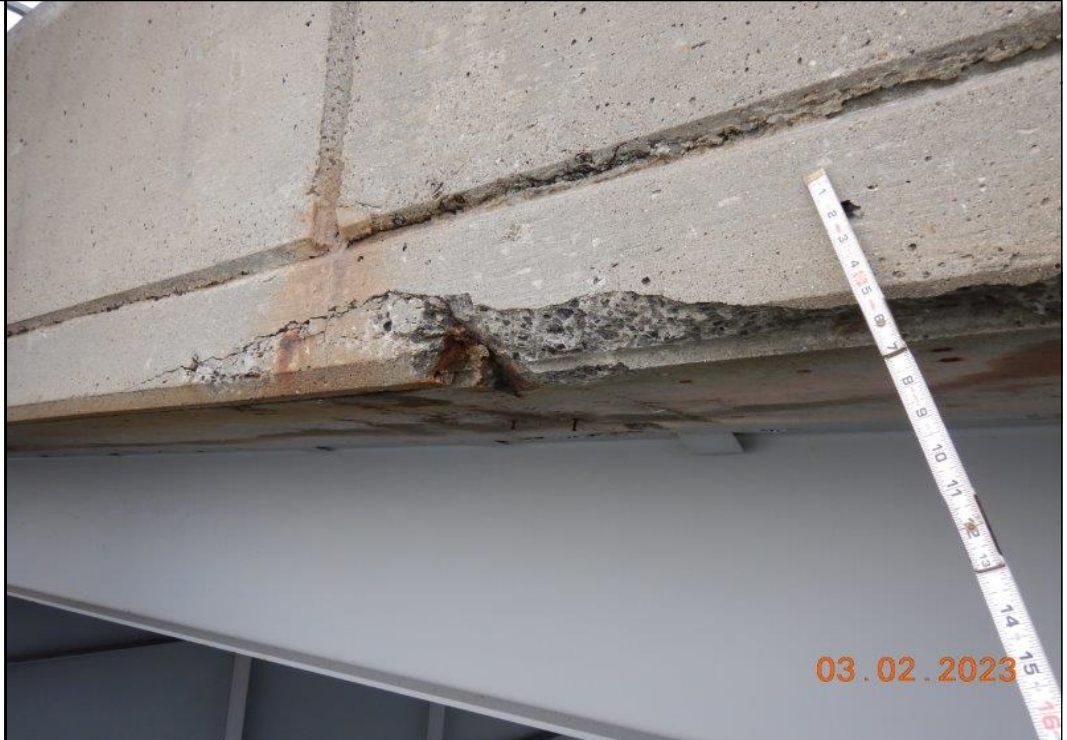
PHOTO NO.: 6
Location: Span 17, East Fascia, at the mid-point between PP11 and PP 12
Direction: Southwest
Description: There is a 2'-1" long x 4" high x 6" deep edge spall with exposed and corroded reinforcement and adjacent delamination 2'-3" long x 4" high x 6" wide.
Element #: 58.03 - Fascias
Rating #: 5
MDTA Repair: 2
Repair Id: 2021-BCZ472001(S17-S19)-00003

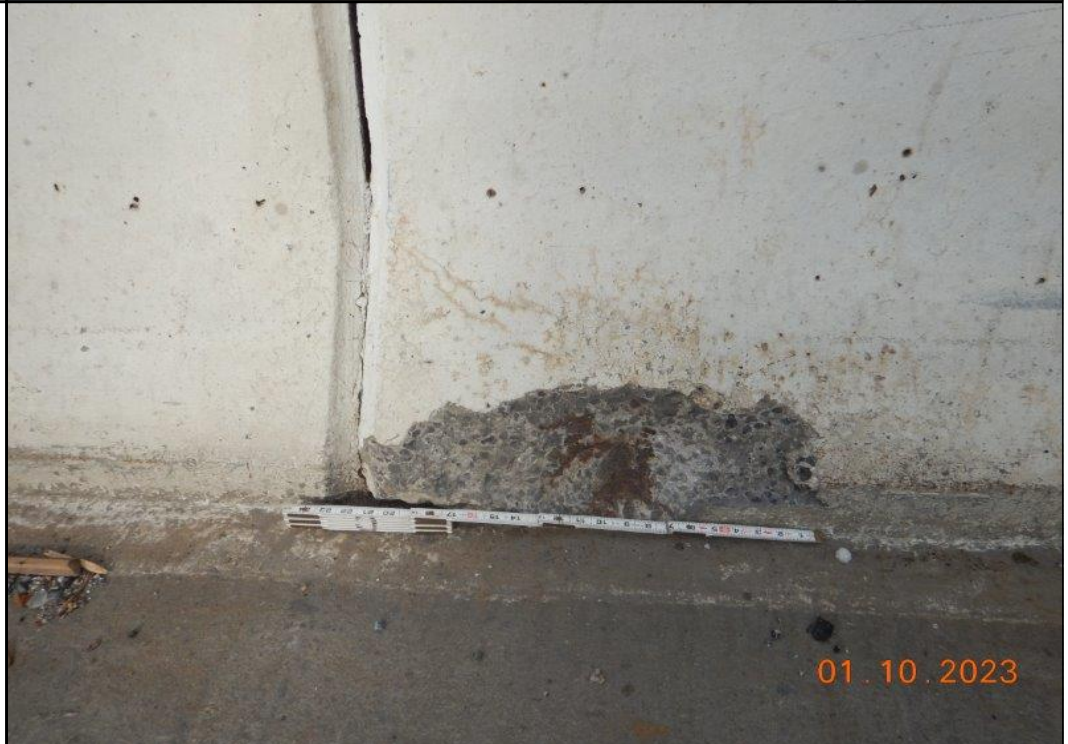
PHOTO NO.: 9

Location: Span 17, West Parapet, West Face, between PP5 and PP6.

Rating #: 5

MDTA Repair: 2
Repair Id: 2019-BCZ472001(S17-S19)-00033

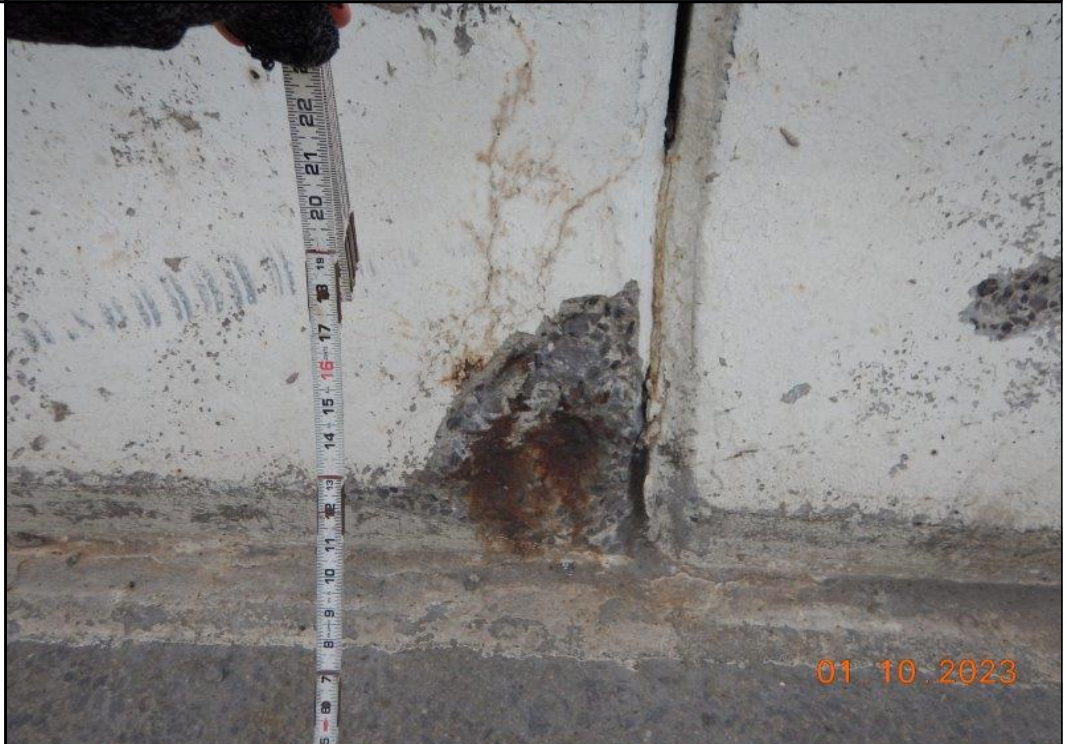
PHOTO NO.: 12
Location: Span 17, Median, West Face, 15'-0" north of PP19
Direction: East
Description: There is a 9" wide x 1'-0" high x 2" deep spall with exposed corroded steel reinforcement.
Element #: 58.06 - Median
Rating #: 5
MDTA Repair: 2
Repair Id: 2021-BCZ472001(S17-S19)-00008

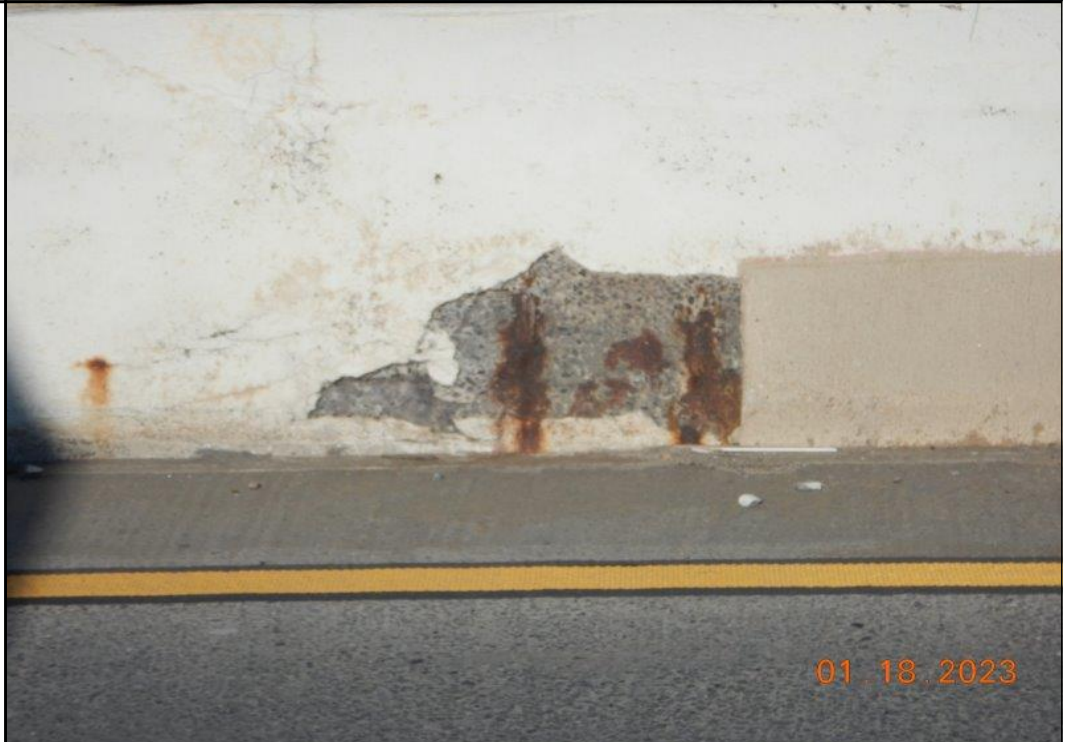
PHOTO NO.: 14
Location: Span 17, Median, East Face, at the base, 4'-0" south of PP17
Direction: West
Description: There is a 2'-6" wide x 1'-2" high x 1" deep spall with exposed corroded steel reinforcement and an adjacent 1'-6" wide x 1'-0" high delamination.
Element #: 58.06 - Median
Rating #: 5
MDTA Repair: 2
Repair Id: 2013-BCZ472001(S17-S19)-00176

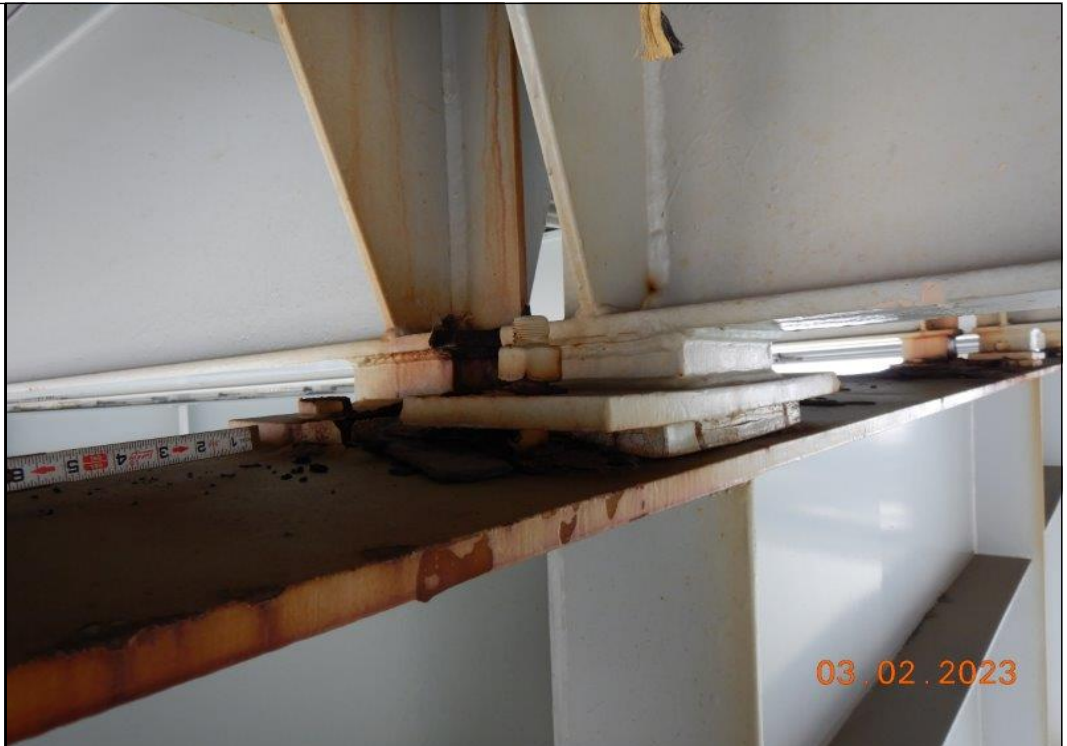
PHOTO NO.: 19
Location: Span 17, Stringer Bearings, at Floorbeam 9
Direction: Southwest
Description: There is minor to moderate corrosion throughout. Corrosion is worst on Stringer 6, 7, and 8 Bearings, with moderate corrosion and delamination.
Element #: 59.PP 09 - PP 10
Rating #: 7
MDTA Repair: 3
Repair Id: 2019-BCZ472001(S17-S19)-00396

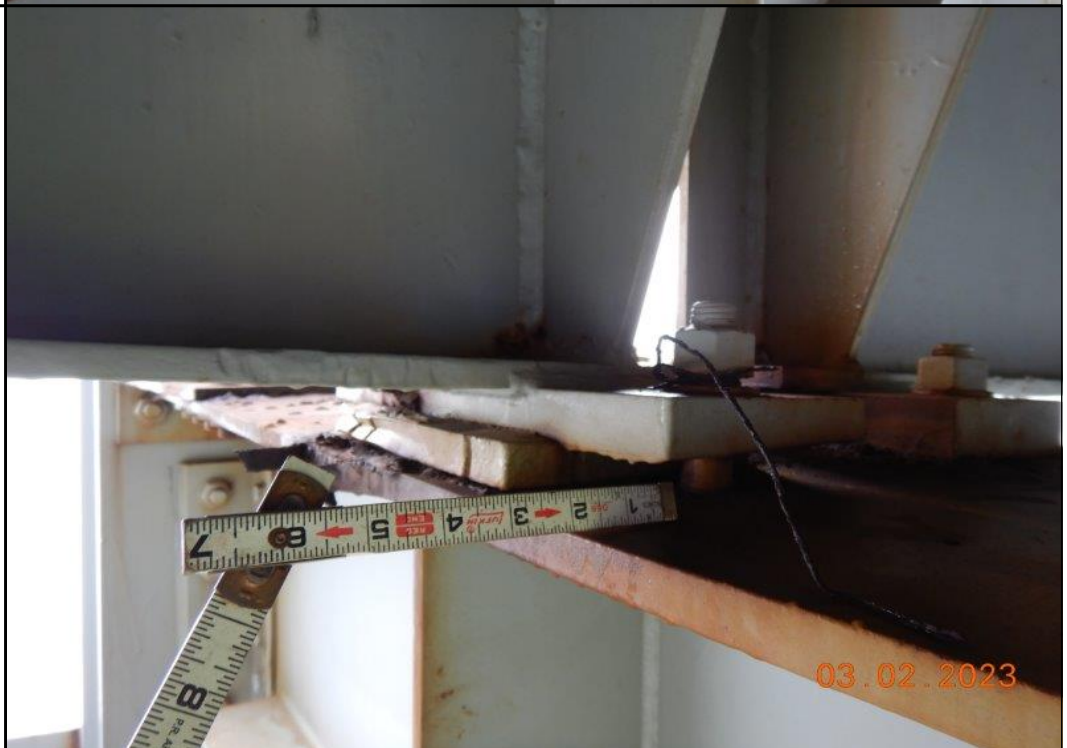
PHOTO NO.: 20
Location: Span 17, Stringer 9 Bearing, at Floorbeam 9
Direction: Southeast
Description: The bearing pad is improperly sized and overhangs the sole plate by 1" on the north edge, but is flush on the south edge.
Element #: 59.PP 09 - PP 10
Rating #: 7
MDTA Repair: 3
Repair Id: 2019-BCZ472001(S17-S19)-00412

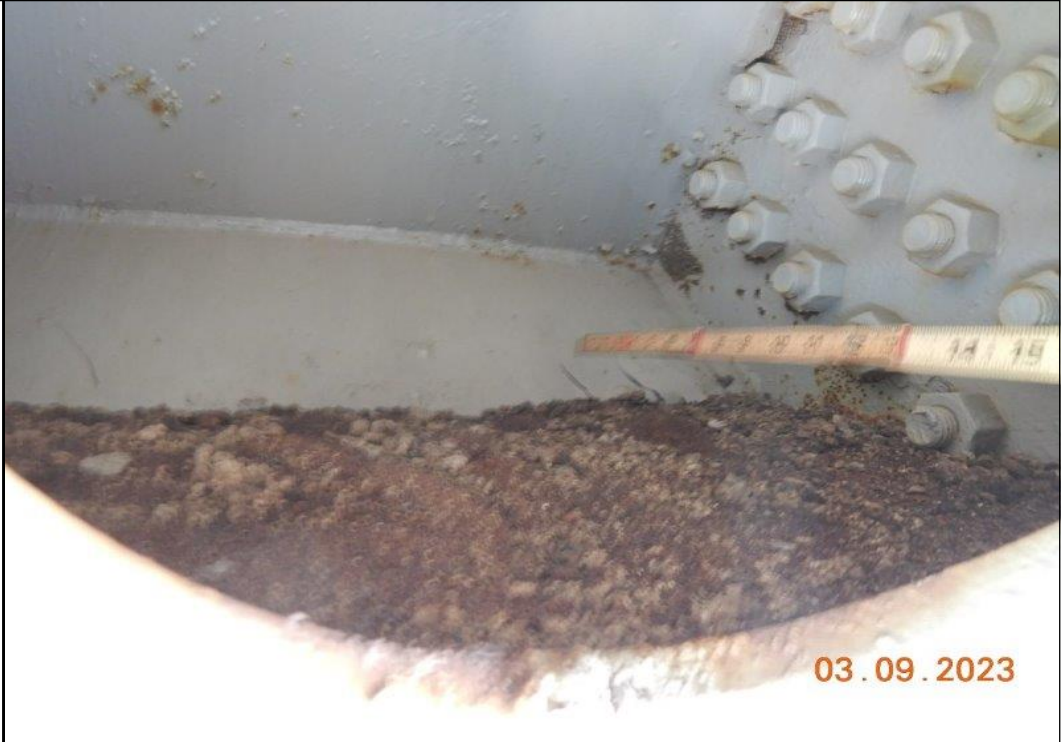
PHOTO NO.: 24

Location: Span 17, East
Truss, U11-M12, Top
Handhole at U11

Rating #: 7

MDTA Repair: 3
Repair Id: 2013-
BCZ472001(S17-S19)-00149

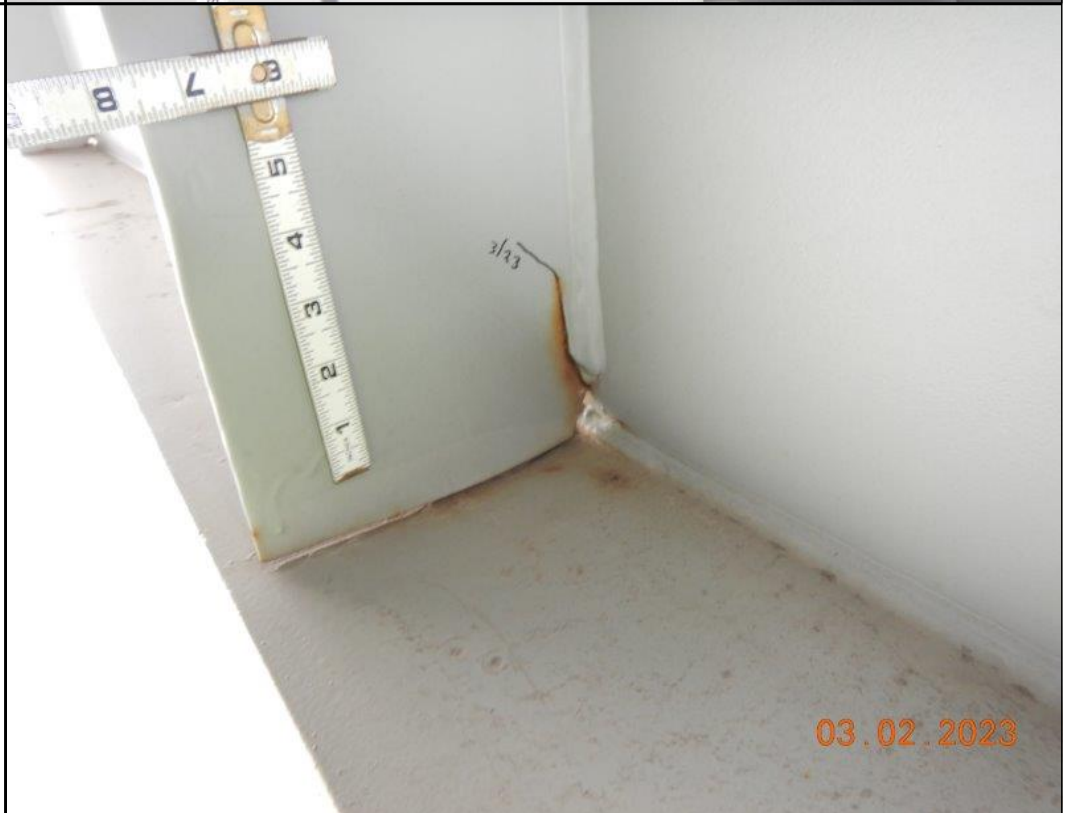
PHOTO NO.: 28

Location: Span 17, Floorbeam 16, North Face, under Stringer 5, vertical stiffener, at the Bottom Flange

Rating #: 7

MDTA Repair: 2
Repair Id: 2023-BCZ472001(S17-S19)-00046

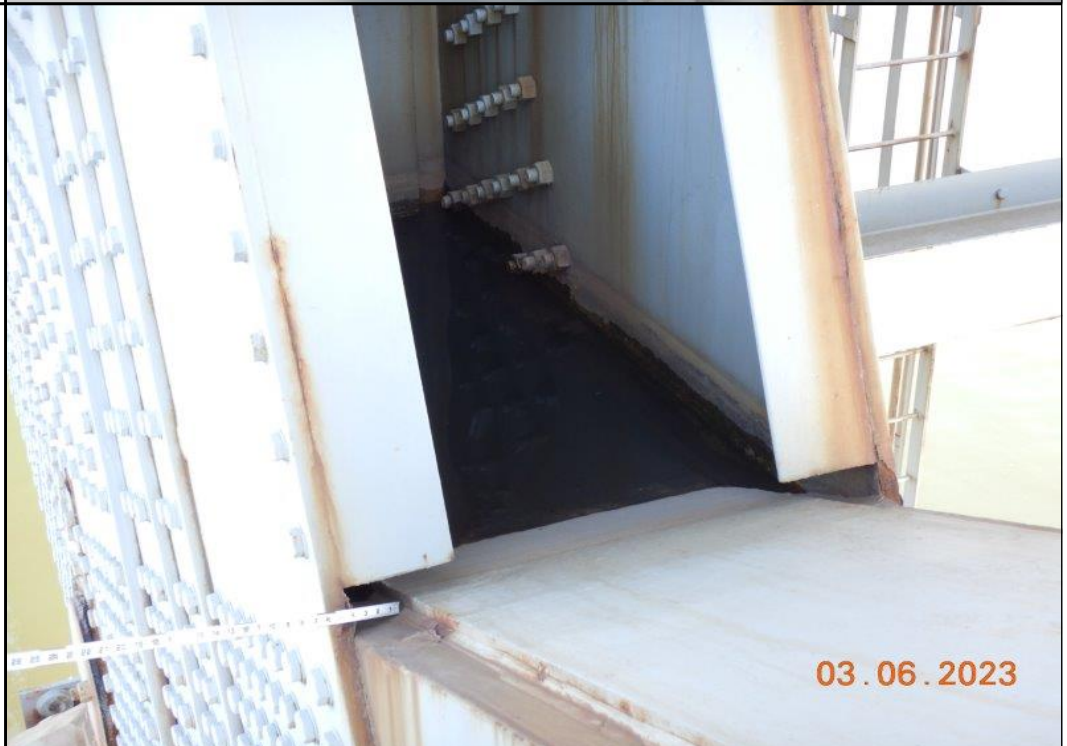
PHOTO NO.: 37
Location: Span 17, West
Truss, L25-U25, Interior
Direction: Northeast
Description: There is 6" of
standing water and heavy
debris in members being
retained between gusset
plates. Water is leaking from
inside member immediately
above bearings from L25 and
sitting at the bases of the
bearings.
Element #: 59.PP 24- PP 25
Rating #: 6
MDTA Repair: 3
Repair Id: 2010-BCZ472001-
00198

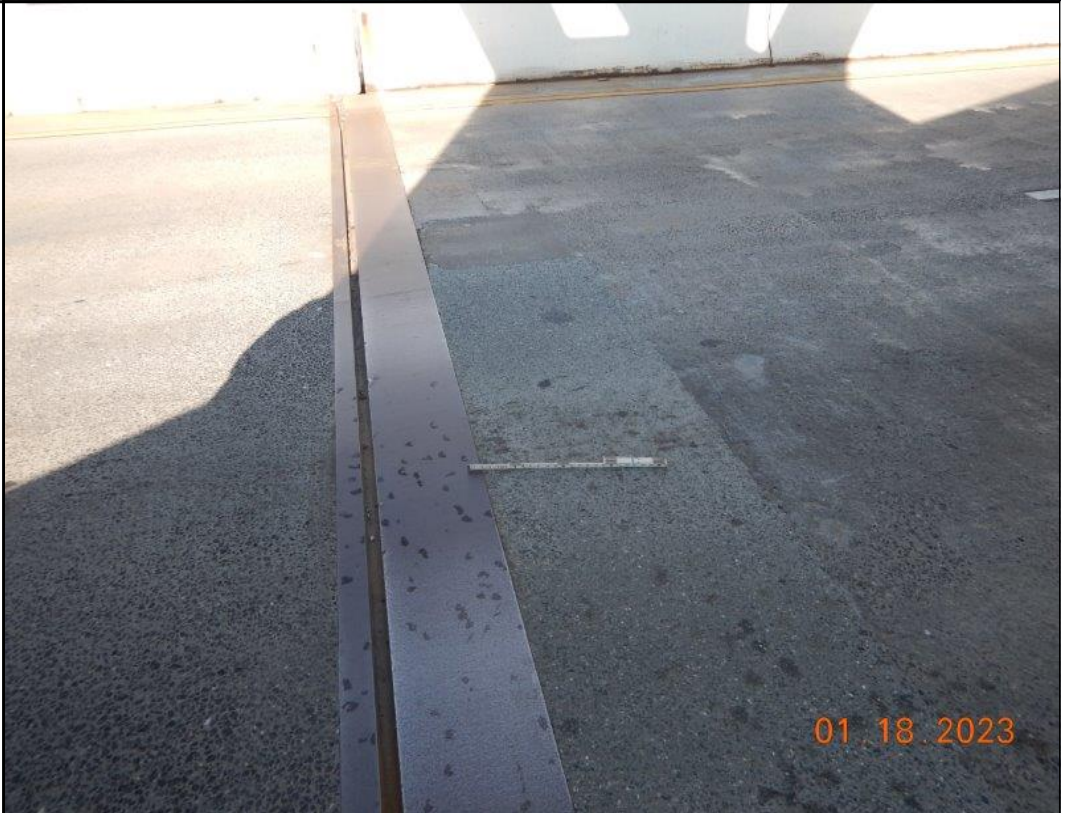
PHOTO NO.: 41
Location: Span 18, Northbound Right Lane, just north of the PP29 joint, 6'-0" from the lane line
Direction: West
Description: There is a 10" long x 1'-6" wide area of delamination with an 8" long x 1'-3" wide up to 2" deep spall with exposed corroded steel reinforcement. FY 2023 Inspection: This defect has been repaired. Repair Status changed to CLOSE-MDTA.
Element #: 58.01 - Wearing Surface
Rating #: 5
MDTA Repair: 2
Repair Id: 2021-BCZ472001(S17-S19)-00011

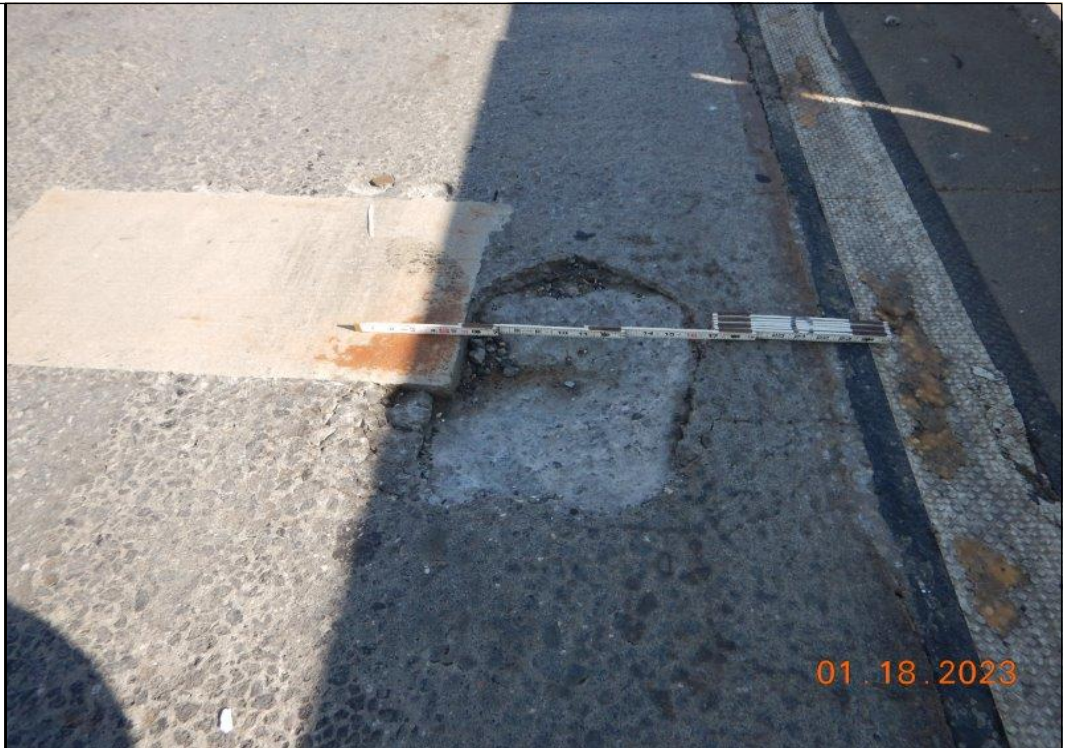
PHOTO NO.: 42
Location: Span 18,
Northbound Right Lane,
15'-0" north of PP38 along
right wheel path
Direction: North
Description: There is a 1'-4"
long x 1'-0" wide x 1 3/4"
deep spall.
Element #: 58.01 - Wearing
Surface
Rating #: 5
MDTA Repair: 1
Repair Id: 2023-
BCZ472001(S17-S19)-00076

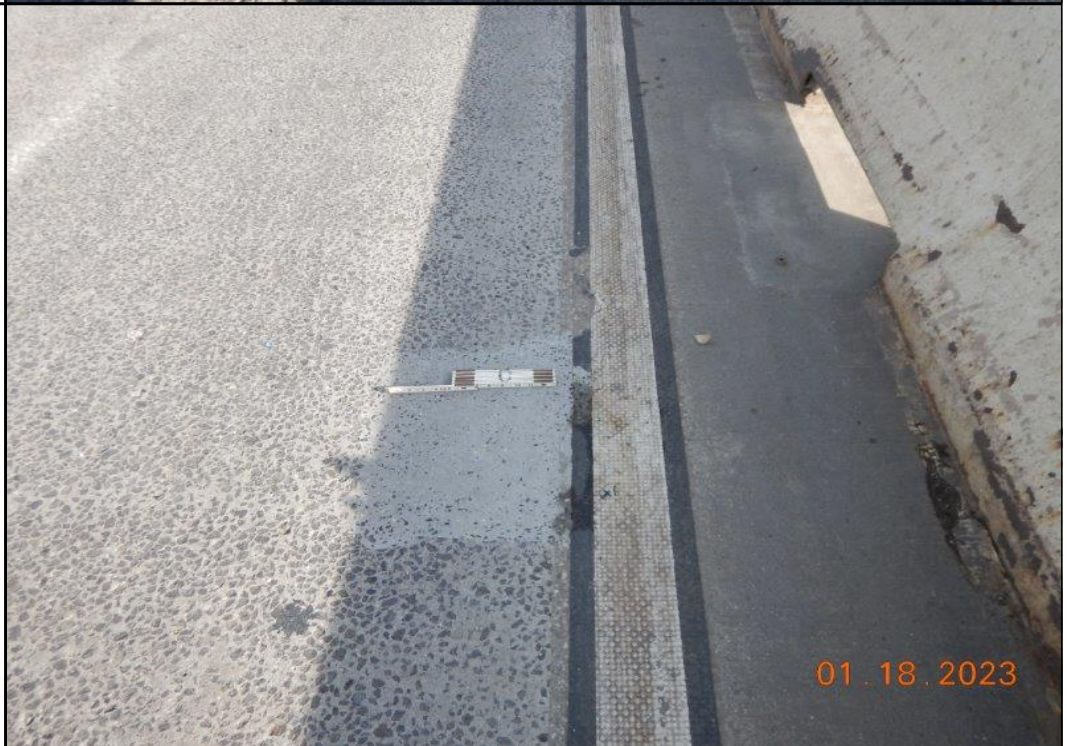
PHOTO NO.: 43
Location: Span 18,
Northbound Right Lane, 8'-6"
south of PP56
Direction: North
Description: There is a repair
spall.
Element #: 58.01 - Wearing
Surface
Rating #: 5
MDTA Repair: 3
Repair Id: 2021-
BCZ472001(S17-S19)-00012

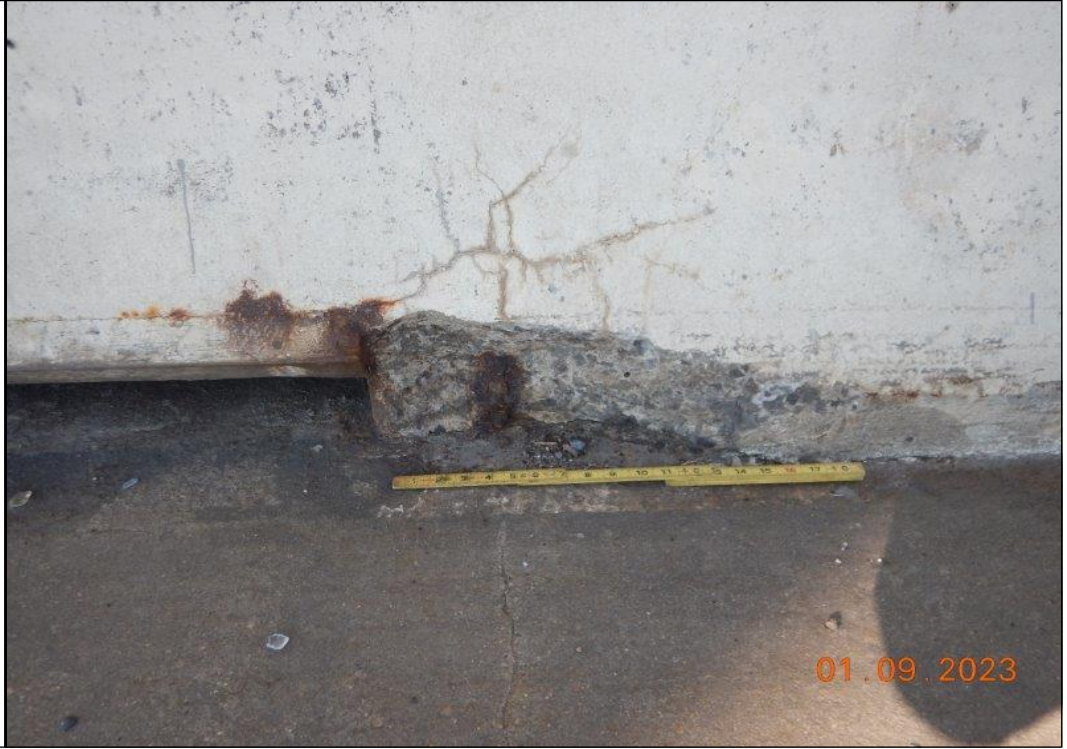
PHOTO NO.: 45
Location: Span 18, West Parapet, East Face, 5'-0" north of PP61 at scupper
Direction: West
Description: There are two (2) 1'-6" long x 7" high x 2 1/2" deep spalls with exposed corroded steel reinforcement.
Element #: 58.04 - Railings & Parapets
Rating #: 5
MDTA Repair: 3
Repair Id: 2017-BCZ472001(S17-S19)-00018

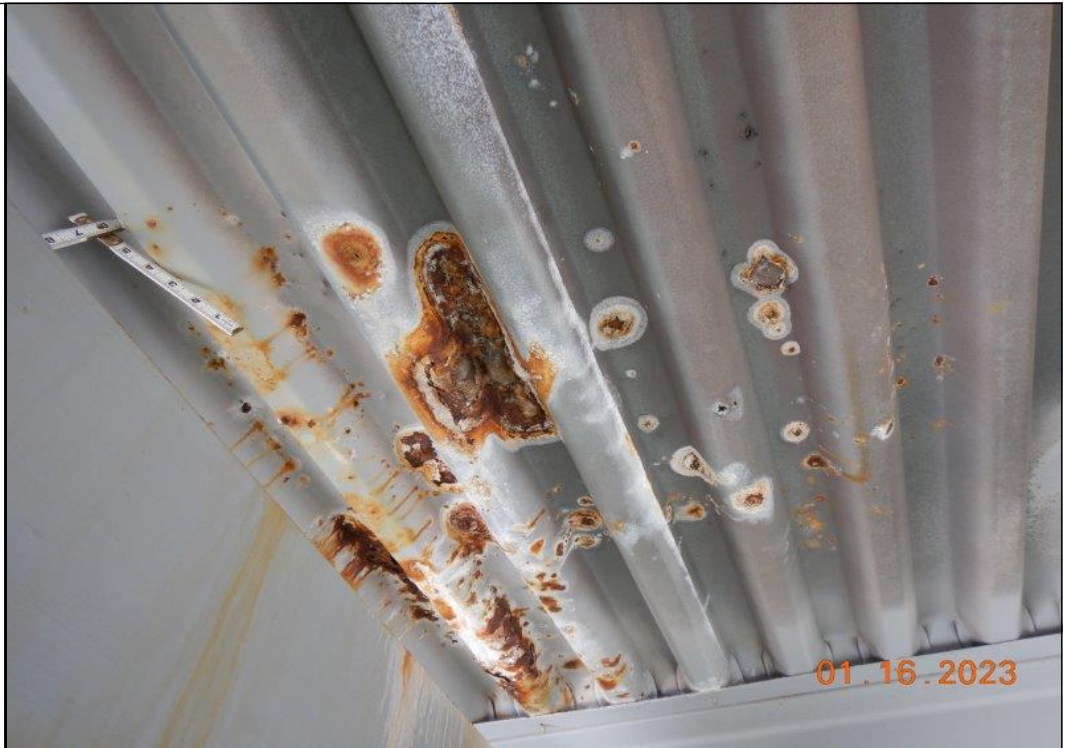
PHOTO NO.: 46
Location: Span 18, PP35 - PP36, Bay 9, SIP Forms, mid-length
Direction: West
Description: There is a 3'-0" long x 3'-0" wide area of moderate corrosion with several 4" diameter areas of 100% section loss.
Element #: 58.07 - Deck Underside
Rating #: 7
MDTA Repair:
Repair Id:

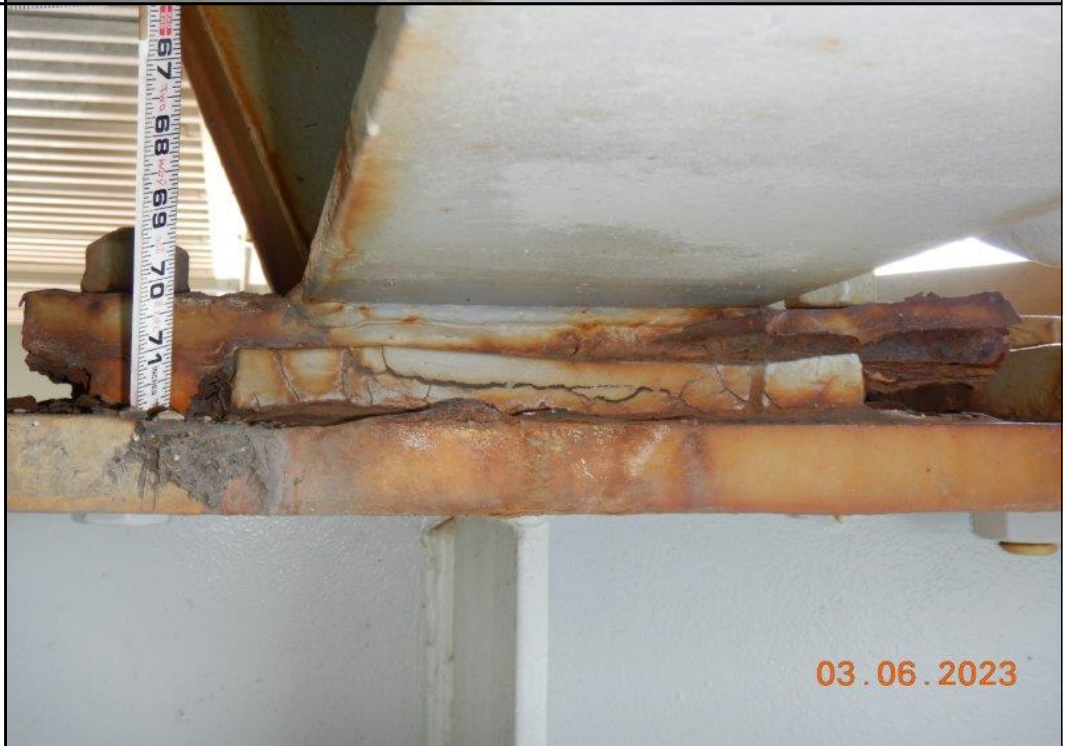
PHOTO NO.: 47
Location: Span 18, Floorbeam 25, Stringer 1 Bearing Pad
Direction: South
Description: The bearing pad is split.
Element #: 59.PP 25- PP 26
Rating #: 7
MDTA Repair: 3
Repair Id: 2021-BCZ472001(S17-S19)-00257

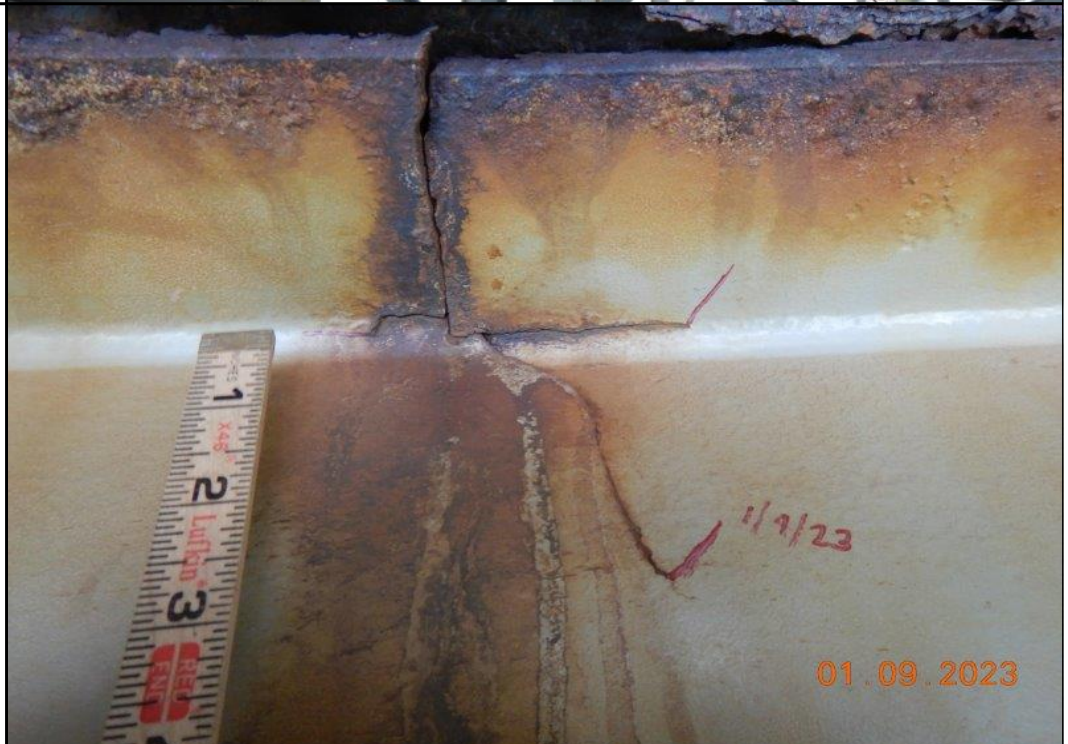
Description: There is a hairline crack in the top flange for 2 3/4" long and in the web for 3 1/2" long with 1/4" lateral offset of the top flange.

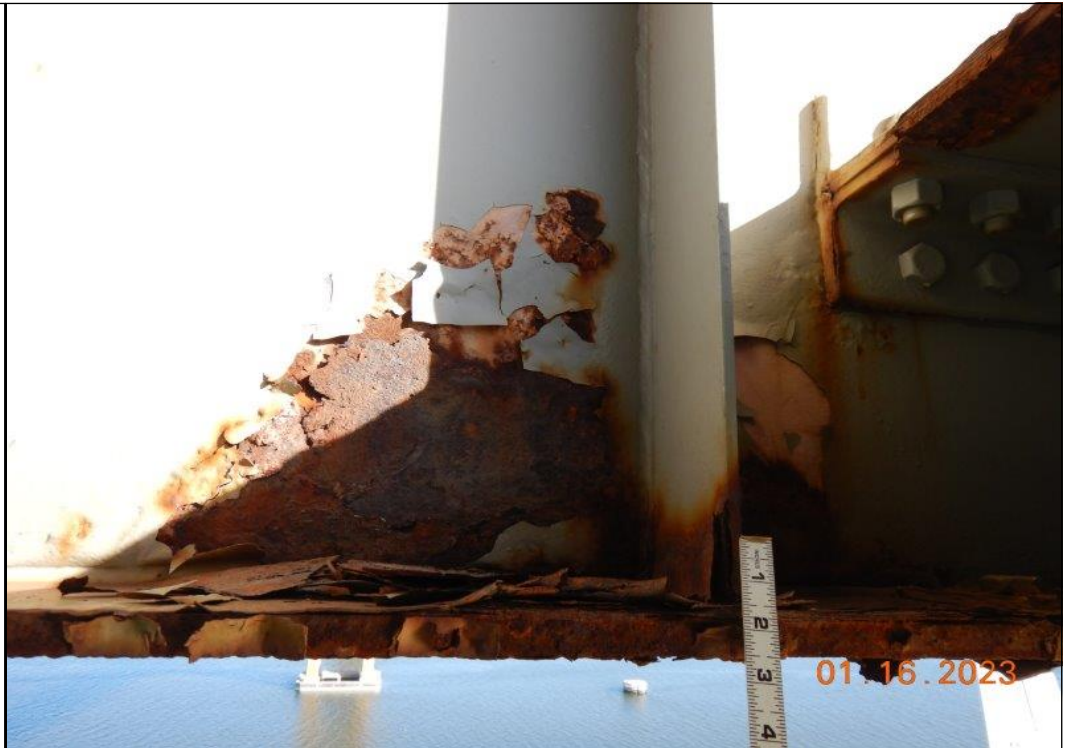
PHOTO NO.: 54

Location: Span 18,
Floorbeam 30, south web,
east end, and Bottom Flange

Description: There is a 1'-6"
long x 1'-0" high x full-width
of Bottom Flange Top Face
are of moderate corrosion
and paint failure.

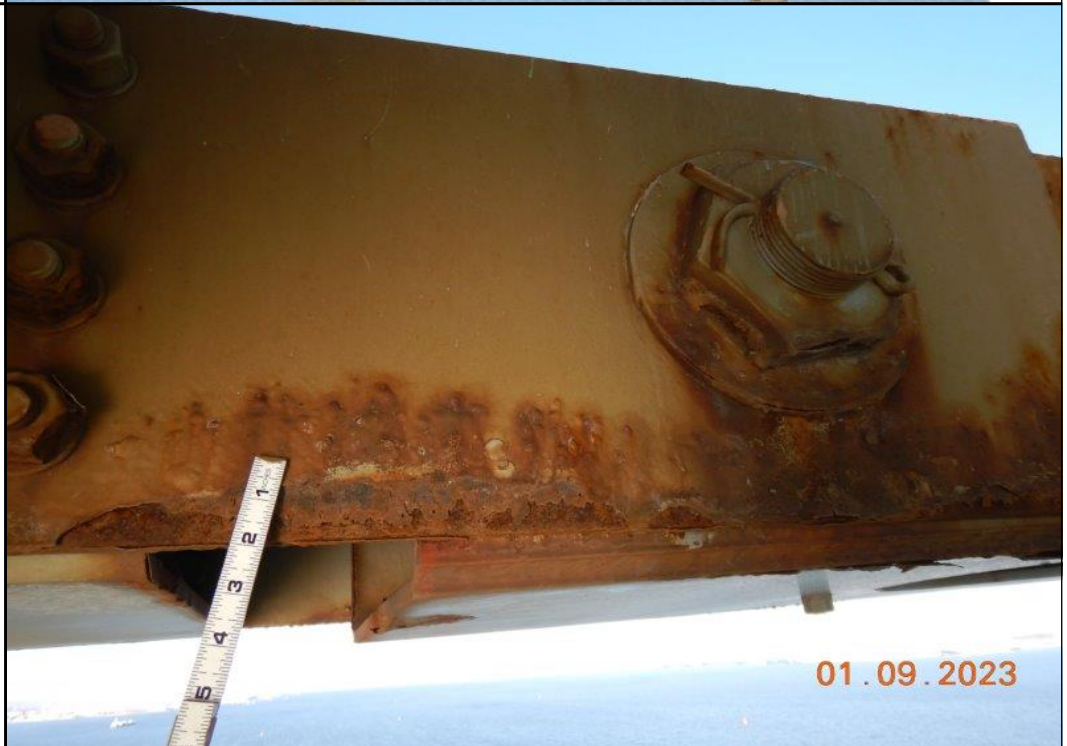
PHOTO NO.: 55

Location: Span 18, West
Truss, Suspended Bottom
Chord, B29-B30, at the Field
Splice with pin

Description: There is
corrosion and the bottom
chord segments are
misaligned up to 1/2" vertical
at the splice and vibrate
under live load.

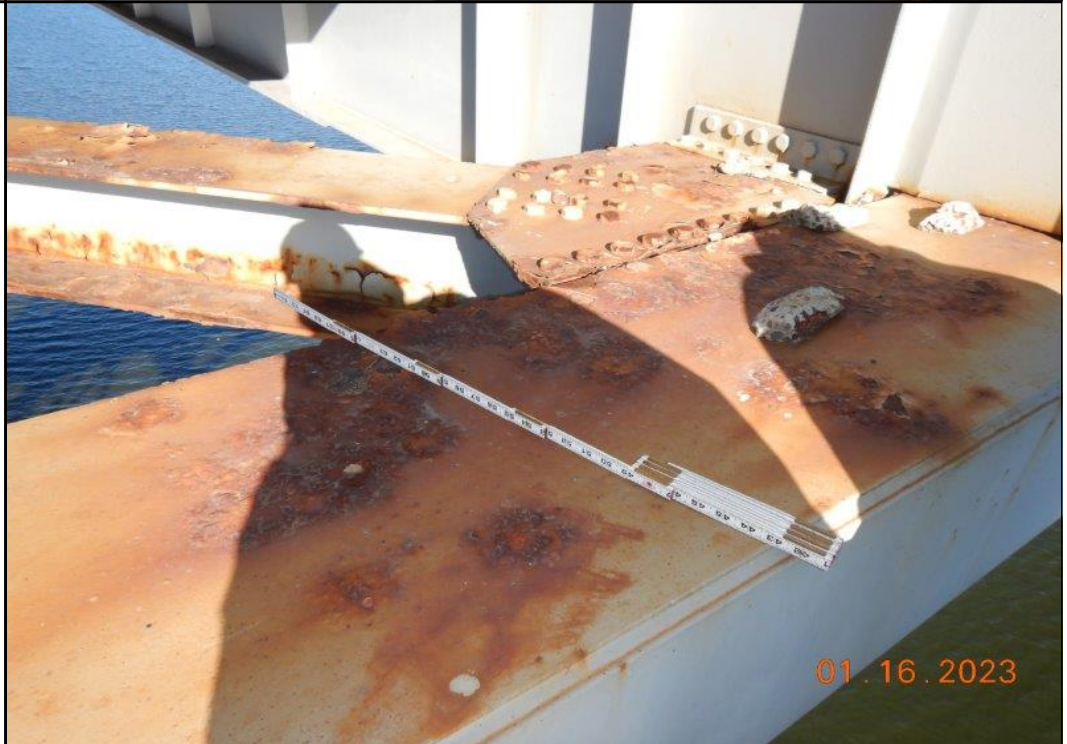
PHOTO NO.: 57
Location: Span 18, East Truss, Suspended Bottom Chord, B29-B30, near B30, West, Top and Bottom Faces
Direction: Northwest
Description: There is heavy corrosion, paint failure up to 6'-0" long x full-width x full-height and corrosion staining with up to 1/16" deep section loss.
Element #: 59.PP 29- PP 30
Rating #: 6
MDTA Repair: 3
Repair Id: 2021-BCZ472001(S17-S19)-00264

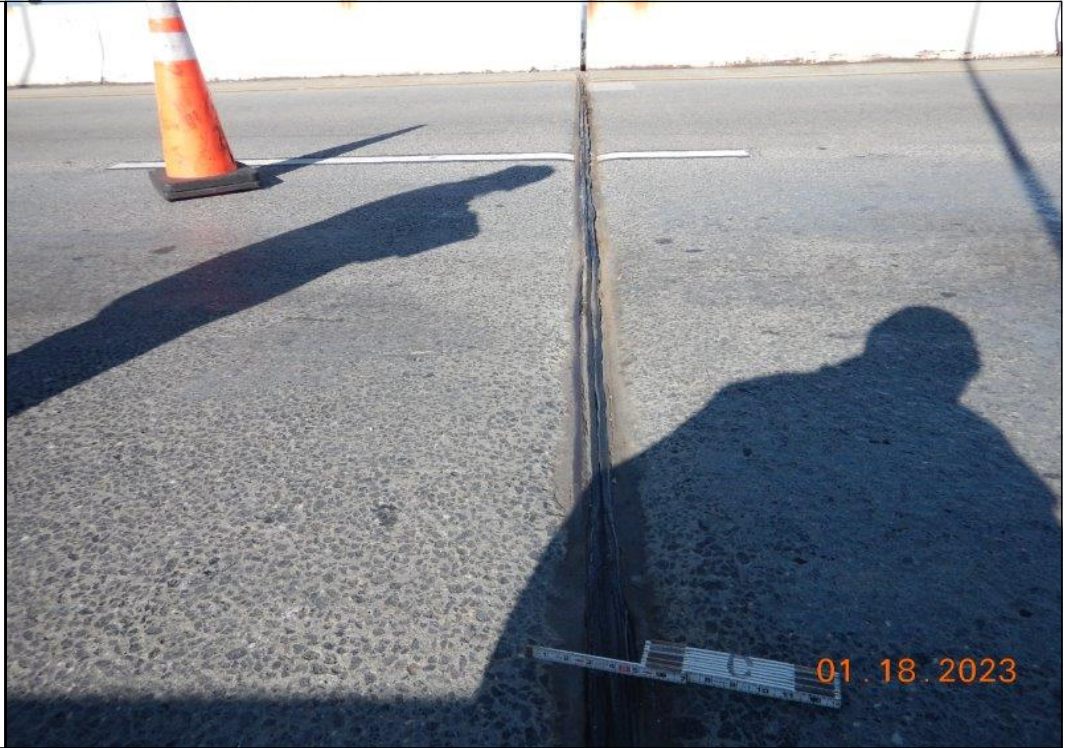
PHOTO NO.: 60
Location: PP33 Northbound Joint Seal
Direction: West
Description: Joint seal is bulging and torn throughout.
Element #: 59.PP 32- PP 33
Rating #: 5
MDTA Repair: 3
Repair Id: 2023-BCZ472001(S17-S19)-00411

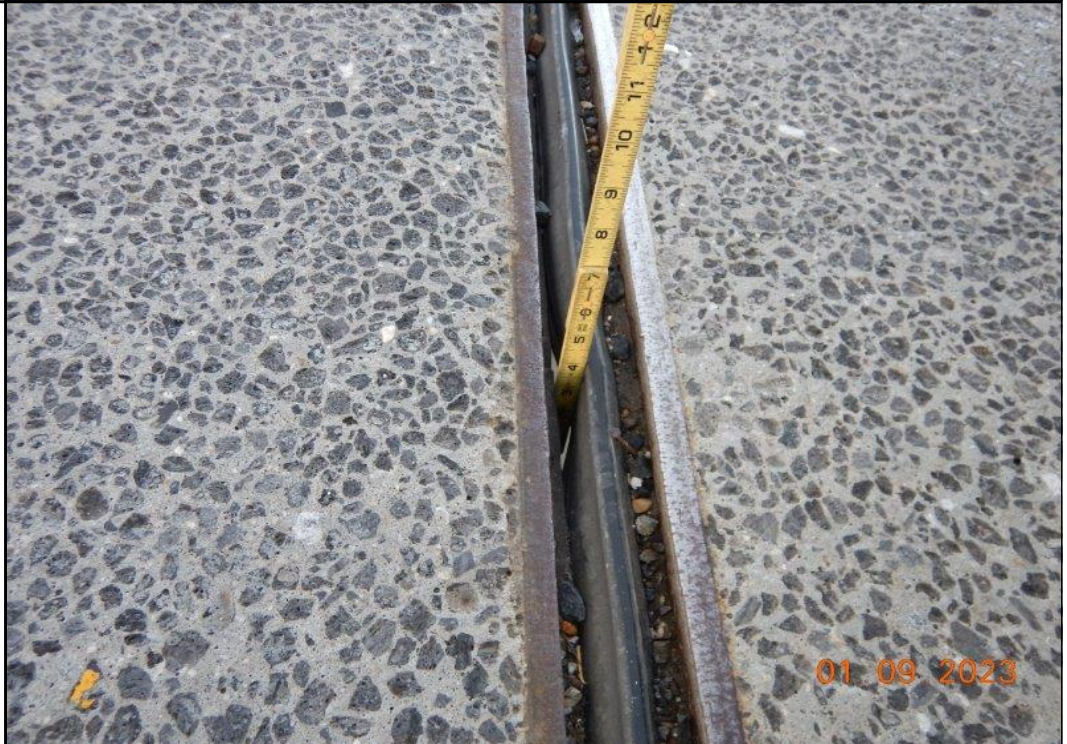
PHOTO NO.: 61
Location: Span 18, PP33 Seal, Southbound Right Lane, Right Wheel Line
Direction: East
Description: There is a 2'-0" long tear in the joint seal
Element #: 59.PP 32- PP 33
Rating #: 5
MDTA Repair: 2
Repair Id: 2021-BCZ472001(S17-S19)-00317

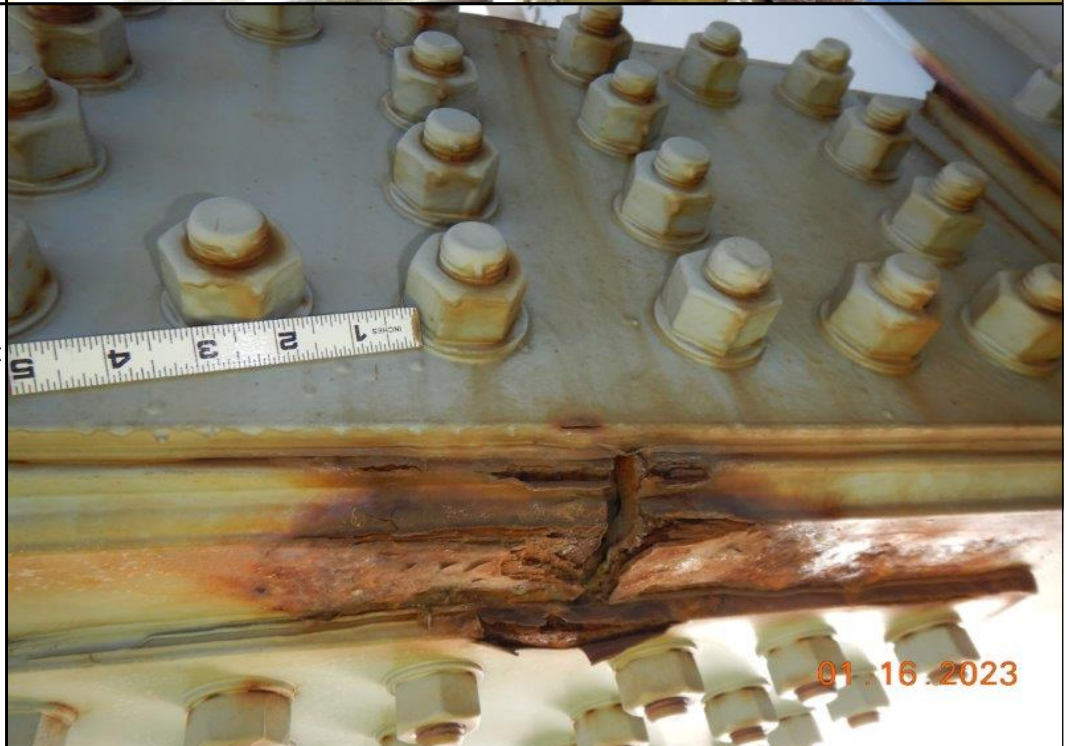
Description: There is a 1'-0"
long x 3" wide area of
moderate corrosion with paint
failure and minor laminar
corrosion.

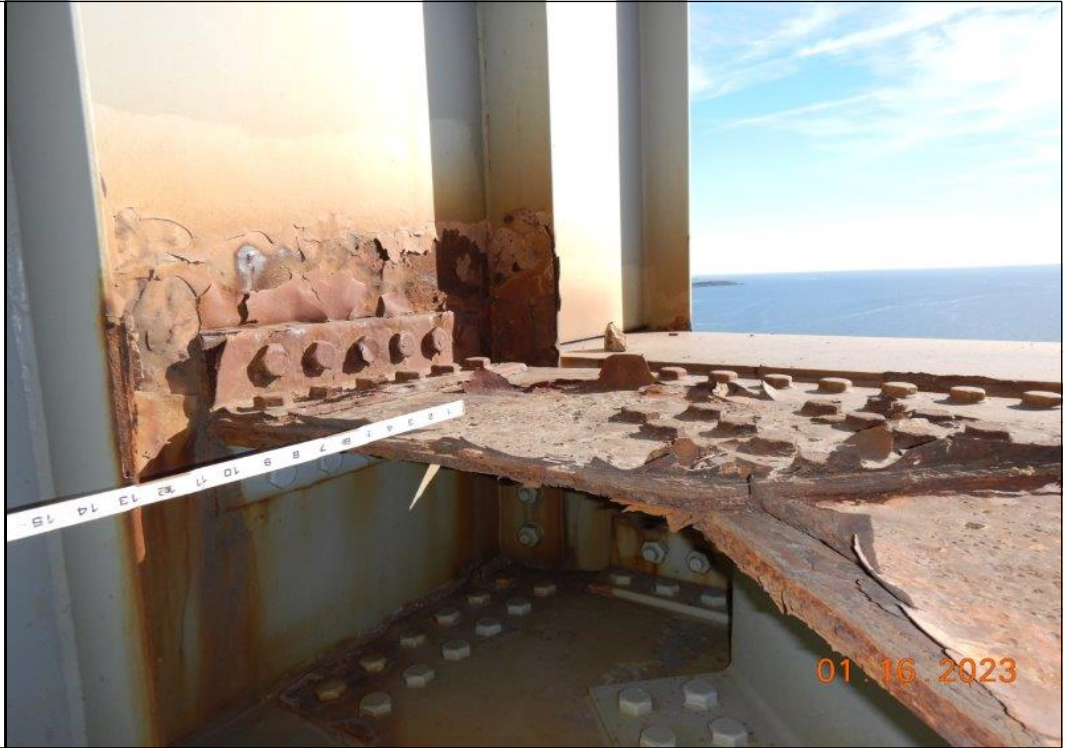
Description: There is heavy corrosion with paint failure and moderate laminar corrosion and minor section loss.
