MDTA 2023 Bridge Inspection Report (S17-S19)

MARYLAND TRANSPORTATION AUTHORITY
FSK-Francis Scott Key Bridge
Bridge - Biennial
FOR
STRUCTURE No. BCZ472001(S17-S19)
IS 695 OVER PATAPSCO RIVER

BIN: BCZ472001(S17-S19)

Date: 01/09/2023

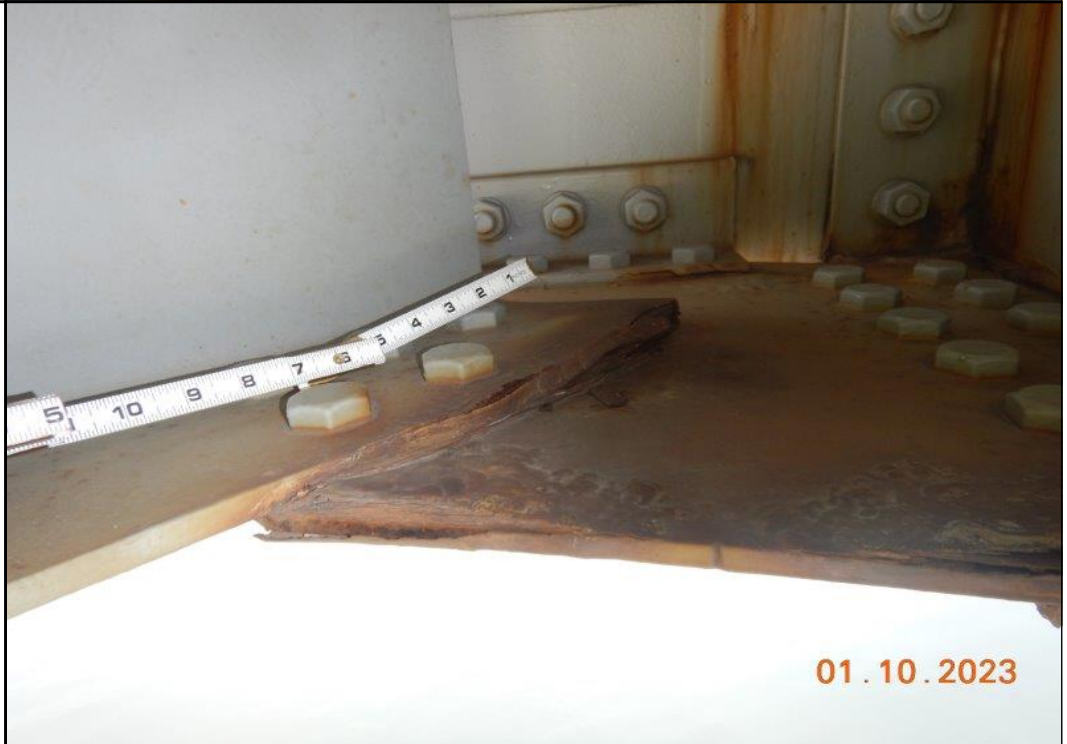
PHOTO NO.: 65

Location: Span 18, Suspended Roadway Lateral Brace, connection to the West Truss, at B35, Bottom Connection Plate

Description: There is 3/4" pack rust for 4" long between the flange and connection plate that bows up at the corner. This is typical at many locations.

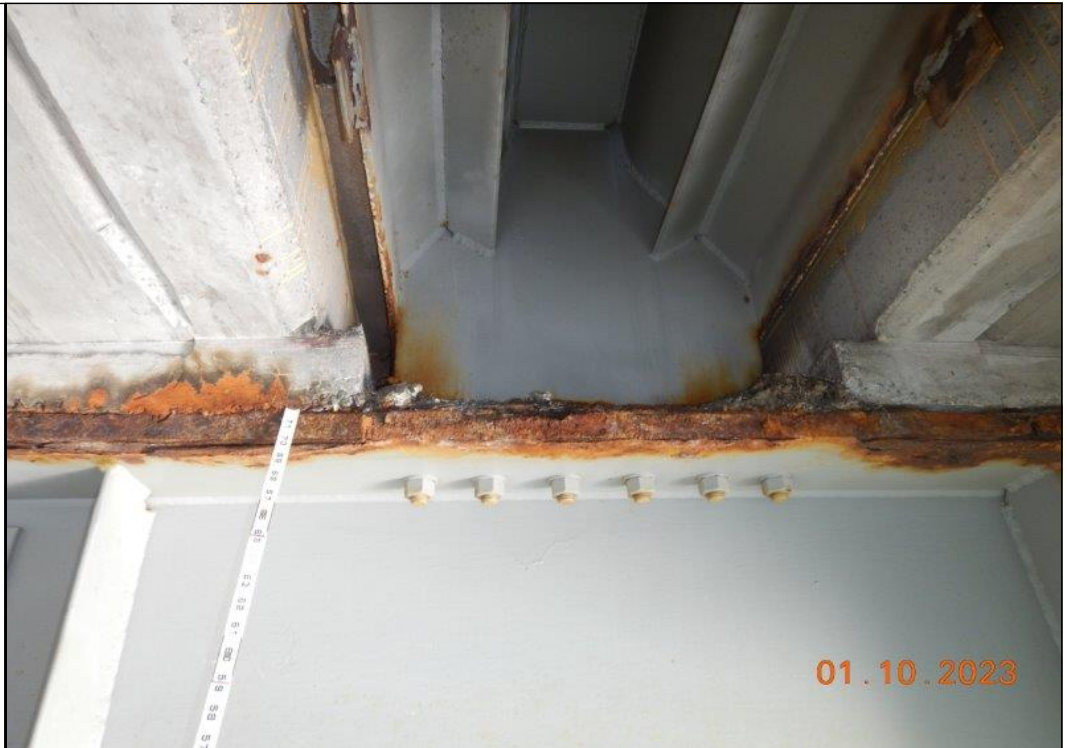
Description: There is a 6'-0"
long area of moderate
corrosion with minor section
loss and moderate laminar
corrosion.

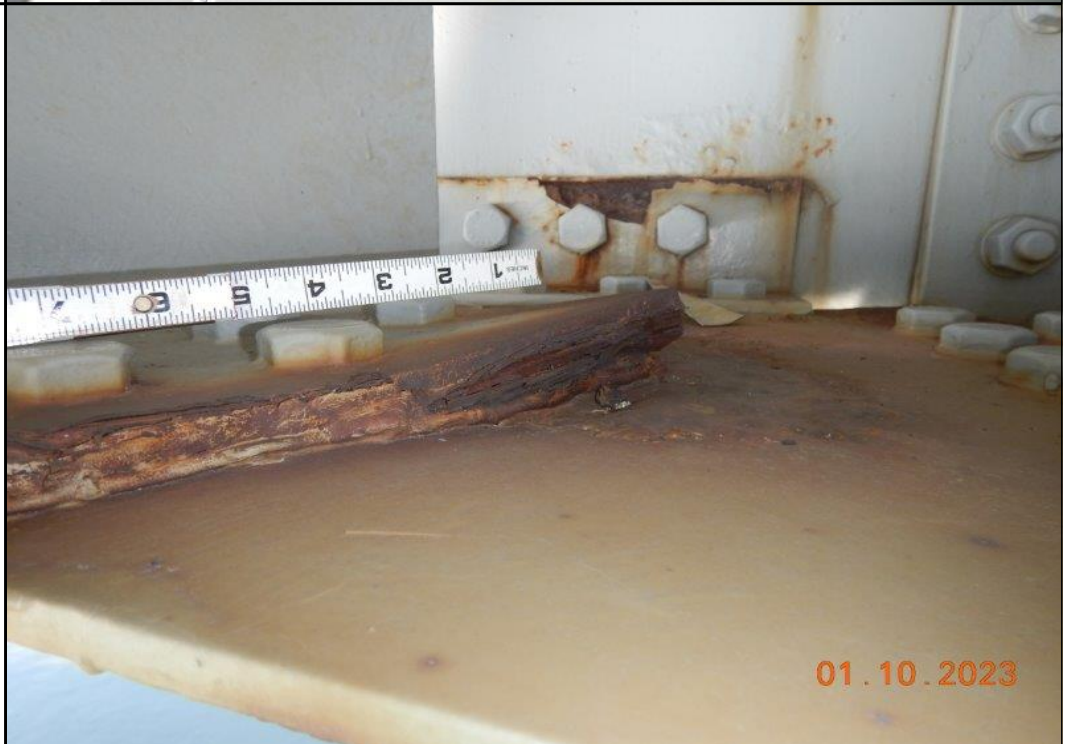
PHOTO NO.: 69

Location: Span 18,
Suspended Roadway Lateral
Brace, connection to the East
and West Truss, at B40,
Bottom Connection Plate,
north corner

Description: There is 5" long
x up to 3/4" high upward
bending due to pack rust.

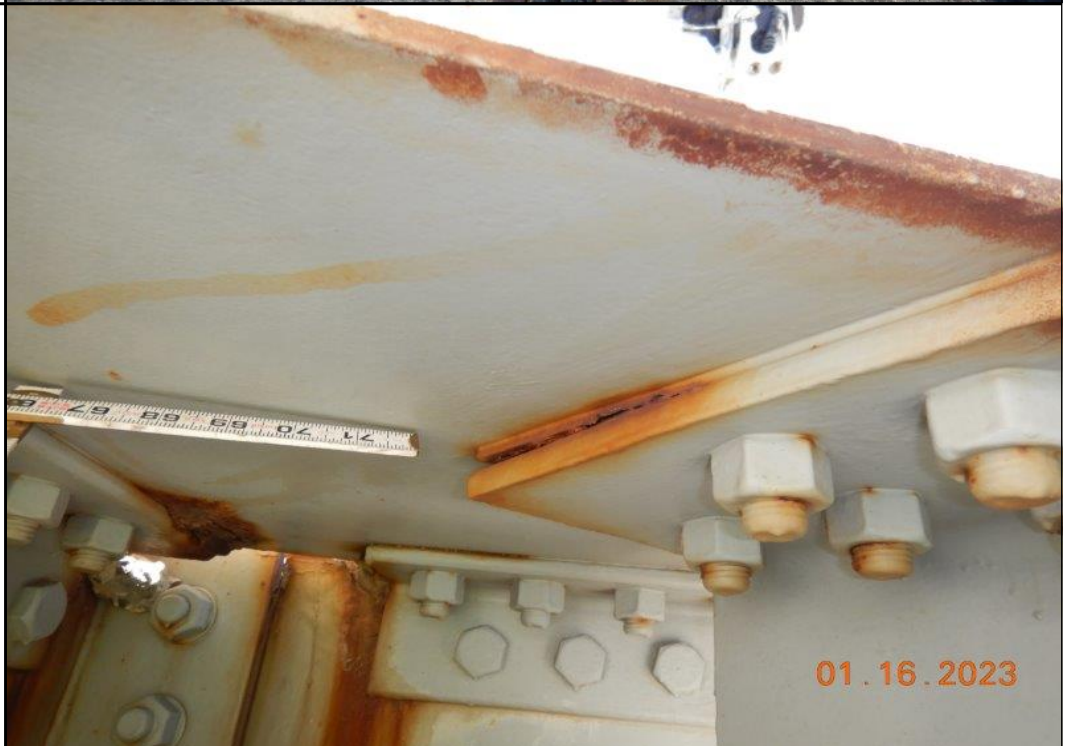
PHOTO NO.: 71
Location: Span 18,
Suspended Roadway Lateral
Brace, connection to the East
Truss, at B41, Top and
Bottom Connection Plate
Direction: East
Description: The top and bottom flange are deformed 1/2" due to pack rust for 5" long which cause it to bend up and down.
Element #: 59.PP 40- PP 41
Rating #: 7
MDTA Repair: 3
Repair Id: 2019-BCZ472001(S17-S19)-00151

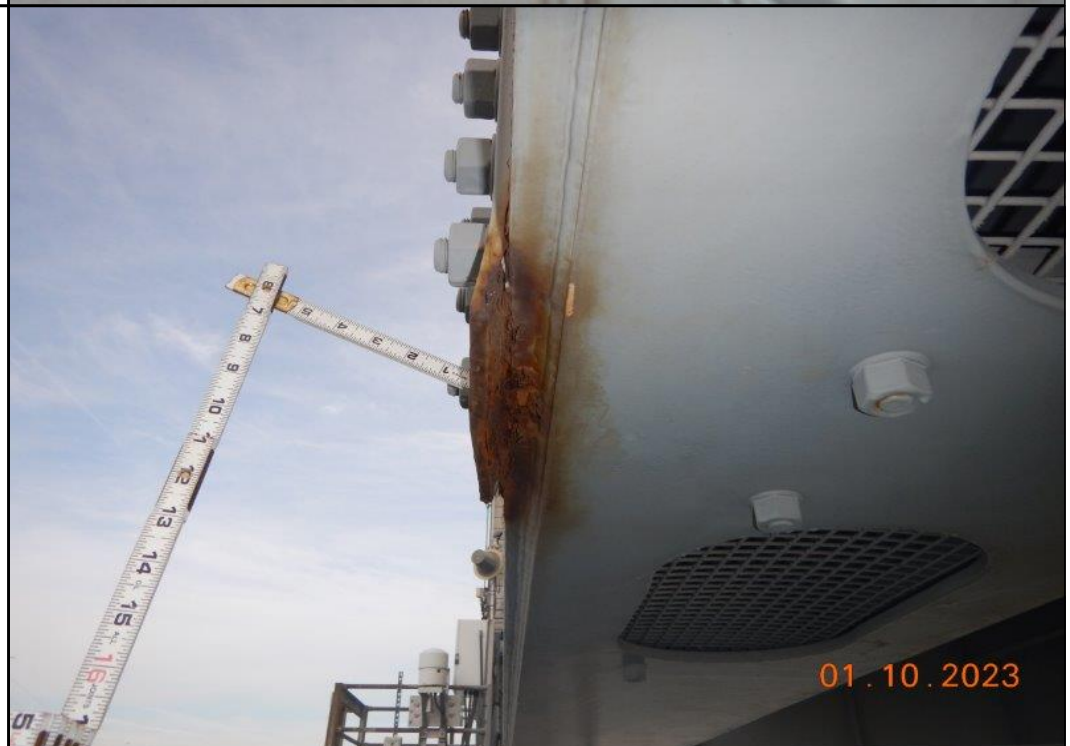
Description: The gusset plate is bent outward 1/4" due to full-width x 2" high pack rust.

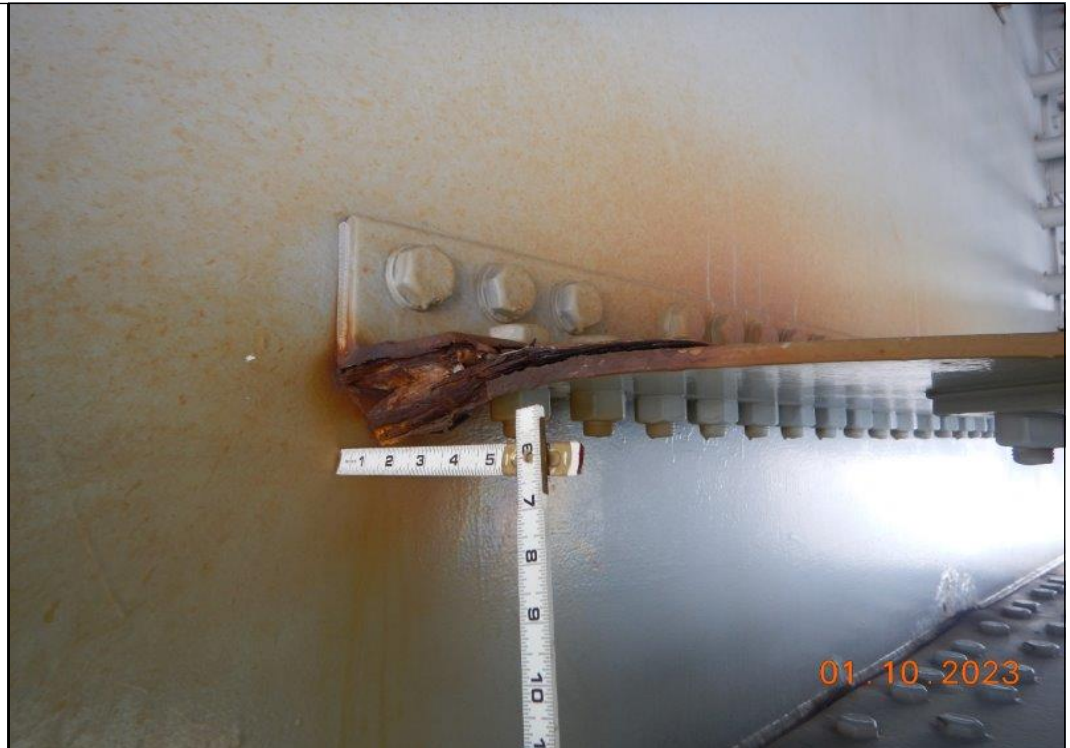
PHOTO NO.: 74

Location: Span 18,
Suspended Roadway Lateral
Brace, center connection at
Floorbeam 42, Top
Connection Plate

Description: The connection
plate along east edge is
bowed downward 1" over a
4" length due to pack rust.

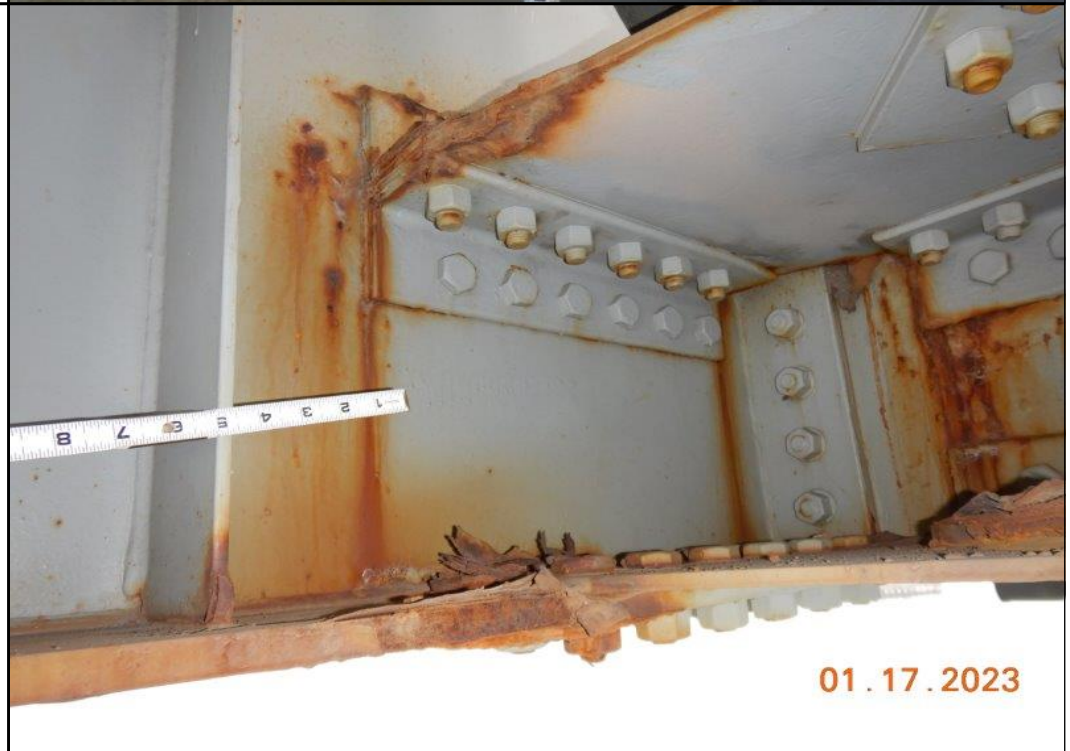
PHOTO NO.: 75

Location: Span 18,
Floorbeam 45, South Face,
east end, at the lower lateral
brace connection

Description: There is a 9"
long x 3" wide area of
moderate corrosion, peeling
paint, and minor laminar
corrosion on the bottom
flange and a 4" diameter
area on the web of moderate
corrosion.

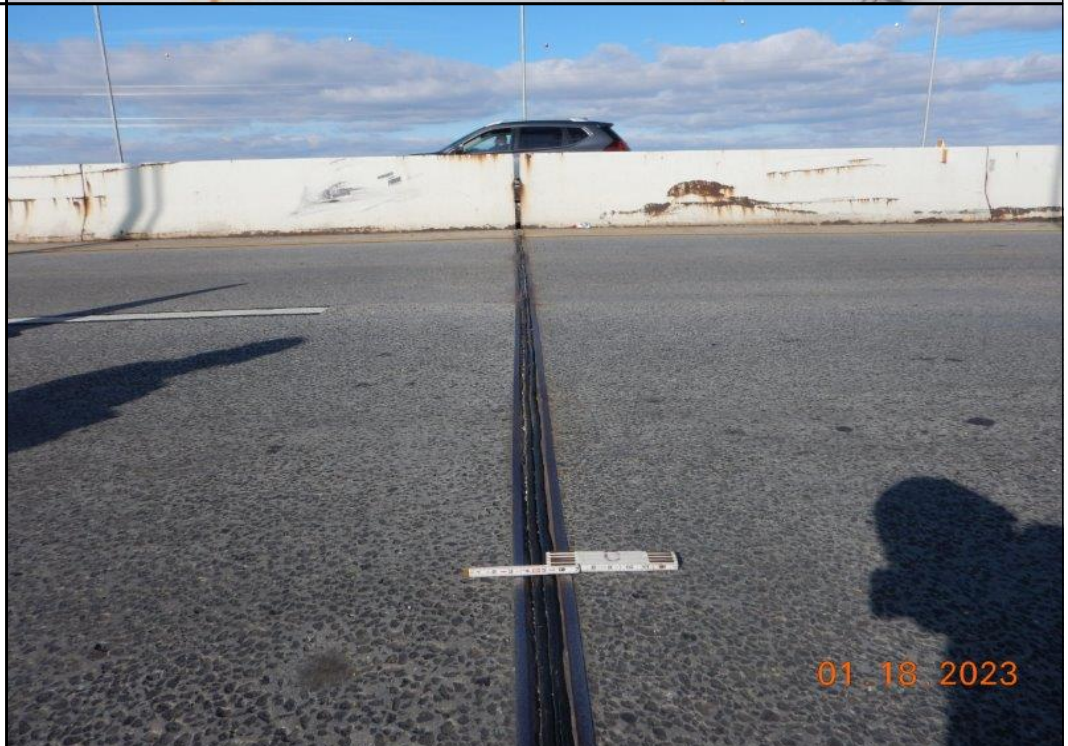
PHOTO NO.: 77

Location: Span 18, PP49 Joint (Northbound Lanes shown)

Description: There is moderate cracking and tears of the joint seal at the roadway causing minor leakage at random locations to the elements below and corrosion to the open joint below deck.

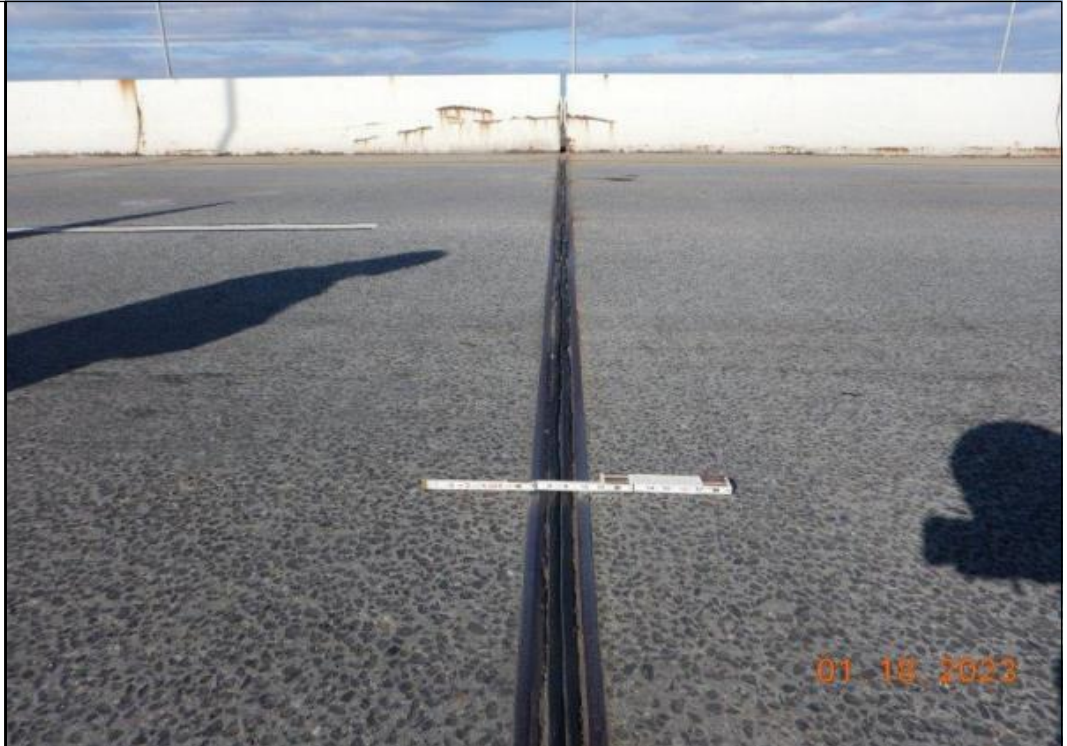
PHOTO NO.: 78
Location: Span 18, PP53 Joint (Northbound lanes shown)
Direction: West
Description: There is moderate cracking and tears of the joint seal at the roadway causing minor leakage at random locations to the elements below and corrosion to the open joint below deck.
Element #: 59.PP 52- PP 53
Rating #: 5
MDTA Repair: 2
Repair Id: 2013-BCZ472001(S17-S19)-00136

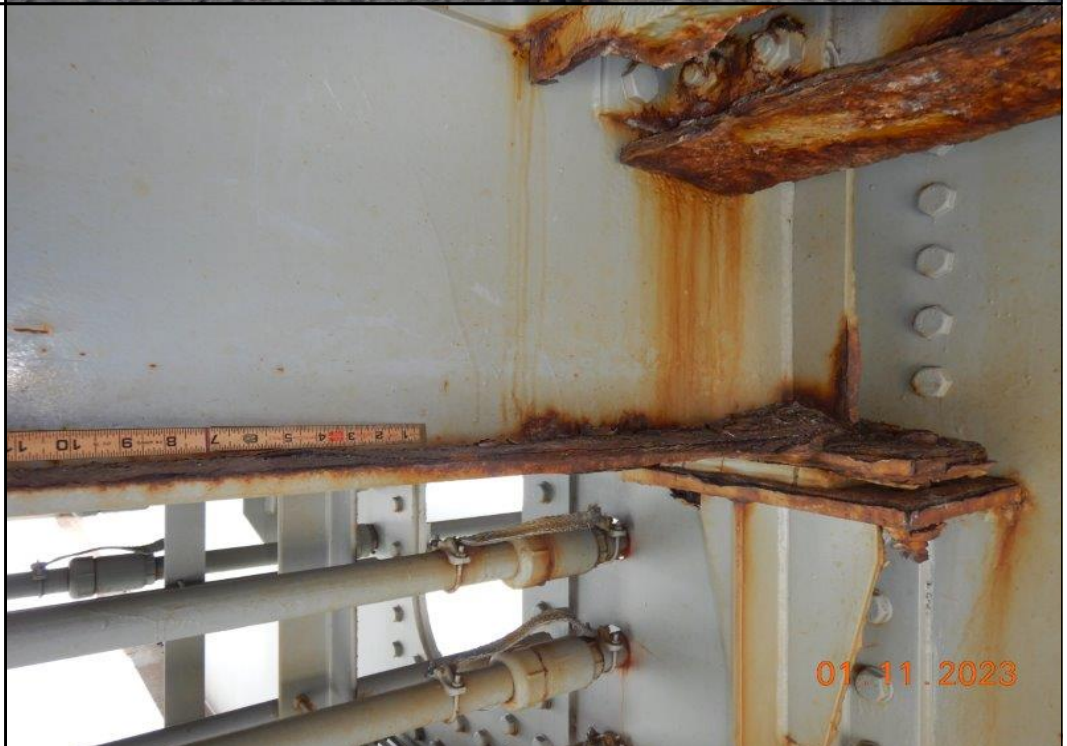
PHOTO NO.: 79
Location: Span 18, Stringer 5 and 6, at Floorbeam 53, Top and Bottom Faces of Bottom Flange
Direction: Northwest
Description: There is an up to 2'-6" long area of moderate corrosion with moderate laminar corrosion.
Element #: 59.PP 52- PP 53
Rating #: 6
MDTA Repair: 3
Repair Id: 2023-BCZ472001(S17-S19)-00216

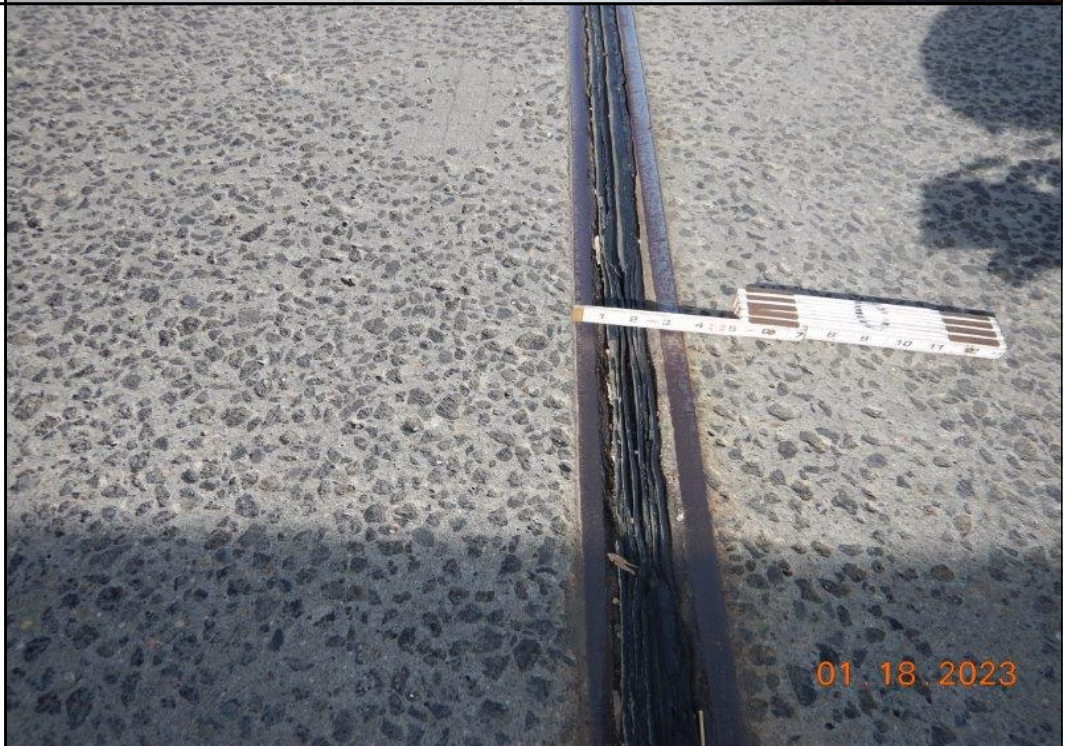
PHOTO NO.: 81

Location: Span 18, PP 57 Joint (Northbound lanes shown)

Description: PP 57 Joint there is moderate cracking and tears of the joint seal at the roadway causing minor leakage at random locations to the elements below and corrosion to the open joint below deck.

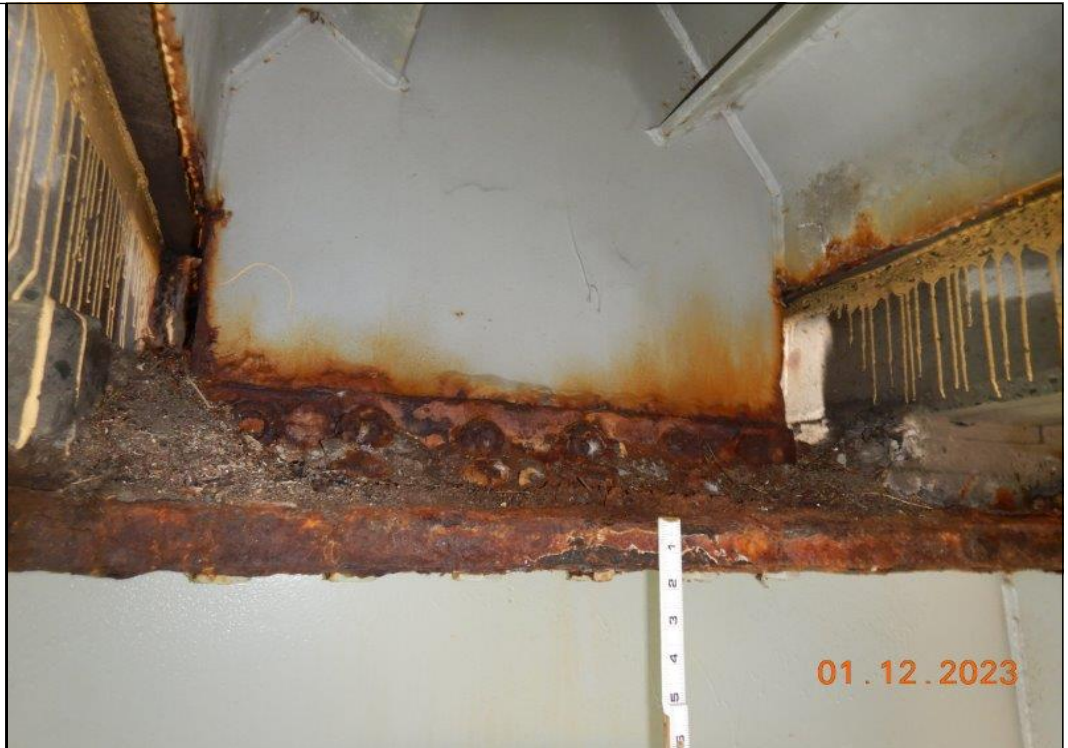
PHOTO NO.: 82

Location: Span 18,
Floorbeam 57, North Face,
in Bay 5, Top Flange

Description: There is heavy
corrosion and moderate
laminar corrosion. There is a
2'-0" long x 1" wide area with
1/4" section loss.

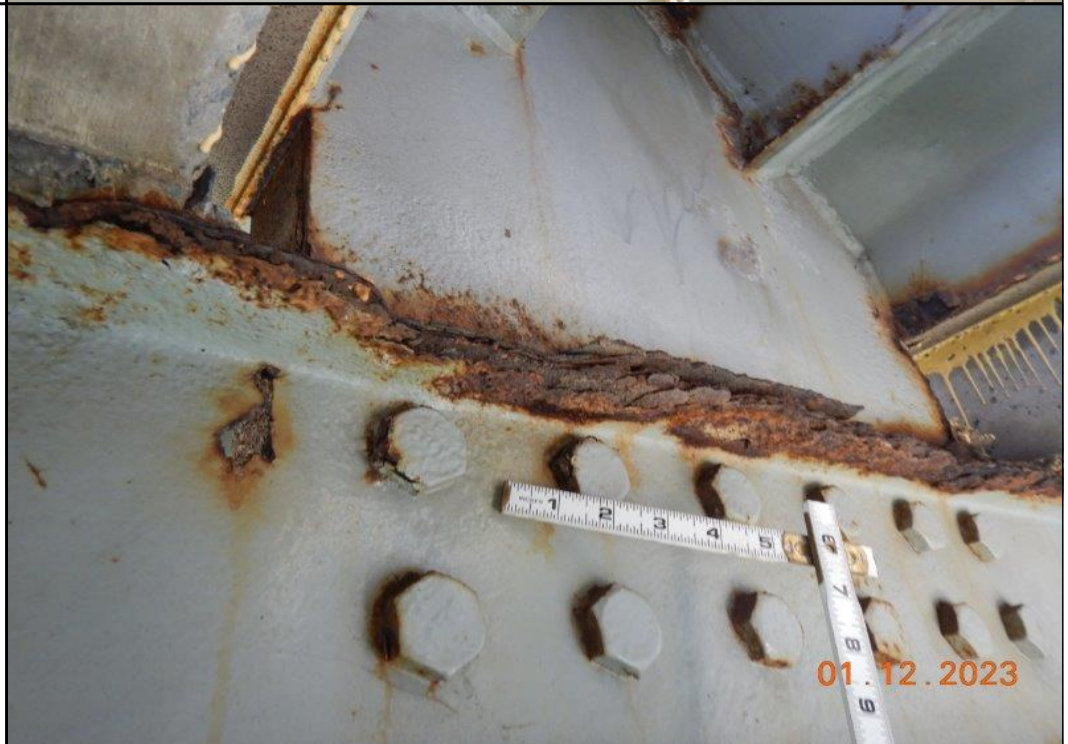
PHOTO NO.: 83

Location: Fourth Median
Support Diaphragm from
Floorbeam 58, Top Flange

Description: There is heavy
corrosion with paint failure
and heavy laminar corrosion.
There is a 2'-6" long x up to
1" wide area of 100% section
loss on the Top Flange

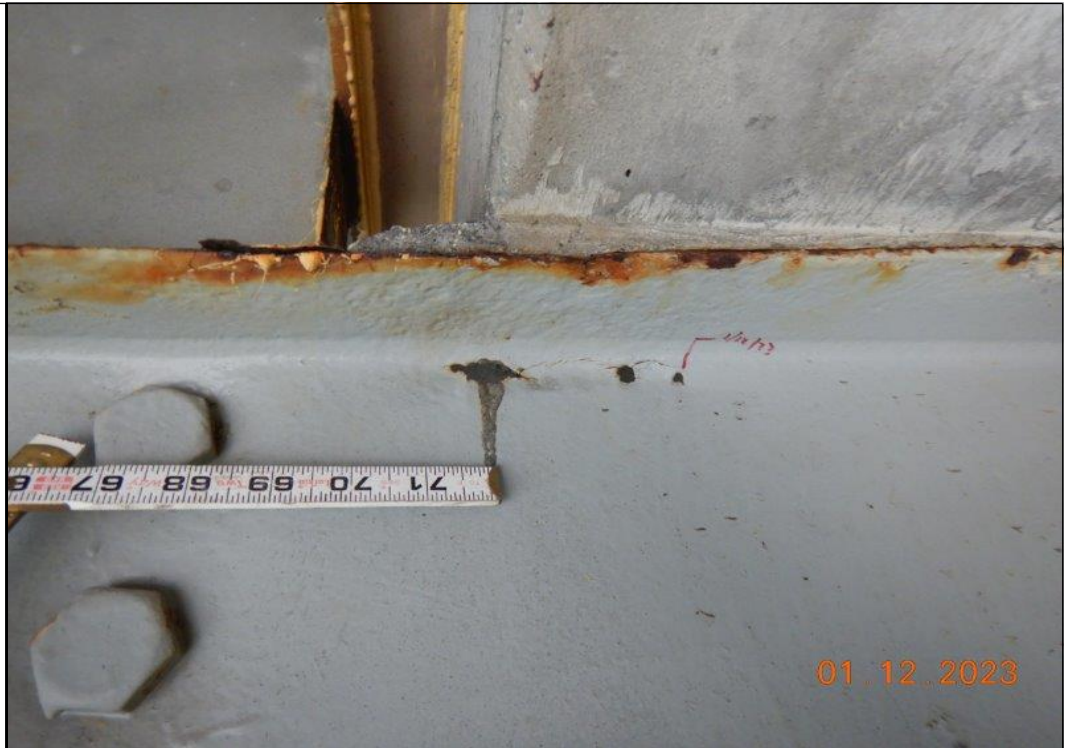
PHOTO NO.: 84

Location: Span 18, First
Median Support Diaphragm,
from Floorbeam 59

Description: There are three
(3) up to 1 1/2" wide x up to
1/2" high holes in the web
with an associated 2 3/8"
long horizontal crack. There
is intermittent knife edging in
the top flange.

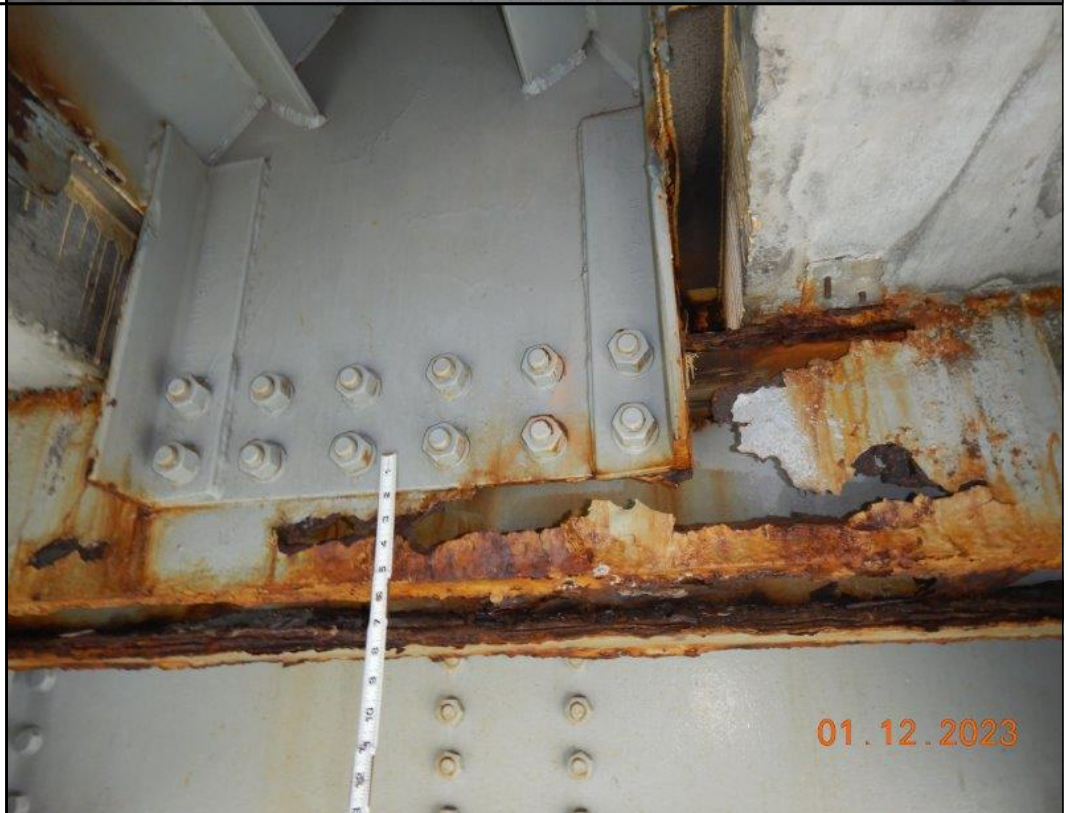
PHOTO NO.: 85

Location: Span 18, Ninth
Median Support Diaphragm
from Floorbeam 60, Top and
Bottom Flanges

Description: There is heavy
corrosion, knife edging and
areas up to full-width of full-
length up to 100% section
loss. There is a 3'-3" long x
3" to 8" high area of 100%
section loss in the web
adjacent to the east side of
the parapet bulkhead plate in
the top flange.

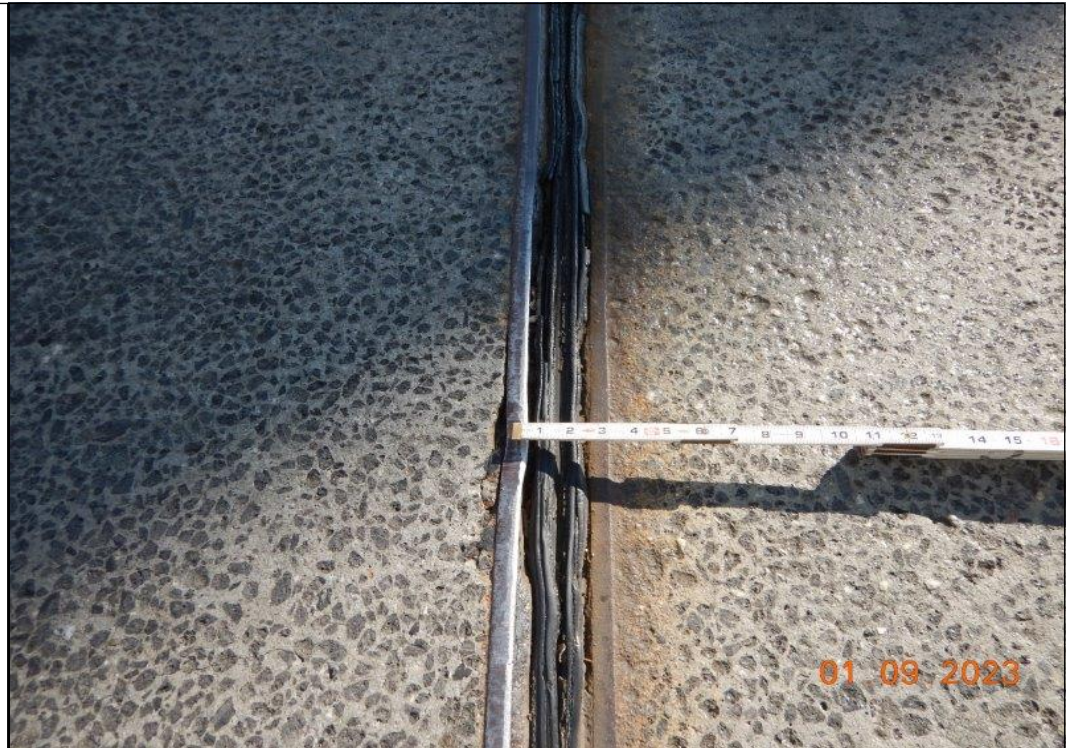
Description: There is moderate cracking and tears of the joint seal at the roadway causing minor leakage at random locations to the elements below and corrosion to the open joint below deck.

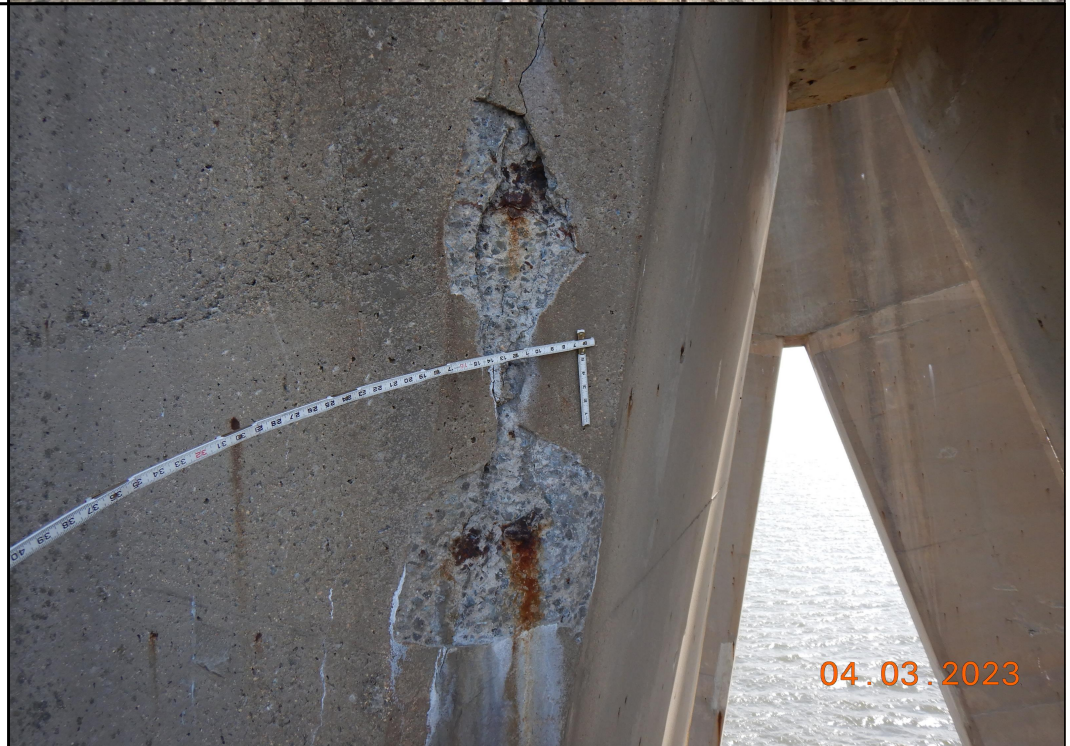
PHOTO NO.: 87

Location: Pier 18, Northwest
Column, Southwest Corner,
at the top

Description: There is a 1'-2" wide x 3'-0" high x 2" deep spall with exposed corroded reinforcement.

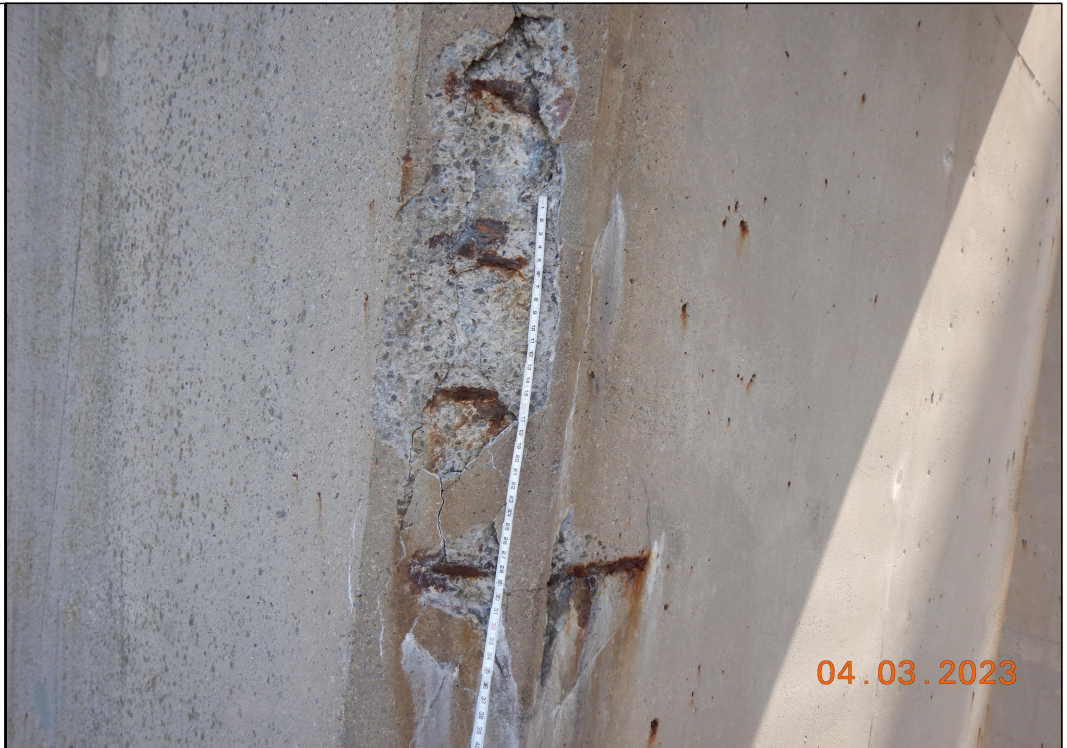
Description: There is a 1'-0" wide x 4'-0" high x 2" deep spall with exposed corroded reinforcement and an adjacent 1'-0" wide x 1'-0" high x up to 1" deep spall on the south face.

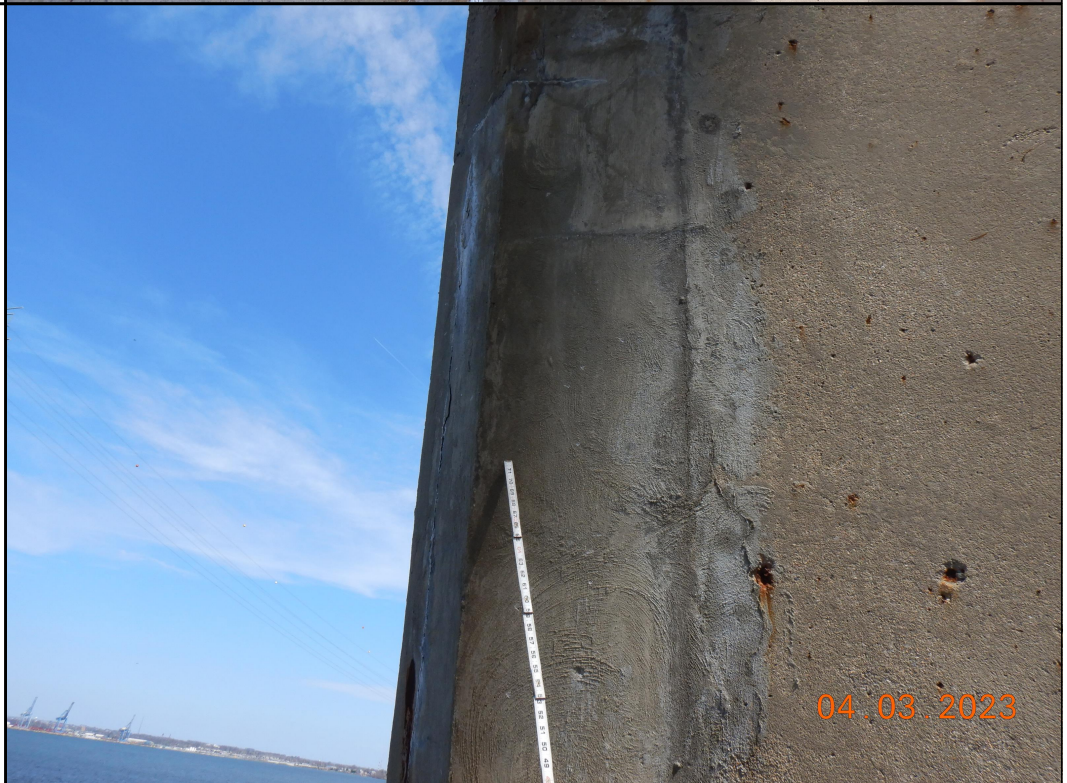
PHOTO NO.: 89

Location: Pier 18, Northwest Column, South Face, 37'-0" from the base, west end

Description: There is a 2'-0" wide x 2'-0" high area of delamination. FY 2023 Inspection: This defect has been repaired. Repair status changed to CLOSE-CONSULTANT. Concrete repair patch exhibits moderate efflorescence along the west edge.

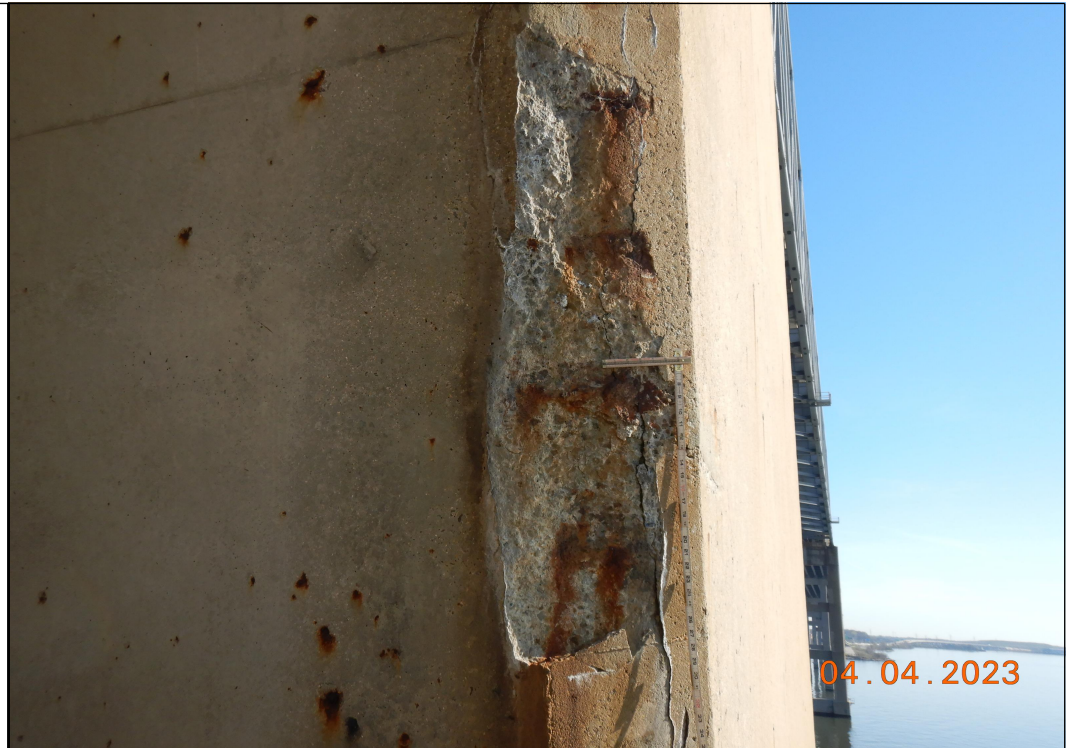
Description: There is a 1'-8" wide x 4'-0" high x 2" deep spall with exposed and corroded reinforcement with an associated up to 2'-3" wide x 9'-6" high area of delamination above.

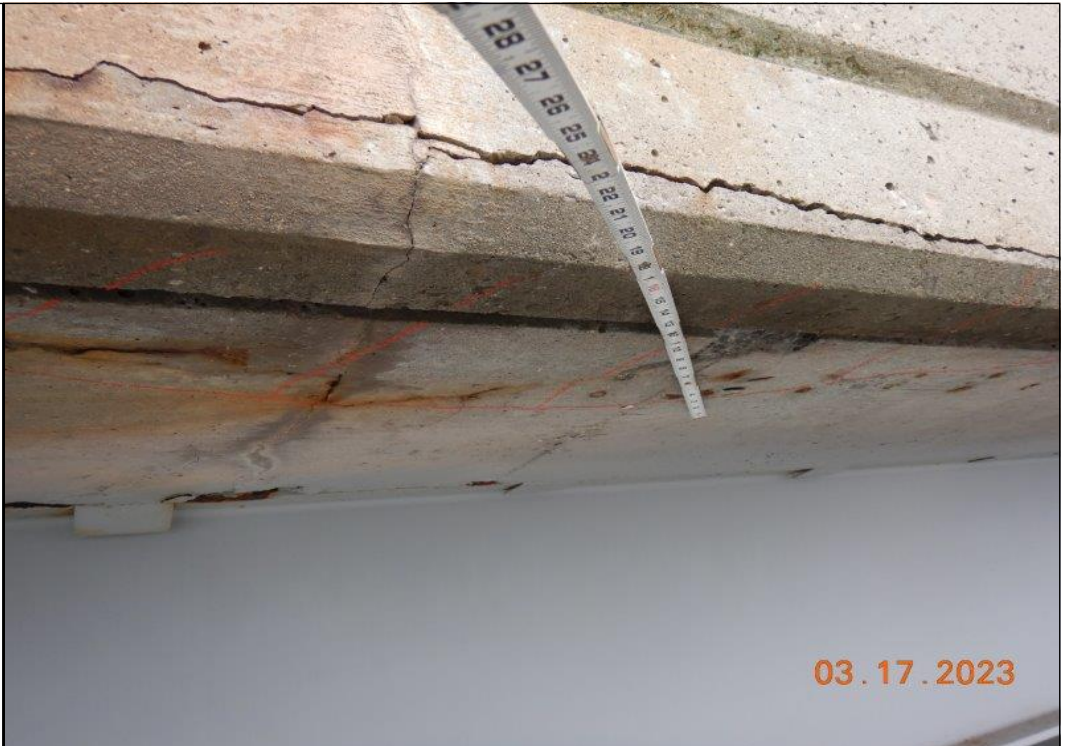
PHOTO NO.: 95

Location: Span 19, West Parapet, East and Top Face, at PP68

Description: There is a full-height x 2'-0" long x full-width delamination with 1/16" wide cracking.

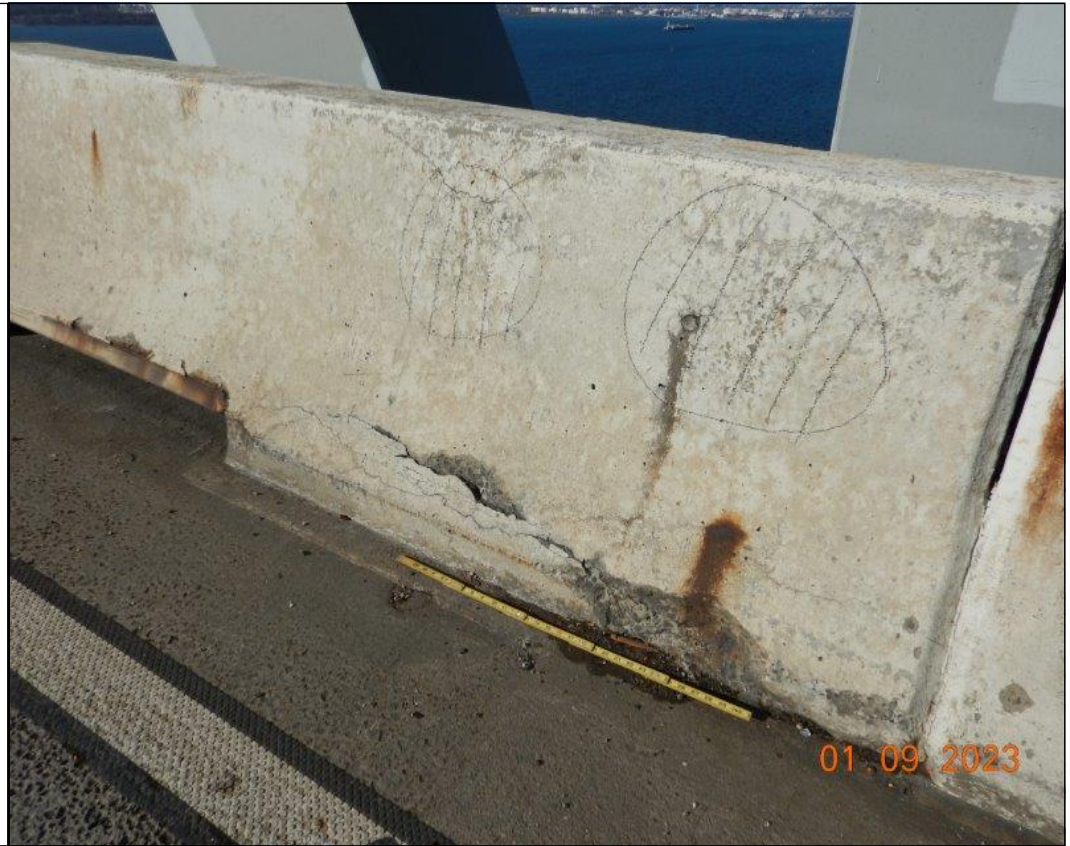
PHOTO NO.: 97

Location: Span 19, East Parapet, East Face, midway between PP67 and PP68

Description: There is a 2'-8" high x 1'-0" wide x 5" deep spall with exposed corroded steel reinforcement and embedded wood.

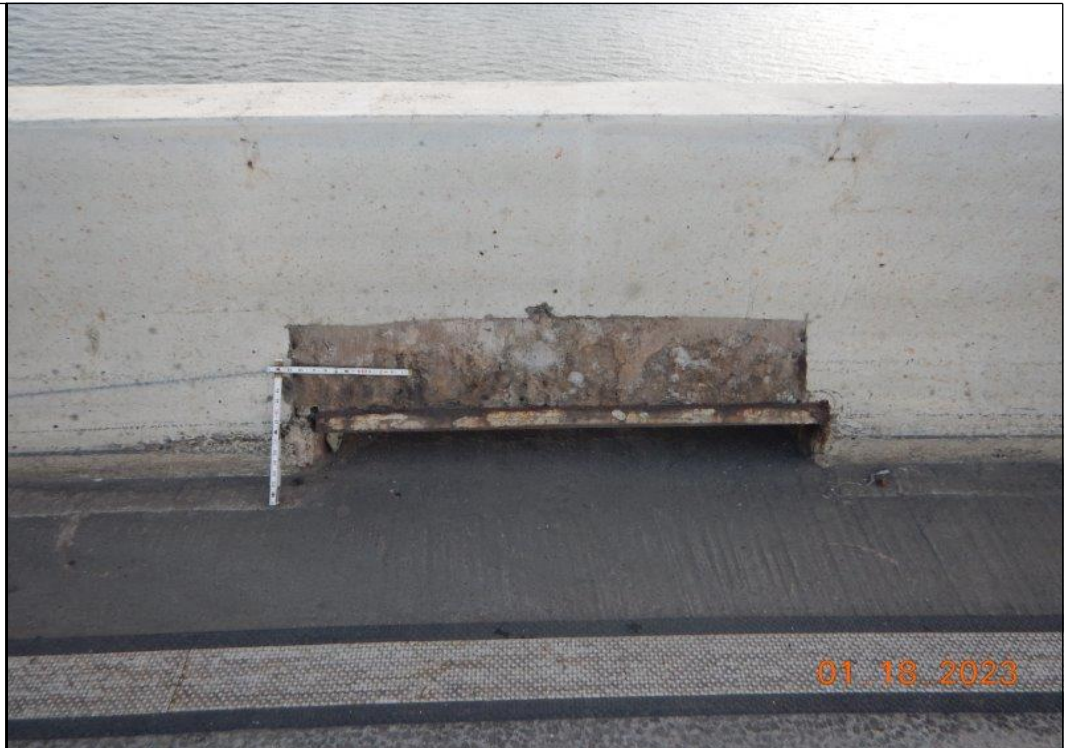
PHOTO NO.: 99

Location: Span 19, Median, East Face, 15'-0" north of PP75

Description: There is a 1'-4" long x 1'-0" high x 2" deep spall with exposed corroded steel reinforcement.

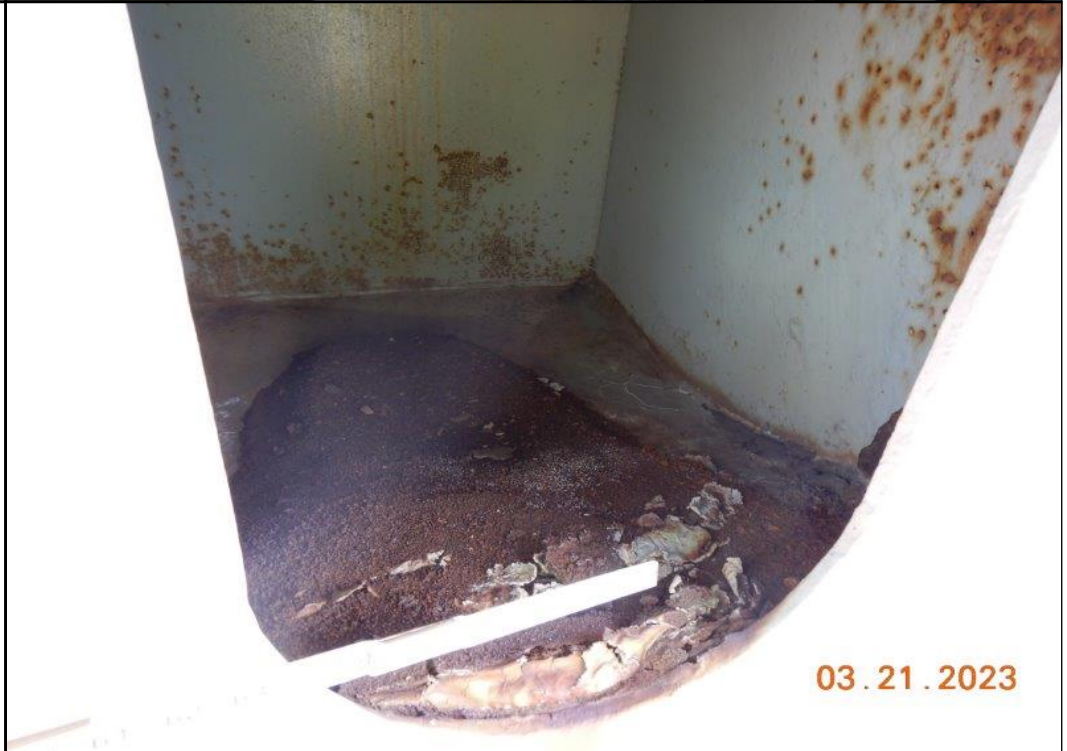
PHOTO NO.: 101
Location: Span 19, East Truss, U67-M68, Top Handhole at U67
Direction: North
Description: There is minor debris accumulation at the diaphragm with evidence of ponding water and corrosion bleeding from the hole. FY 2023 Inspection: This defect has been repaired. Repair status changed to CLOSE-CONSULTANT.
Element #: 59.PP 67- PP 68
Rating #: 6
MDTA Repair: 3
Repair Id: 2019-BCZ472001(S17-S19)-00498

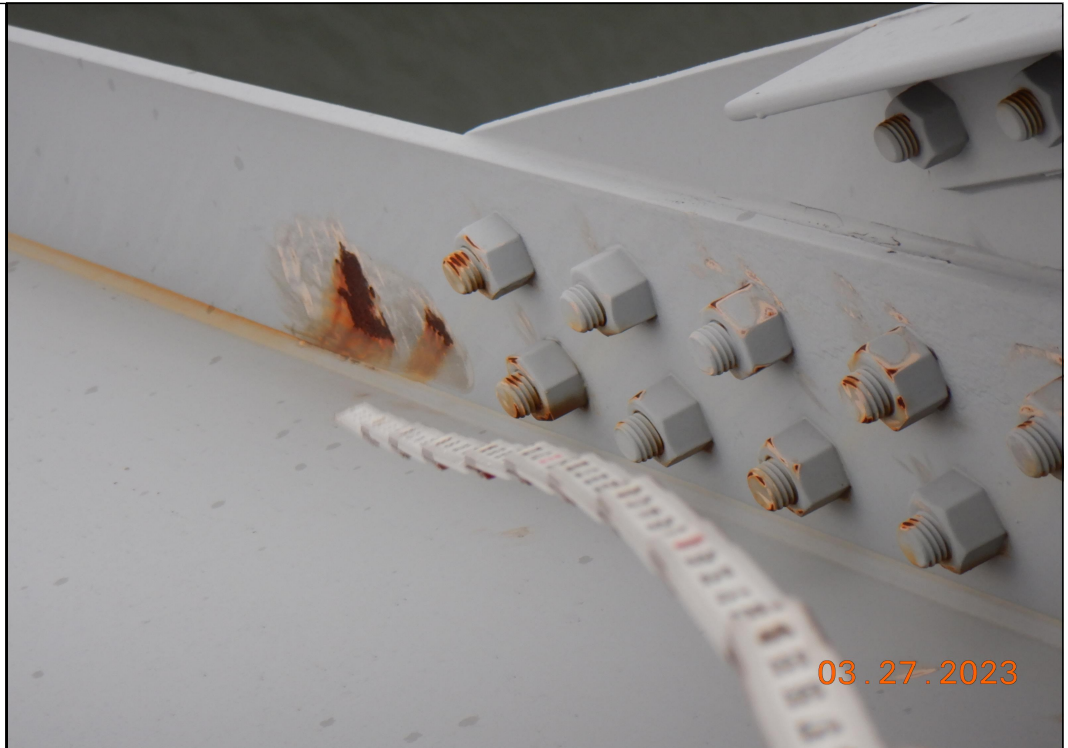
PHOTO NO.: 105

Location: Span 19, Floorbeam 73, connection to the West Truss, Top Flange connection plate, North Side

Description: There is a deformation at the Tee connection and the top flange, bending the top flange of the floorbeam down 3/8" for a 4" length. Previously noted pack rust was not observed in FY 2023 Inspection. Repair status changed to CLOSE-CONSULTANT.

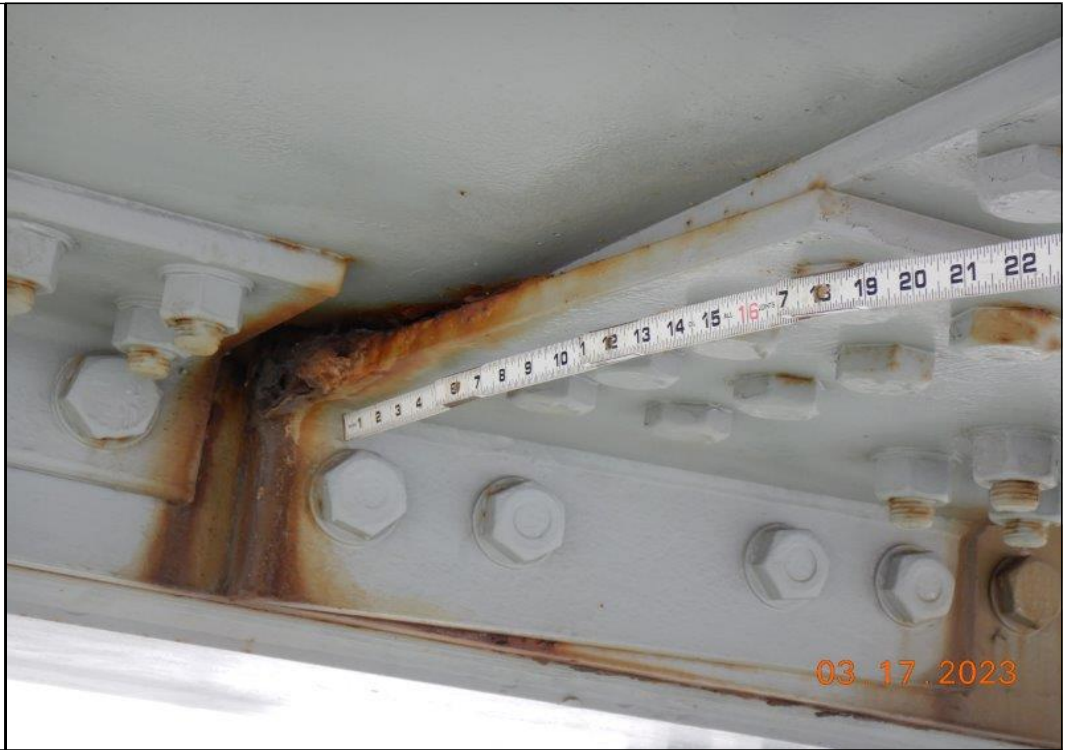
PHOTO NO.: 107

Location: Span 19, Lower
Lateral Brace, Center
Connection at Floorbeam 74
