MDTA 2023 Bridge Inspection Report (S17-S19)

MARYLAND TRANSPORTATION AUTHORITY
FSK-Francis Scott Key Bridge
Bridge - Biennial
FOR
STRUCTURE No. BCZ472001(S17-S19)
IS 695 OVER PATAPSCO RIVER

BIN: BCZ472001(S17-S19)

Date: 01/09/2023

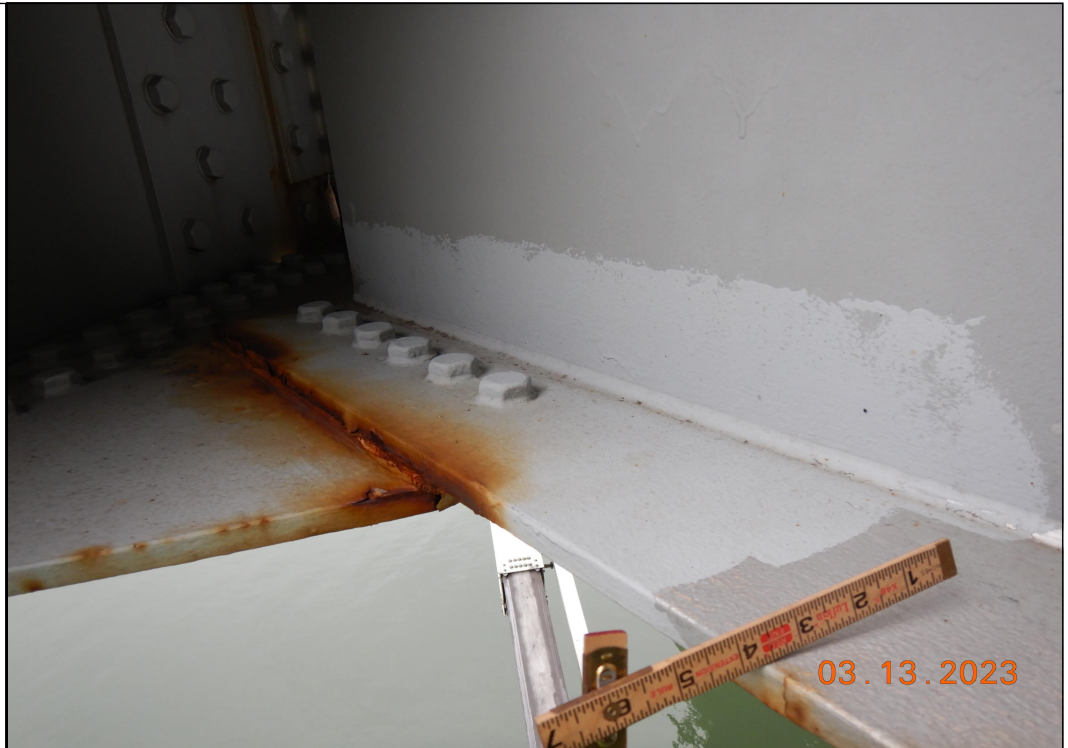
PHOTO NO.: 109

Location: Span 19, West Truss, Top Chord, U81-U83, at U81, Interior

Description: There is minor freckled corrosion on all faces for the end 4'-0".

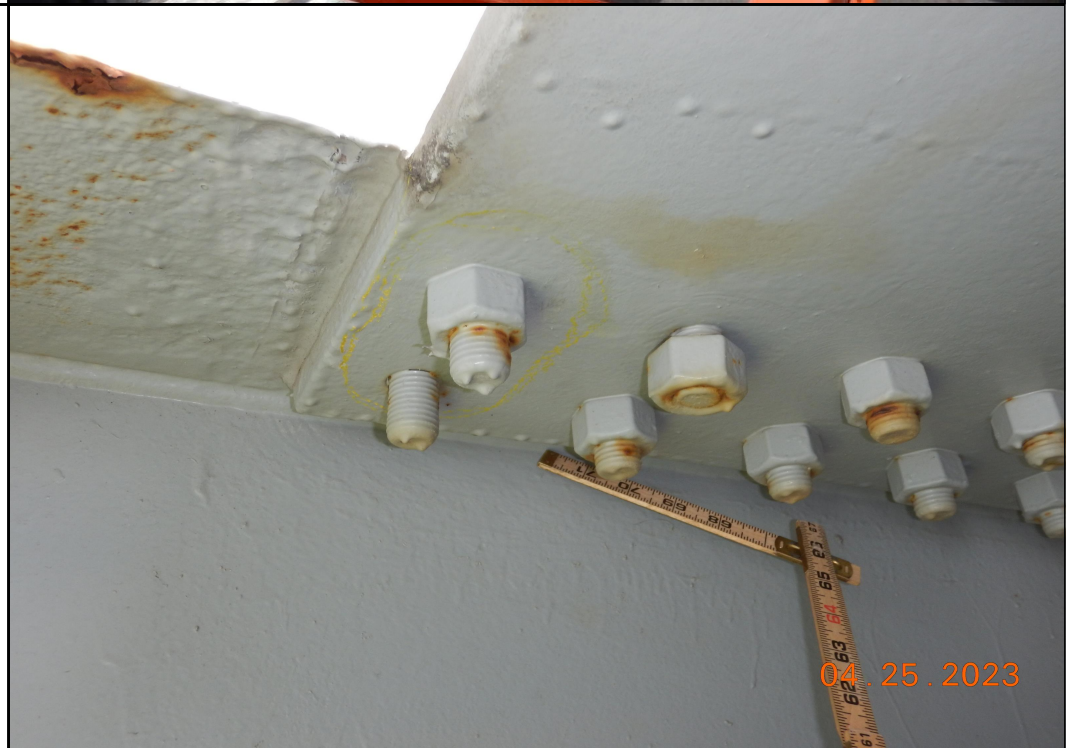
PHOTO NO.: 112

Location: Span 19, West Truss, at L85, Inboard Gusset Plate, West Face

Description: There is paint failure for approximately 90% of the area.

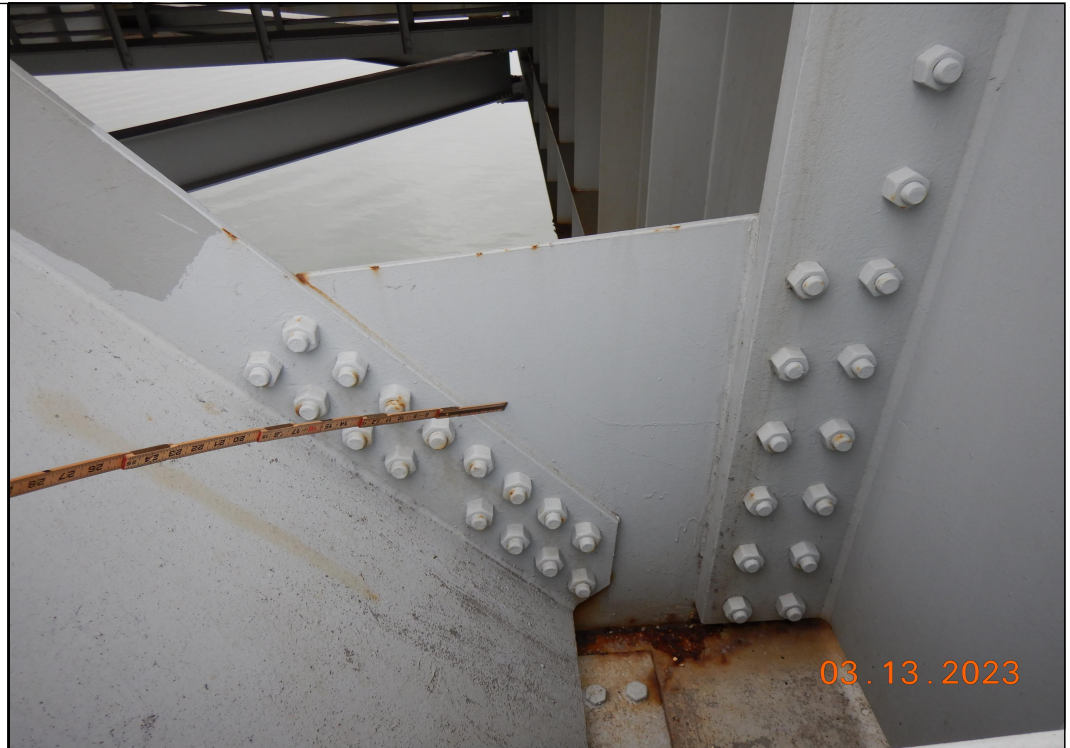
PHOTO NO.: 113

Location: Span 19, East Truss, Bottom Chord, L85-L86, Field Splice, Bottom Plate

Description: The east and west edges of the splice plate are pried down up to 2" due to pack rust, minor surface corrosion is reactivating on the ends of plate along all four sides. There is also a 2" wide band of up to 3/16" painted over section loss adjacent to the splice on the east and west sides.

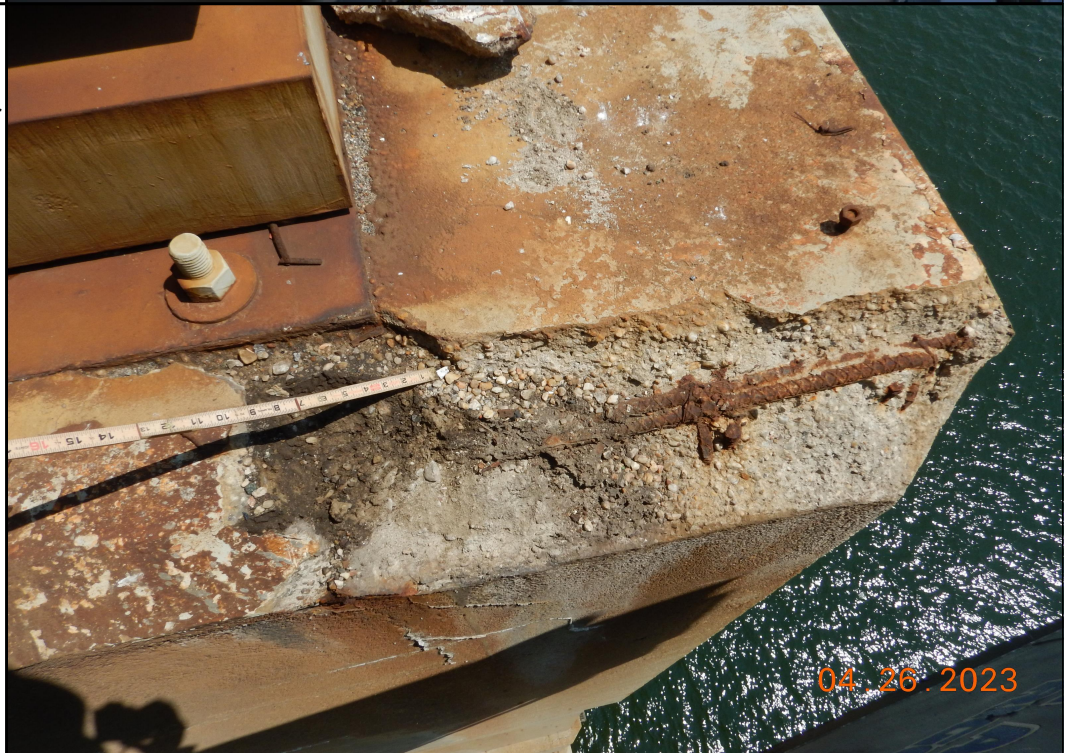
PHOTO NO.: 115
Location: Top face,
Southeast corner of Cap near
East Truss Bearing
Direction: North
Description: There is a 3'-0"
long x 1'-0" wide x 1'-0" high
corner spall with exposed
corroded reinforcement. FY
2023 Inspection: This defect
was still observed. Repair
status changed from CLOSE-
MDTA to OPEN.
Element #: 60.03 -
Capbeam/Top of Pier
Rating #: 6
MDTA Repair: 3
Repair Id: 2015-
BCZ472001(S17-S19)-00025

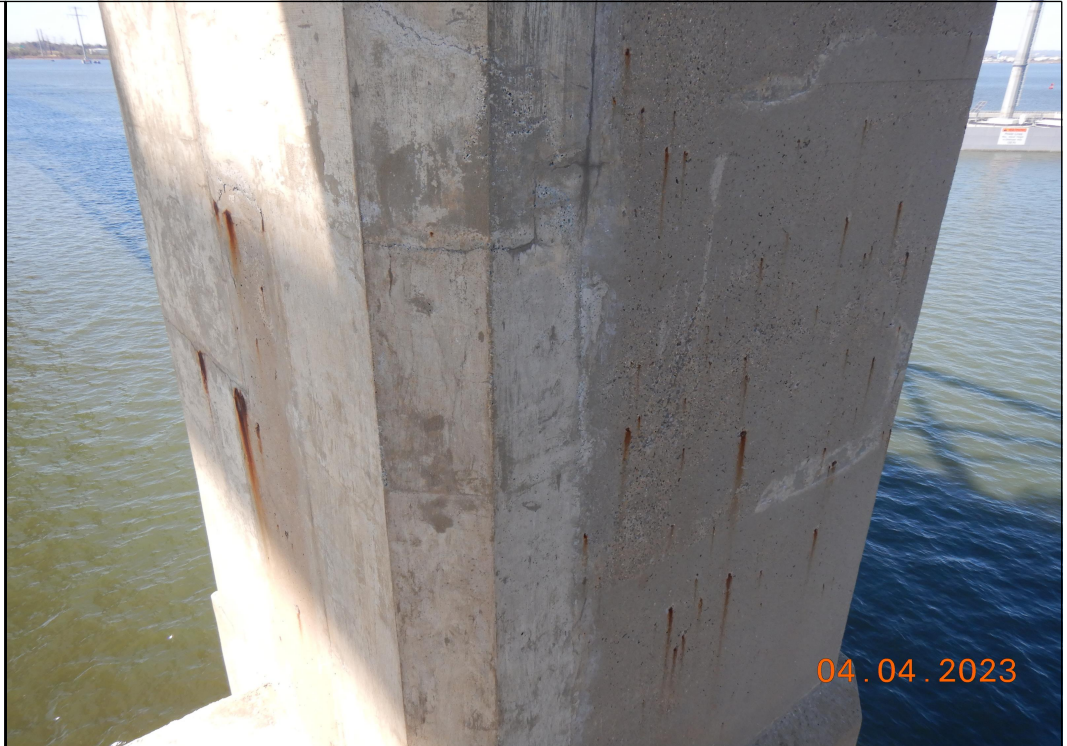
PHOTO NO.: 117

Location: Pier 19, West Column, South Face, just above the upper strut

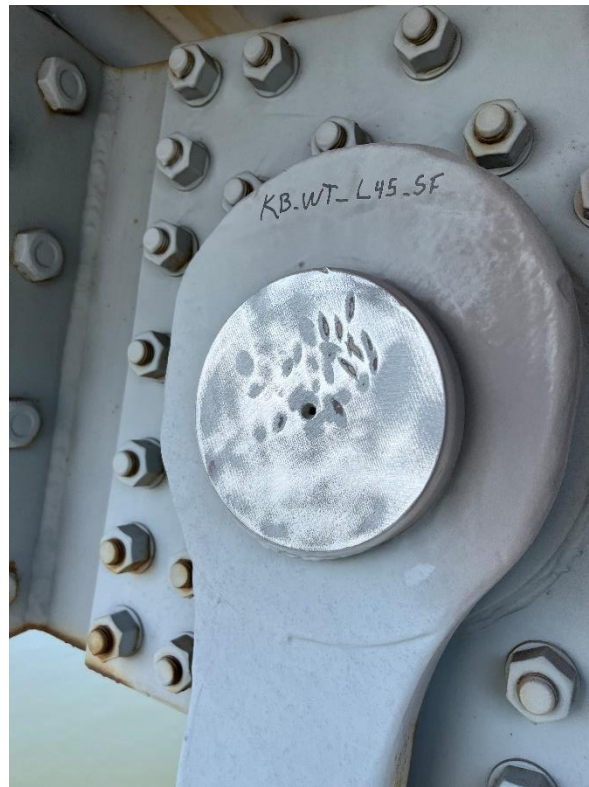
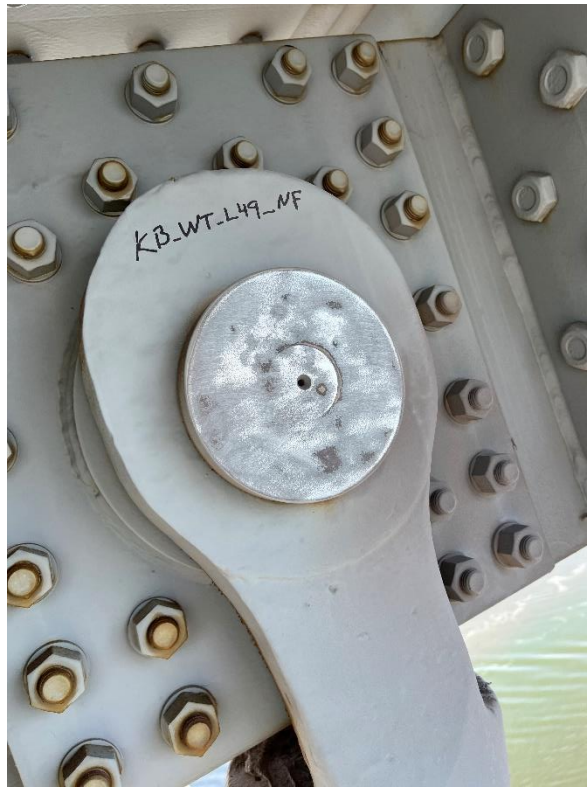
Figure A7: KB-WT-L45-NF

- + 6 indications were identified. These indications are consistent with wear grooving at intermediate framing members of the hanger and chord assembly. The indications were identified in the following pins: L34, L45, L53, L57 (at two locations), and B37.

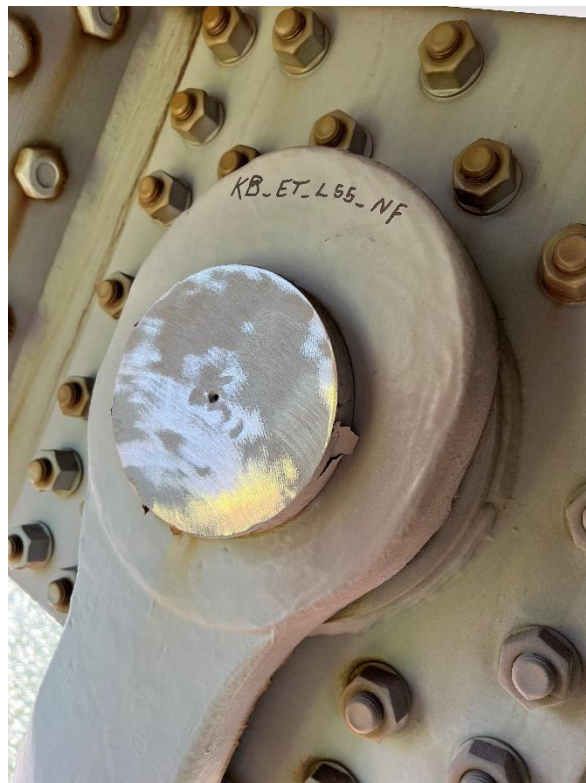
Figure A45: KB-ET-L55-SF

Pin Location Information	Figure #	Backwall Information
<p>Span: 18 Pin Number: L55 Truss (E/W): East Pin Face (N/S): South Date Taken: 3/8/2023</p> <p>Footnotes:</p>	A45	<p>Backwall Distance ("): 14.026" Reference dB at 80% Backwall Height: 42+0.4 Indication (y/n): N Filename: KB_ET_L55_SF Additional Notes: -Slight corrosion on threads</p>
<p>Span: 18 Pin Number: L55 Truss (E/W): East Pin Face (N/S): North Date Taken: 3/8/2023</p> <p>Footnotes:</p>	A46	<p>Backwall Distance ("): - Reference dB at 80% Backwall Height: 42+0.4 Indication (y/n): N Filename: KB_ET_L55_NF Additional Notes: -Slight corrosion on threads</p>
<p>Span: 18 Pin Number: L59 Truss (E/W): East Pin Face (N/S): South Date Taken: 3/8/2023</p> <p>Footnotes:</p>	A47	<p>Backwall Distance ("): 13.933" Reference dB at 80% Backwall Height: 42+6.2 Indication (y/n): N Filename: KB_ET_L59_SF Additional Notes: N/A</p>
<p>Span: 18 Pin Number: L59 Truss (E/W): East Pin Face (N/S): North Date Taken: 3/8/2023</p> <p>Footnotes:</p>	A48	<p>Backwall Distance ("): - Reference dB at 80% Backwall Height: 42+4.2 Indication (y/n): N Filename: KB_ET_L59_NF Additional Notes: N/A</p>

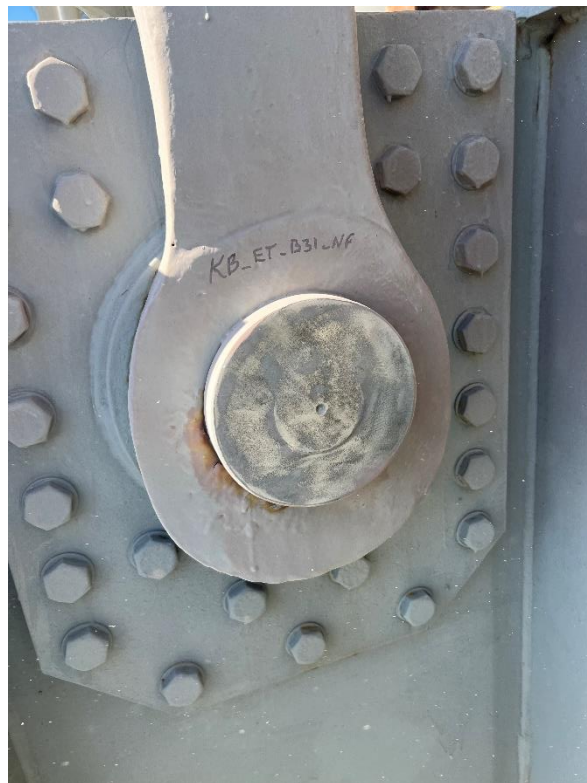
Figure A49: KB-ET-B31-SF

Pin Location Information	Figure #	Backwall Information
<p>Span: 18 Pin Number: B31 Truss (E/W): East Pin Face (N/S): South Date Taken: 3/9/2023</p>	<p>CORROSION ON PIN FACE</p>

<p>Footnotes:</p>	<p>Backwall Distance ("): 13.687" Reference dB at 80% Backwall Height: 40.8-5.7 Indication (y/n): N Filename: KB_ET_B31_SF Additional Notes: N/A</p>
<p>Span: 18 Pin Number: B31 Truss (E/W): East Pin Face (N/S): North Date Taken: 3/9/2023</p>	<p>CORROSION ON PIN FACE</p>

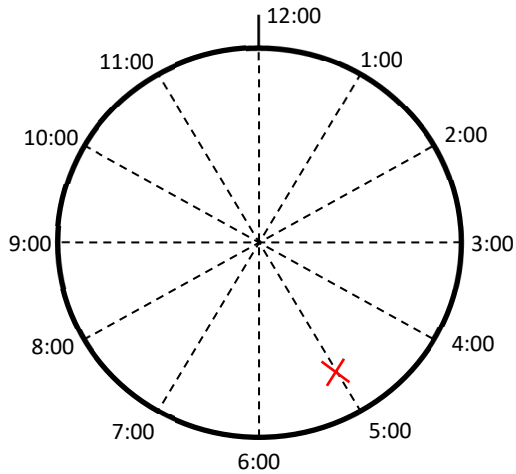
Scanning Face: South Face

Indication Depth (in): 6.185"

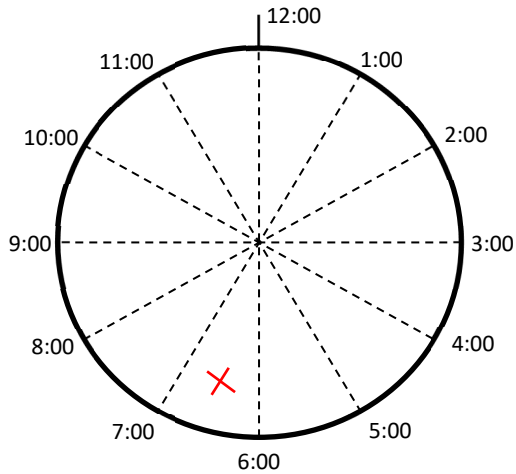
Scanning Face: South Face

Indication Depth (in): 4.974"

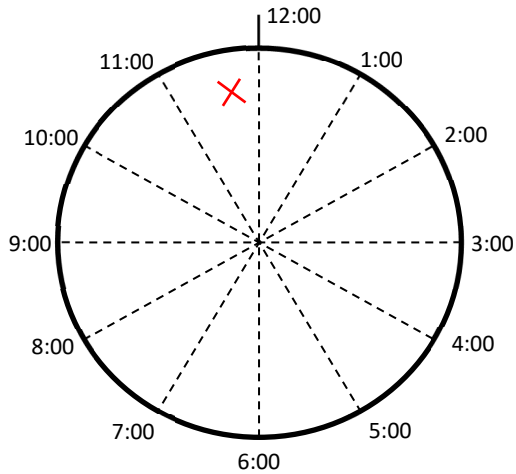
Scanning Face: North Face

Indication Depth (in): 2.591"

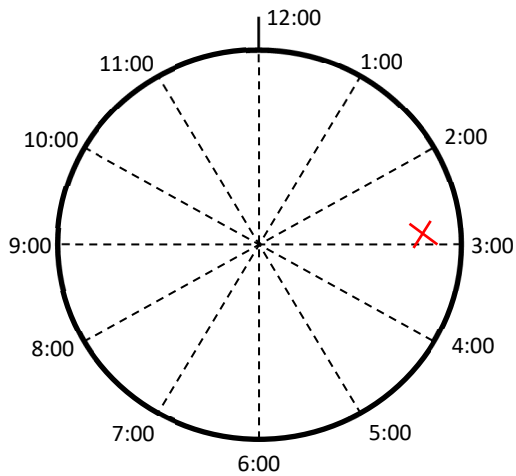
Scanning Face: South Face

Indication Depth (in): 5.230"

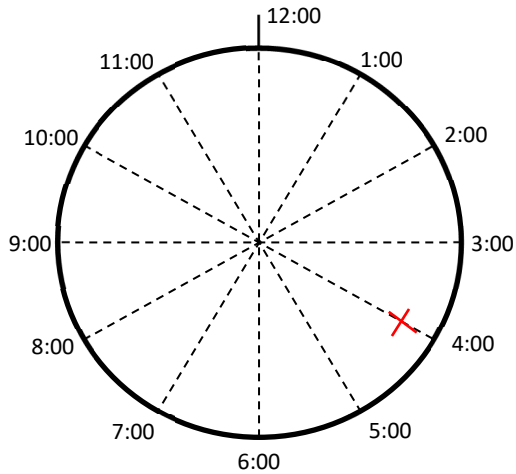
Scanning Face: South Face

Indication Depth (in): 5.098"

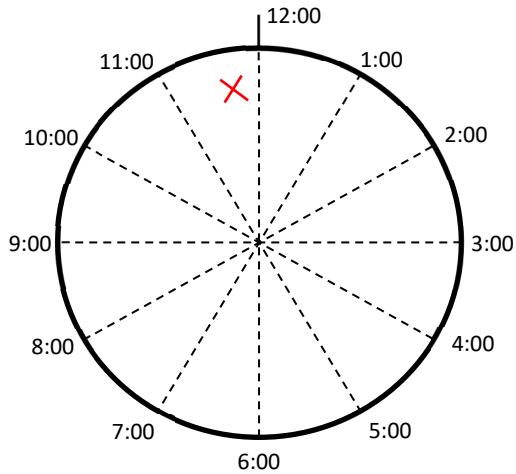
Scanning Face: South Face

Indication Depth (in): 7.607"

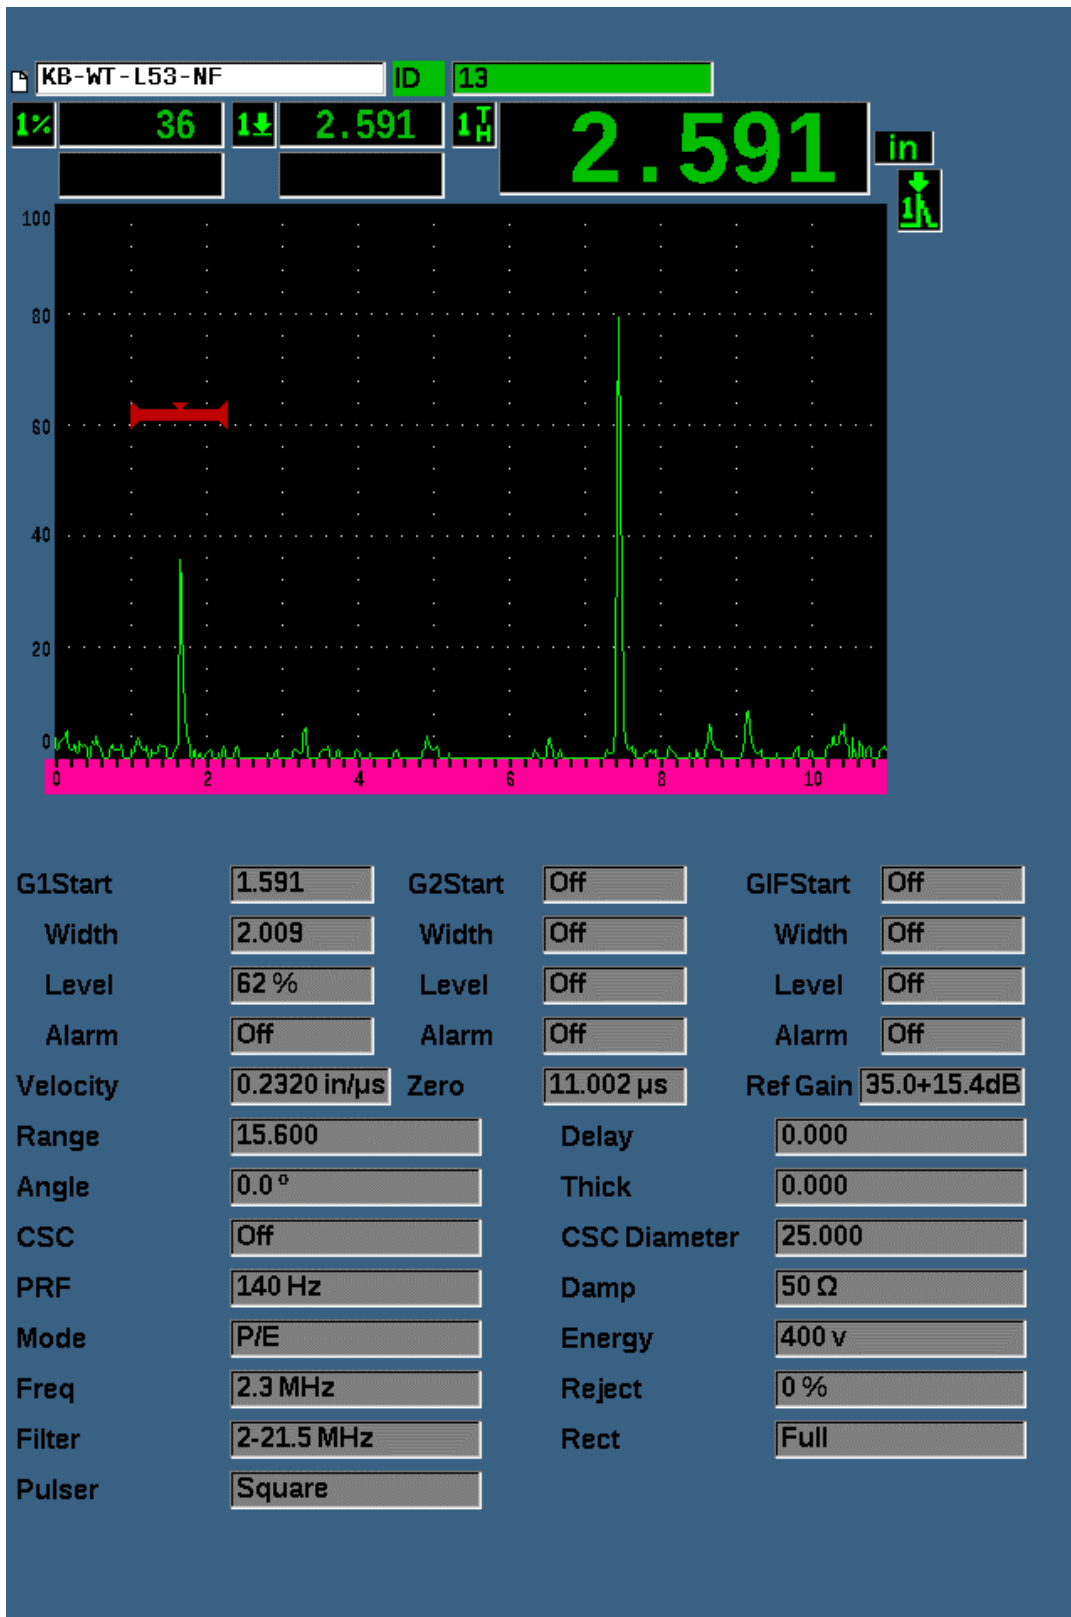
Figure D3: Indication Parameters for KB_WT_L53_NF

<p>Span: 18 Pin Number: L53 Truss (E/W): West Pin Face (N/S): North Date Taken: 3/6/2023</p>	<p>CORROSION ON PIN FACE</p> <p>Footnotes:</p>	<p>Backwall Distance ("): - Reference dB at 80% Backwall Height: 35+15.4 Indication (y/n): Y Filename: KB_WT_L53_NF Additional Notes: See Indication Sheet C3</p>
