**NATIONAL TRANSPORTATION SAFETY BOARD
OFFICE OF HIGHWAY SAFETY
WASHINGTON, D.C.**

**SURVIVAL FACTORS GROUP CHAIRMAN'S
FACTUAL REPORT**

GREENVILLE, ALABAMA – HWY21MH009

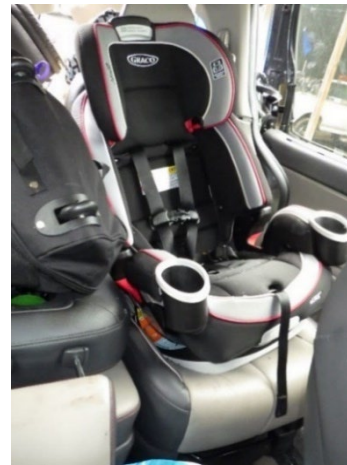
Figure 25. Kia interior looking aft from row 1, driver side

The right-rear and middle seats of the second row had the seatbacks folded down into a stowed position at the time of the vehicle inspection, as shown in Figure 24. The left rear row 2 passenger seat had a forward-facing child car seat with a 5-point harness, as shown in Figure 25. The child car seat was labeled: Graco 4ever and was displaced inboard approximately 20 degrees with the right inboard edge depressed about 3 inches into seat pan. There was blood on the (folded down) middle headrest. The aft surface of the right-rear, second-row seat was deformed in the center at the lower left inboard quadrant.
