National Transportation Safety Board

ERA22FA261

WRECKAGE EXAMINATION SUMMARY

Location: Panama City, Florida
Date: June 6, 2022
Time: 1610 CDT
2110 UTC
Airplane: Piper PA-28RT-201

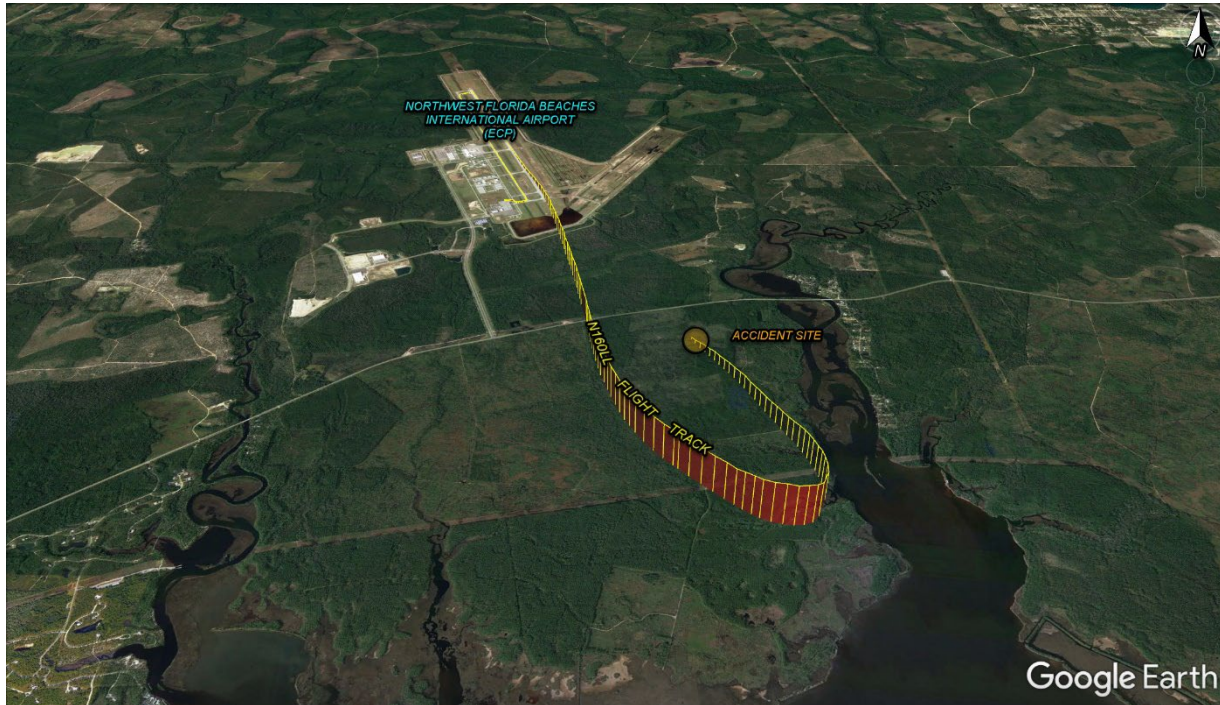
Figure 1 - ASD-B Track

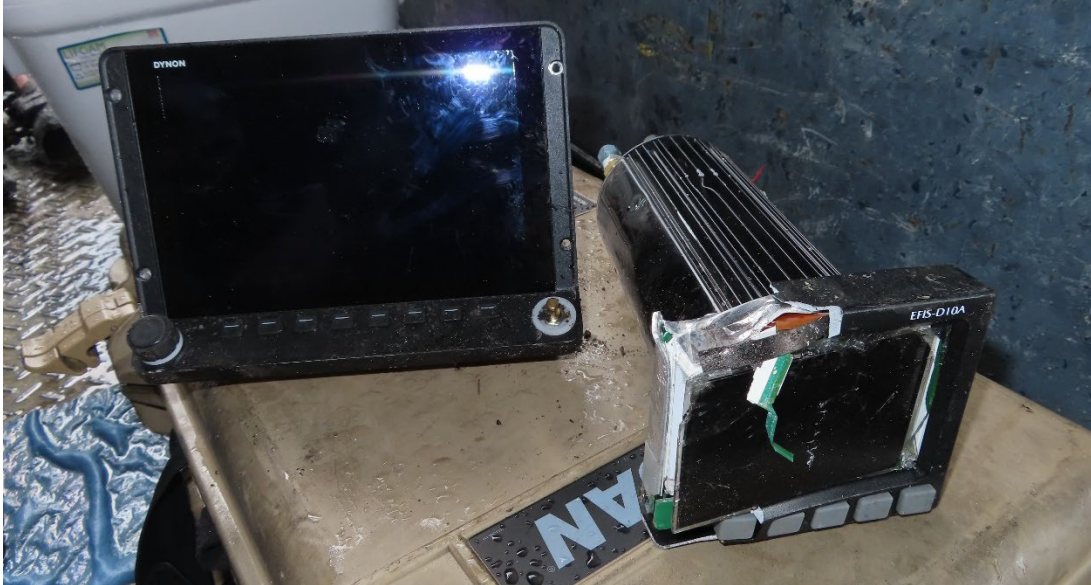
The airplane was equipped with Dynon HDX avionics and a Dynon D-10A that were removed and retained for data download.

Figure 9. View of units retained for data download.

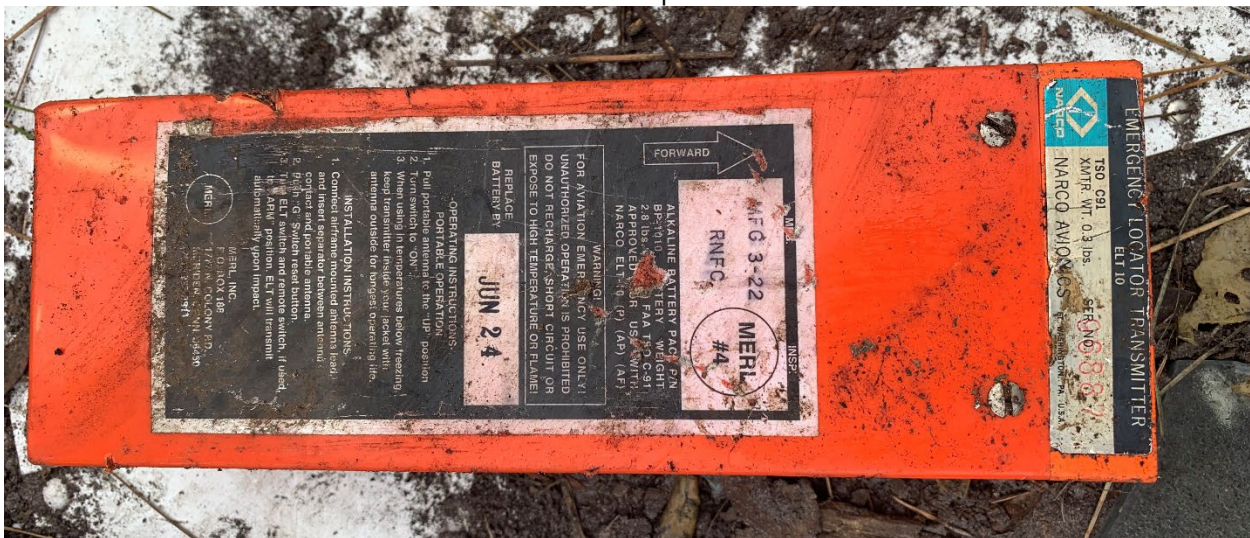
The ELT was located secured to the airplane.

Figure 10. ELT found in airplane.

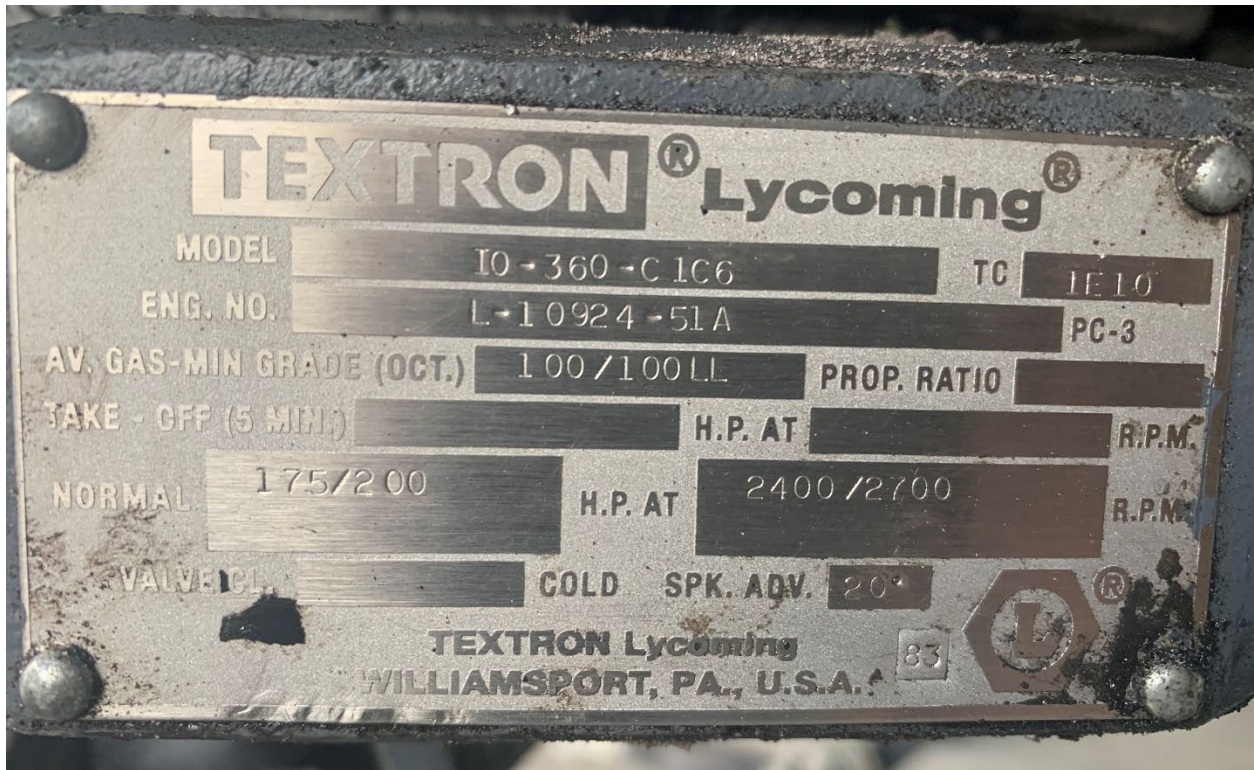
Figure 11. Engine Data Plate

Rated power - 200 HP

Most recent inspection - Annual inspection - May 11, 2022

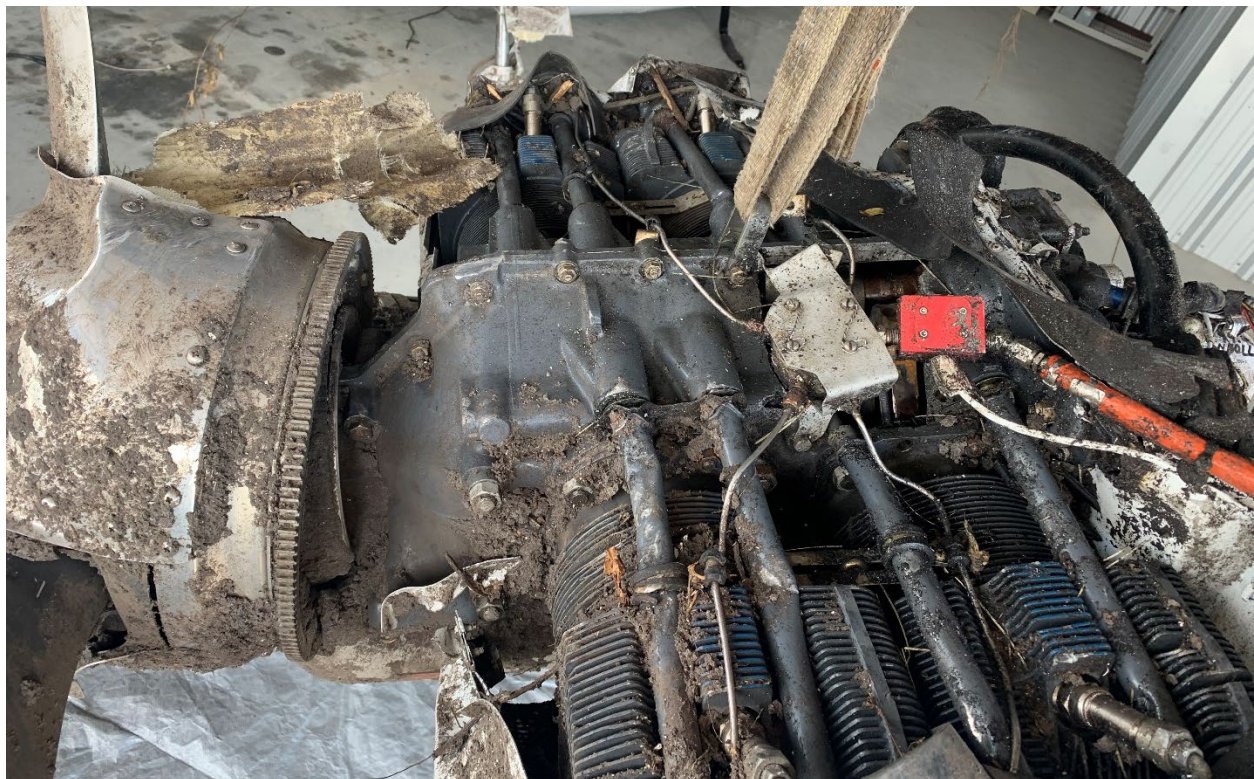
Figure 12. Top view of engine.

The engine remained partially attached to the fuselage through the engine mounts, cables, and wires. It was separated from the firewall for examination.

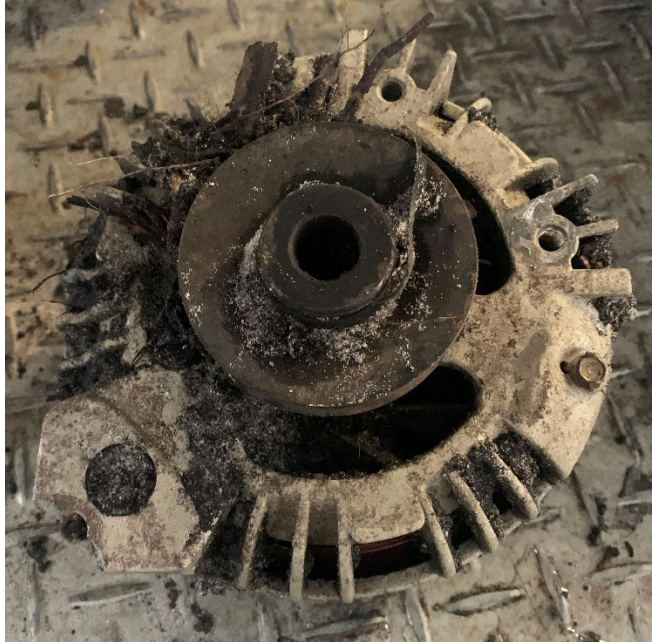
The alternator was impact separated from the engine and located in the vicinity of the main wreckage.

Figure 16. View of Alternator

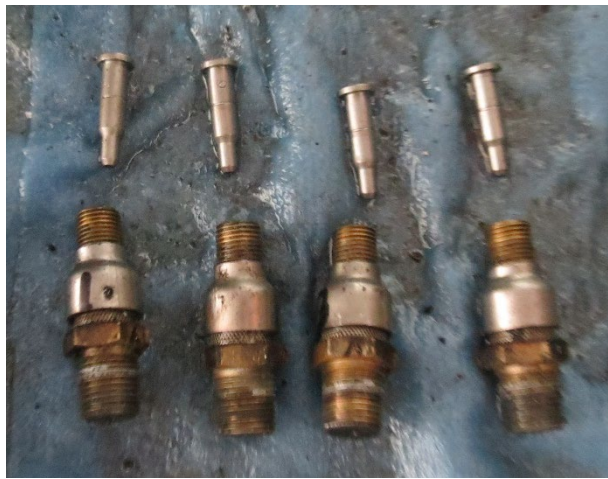
The fuel injector nozzles were removed from the cylinders and were not obstructed.

Figure 20. View of fuel injectors.

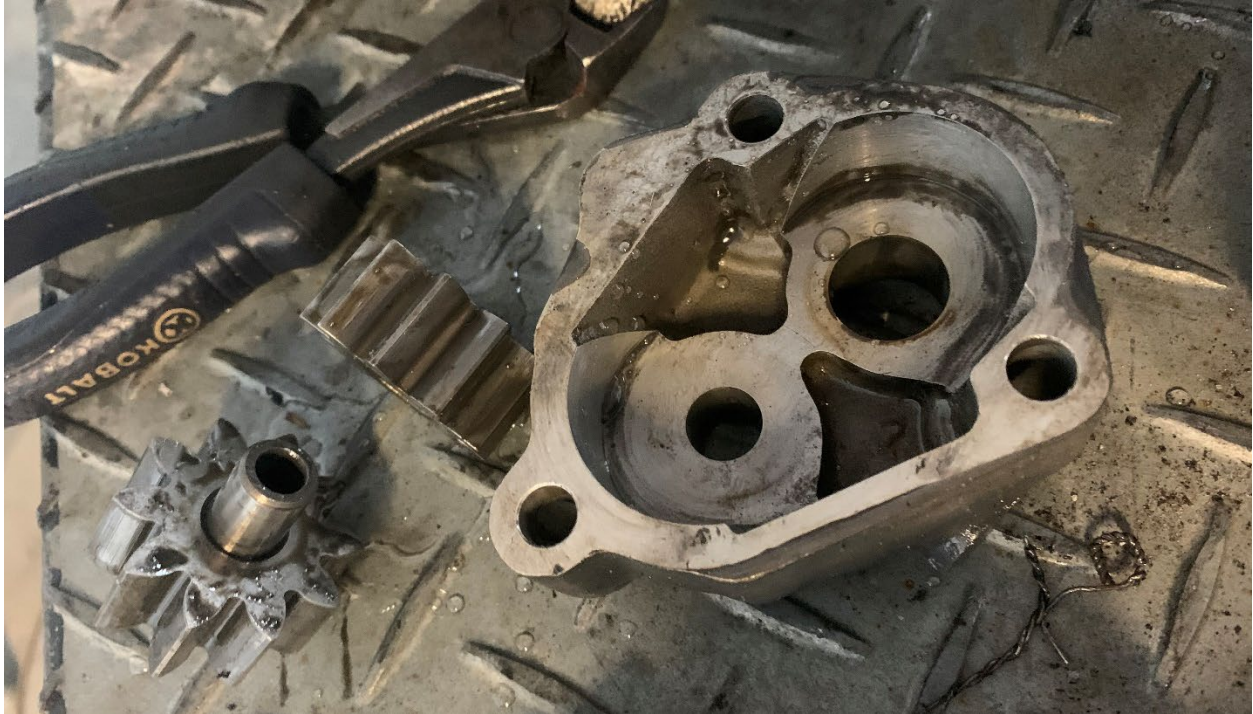
The oil pump was examined and could be rotated by hand. It was disassembled and no scoring was noted on the oil pump gears or the housing.

Figure 25. View of engine driven oil pump.

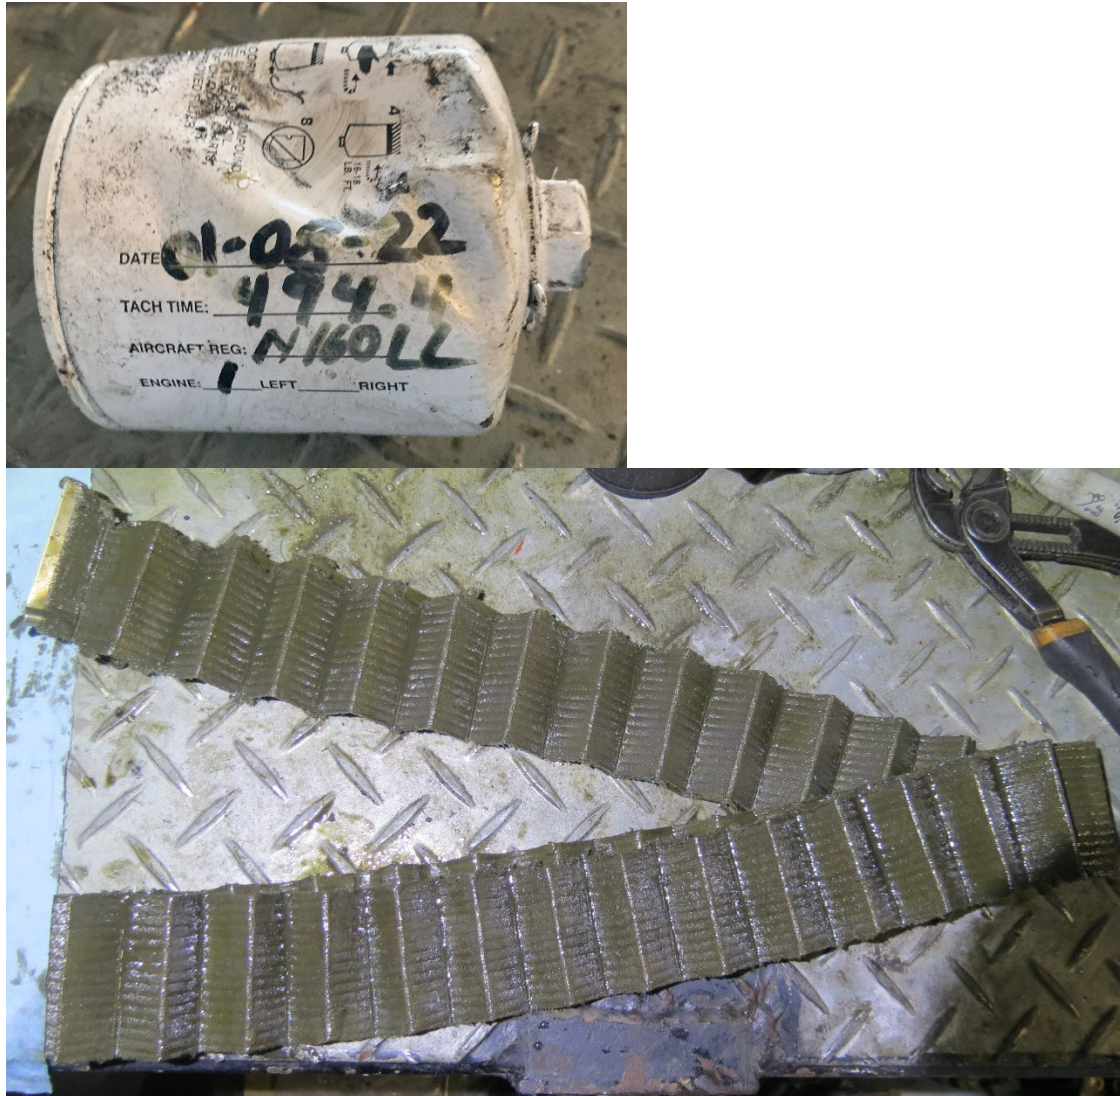
The oil filter adaptor was partially separated from the engine. The oil filter was removed from the engine and disassembled. The filter element was removed and no debris was noted in the filter. The oil filter date noted January 8, 2022, with a tachometer time of 494.4 hours.

Figure 26. View of oil filter housing and filter.

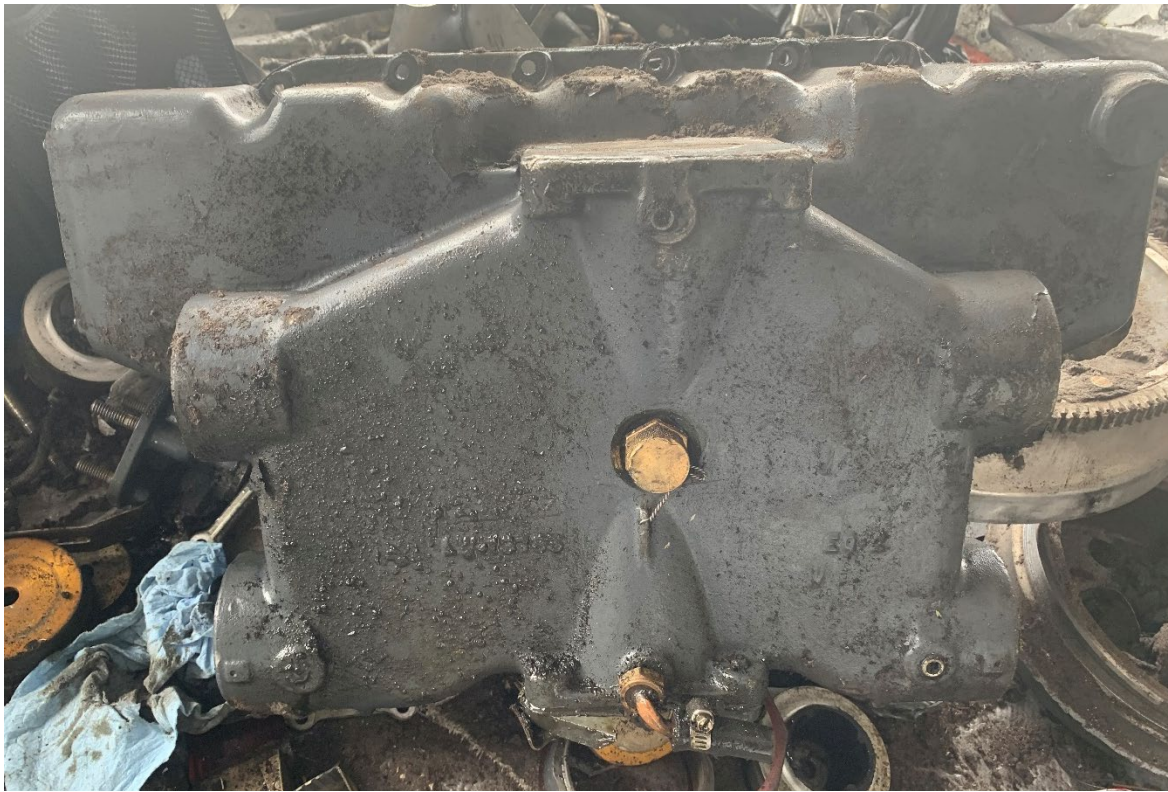
The oil drain plug remained seated and safety wired into the oil sump.

Figure 28. View of oil drain plug safety wired into the oil sump.

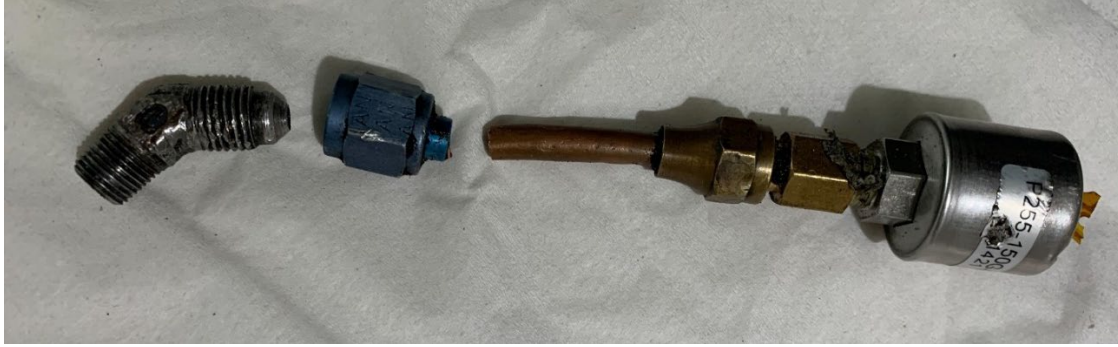
The oil pressure sensor was separated from the engine. The copper line was fractured at the fitting to the accessory section of the crankcase. The copper line and oil pressure sensor were retained for further examination. According to the STC and installation instructions, "Always mount the sensor to the airframe structure and connect it with flexible hose to minimize vibration effects." Furthermore, the oil pressure sensor did utilize a restrictor fitting.

The oil pressure sensor, copper line, and restrictor fitting were retained for further examination.

Figure 30. View of oil sensor line retained for further examination.
