# NATIONAL TRANSPORTATION SAFETY BOARD

MATERIALS LABORATORY FACTUAL REPORT

Report No. 18-003

Place : Millersville, Pennsylvania  
Date : July 2, 2017  
Vehicle : Natural gas mechanical tapping tee assembly  
NTSB No. : DCA17FP006  
Investigator : Roger Evans (RPH)

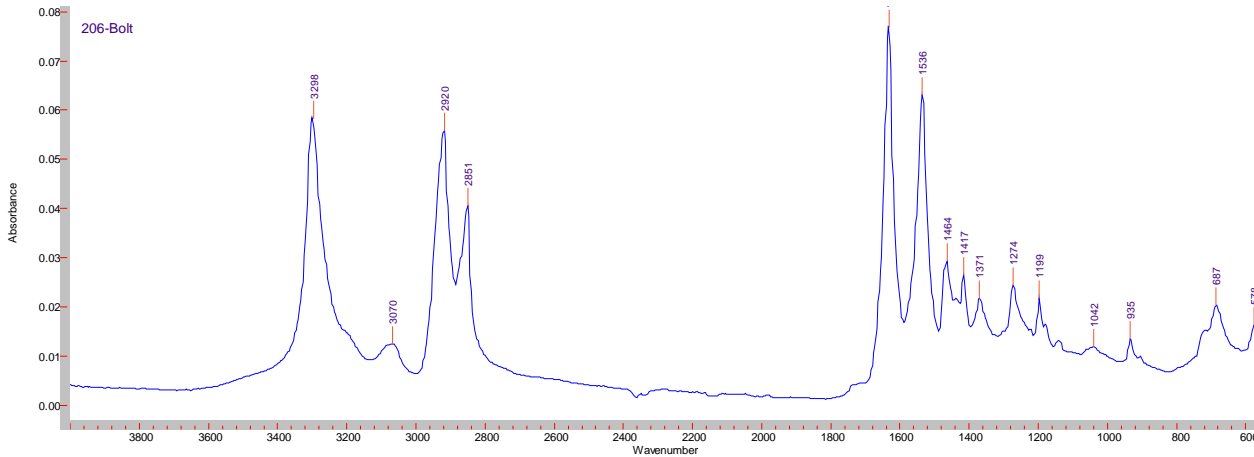
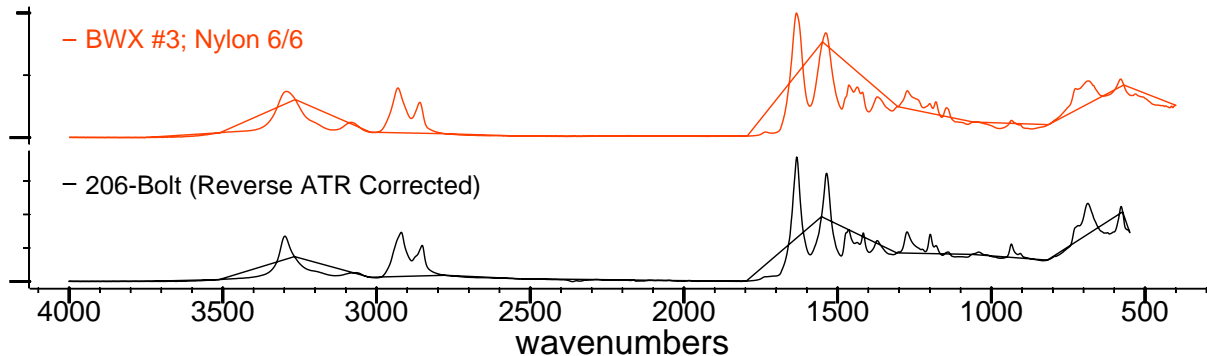
Appendix A1. FTIR spectrum of bolt "2" from dwelling 206 showing the identity of specific wavenumber peaks.

Appendix A2. FTIR spectrum of Nylon 6/6 library reference standard (top spectrum) is consistent with that of bolt "2" from dwelling 206 (bottom spectrum).

The BOLT sample from dwelling 206 spectrum contained the following combination of spectral peaks corresponding to particular functional groups found within the molecular structure of the bolt material. The presence of two peaks at  $\sim 3300\text{ cm}^{-1}$  and at  $\sim 3070\text{ cm}^{-1}$  is indicative of nitrogen-hydrogen (N-H) stretching bonds. The presence of a strong doublet peak between  $\sim 2900\text{ cm}^{-1}$  and  $\sim 2850\text{ cm}^{-1}$  is indicative of a carbon-hydrogen (C-H) single stretching bond. The presence of a single peak  $\sim 1640\text{ cm}^{-1}$  is indicative of a double bonded carbon-oxygen (C=O) group. The presence of a single peak  $\sim 1530\text{ cm}^{-1}$  is indicative of a nitrogen-hydrogen (N-H) bending bond. The presence of a single peak  $\sim 1371\text{ cm}^{-1}$  is indicative of a carbon-nitrogen (C-N) bond. The presence of a single peak  $\sim 935\text{ cm}^{-1}$  is indicative of a carbon-carbon=oxyen (C-C=O) group. This combination of functional groups is consistent with a polyamide. A spectral library search was perform using this spectrum. The search found a very strong match to Nylon 6/6.

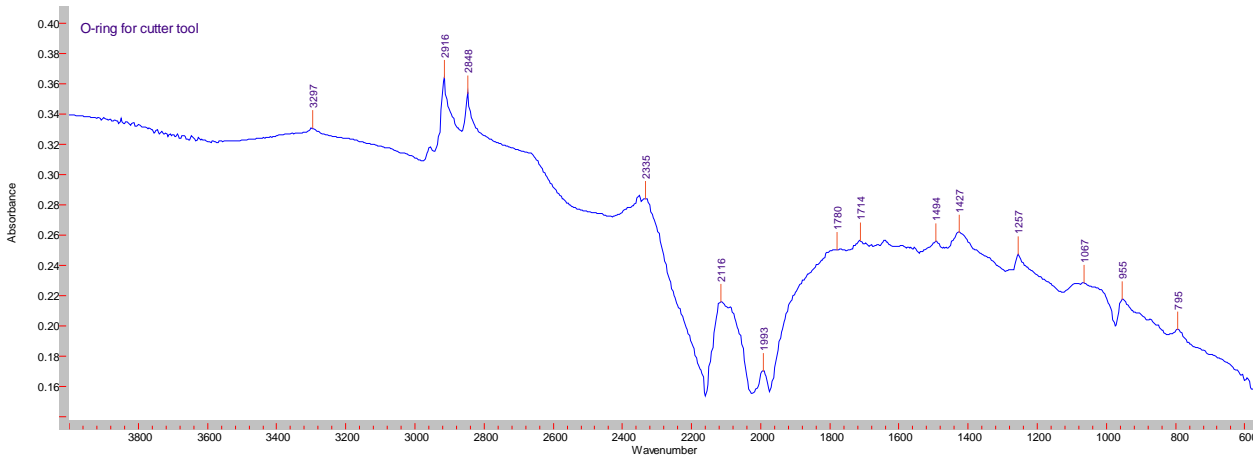
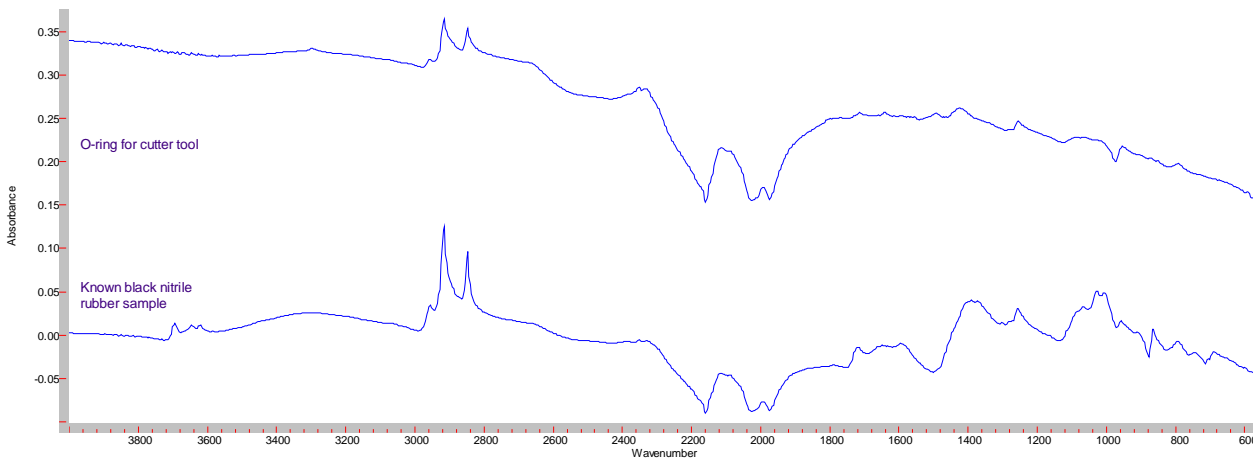
Appendix A3. FTIR spectrum of the cutter tool O-ring for the tee assembly from dwelling 206 showing the identity of specific wavenumber peaks.

Appendix A4. FTIR spectrum of the cutter tool O-ring from dwelling 206 (top spectrum) is consistent with that from a sample of a known sample of black nitrile rubber (bottom spectrum).

The samples identified as SADDLE O-RING and CUTTER TOOL O-RING shared matching spectra indicating that both samples were the same material. Both spectra contained the following combination of spectral peaks corresponding to particular functional groups found within the molecular structure of the material. The presence of a low broad peak between  $\sim 3100\text{ cm}^{-1}$  is indicative of a carbon-hydrogen (C-H) functional group that is double bonded to another molecule (most likely another carbon molecule). The presence of a strong doublet peak between  $\sim 2900\text{ cm}^{-1}$  and  $\sim 2850\text{ cm}^{-1}$  is indicative of a carbon-hydrogen (C-H) single stretching bond. The presence of a single peak  $\sim 2230\text{ cm}^{-1}$  is indicative of a triple bonded carbon-nitrogen ( $\text{C}\equiv\text{N}$ ) group. The presence of a single broad peak  $\sim 2100\text{ cm}^{-1}$  is indicative of double bonded carbon=carbon ( $\text{C}=\text{C}$ ) group (most likely in the form of elemental carbon). The presence of a single peak  $\sim 1990\text{ cm}^{-1}$  is indicative of another double bonded carbon group (alkene). The presence of a single peak  $\sim 1470\text{ cm}^{-1}$  is indicative of a carbon-hydrogen<sub>2</sub> ( $\text{C-H}_2$ ) bending bond. The presence of a single peak  $\sim 950\text{ cm}^{-1}$  is indicative of a carbon-hydrogen<sub>3</sub> ( $\text{C-H}_3$ ) bending bond. A spectral library search was performed on both O-ring samples. The search found a match to acrylonitrile/butadiene copolymer (n-butyl rubber or nitrile rubber).

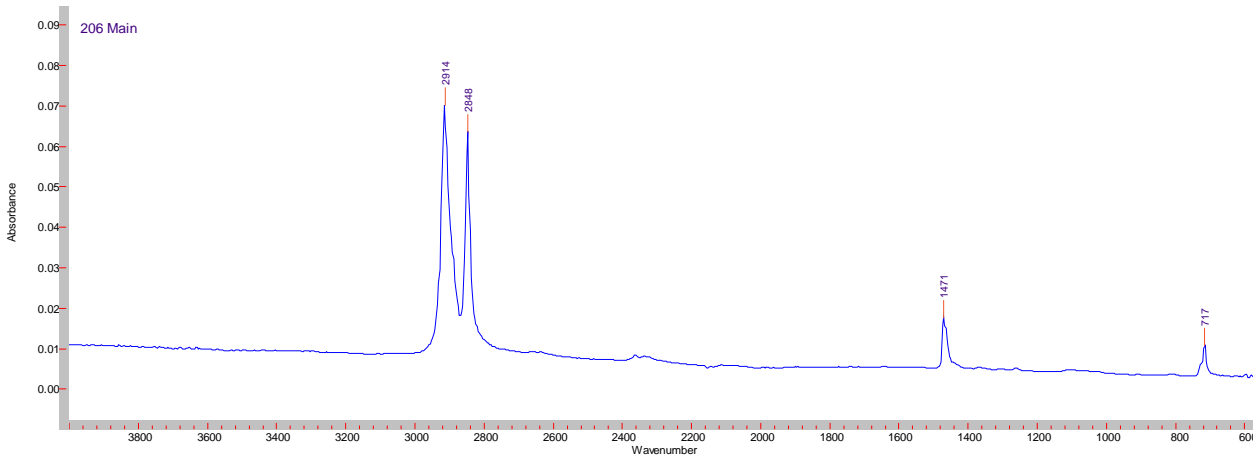
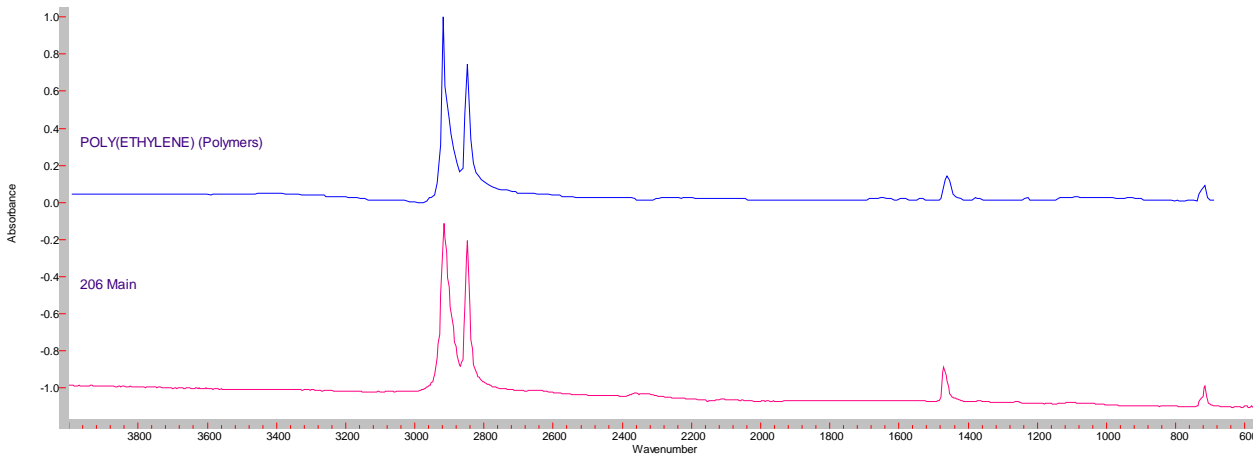
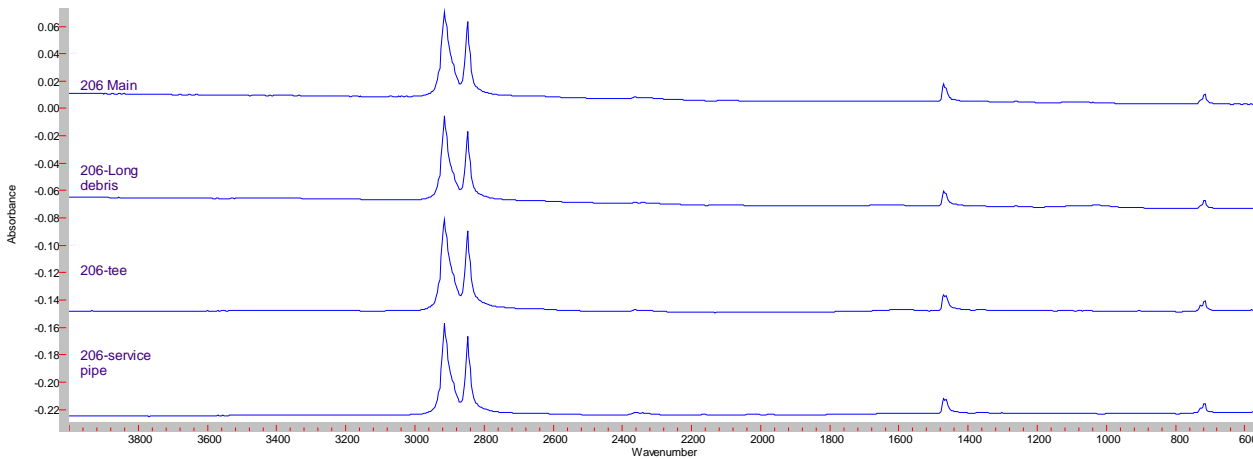
Appendix A5. FTIR spectrum of the tee assembly main associated with dwelling 206 showing the identity of specific wavenumber peaks.

Appendix A6. FTIR spectrum of polyethylene library reference standard (top spectrum) is consistent with spectrum of that from the main (bottom spectrum).

Appendix A7. FTIR spectra for the main, long curled debris found in the pierced hole of the main, tee assembly tower portion, and service pipe, all from dwelling 206 (from top to bottom spectrum, respectively). They are all similar and consistent with polyethylene.

The samples identified as MAIN, LONG DEBRIS, TEE and SERVICE PIPE shared matching spectra indicating that all four samples were the same material. The four spectra contained the following combination of spectral peaks corresponding to particular functional groups found within the molecular structure of this material. The presence of a strong doublet peak between  $\sim 2900\text{ cm}^{-1}$  and  $\sim 2850\text{ cm}^{-1}$  is indicative of a carbon-hydrogen (C-H) single stretching bond. The presence of a single peak  $\sim 1470\text{ cm}^{-1}$  is indicative of a carbon-hydrogen<sub>2</sub> (C-H<sub>2</sub>) bending bond. The presence of a single peak  $\sim 700\text{ cm}^{-1}$  is indicative of multiple carbon-hydrogen<sub>2</sub> (C-H<sub>2</sub>) bending bonds. A spectral library search was performed on a representative spectrum for this group. The search found that the material in the four samples was a very strong match to polyethylene (PE).

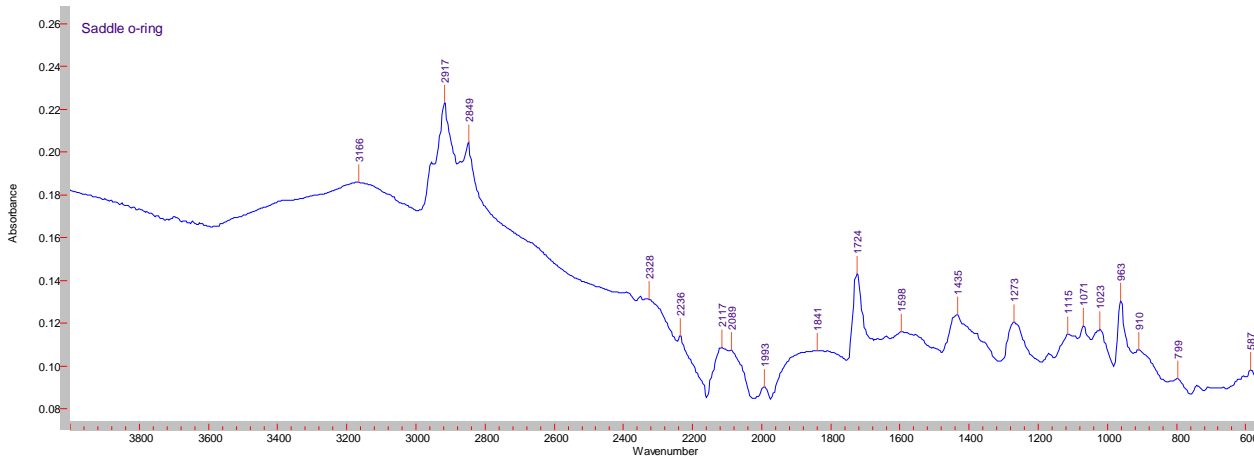
Appendix A8. FTIR spectrum of the saddle O-ring for the tee assembly from dwelling 206 showing the identity of specific wavenumber peaks.

In the spectrum for the SADDLE O-RING sample, one peak was found that was not found in the CUTTER TOOL O-RING sample or the known sample. The presence of a single peak  $\sim 1700\text{ cm}^{-1}$  is indicative of double bonded carbon=carbon (C=C) group. The presence of the a carboxy (C=O) group could indicate the presence of a foreign material on the surface of the O-ring. Carboxy groups are common in a wide variety of materials including materials containing carboxylic acids, esters and carboxylates (a class of surfactants).

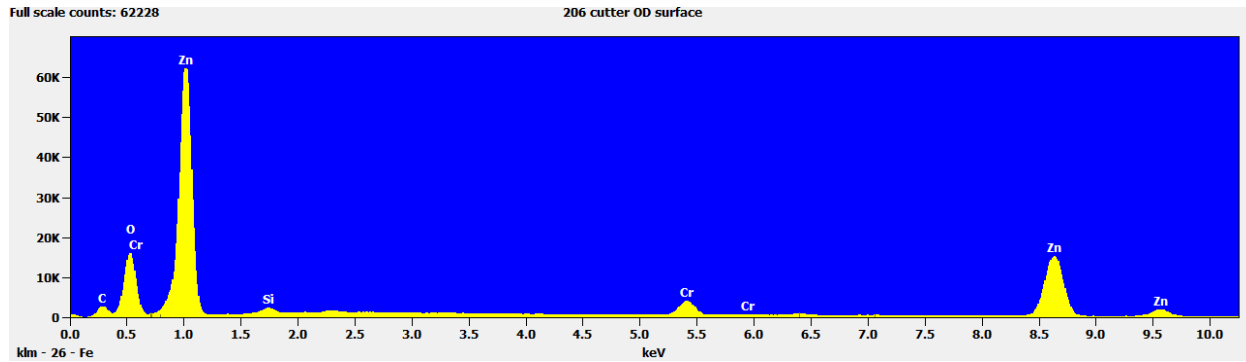
Appendix D1. EDS spectrum of the shank portion of the cutter tool from dwelling 206, showing major elemental peaks of zinc and minor elemental peaks of oxygen, carbon, silicon, and chromium.

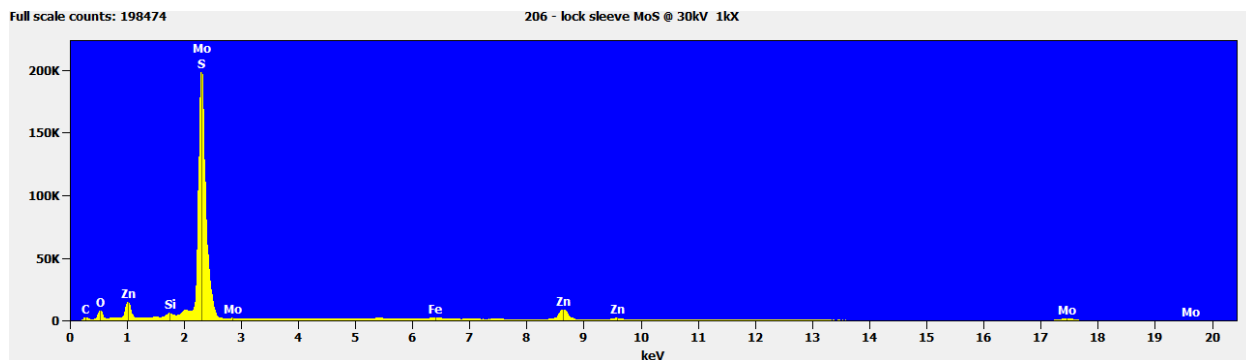
Appendix D3. EDS spectrum of molybdenum disulfide particles found on the ratchet surface of the cutter tool from dwelling 206, showing major elemental peaks of molybdenum and sulfur, and minor elemental peaks of zinc, oxygen, and carbon.

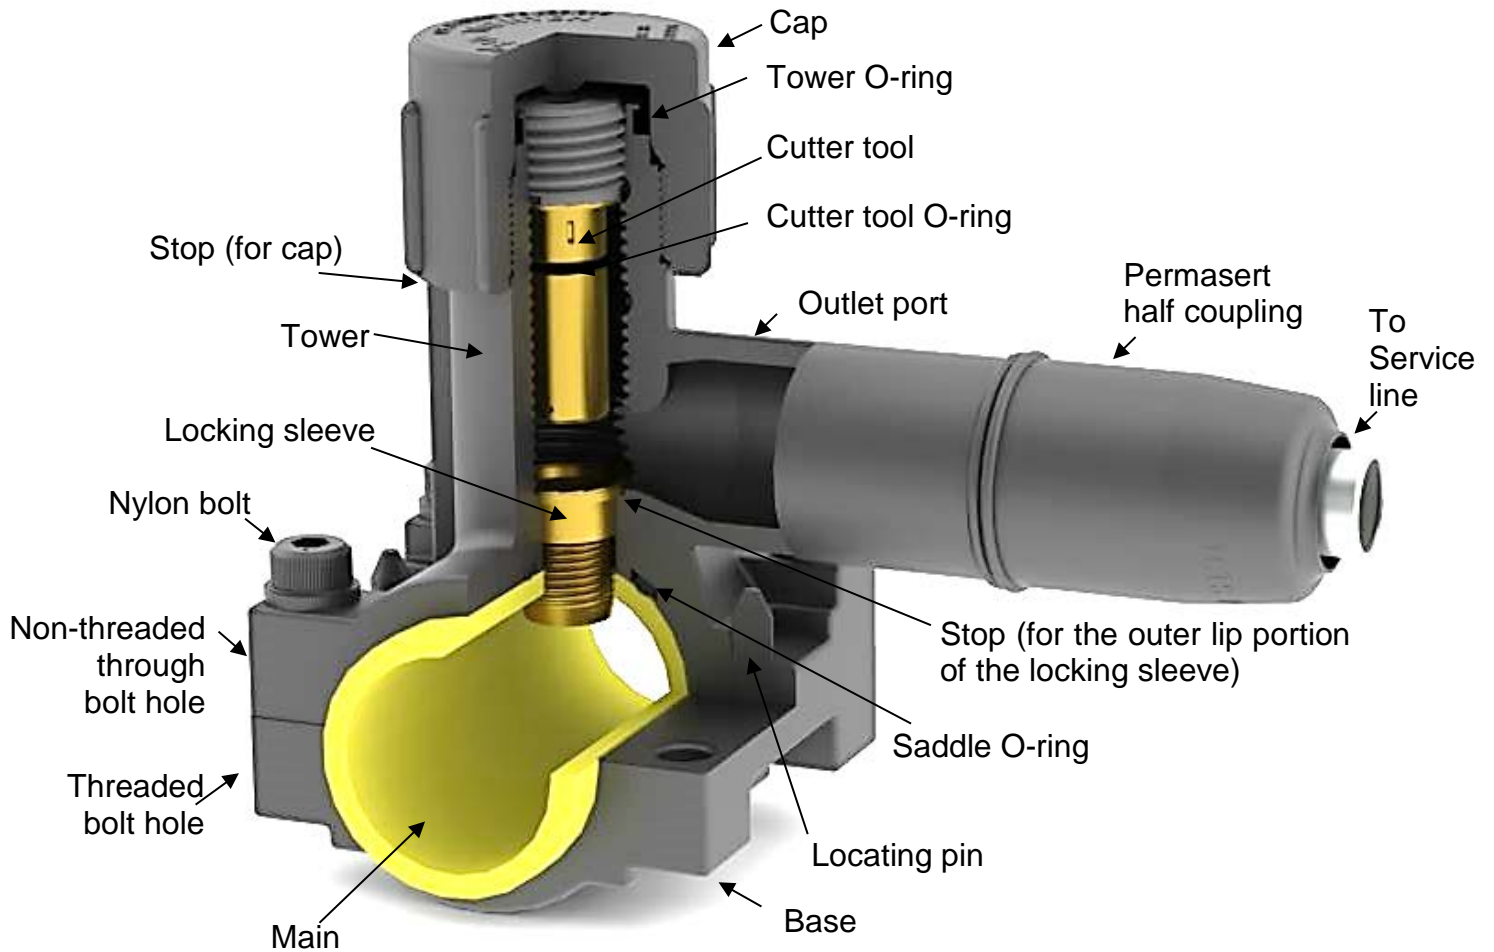
The shank portion of the cutter tool contained a slot for an O-ring (see figure 3). According to the engineering drawing for the cutter tool, the O-ring is specified as BUNA-N (Nitrile) that is to be coated with a silicone oil. Examination of the cutter tool revealed the slot and O-ring were covered with brown granular-like deposits, similar to soil particles. FTIR analysis of the cutter tool O-ring at the Safety Board Materials Laboratory produced a spectrum consistent with nitrile (see Appendices A3 and A4). The size of the O-ring for the cutter tool is specified in Perfection Corporation engineering drawing number 53778, Revision D, titled 'Cutter Assembly Ratchet for 2", 3", 4" & 6" PMTT'. The measured size of the O-ring for the cutter tool is shown in table 5. The inside diameter and thickness of the O-ring for the cutter tool was within the size specified by the manufacturer, see table 5.

Figure 3. Diagram of a Permalock® mechanical tapping tee assembly that was not involved in the accident showing a partial cross section through the wall and the specified location of the cutter tool and locking sleeve after installation. For educational purposes only. The color of various portions of the assembly does not reflect those from the accident. The tee assembly involved in the accident contained an excess flow valve between the outlet port and Permasert half coupling that is not illustrated in this diagram. Courtesy of Elster-Perfection Corporation (currently Honeywell).

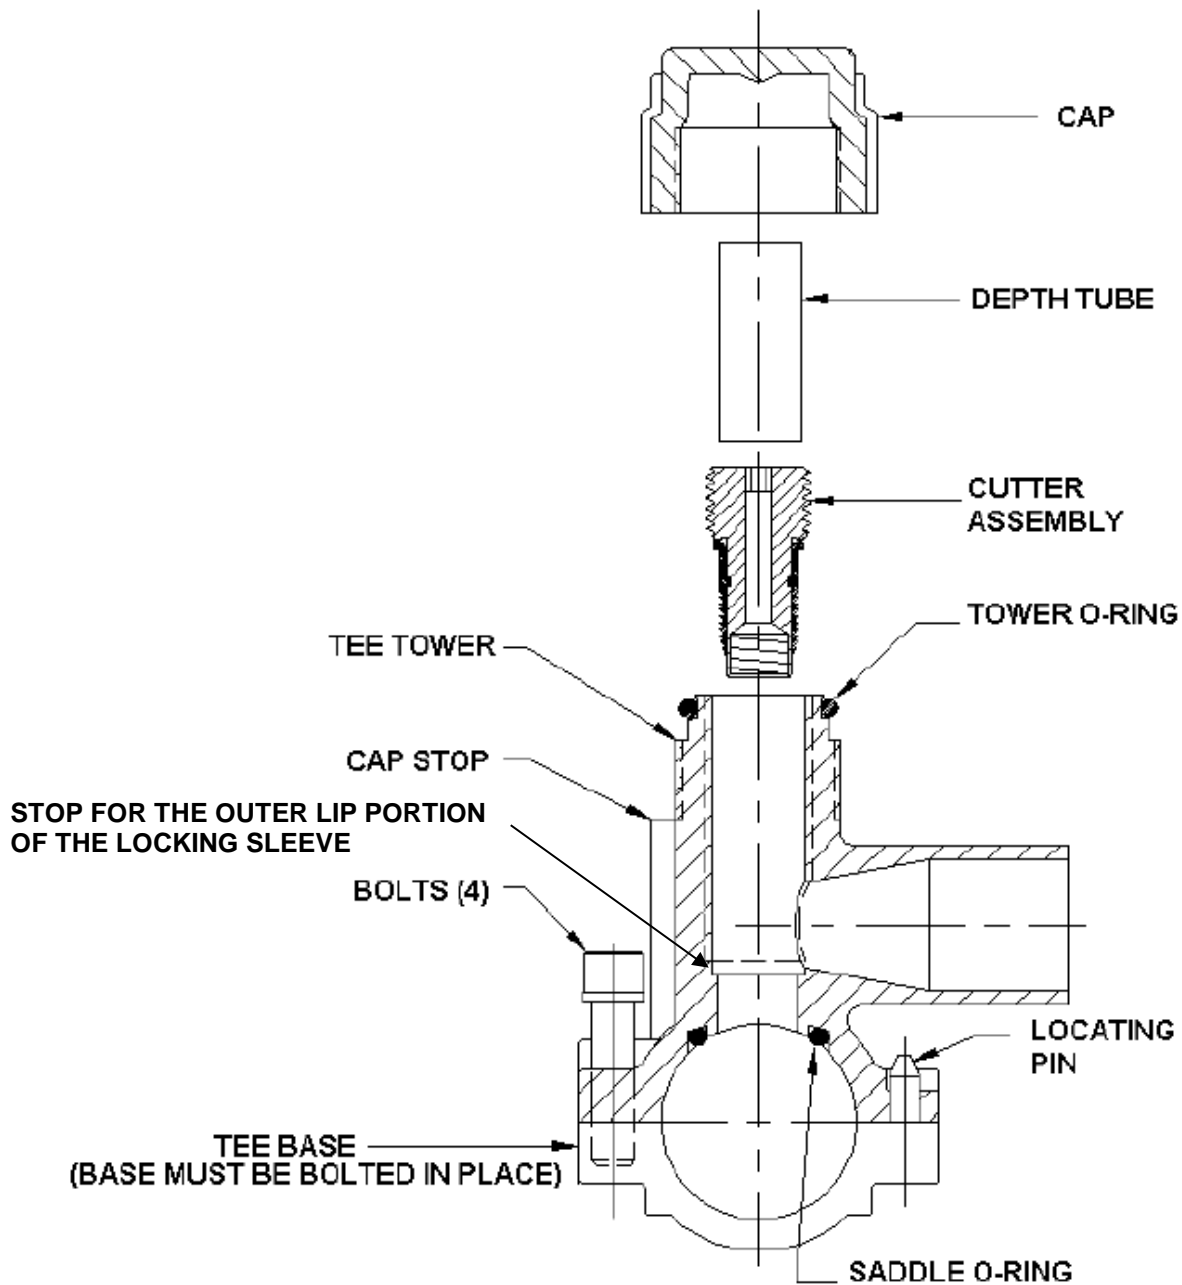
Figure 4a. Cross section diagram of a Permalock® mechanical tapping tee assembly. The cutter assembly is comprised of two pieces, a cutter tool portion that is inserted into a locking sleeve portion. The depth tube is plastic piece of thin-walled pipe that is supplied with the tee shipment from the factory and is used to verify correct installed depth of the cutter assembly. Source: Elster-Perfection Corporation (currently Honeywell).

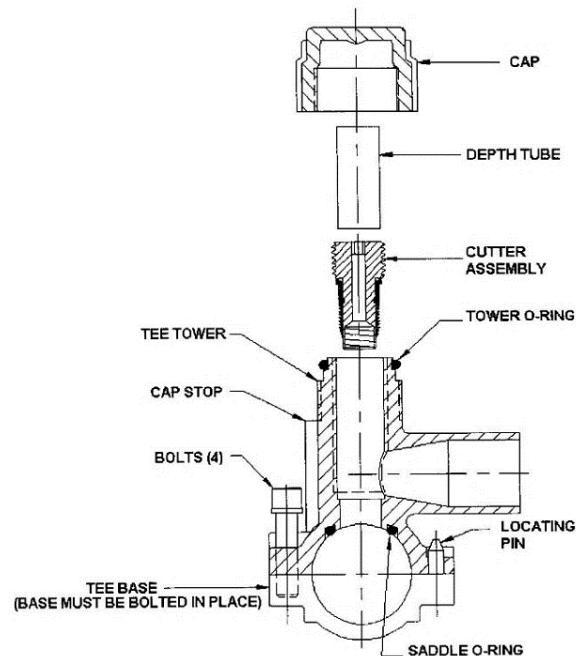
written instructions indicate to thread the cutter assembly until it becomes snug, and the top of the depth tube should be flush to 1/8 inch (0.13 inch) above the top of the tower. Although not specifically mentioned in the written instructions, at this point the outer lip (flange portion) of the locking sleeve should have made contact with the manufactured step (referred to as a stop) near the bottom end of the hollow tower (see figures 3 and 4a). Now, the locking sleeve secures the tower portion to the main. The next step is to open a gas path between the main and service pipe. To do this, the wrench is turned counterclockwise, an action that causes the cutter tool to separate (disengage) from the locking sleeve. The cutter tool is threaded upward until the top portion of the cutter tool is flush with the top of the tower. The cutter tool remains inside the tower portion for the duration of service. The depth tube is removed from the tower and discarded. A cap is manually screwed onto the top of the tower portion, hand tightened, until the cap contacts a molded-in-place stop (located on the outer surface of the tower).

Figure 4b. Written installation instructions for installing a Perfection Permalock® tee assembly to a main. Applicable to the tee assembly involved in the accident. Courtesy of Honeywell.

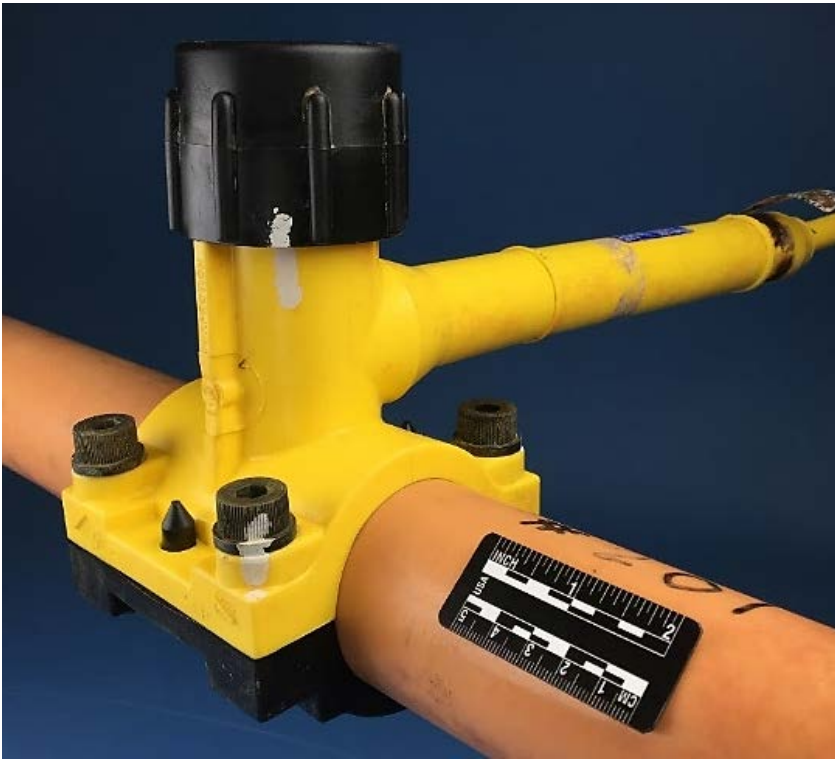
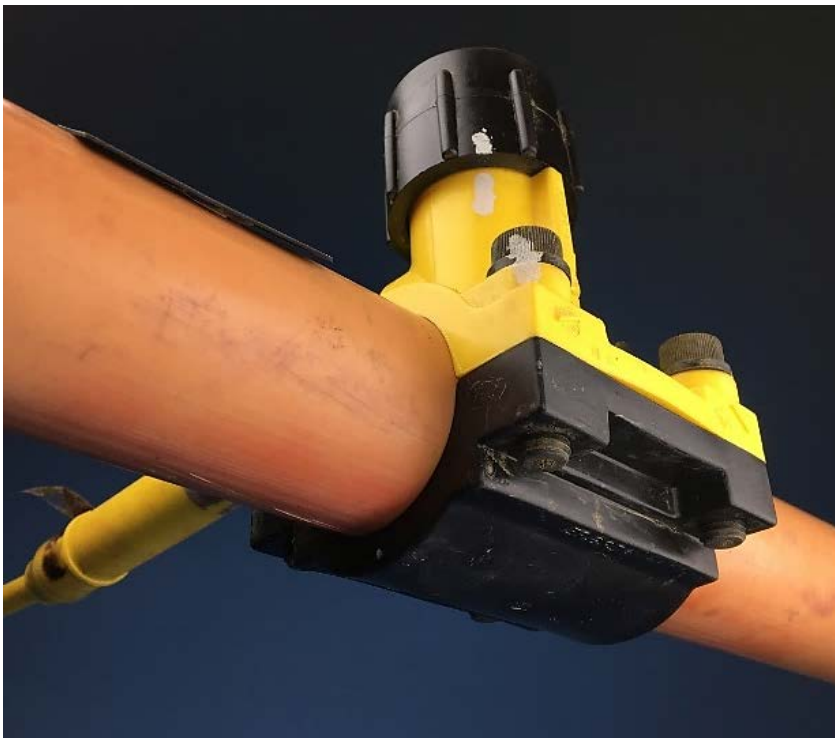
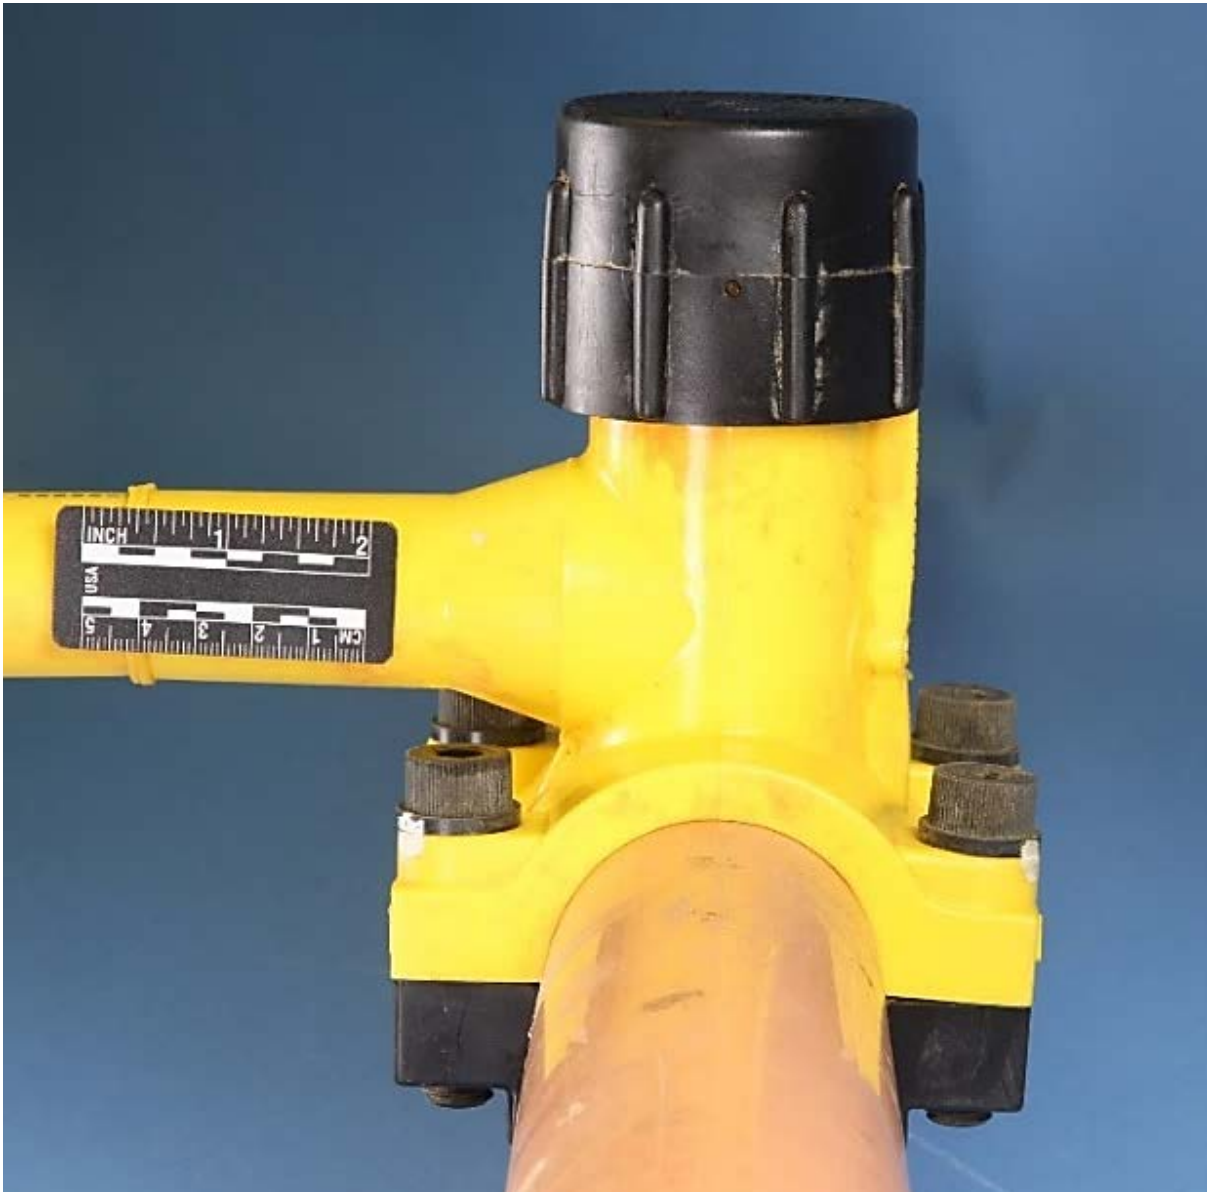
Figures 21 through 23 show close-up photographs of the tapping tee assembly from dwelling 201. Visual examination of the tee assembly from dwelling 201 revealed the four Nylon bolts were intact. This tapping tee assembly was manufactured by the same company and grade materials as those from 206 Springdale Lane. The tower portion of the tapping tee assembly was manufactured in January 1998, and the base was manufactured in June 1997, based on markings found on the tee assembly.

Figure 21. Photograph of the tee assembly from dwelling 201.

Figure 22. Photograph of the tee assembly from dwelling 201 showing a portion of the base.

Figure 23. Photograph of the tee assembly from dwelling 201 showing the side view.

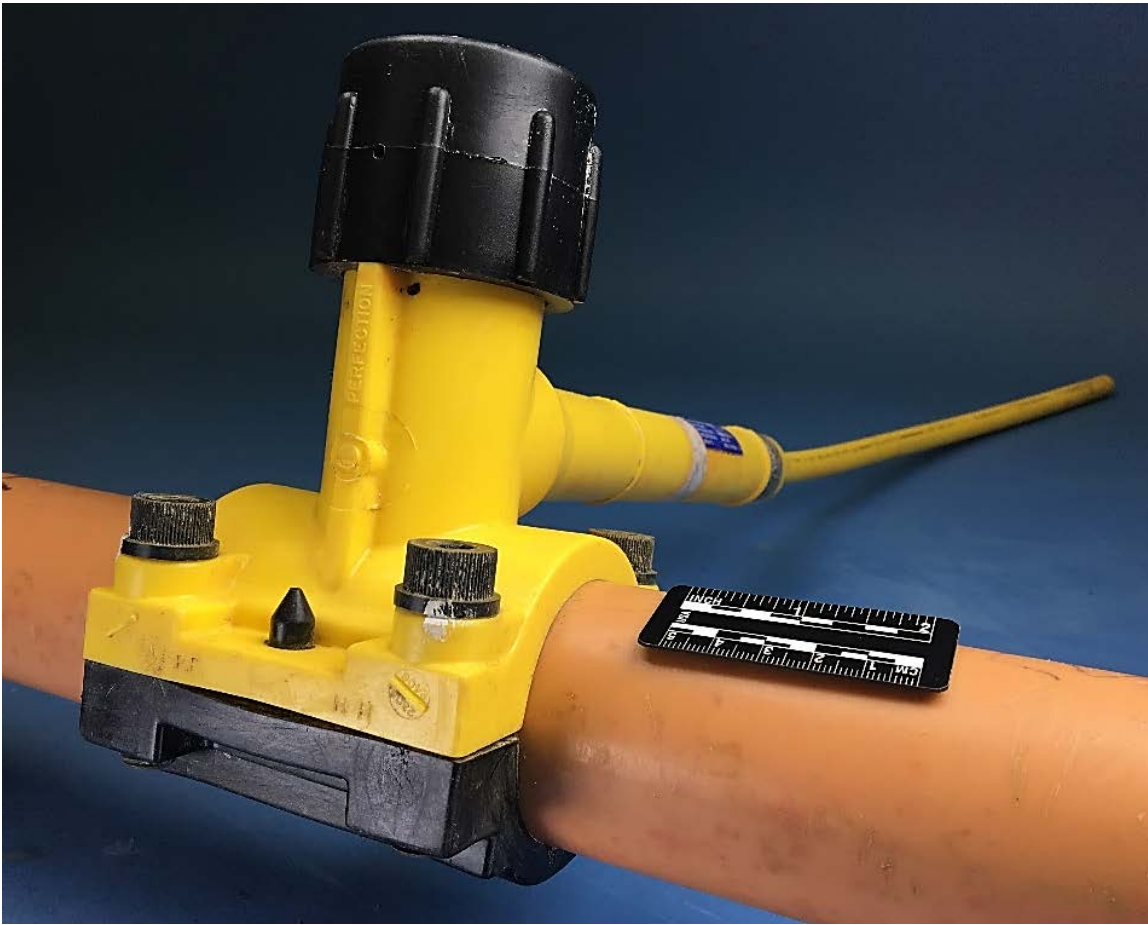
Figure 29 shows a photograph of the tee assembly from dwelling 202. Visual examination of the tee assembly revealed the four Nylon bolts were intact. The tower and base portions of the tapping were manufactured by the same company, grade material, and month of manufacture, as that from the 206 Springdale Lane, based on markings found on the tee assembly. When looking into the outlet port, the locking sleeve and cutter tool were in a position that was similar to that from the tee assembly associated with dwelling 201, consistent with a locking sleeve that was threaded to the main. The cutter tool and locking sleeve were extracted from the tee assembly. The surfaces of the extracted cutter tool and locking sleeve were clean with no evidence of granular-like particles, with the exception that the threaded portion of the locking sleeve contained brown stain material in the area that corresponded to the intersection between the wall of the main and the bottom of the tower. The size of the cutter tool and locking sleeve (see table 4), and the size of the cutter tool O-ring (see table 5), were within the size specified by the manufacturer. The measured size of the saddle O-ring is shown in table 6. The inside diameter of the saddle O-ring was within the size specified by the manufacturer (see table 6). A thickness was specified for the saddle O-ring. The height and width of the O-ring were measured. The height of the saddle O-ring was slightly less than the specified thickness the width of the saddle O-ring was slightly greater than the specified thickness.

Figure 29. Photograph of the tee assembly from dwelling 202.

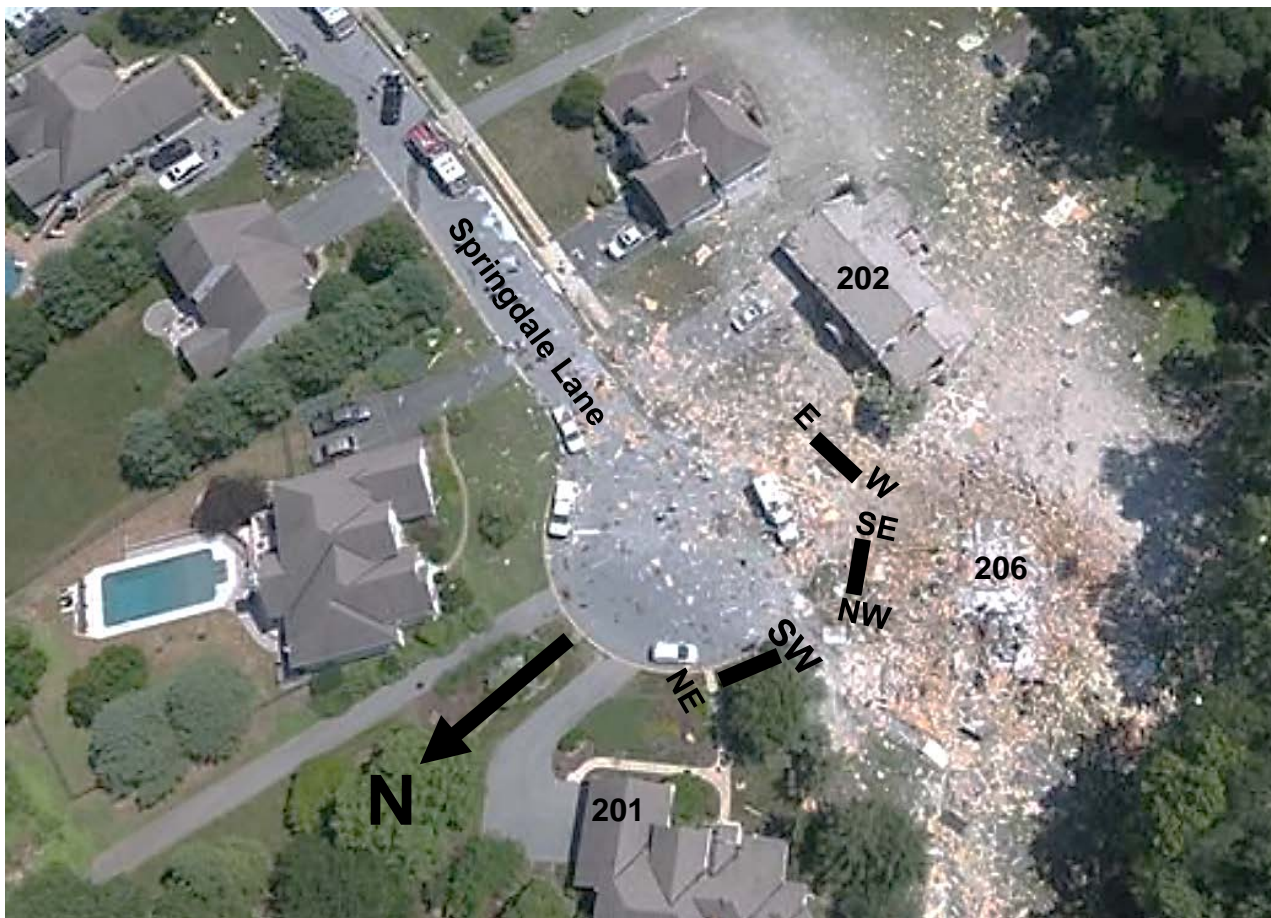
Figure 30 shows an overhead photograph of dwelling 206 after the accident. The main was located on a cul-de-sac and contained a slight curvature to accommodate the curvature of the cul-de-sac. The diameter of the street (asphalt) portion of the cul-de-sac that was located in front of dwelling 206 involved in the accident measured approximately 90 feet. The main was located approximately 48 feet from the center of the cul-de-sac. The outlet portion of each tapping tee assembly was facing away from the center of the cul-de-sac.

The main in the area of the tee assembly for dwelling 201 was located in a Southwest (SW) to Northeast (NE) orientation. The main in the area of the tee assembly for dwelling 202 was located in an East (E) to West (W) orientation. The main in the area of the tee assembly for dwelling 206 was located in a Southeast (SE) to Northwest (NW) orientation. The orientation directions were marked on the cut segments of the main, see figures 1 and 2, and correspond to those shown in figure 30.

Figure 30. Overhead photograph of the house that was involved in the accident (206 Springdale Lane). Three four-foot long main segments each containing the tapping tee assembly for dwellings 201, 202, and 206, were removed from the accident site and transported to the Safety Board Materials Laboratory. The approximate location of removed gas main segments are indicated by a black line. The cut ends of the gas main segments were labeled with approximate orientation relative to the North (N) direction. For example, the gas main portion in front of dwelling 206 was oriented in the SE-NW direction.
