Re: Beta's Proposed Findings, Probable Cause Statement, and Safety Recommendations regarding January 2021 Anchor Drags and October 2021 Oil Spill in San Pedro Bay

Beta Operating Company, LLC ("Beta") writes pursuant to 49 C.F.R. § 831.14(a) to submit proposed findings, probable cause statement, and safety recommendations regarding the January 2021 anchor-dragging incident and October 2021 oil spill in San Pedro Bay.

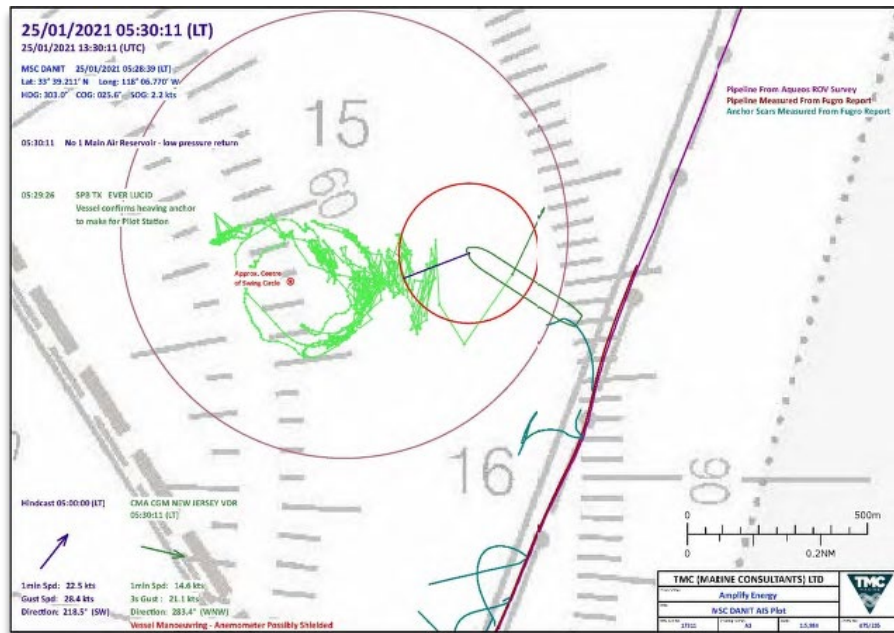
At 5:27 a.m., VTS called the *Danit* because the *Danit*’s “alarm . . . [was] sounding and [VTS] would like to confirm you are not dragging anchor.” The *Danit*’s Captain responded that the vessel was “not dragging for the moment.”²⁹ At 5:30 a.m., however, AIS data showed the *Danit*, was in fact, dragging in a north-easterly direction at around 2.2 knots.³⁰

Had the *Danit* had her engines at immediate readiness before 5:30 a.m., she likely could have prevented dragging altogether, or at the very least mitigated the speed or trajectory of the

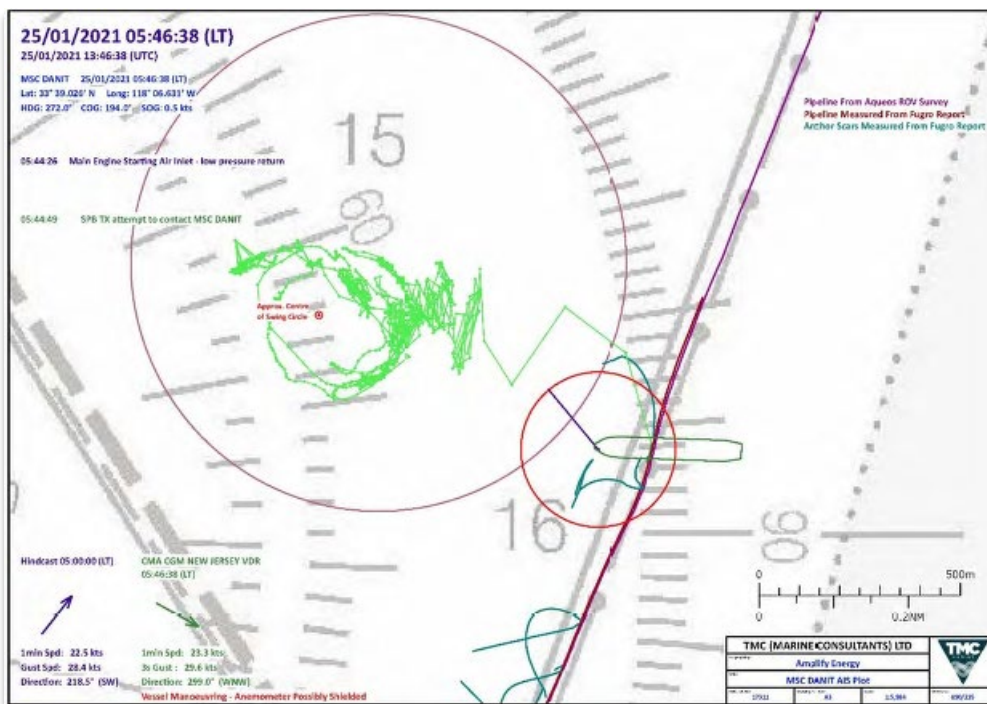
drag. But the *Danit's* main engine was not engaged and set to bridge control until 5:23 a.m.³¹ Further, its engine room was unprepared. The *Danit's* engine starts by injecting air into the rotor, and that air is stored in air bottles with particular dimensions and regulated pressure. Air injections are required for each start of the engine or any change from “dead slow ahead” (forward) to “dead slow astern” (backward). The *Danit's* air bottles were not full the morning of January 25, 2021, limiting the amount of available engine starts. The *Danit* experienced multiple low air pressure alarms that morning, indicating the pressure was dangerously low and within the range where the engine might fail to start due to lack of air.³² By 5:46 a.m., as shown in the next graphic, the *Danit's* bow crossed over the Pipeline for the first time. Had the *Danit's* air bottles been properly maintained and full, the *Danit* may have been able to prevent dragging anchor across the Pipeline by fully engaging its engines “dead slow head” or “slow ahead” and driving into the wind.

At 5:49 a.m., VTS again radioed the *Danit*. This time, the *Danit's* Captain replied that the vessel “cannot hold position anymore, we use engine, and we start to heave up. We intend to drift inside VTS area, start to heave up anchor, we proceed to drift south inside VTS area.”³³ VTS responded to confirm receipt that the *Danit* was heaving anchor and would proceed southward to drift. According to its bridge bell book, the *Danit* began heaving up anchor four minutes after its bow crossed the Pipeline, and shortly after it radioed VTS, at 5:50 a.m.³⁴ But, the *Danit* did not succeed in raising its anchor until 8:20 a.m., two-and-a-half hours later.³⁵ In the intervening hours, the *Danit* crossed back and forth across the Pipeline multiple times with its anchor deployed.

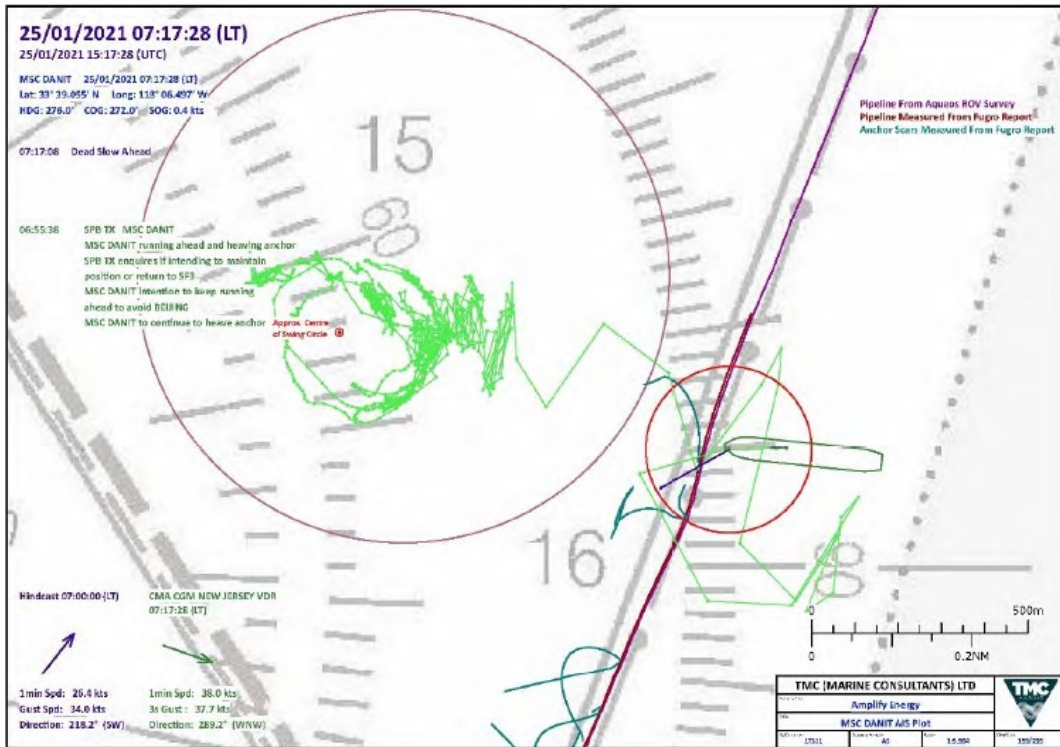
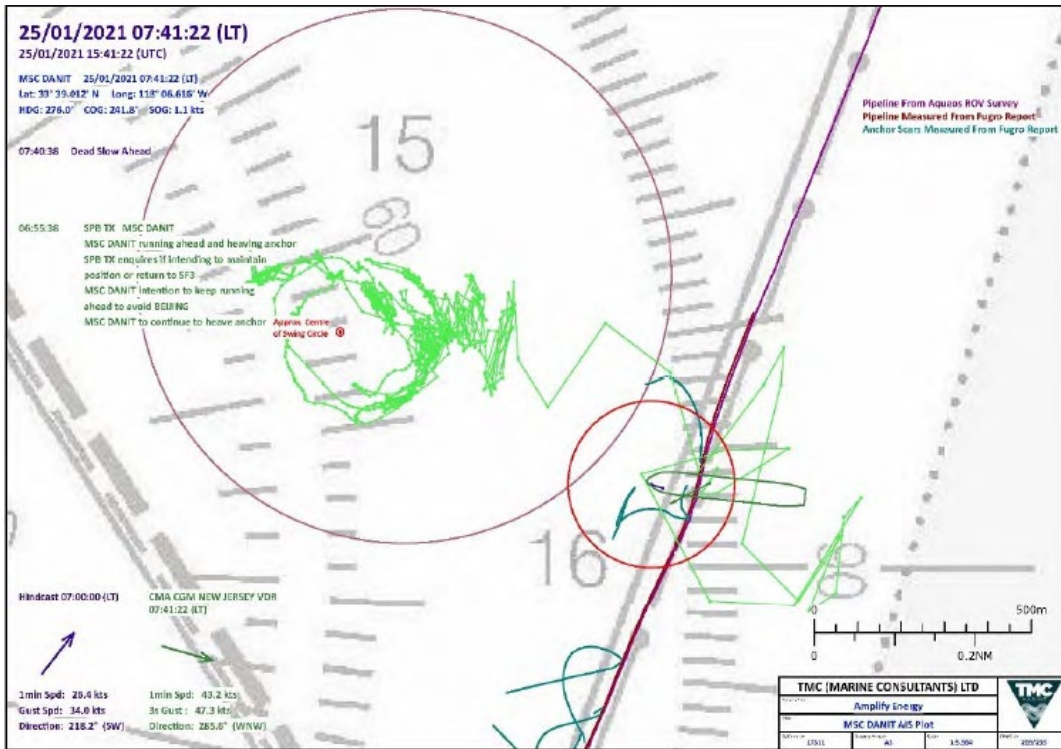
Between 7:00 a.m. to 8:05 a.m., the *Danit* remained within the vicinity of the Pipeline:

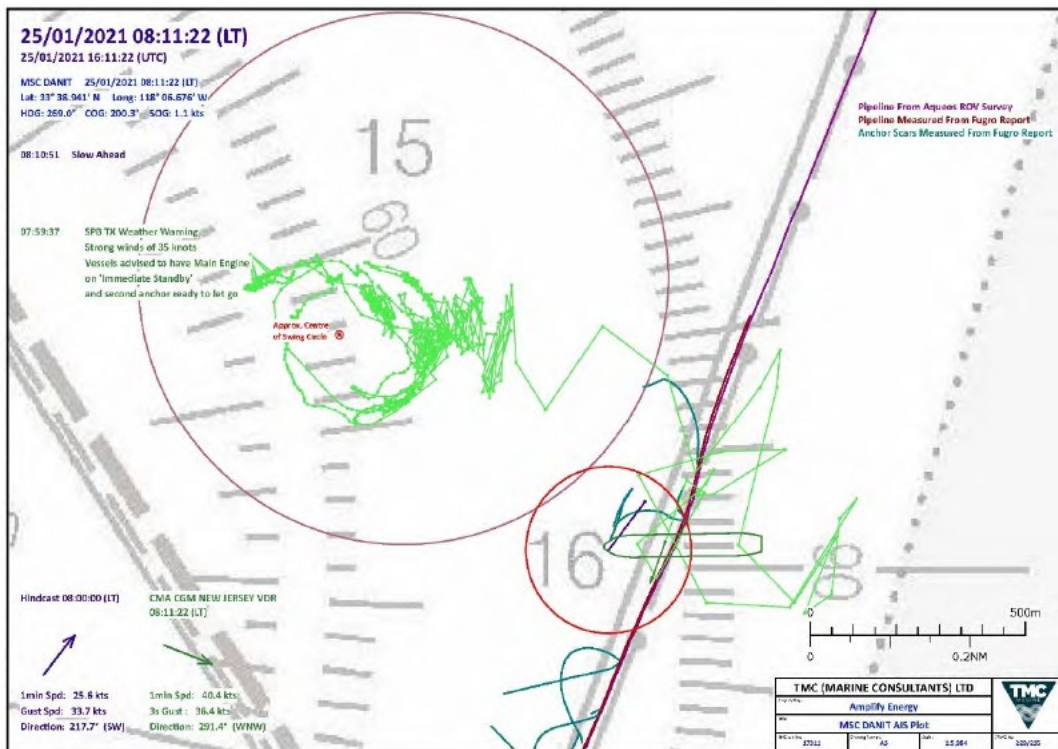
The AIS data also shows the *Danit* situated over the Pipeline at 8:11 a.m.:

In short, the *Danit* struck and damaged the Pipeline with its anchor. The Pipeline was in a no-anchor zone. The *Danit* would not have struck the Pipeline had the *Danit* followed the VTS heavy weather protocol or if its crew exercised sound seamanship. The *Danit* did not report its anchor strikes to Beta.

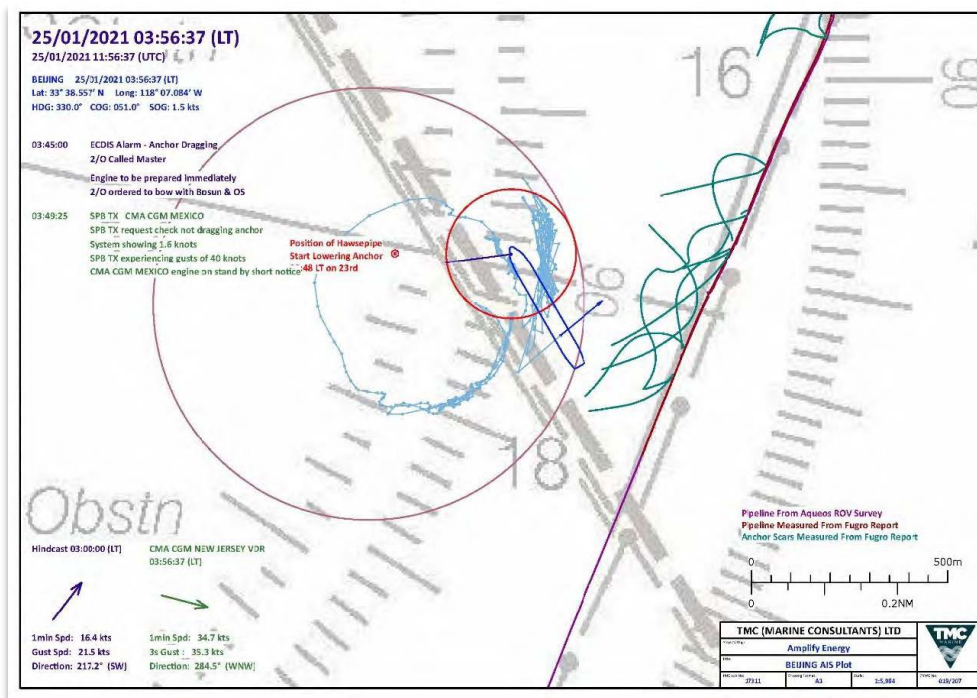
The Beijing. According to the Master of the *Beijing*, the crew reported that it observed the vessel dragging anchor at 3:54 a.m., nearly two hours after the VTS warned all vessels to have their engine on immediate standby.⁴⁰ A minute later, the Master reportedly called members of the vessel’s crew to begin the process of heaving up the anchor. But the *Beijing* had reacted too late, because at 3:56 a.m., the *Beijing* was already dragging anchor at a speed of 1.5 knots toward the Pipeline:

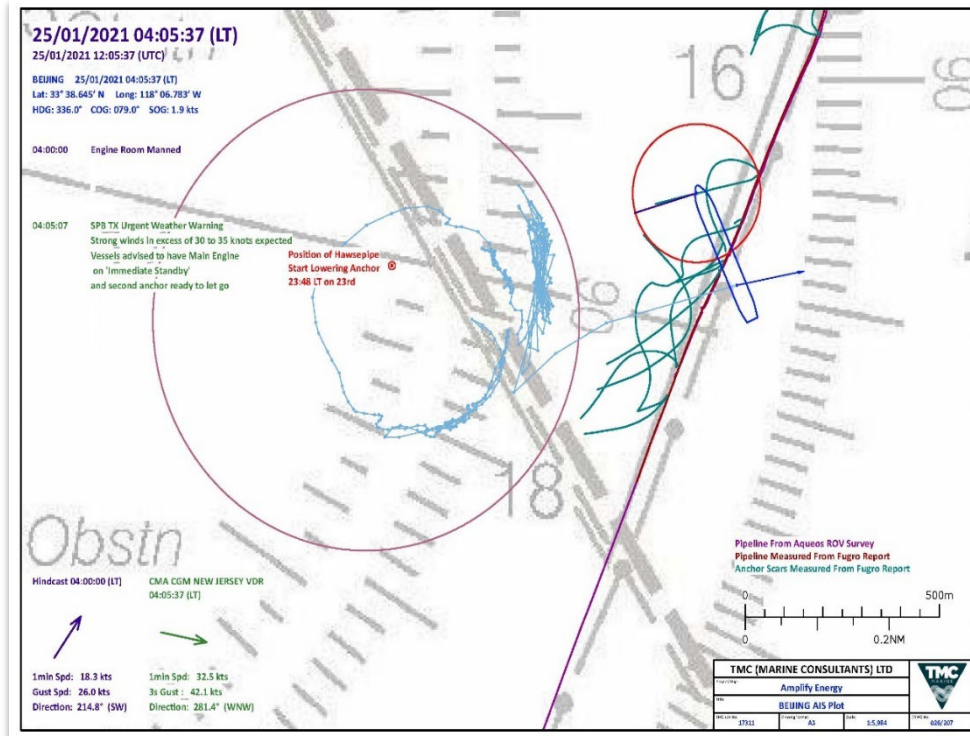
After informing the VTS it was dragging anchor, the *Beijing*’s Master reported that at 4:05 a.m., the crew began heaving up the anchor.⁴³ Again, it was too late; the vessel was already dragging anchor over the Pipeline:

Because of the *Beijing* crew's slow reaction and failure to heed the VTS's warning to put its engine in standby at 2:00 a.m., the *Beijing* dragged anchor over the Pipeline without use of its main engines. Indeed, according to the *Beijing*'s alarm log, the main engines were dead prior to 4:06:28 a.m.⁴⁴ According to the Master, it was not until 4:10 a.m. that the main engine was tested and found ready.⁴⁵ Prior to that time, the *Beijing* would not have been able to counteract her dragging or arrest her movement with use of her engine. At 4:11:37 a.m., the *Beijing* remained over the Pipeline with its anchor deployed. According to its bell book log, the *Beijing*'s first recorded engine movement did not take place until 4:25 a.m., which was too late to prevent the *Beijing* from dragging over the Pipeline.⁴⁶

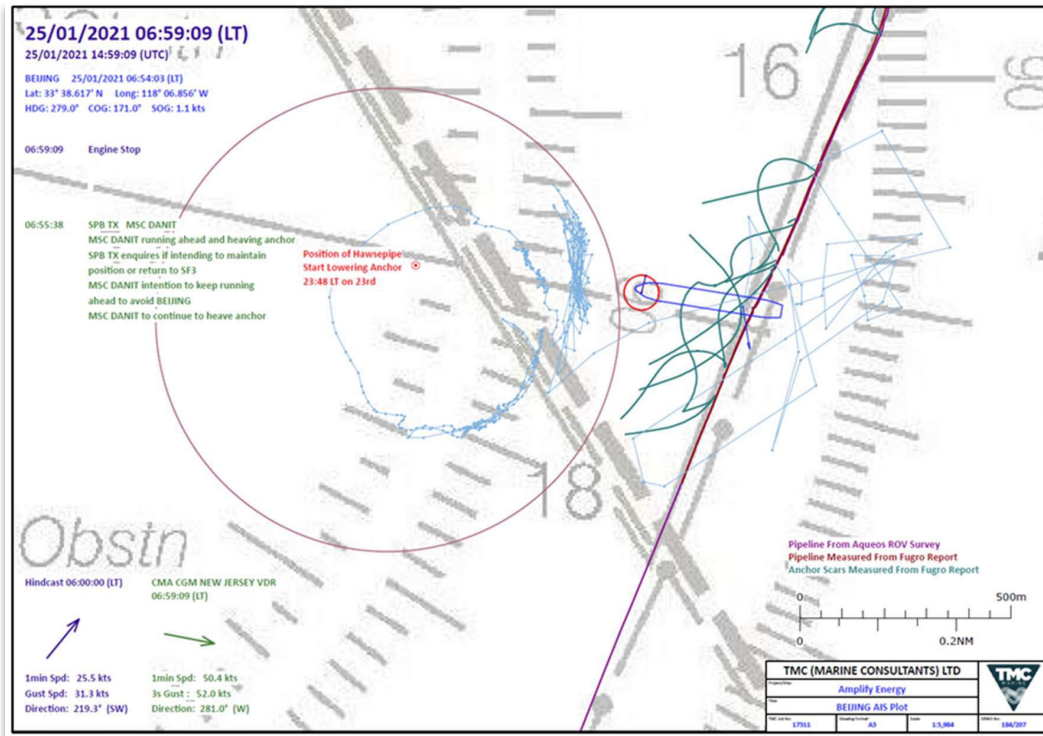
In short, the *Beijing* struck and damaged the Pipeline with its anchor. The Pipeline was in a no-anchor zone. The *Beijing* would not have struck the Pipeline had the *Beijing* followed the VTS heavy weather protocol or if its crew exercised sound seamanship. The *Beijing* did not report its anchor strikes to Beta.
