NATIONAL TRANSPORTATION SAFETY BOARD

AIRFRAME AND ENGINE EXAMINATION

WPR19LA063

Accident Date: January 13, 2019 Exam Date: September 24, 2019

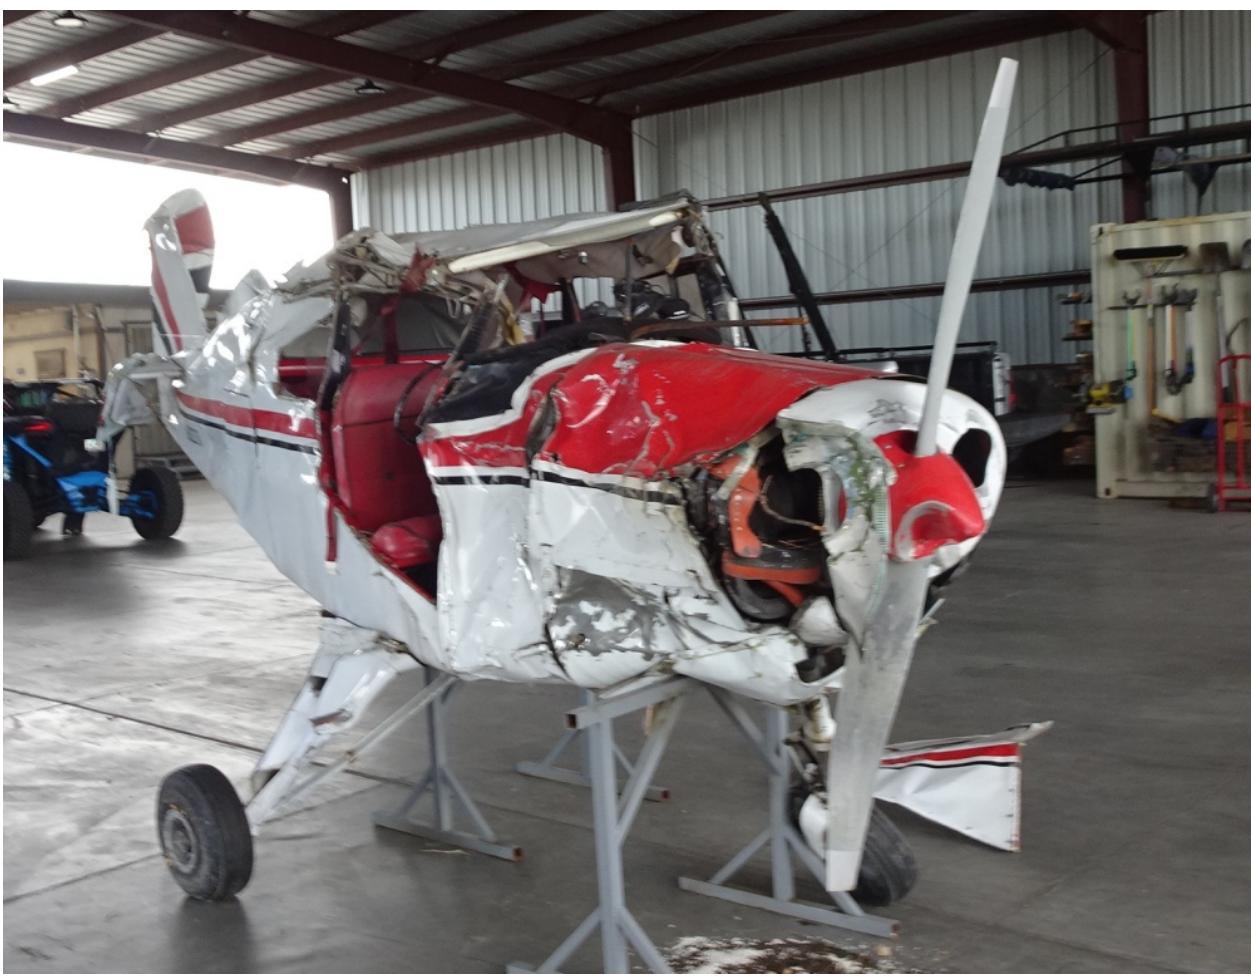
Figure 4 - Front Right View

The fuselage was generally intact but displayed crushing and deformation throughout its structure. The cabin roof was crushed and deformed downward, and the window frames were buckled. Some aft crushing deformation was noted adjacent to the firewall and door frame. The forward cabin door was impact-separated; it was buckled and deformed, and the window was shattered. The windscreens and windows were fractured and separated from their frames. The baggage door remained in its frame, and was jammed closed.

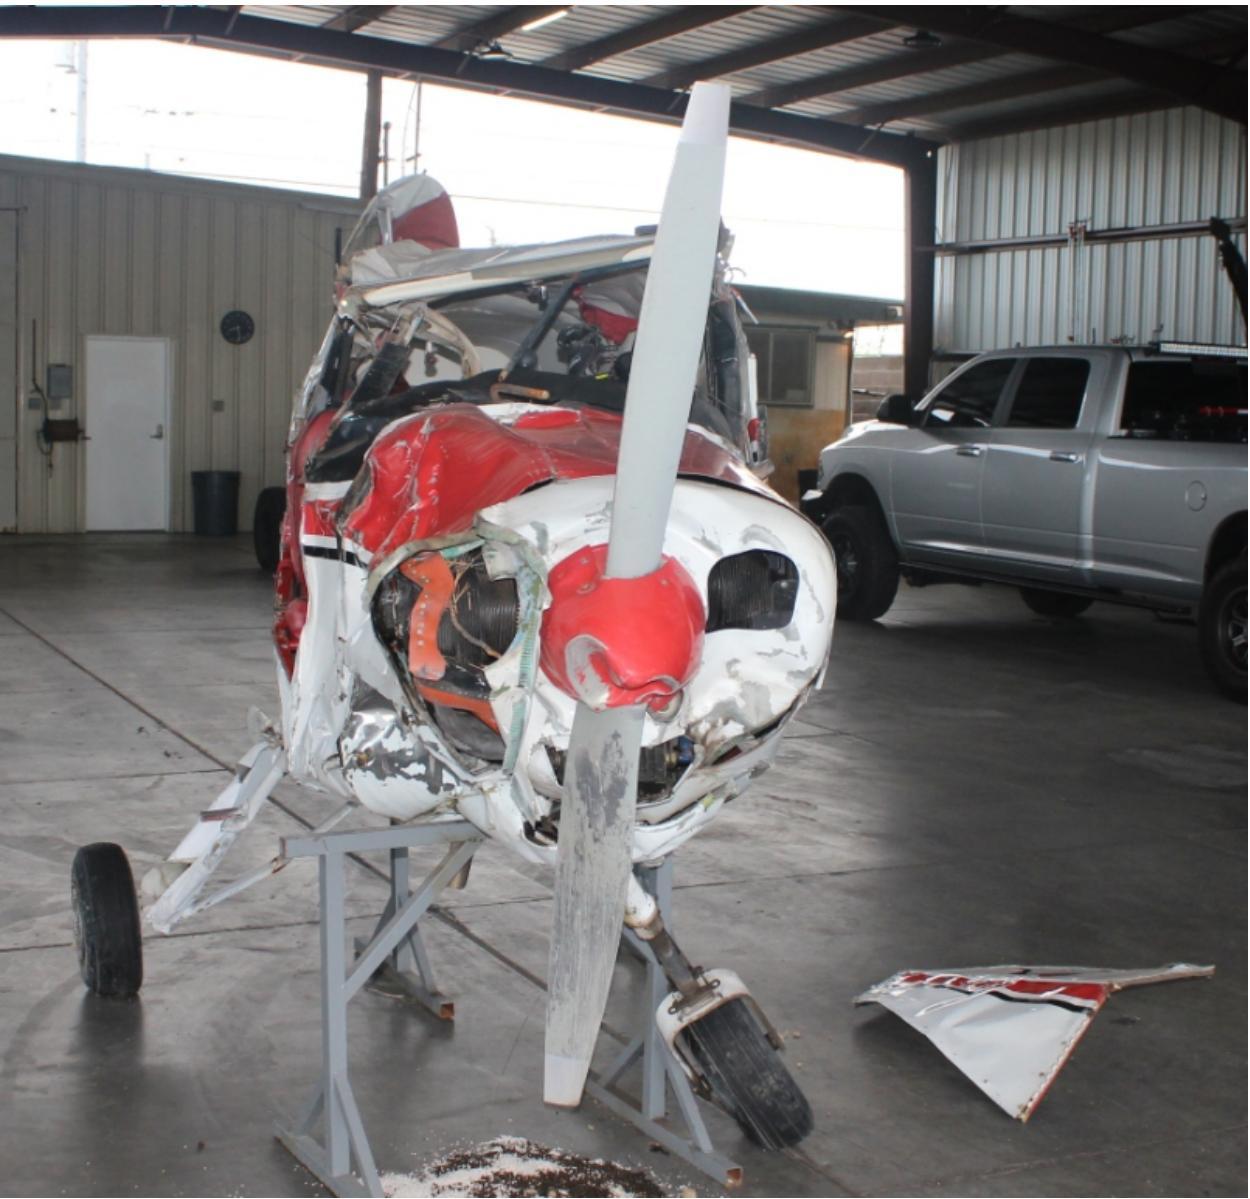
Figure 5 - Front View

The left main landing gear was broken free from the bungee and displaced upward. The wheel assembly was impact separated and was not observed during examination. The right main landing gear was impact-separated from the bungee with some impact damage noted. The nose gear remained attached but was partially displaced aft, up, and left.

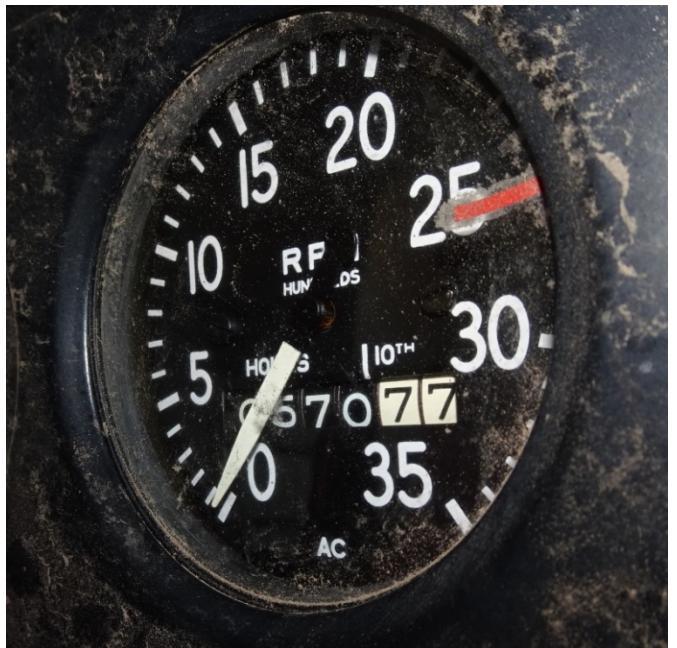
Figure 11 - Tachometer

Some deformation was noted to the instrument panel. Radios and instruments remained mounted in the panel. The cockpit throttle control was set to idle, the mixture set to full rich Both the throttle and mixture knobs were jammed and could not be moved. The primer knob was in and locked. The carburetor heat knob was set to off. The magneto switch was set to both; however, the key was absent and not located.

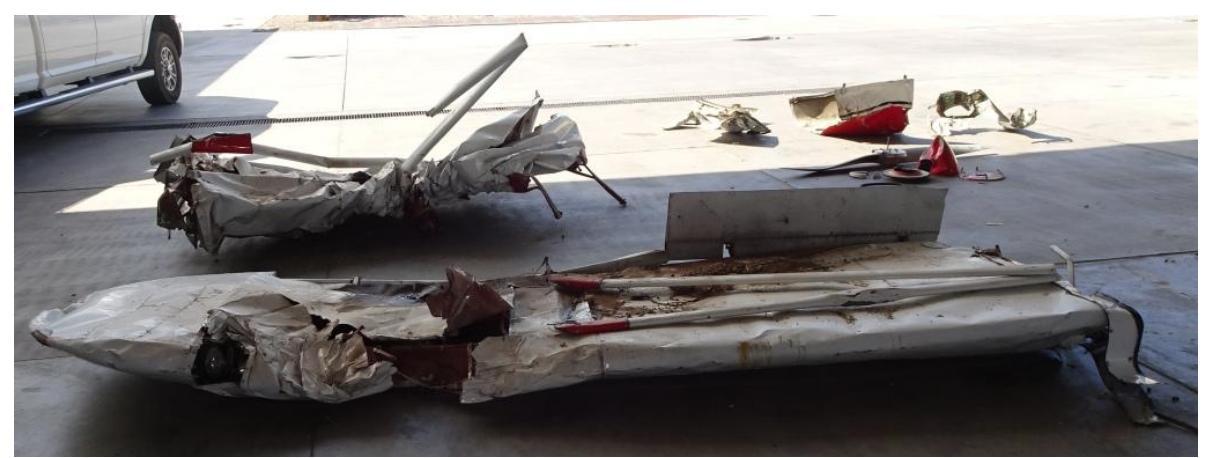
Figure 16 - Left (foreground) and Right (background) Wings

The left wing was cut from the fuselage at the wing root during recovery. Some deformation and buckling were noted throughout the wing skins and structure. An area of aft crushing and tearing was noted about 5 ft from the wing root, extending to the tip. The lift struts remained attached to the wing and displayed recovery cuts ≈ 12 inches from the fuselage attachment clevises.

The flap remained attached to the wing and was extended beyond its normal range and lay roughly perpendicular to the wing's chord. Some buckling and distortion were noted along its inboard end. The flap control cable remained attached to the flap control bracket and terminated in a recovery cut near the wing root.

The fuel tank remained in place in the inboard wing section. The tank displayed some buckling and denting. The fuel filler cap was absent, the filler neck showed no obvious damage, and the wing skin covering the tank showed no marks consistent with contact with a fuel cap. When a donor fuel cap was installed, it locked into place within the filler neck. No fuel was observed within the tank.

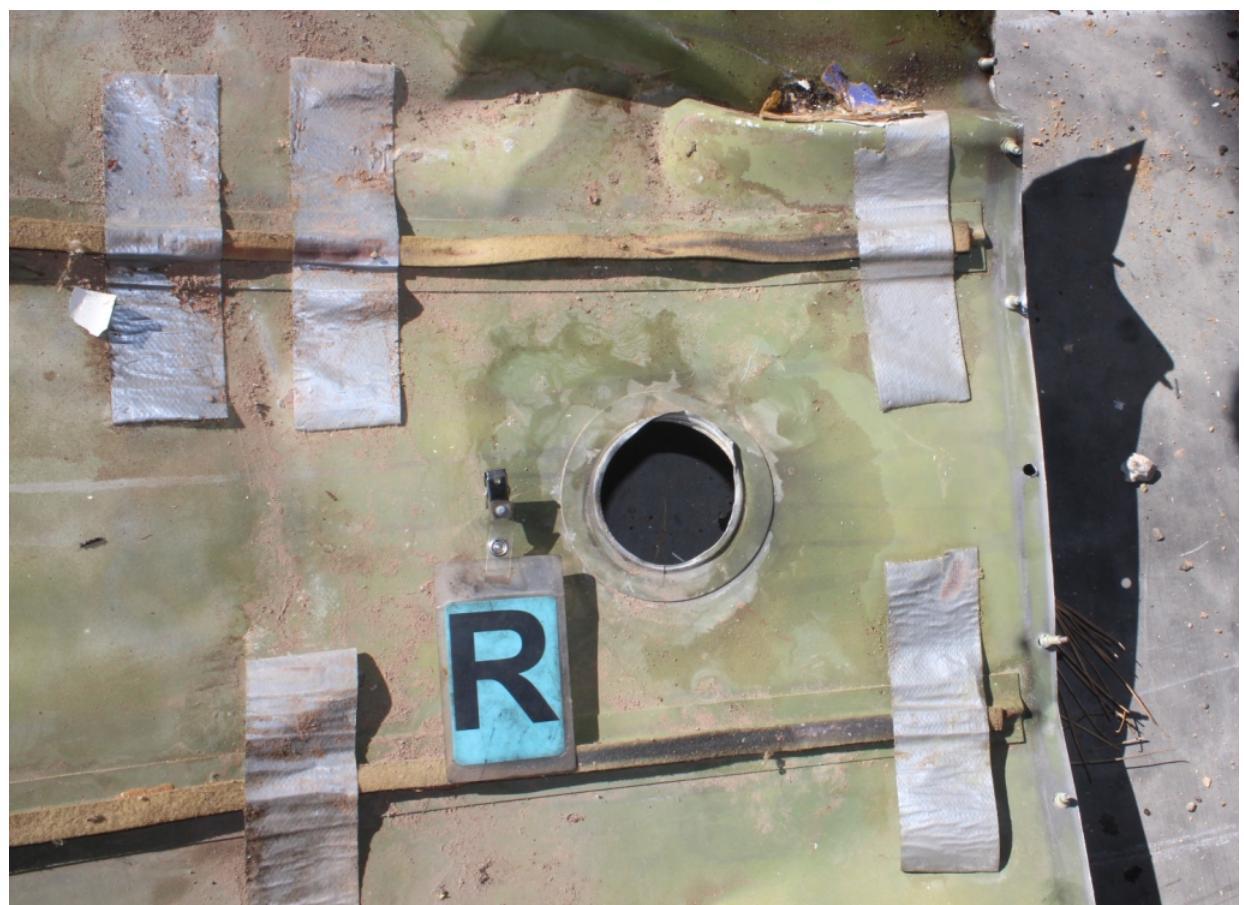
Figure 22 - Underside of Right Wing Skin with Fuel Port Cutout

The fuel tank remained in place in inboard wing section; it was crushed and deformed. The fuel filler cap was absent and the filler neck showed no obvious damage. The wing skin covering the tank partially overrode the filler neck but showed no marks consistent with contact with a fuel cap. When a donor fuel cap was installed, it locked into place within the filler neck. No fuel was observed within the tank.

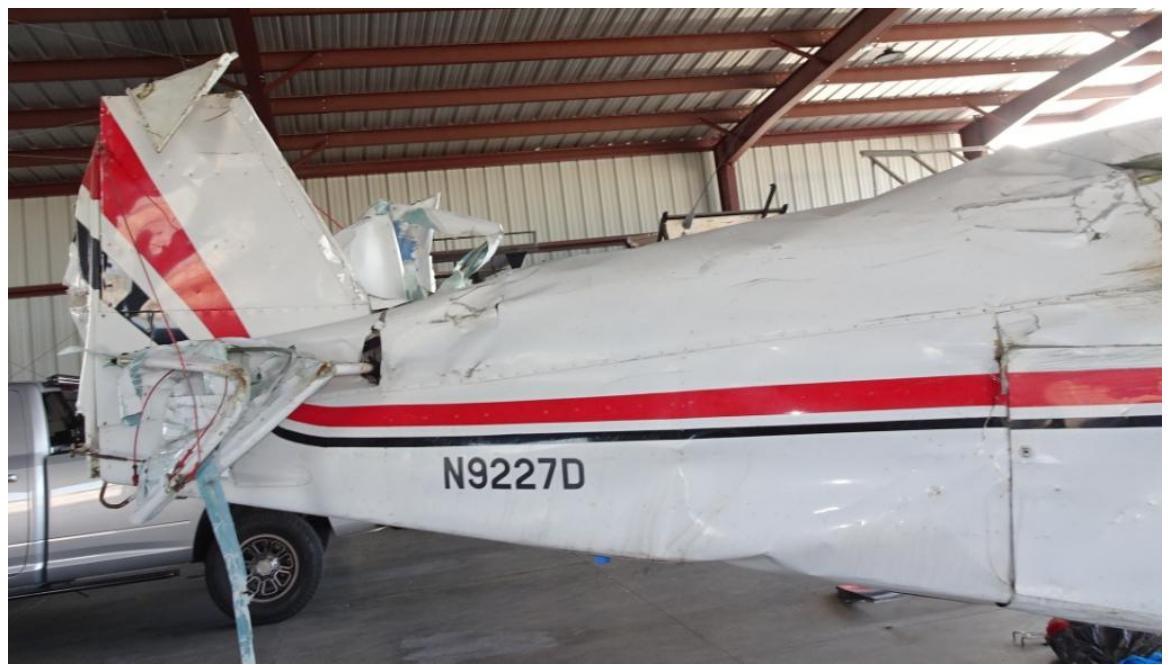
Figure 25 - Right Aft Fuselage and Empennage

The aft fuselage/tailcone section remained attached to the cabin section and displayed some wrinkling and deformation. The underside appeared clean and was free of oil. The TSO C91 ELT (121.5 MHz) had been removed from its tray and disconnected from its antenna during the recovery of the aircraft; it was found switched to OFF during this examination. When or by whom the ELT was switched OFF was not able to be determined.

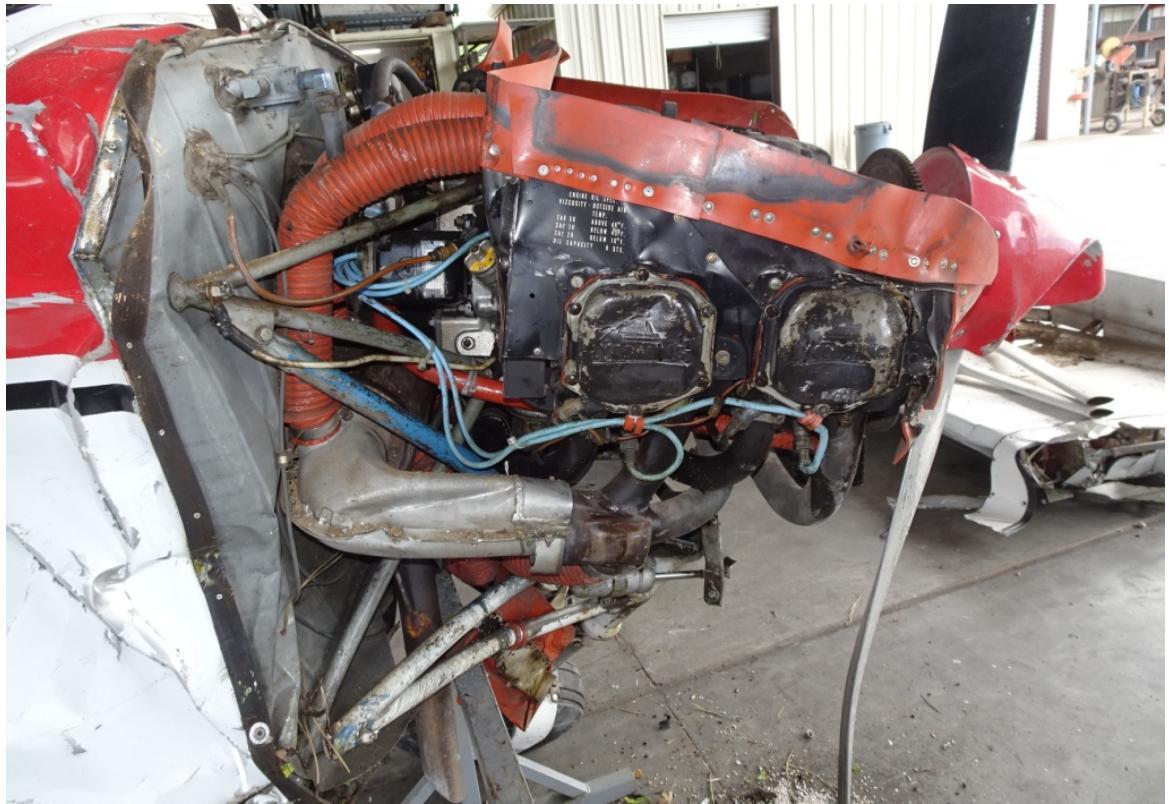
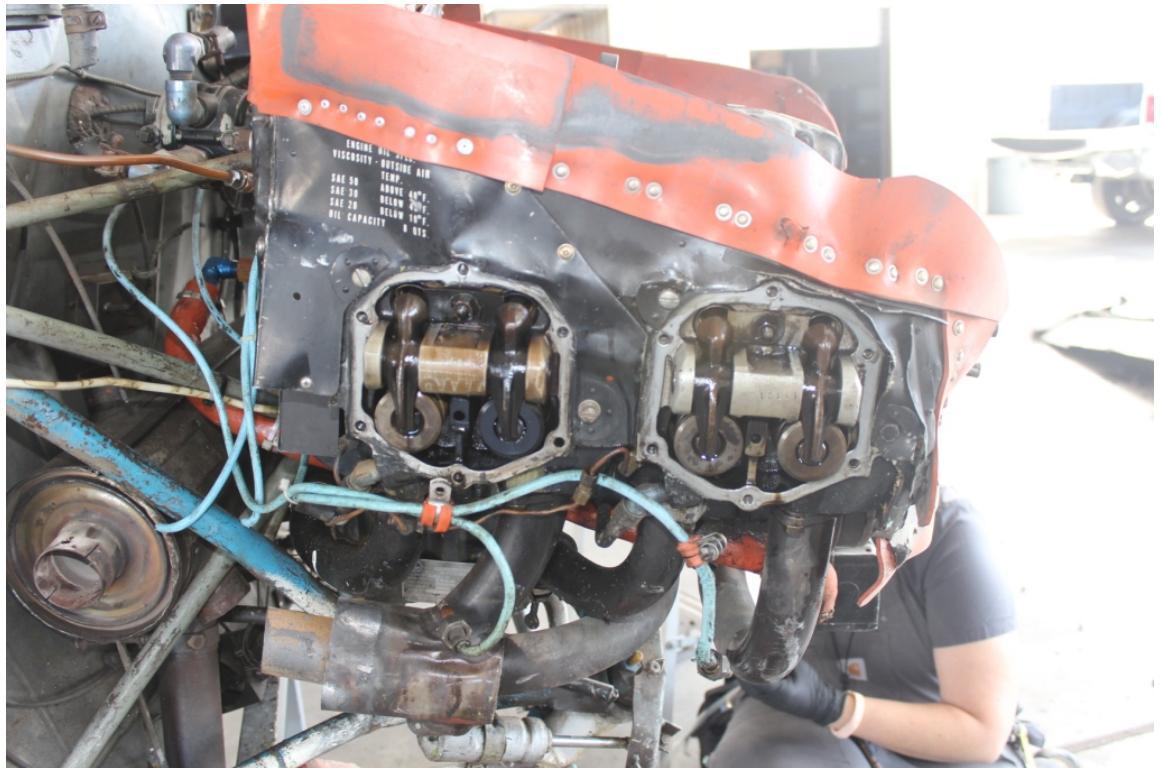
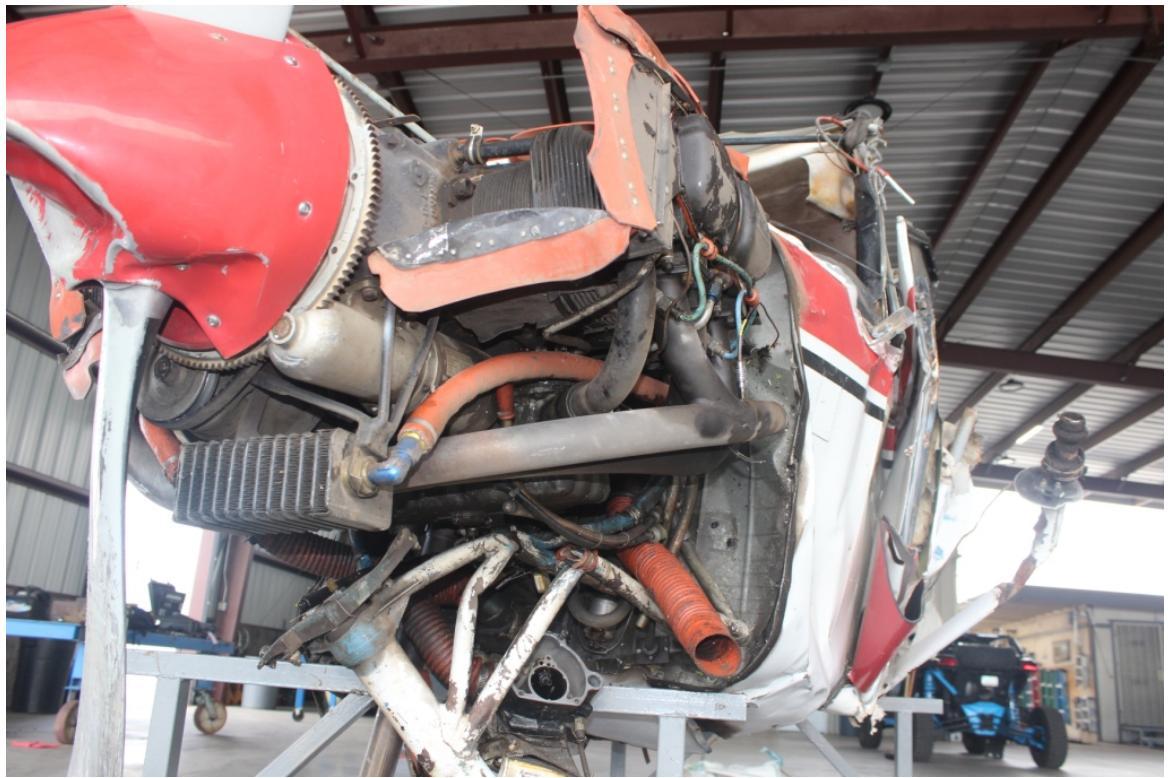
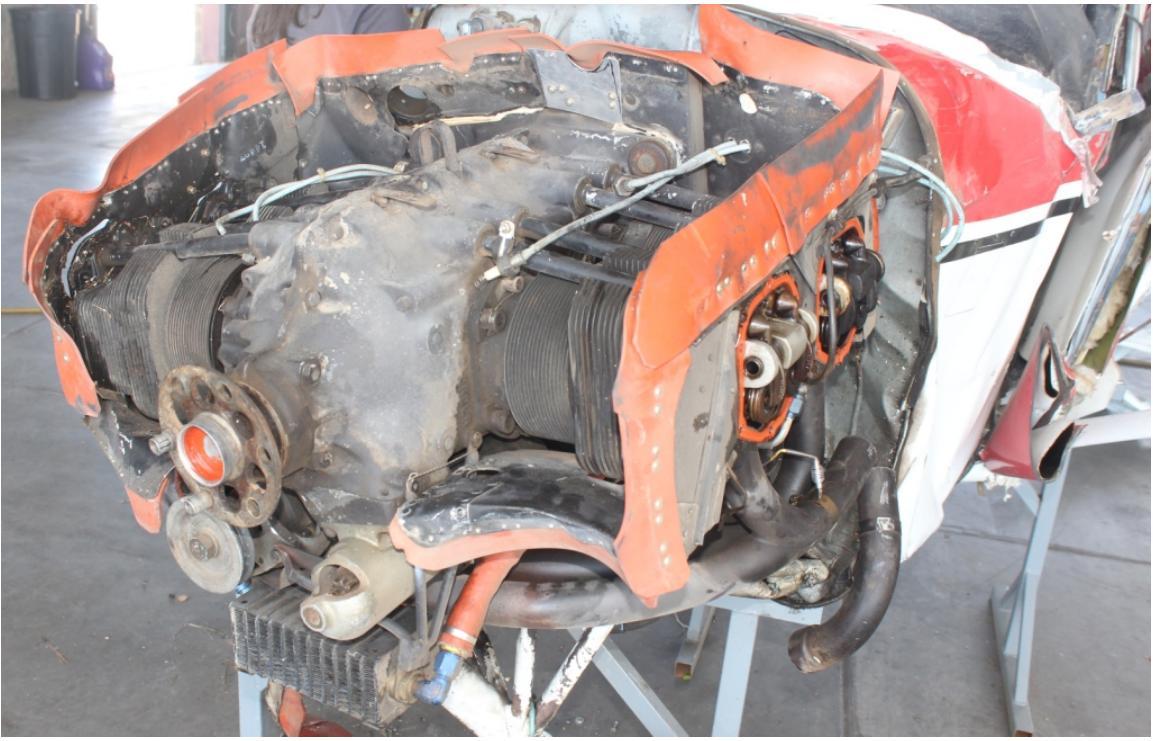
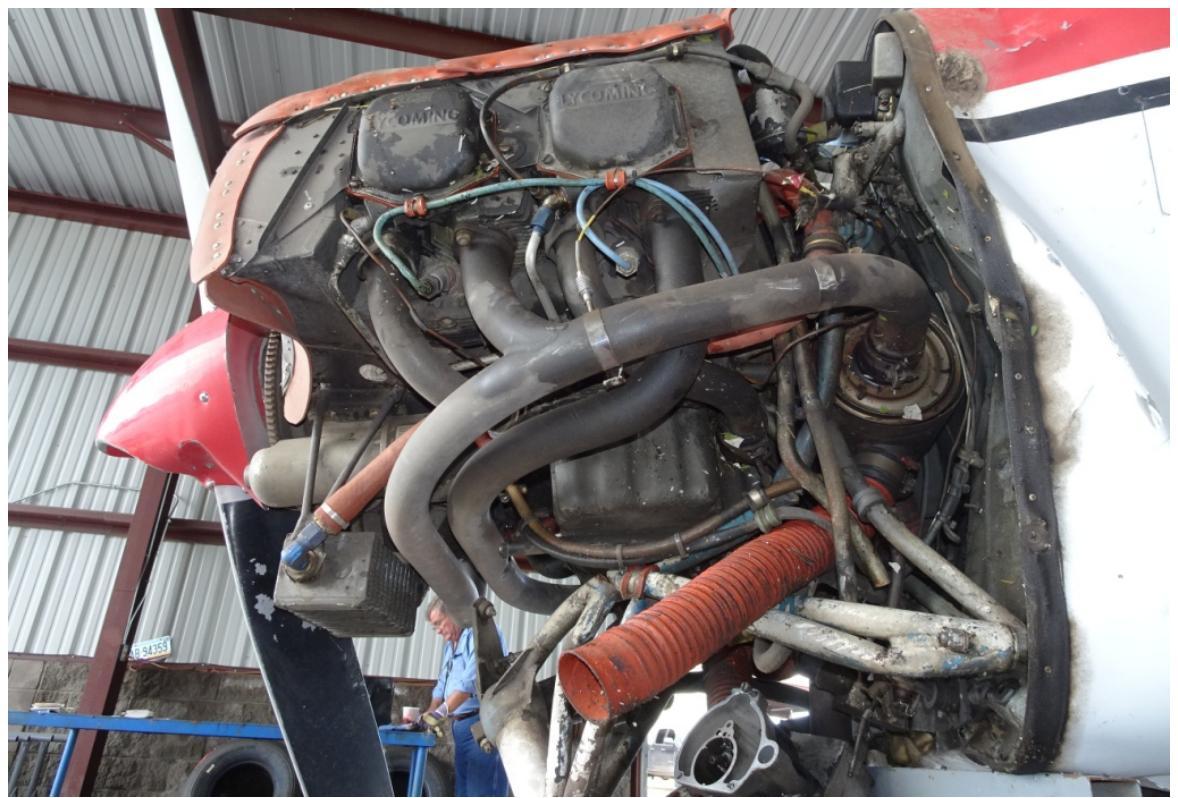
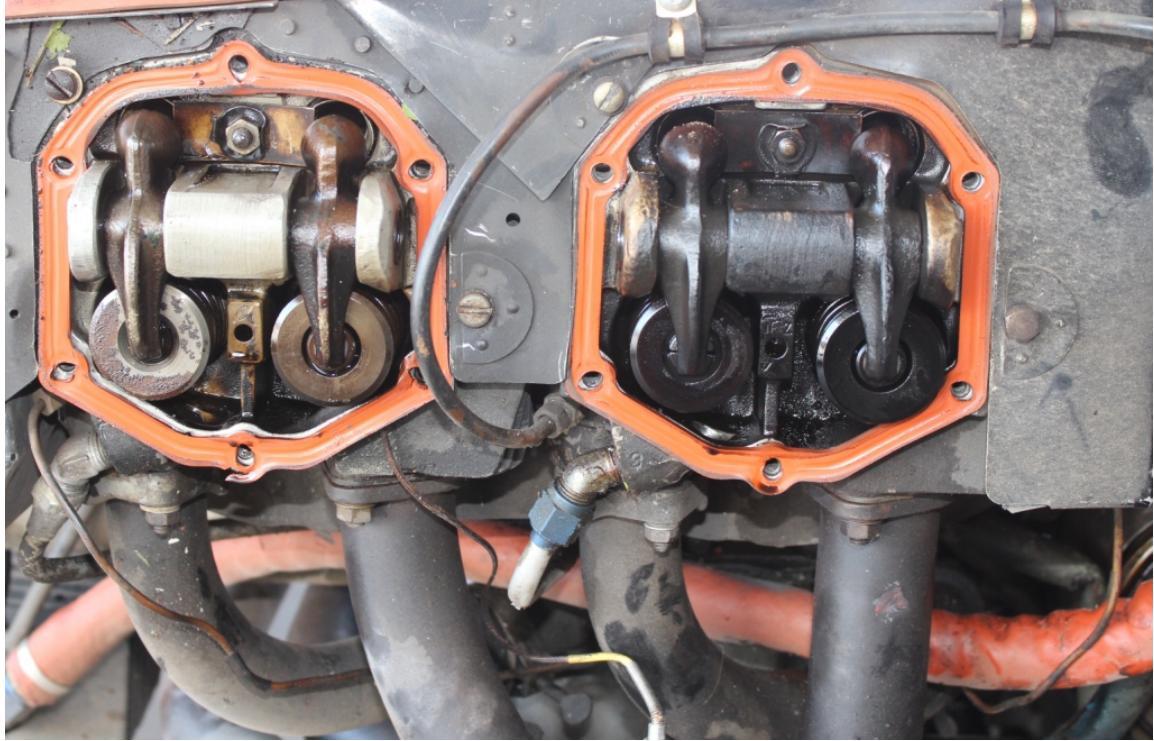
The engine remained attached to the airframe by the engine mount. The subject engine had been pushed aft which deformed the firewall where the engine mount attaches. The nose gear structure was bent aft. The engine had sustained impact damage at the forward bottom area of the engine that separated the airbox and carburetor bowl. Visual examination of the engine revealed no evidence of pre-impact catastrophic mechanical malfunction or fire.

The propeller was removed to facilitate the examination. The top spark plugs were removed, examined and photographed. The crankshaft was rotated by hand at the flange. The crankshaft was free and easy to rotate in both directions. "Thumb" compression was observed in proper order on all four cylinders. The complete valve train was observed to operate in proper order and appeared to be

free of any pre-mishap mechanical malfunction. Normal "lift action" was observed at each rocker assembly. Clean, uncontaminated oil was observed at all four rockerbox areas. Mechanical continuity was established throughout the rotating group, valve train and accessory section during hand rotation of the crankshaft.

There was no evidence of pre-impact mechanical malfunctions observed during the examination of the engine.

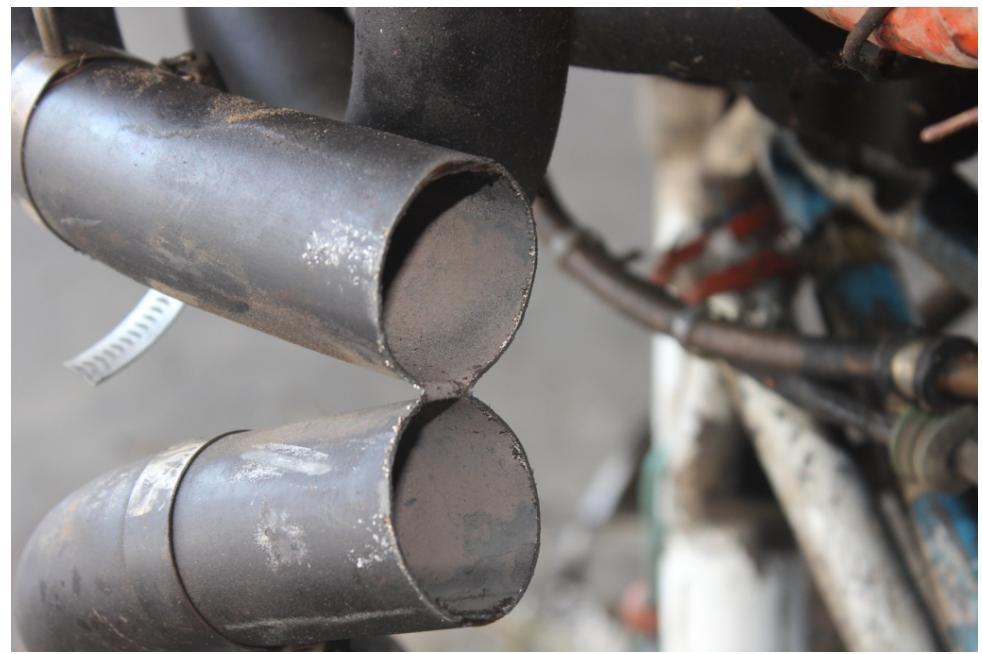
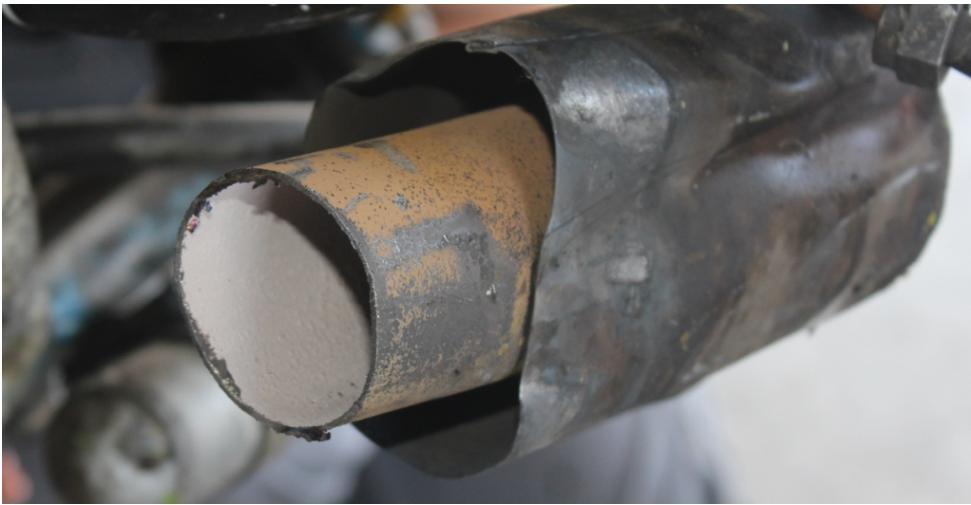
The bottom spark plugs were removed, examined and photographed. The combustion chamber of each cylinder was examined through the spark plug holes utilizing a lighted borescope. The combustion chambers remained mechanically undamaged and there was no evidence of foreign object ingestion or detonation. The valves were intact and undamaged. There was no evidence of valve to piston face contact observed. The gas path and combustion signatures observed at the spark plugs, combustion chambers and exhaust system components displayed coloration consistent with normal operation. There was no oil residue observed in the exhaust system gas path. The exhaust system and mufflers were found free of obstructions.
