## Pipe and Coating Inspection Report: 8162

### Pipe and Coating Inspection Report: 8393

## Pipe and Coating Inspection Report: 8163

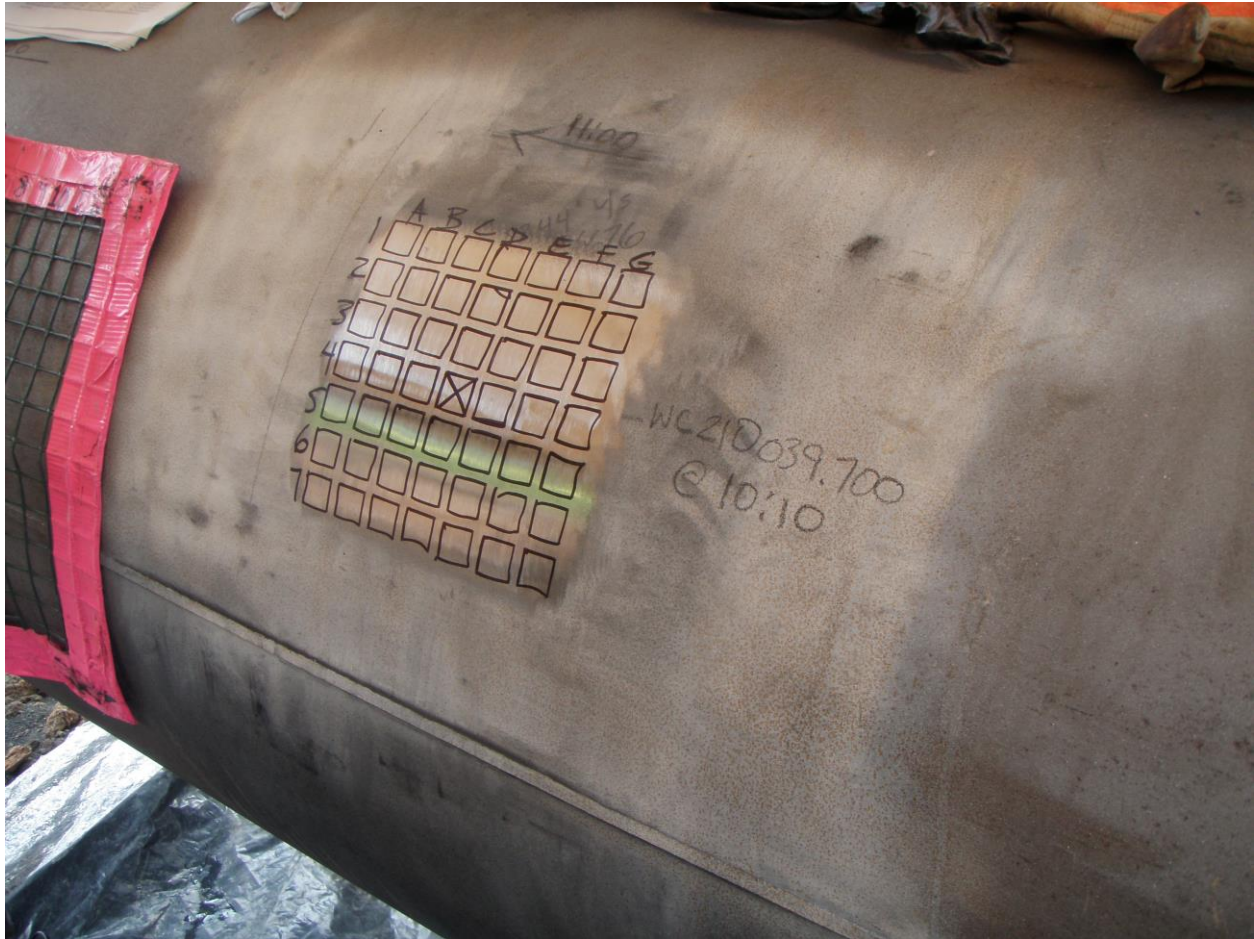
W.C.  
210039.700  
© 10:10

1	2	3	4	5	6	7
A	376	378	381	384	382	376	373
B	377	380	380	382	379	374	371
C	380	377	377	379	379	377	374
D	370	374	376	380	<del>378</del> 375	372	369
E	374	380	381	376	375	369	368
F	374	382	384	376	375	369	369
G	374	381	384	377	373	370	368

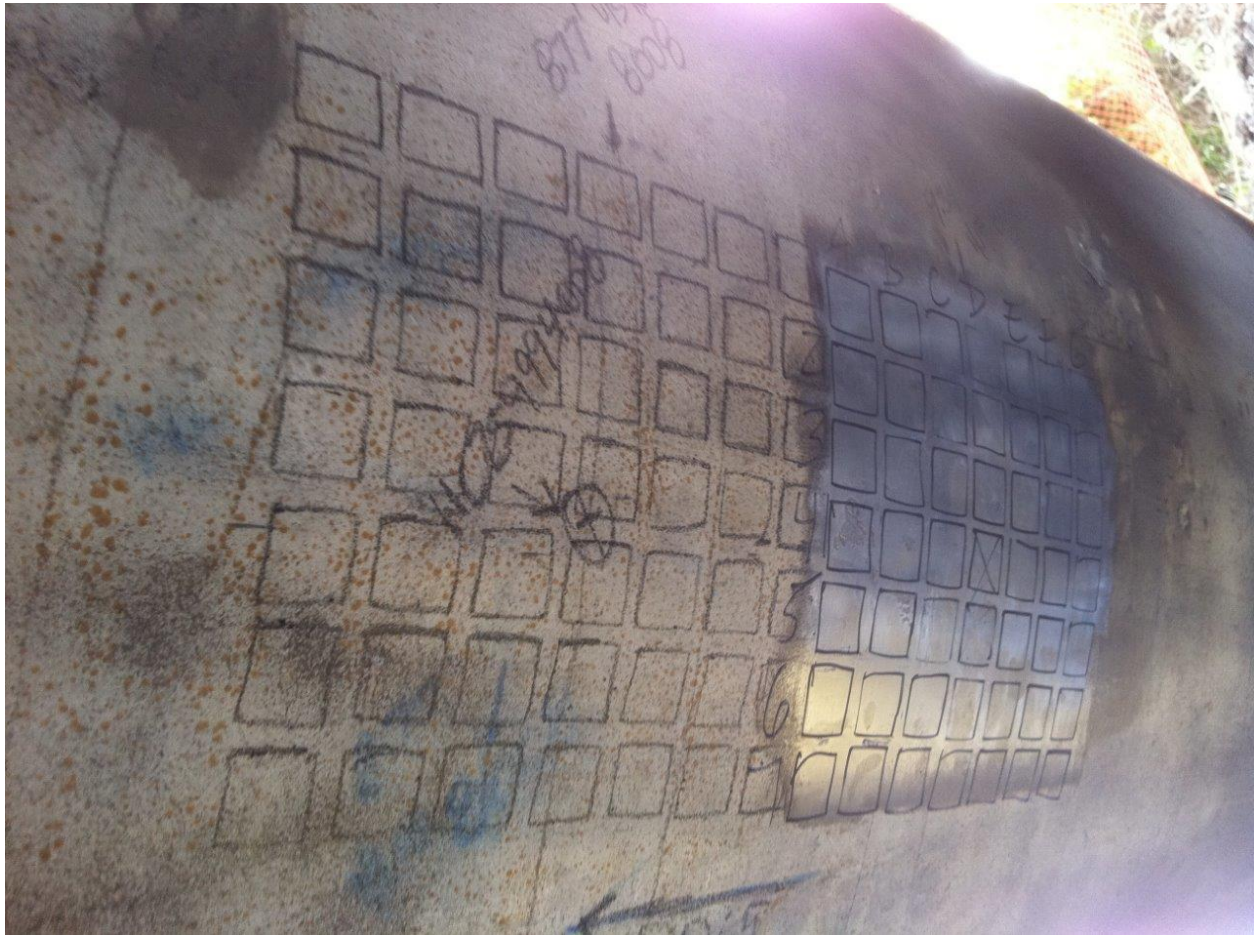
UT OF WC 252993.442

1	2	3	4	5	6	7	8	9	10	11	12
A	398	397	396	396	399	401	403	402	399	398	397	397
B	397	396	397	399	400	399	399	397	397	395	395	397
C	397	398	400	400	398	396	397	396	396	396	399	401
D	402	400	398	397	396	395	397	397	401	405	405	402
E	401	396	395	396	398	398	403	405	405	402	400	396
F	395	395	394	396	399	403	403	400	398	395	395	394
G	397	397	398	401	401	399	396	395	397	394	395	396
H	396	398	398	396	396	394	394	394	393	395	396	397
I	397	396	395									
J												
K												
L
