ENGINE EXAMINATION REPORT

ENGINE MODEL	GTSIO-520-D
ENGINE SERIAL NUMBER	219099-72-D-R
AIRCRAFT MAKE & MODEL	Cessna 421
AIRCRAFT SERIAL NUMBER	421-0164
AIRCRAFT REGISTRATION	N731PF
FILE NUMBER	19-104

ENGINE FIELD INSPECTION REPORT

EXAMINATION		ACCIDENT DATA	
DATE	10/02/2019	NTSB ACCIDENT #	ERA19FA283
FACILITY	Florida Air Recovery	NTSB INVESTIGATOR	Eric Alleyne
ADDRESS	7403 Philips Hwy Jacksonville, FL 32256	FAA INVESTIGATOR	Antonia Gonzalez
		ACCIDENT DATE	09/29/2019
		ACCIDENT LOCATION	Deland, Florida

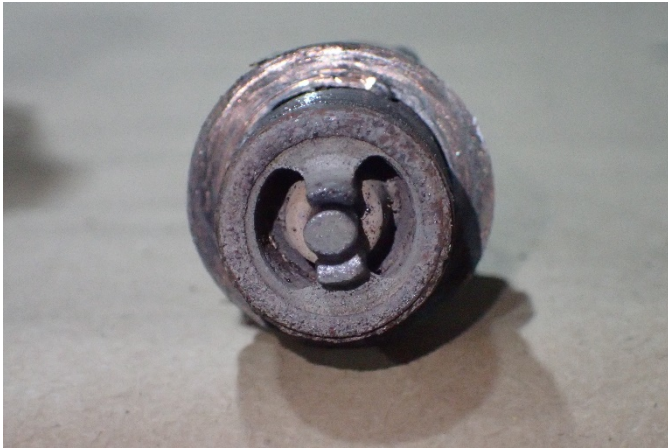
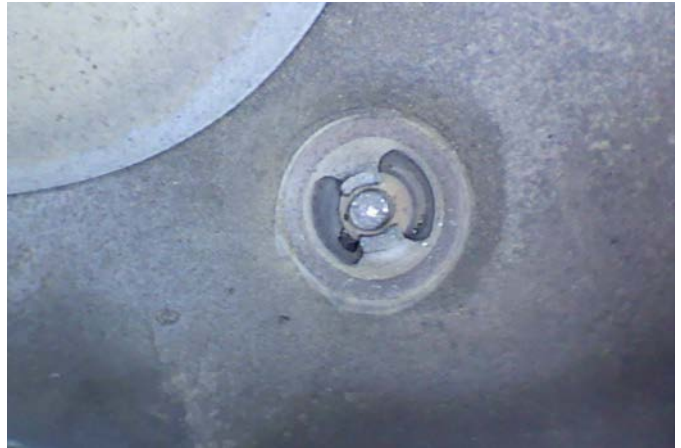
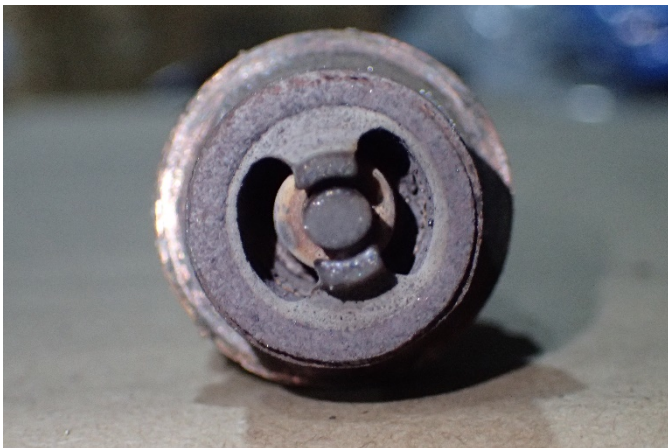
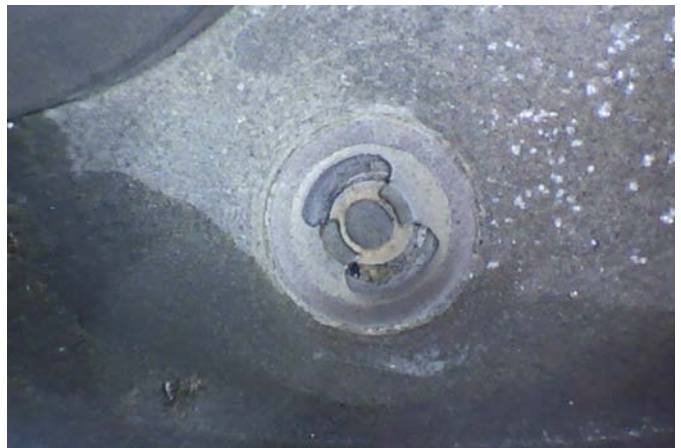
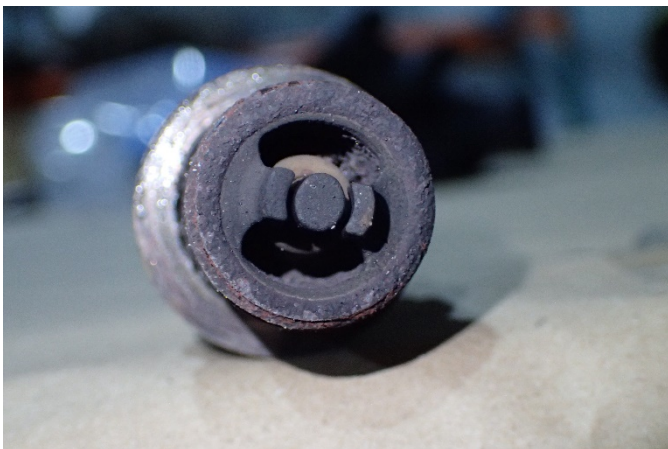
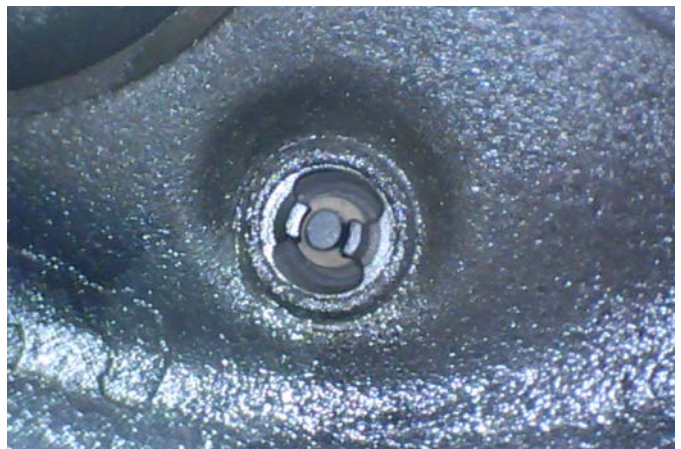
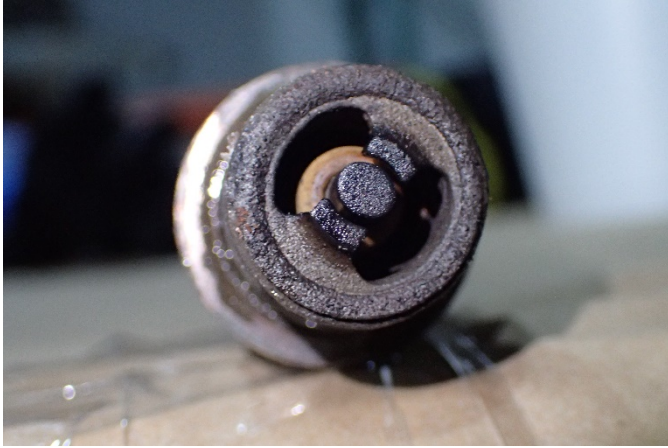
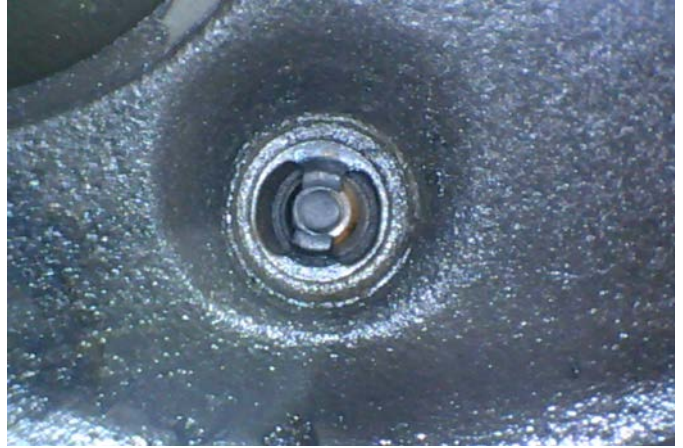
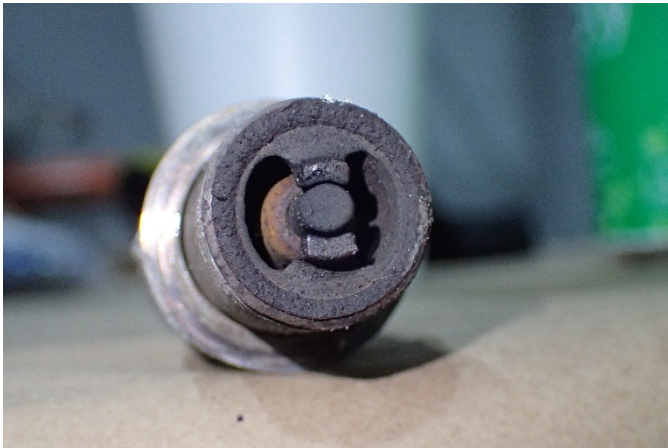
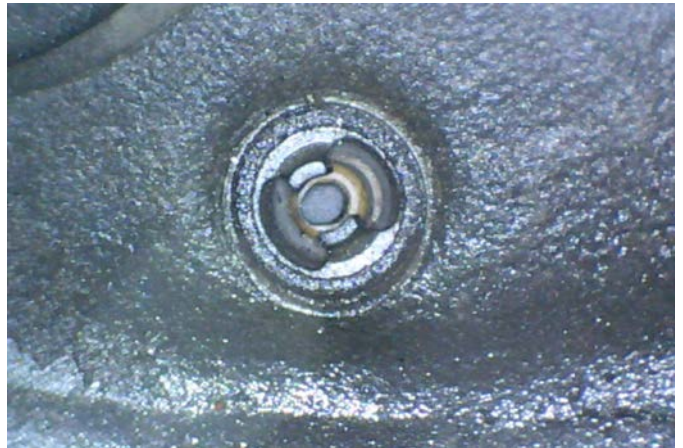
Condition: The spark plugs displayed varying amounts of impact and thermal damage signatures. The top spark plugs were removed for examination and the bottom spark plug electrodes were examined using a lighted borescope. The electrodes displayed normal operating and some of the spark plugs were in a normal worn out condition. There were no anomalies observed.

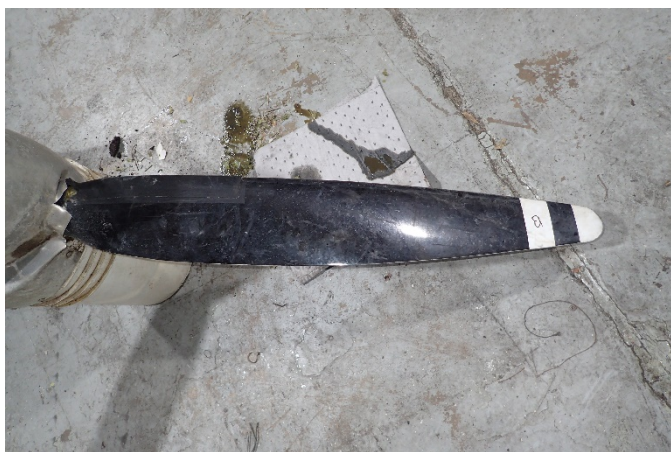
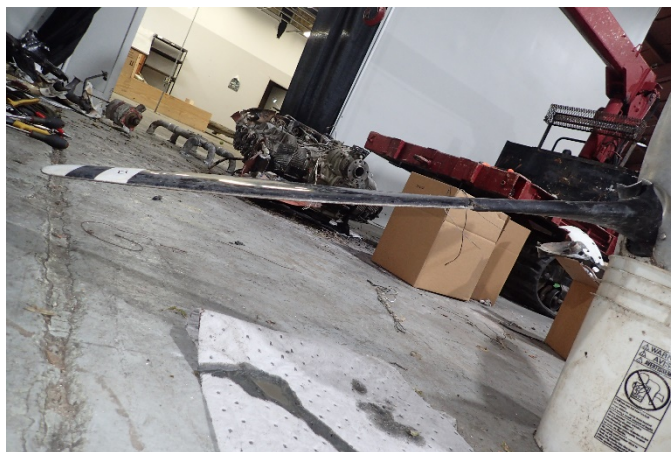
Propeller Blade "B"

Condition: The three-blade, constant speed propeller remained partially attached to the propeller flange and displayed impact damage signatures. The propeller blade marked "A" displayed minor damage to the rubber boot. The propeller blade marked "B" displayed minor impact damage near the root of the blade. Propeller blade marked "C" displayed minor S-bending as well as significant aft bending deformation. During the on-scene portion of the investigation, several tree branches were found with clean approximate 45-degree angle cuts and appeared to have black paint transfer.
