ENGINE EXAMINATION REPORT

ENGINE MODEL	GTSIO-520-D
ENGINE SERIAL NUMBER	188783-9-D
AIRCRAFT MAKE & MODEL	Cessna 421
AIRCRAFT SERIAL NUMBER	421-0164
AIRCRAFT REGISTRATION	N731PF
FILE NUMBER	19-104

EXAMINATION		ACCIDENT DATA	
DATE	10/03/2019	NTSB ACCIDENT #	ERA19FA283
FACILITY	Florida Air Recovery	NTSB INVESTIGATOR	Eric Alleyne
ADDRESS	7403 Philips Hwy Jacksonville, FL 32256	FAA INVESTIGATOR	Antonia Gonzalez
		ACCIDENT DATE	09/29/2019
		ACCIDENT LOCATION	Deland, Florida

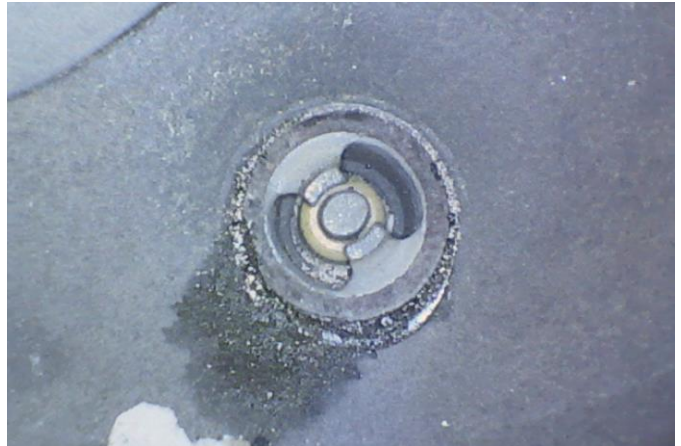
#1 Bottom Spark Plug

The spark plugs remained installed in their cylinders and displayed varying amounts of impact damage. The top spark plugs were removed for examination and the bottom spark plug electrodes were examined using a lighted borescope. The electrodes displayed normal operating and a few of the spark plugs were in a normal worn-out condition when compared with Champion Aviation Service Manual AV6-R.

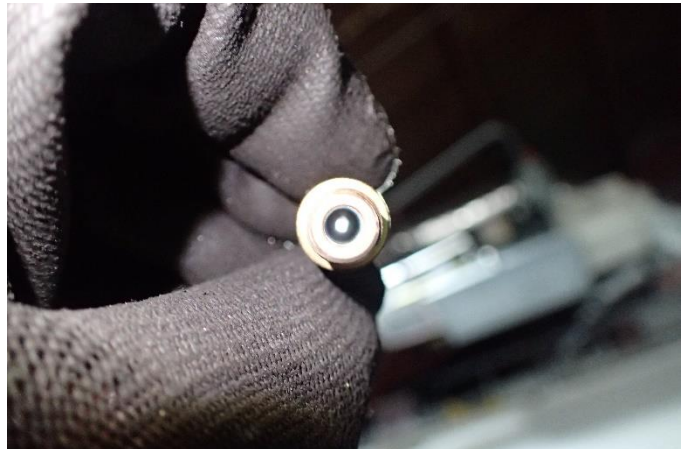
#3 Nozzle

Condition: The fuel nozzles remained installed in their cylinders and displayed varying amounts of thermal damage. The nozzles were removed and were observed to be clear of obstructions.
