**NATIONAL TRANSPORTATION SAFETY BOARD
OFFICE OF MARINE SAFETY
WASHINGTON, D.C. 20594**

**Nautical Operations, Human Performance, and System Safety
Group
Factual Report**

Dredge Waymon Boyd

**Explosion and Fire following Propane Pipeline Strike
Near EPIC Dock, Corpus Christi Ship Channel
Corpus Christi, Texas**

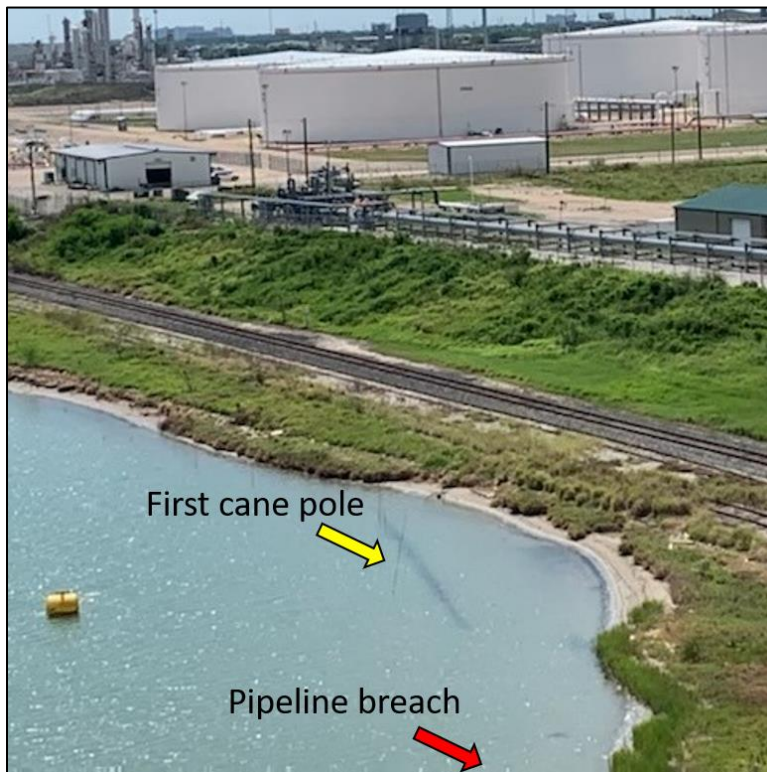
On July 16, the project engineer and the two Enterprise technicians met at the dredging site and noted that “about half” of the cane poles put in place the prior year were still in place. They boarded a skiff (small boat) and, after locating pipeline TX219 using a handheld device, the Enterprise technicians re-marked the location using additional cane poles provided by Orion. The project engineer stated that the poles were placed on the channel side of the pipeline. The Enterprise technician estimated that the poles were spaced about 50 feet apart along the roughly 260-foot section of waterborne pipe, with the first being between 30 to 40 feet from the shoreline where the pipeline entered the water. A photograph of the accident site taken after phase 2 dredging operations began but before the accident occurred shows the cane poles beginning about halfway across that the inlet in the channel that the pipeline crossed (see figure 5).

Figure 5. Preaccident photograph of marking cane poles. (Source: Epic Crude Terminal Company)

The technician stated that, whereas a compulsory marking required markers every 20 feet, a courtesy marking only required markers every 200 feet. After the cane poles were installed, the project engineer took photographs of the poles and the pipeline, which she stated was visible under the water.

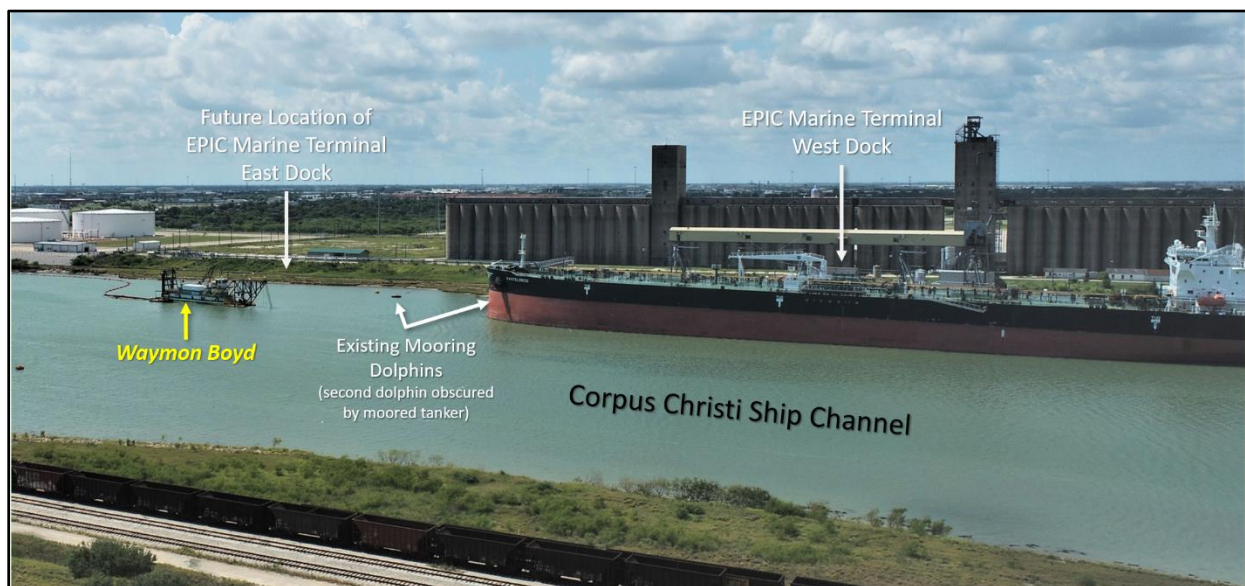
Through the end of July and the first weeks of August, the *Waymon Boyd* operated at the dredge site (see figure 7), working generally east to west beginning on the channel side and moving progressively inshore, as observed in AIS data. According to the dredge crew and a contractor monitoring progress on behalf of EPIC, the dredge had to stop regularly to clean out rocks and debris that had been sucked up by the dredge and lodged in the pump strainer and other areas. Dredging work was also occasionally halted for emergent repairs to equipment.

Figure 7. The *Waymon Boyd* at the EPIC Marine Terminal East Dock site, August 7, 2020. (Source: Orion Marine Group, annotated by NTSB)

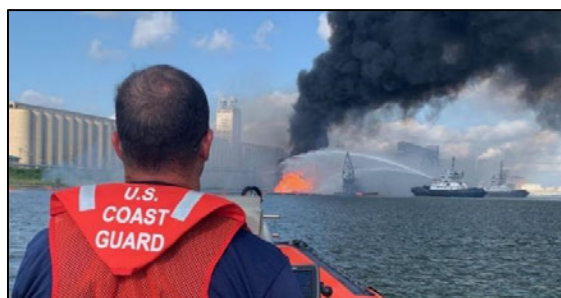
At 0934, the tugboats *Ted C Litton* and *Evelena* arrived on scene and began using their water monitors (canons) to fight the fire on the dredge (see figure 9). About 20 minutes later, the tugboats *Signet Constellation*, *Signet Courageous*, and *Signet Stars & Stripes*, as well as the prevention and response tugboat *Signet Strength*, took over waterborne firefighting efforts.⁴ The *Ted C Litton* and *Evelena* departed the immediate area.

The Signet tugboats remained at the accident site until the fire on the *Waymon Boyd* was extinguished about 1300. Residual propane rising from the breached pipe continued to burn until 1610 local time, when it self-extinguished. The dredge, which continued to smolder, began taking on water 1400. Efforts to stabilize the vessel were unsuccessful, and it sank at 2151.

Figure 9. Tugboats *Ted C Litton* and *Evelena* fight fire at the accident scene. (Source: Coast Guard)

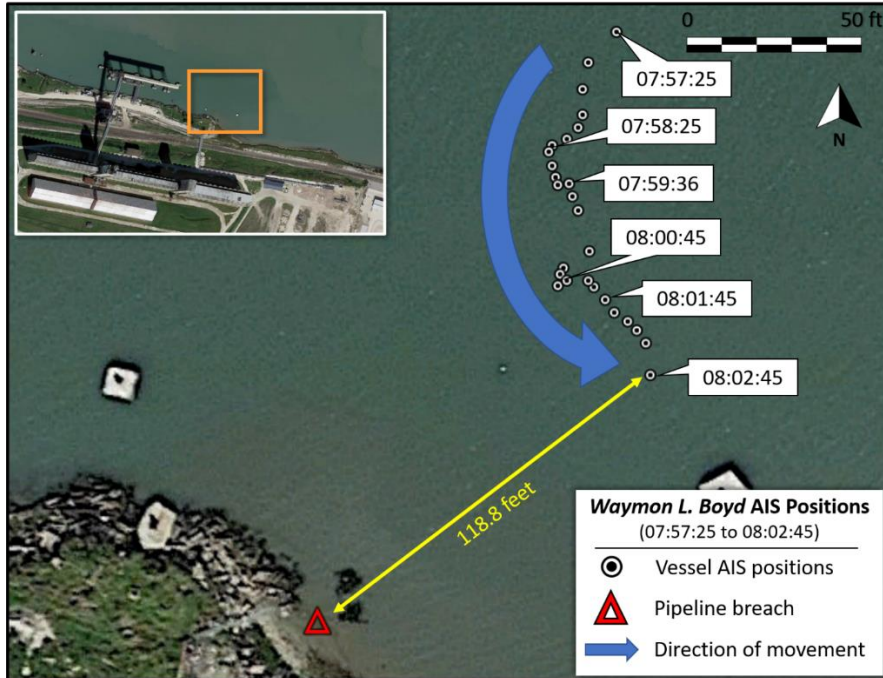
AIS data from the *Waymon Boyd* shows the vessel's movement in the minutes surrounding the accident. Beginning at 07:57:25, the dredge swung in a rough arc in a southeasterly direction, toward the shoreline, with a speed over ground between 0.1 and 0.3 knots (see figure 18). At 08:02:45 (5 minutes 20 seconds time elapsed), the southeasterly swing stopped. At this point, the AIS position of the vessel was about 119 feet from the location of the breach in pipeline TX219. The AIS and GPS antennas were mounted on roof of the *Waymon Boyd's* lever room. Also, the dredge's direction of movement did not reflect its orientation (heading information was not reported by the vessel's AIS). The dredge captain indicated that, about the time the water erupted from the surface of the waterway, the vessel's heading was southwesterly.

Figure 18. *Waymon Boyd* AIS data from 07:57:25 to 08:02:45 on the accident date. (Background source: Google Earth)

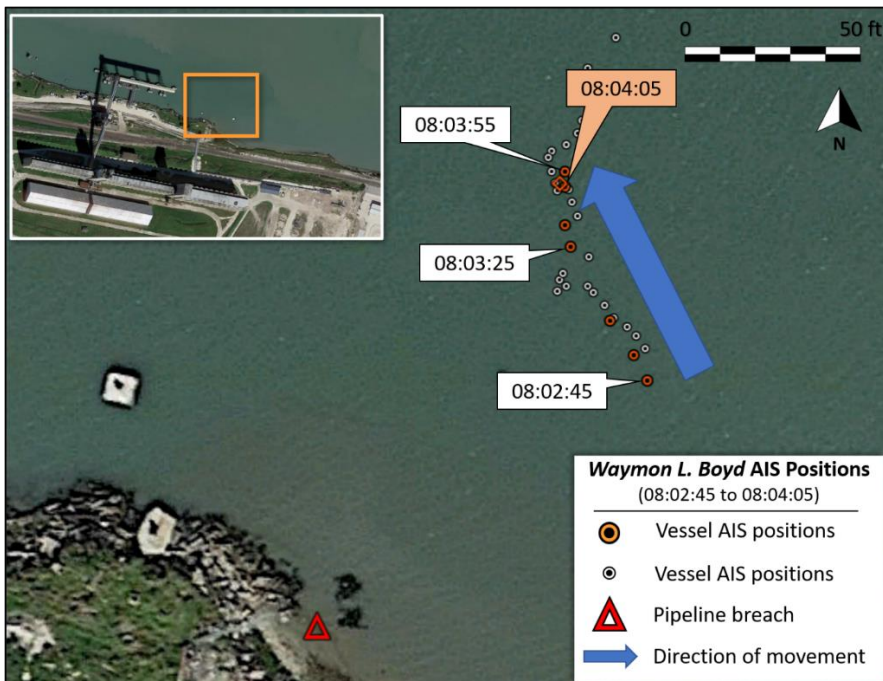
Following the 08:02:45 AIS report, the *Waymon Boyd* moved back to the north, away from the shoreline (see figure 19). The vessel's speed over ground during this motion accelerated from 0.4 knots to 1.3 knots, until the movement stopped about 08:03:55. Ten seconds later, the dredge transmitted its final AIS position report in nearly the same location.

Figure 19. *Waymon Boyd* AIS data from 08:02:45 to 08:04:05 on the accident date. (Background source: Google Earth)

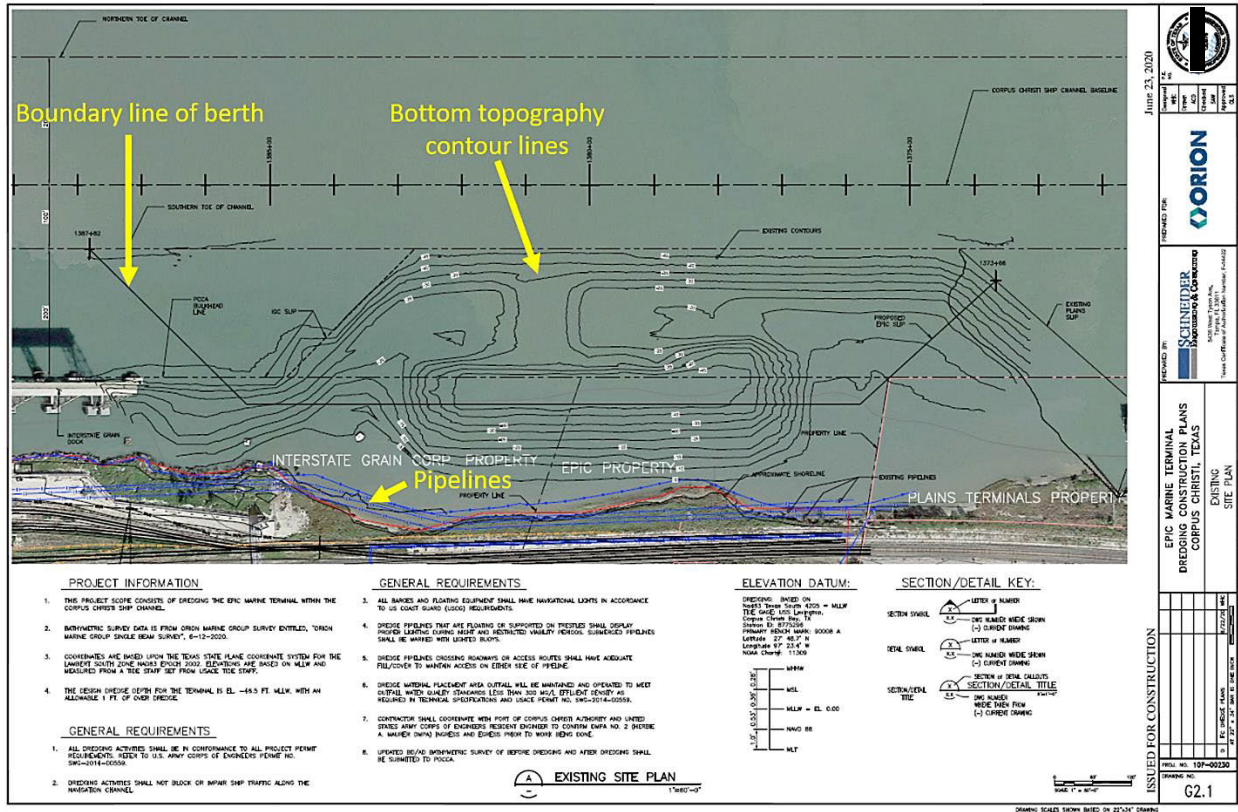
4205 (horizontal datum) and MLLW (vertical datum).¹² The units of length for the datums were feet. According to the design engineer, the pipeline location data came from the December 2018 utilities survey conducted by TMI Solutions. The horizontal datum for the TMI survey was also NAD83 Texas South plane 4205; a vertical datum was not listed.

Figure 21. Existing Site Plan from EPIC East Dock dredging plans, with annotations in yellow by NTSB. (Source: Orion Marine Group)

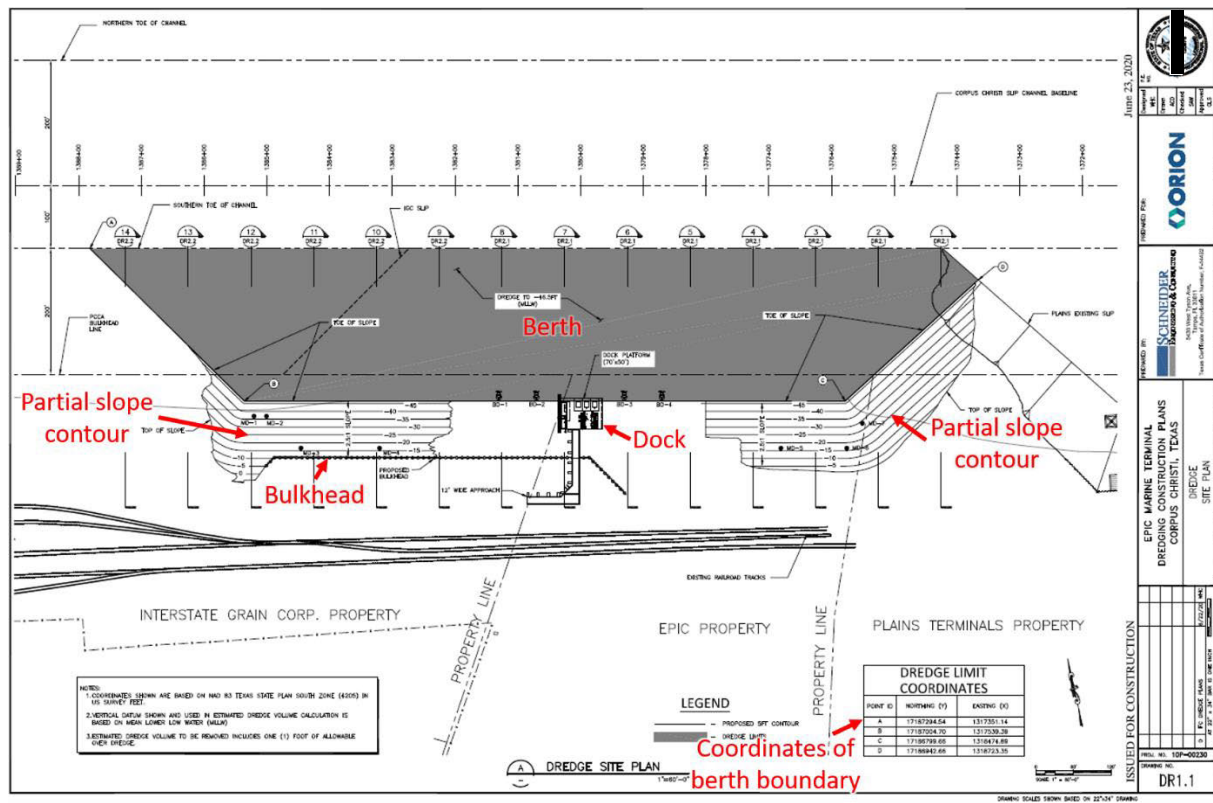
The second section of the dredging plans was the “Dredge Site Plan,” an overhead drawing of the berth, along with the proposed dock, mooring dolphins, and a bulkhead that would extend out from the shoreline and be backfilled and covered (see figure 22). A table in the plan labeled “Dredge Limit Coordinates” listed the coordinates of the boundary of the berth in eastings (X) and northings (Y).¹³ The drawing included a partial depiction of the sloped areas to be dredged during phase 2 of the project, as indicated by contour lines decreasing in depth at 5-foot intervals (the sloped area dredged in phase 1 was not shown). The top of the slope was indicated by the 0-foot depth line, except in the area of the proposed bulkhead where it terminated at about 10-foot depth at the structure (the original Jacobs plans included a similar drawing, with the slope fully depicted). When interviewed, the project engineer stated that the absence of the slope in the vicinity of the

bulkhead was “clearly a gap in these plans” and that, in cases where there were gaps in the plan, “we typically play it conservatively.”

The 2018 TMI Solutions survey data was not included in the Dredge Site Plan. According to the Orion project engineer, there was no company policy providing a minimum distance between pipeline and dredging area for which the pipeline was required to be included in the plan. When asked how she determined the distance between the top of the sloped area and the pipelines, the engineer stated, “I repeatedly just looked at [Dredge Site Plan] and then the [Existing Site Plan] that actually shows the approximate location of the blue lines.” The datum for the Dredge Site Plan was NAD83 Texas State plane 4205, and the units of length were feet.

Figure 22. Dredge Site Plan from EPIC East Dock dredging plans, with annotations in red by NTSB. (Source: Orion Marine Group)

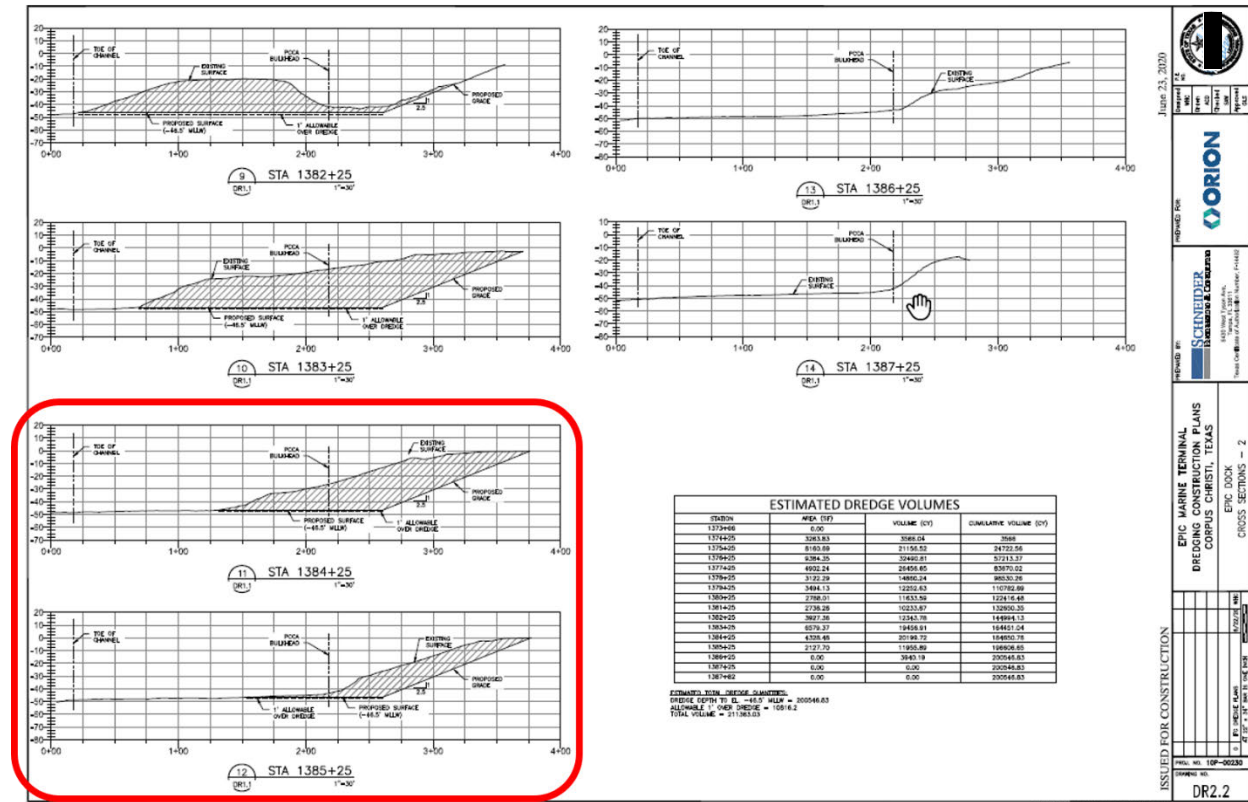
projects in the navigable waterways in the United States, the permitting authority was the US Army Corps of Engineers). The slopes of the dredge area did not have an allowable over dredge. The cross-sectional drawings also included a depiction of the components of the proposed dock, where applicable, and the existing surface of the bottom that was to be removed by the dredging work. The cross-sectional drawings did not show the location of the pipelines in the TMI Solutions utilities survey.

Figure 23. Sample of cross-sectional views from EPIC dock dredging plans. Cross-sections 11 and 12, circled in red by NTSB, were on either side of the accident site. (Source: Orion Marine Group)

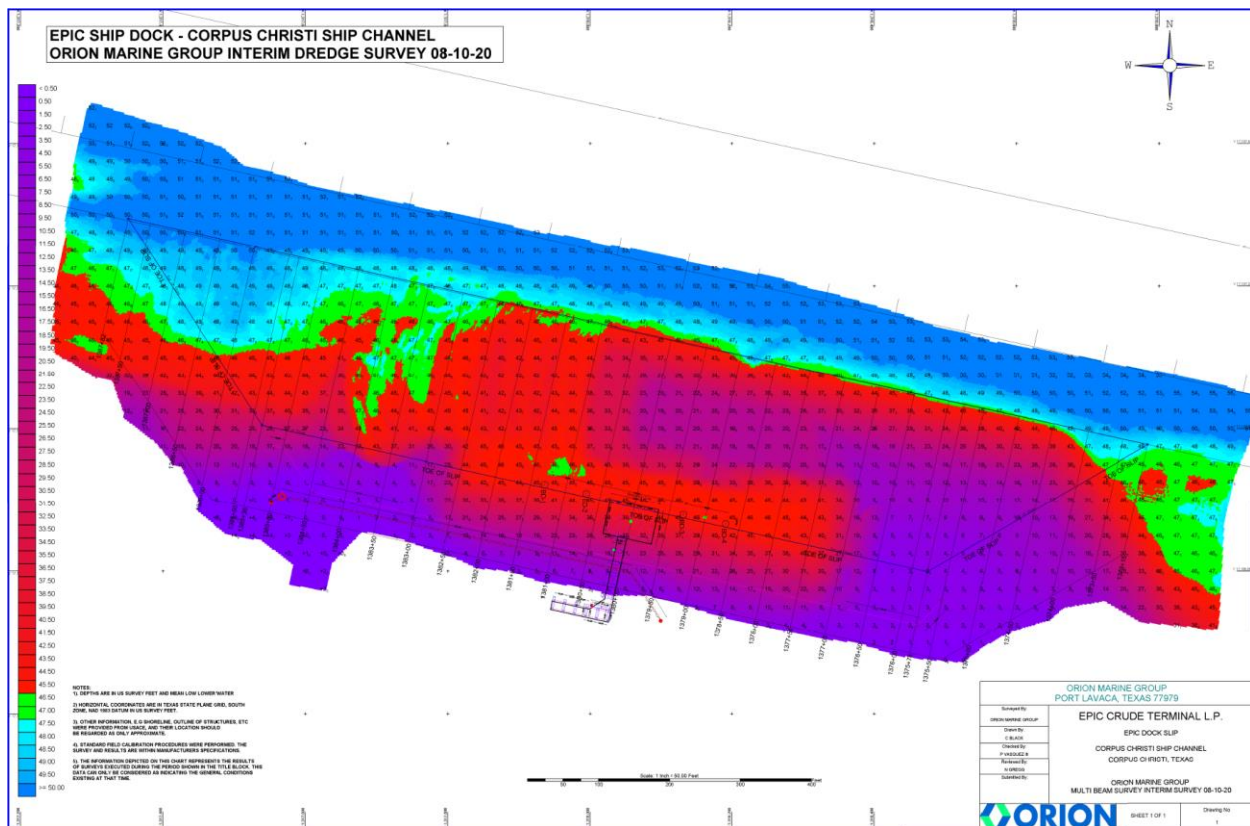
Figure 25. Two-dimensional representation of EPIC Dock site hydrographic survey data developed using HYPACK. Data was collected on August 10, 2020, using multibeam sonar installed on an Orion survey boat. (Source: Orion Marine Group)

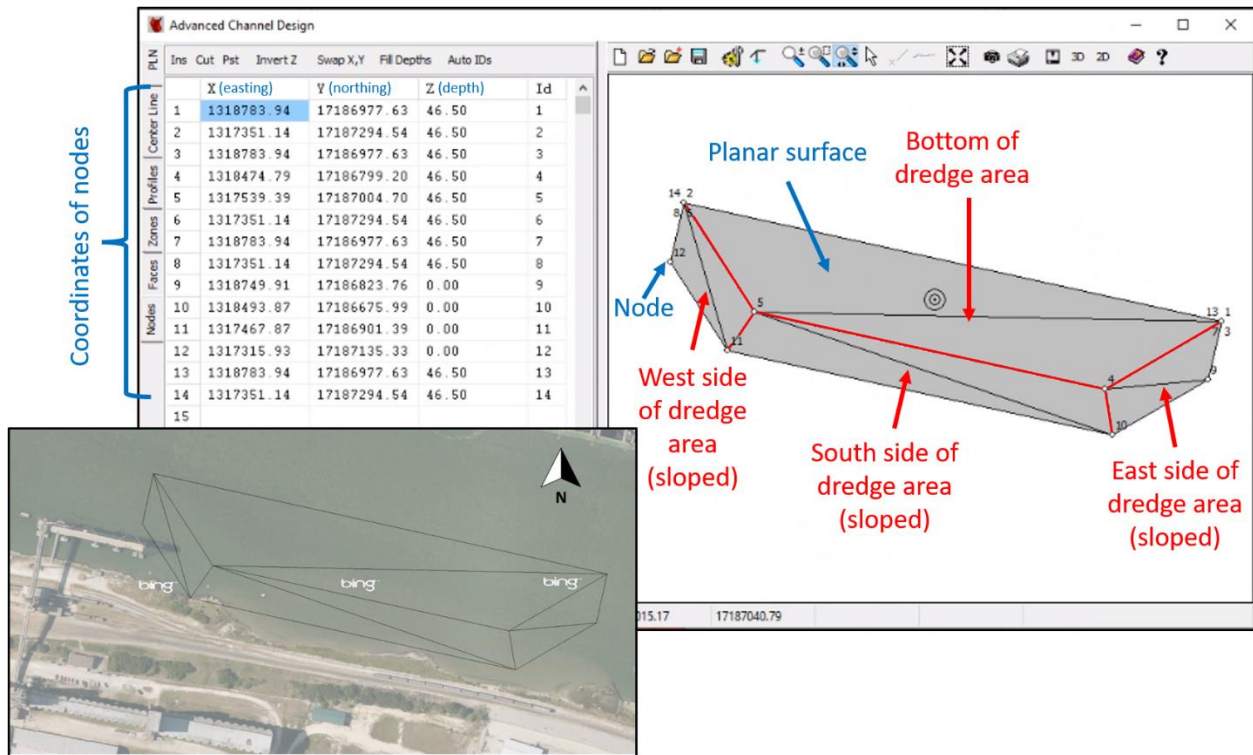
Figure 26. DREDGEPACK dredge template for EPIC Dock project, annotated in blue and red by NTSB. Inset is dredge template overlaid on satellite image of site. (Sources: template data source - Orion Marine Group; satellite imagery as displayed in DREDGEPACK - Microsoft Bing)

The Orion Marine Group survey superintendent told investigators that he developed the DREDGEPACK dredge template for phase 2 of the EPIC East Dock project (figure 26 above) from the June 23, 2020, Schneider Engineering and Consulting drawings. Using the coordinates listed in the Dredge Site Plan (figure 22 above), he created the nodes for the boundary of the berth floor. He stated that he adjusted the coordinates of the north east corner of the berth (point D in the engineering drawing, node 1/3/7/13 in the DREDGEPACK template) so that the boundary of the berth terminated at the ship channel. After entering the given coordinates, the survey superintendent used DREDGEPACK’s slope creator tool to determine the coordinates for the nodes at the top of the sloped sides, entering a slope ratio of 2.5:1 per the engineering drawings. Note that in the completed template that the southwest corner of the dredging area lies over land. This area is immediately to the west of the pipeline breach location.

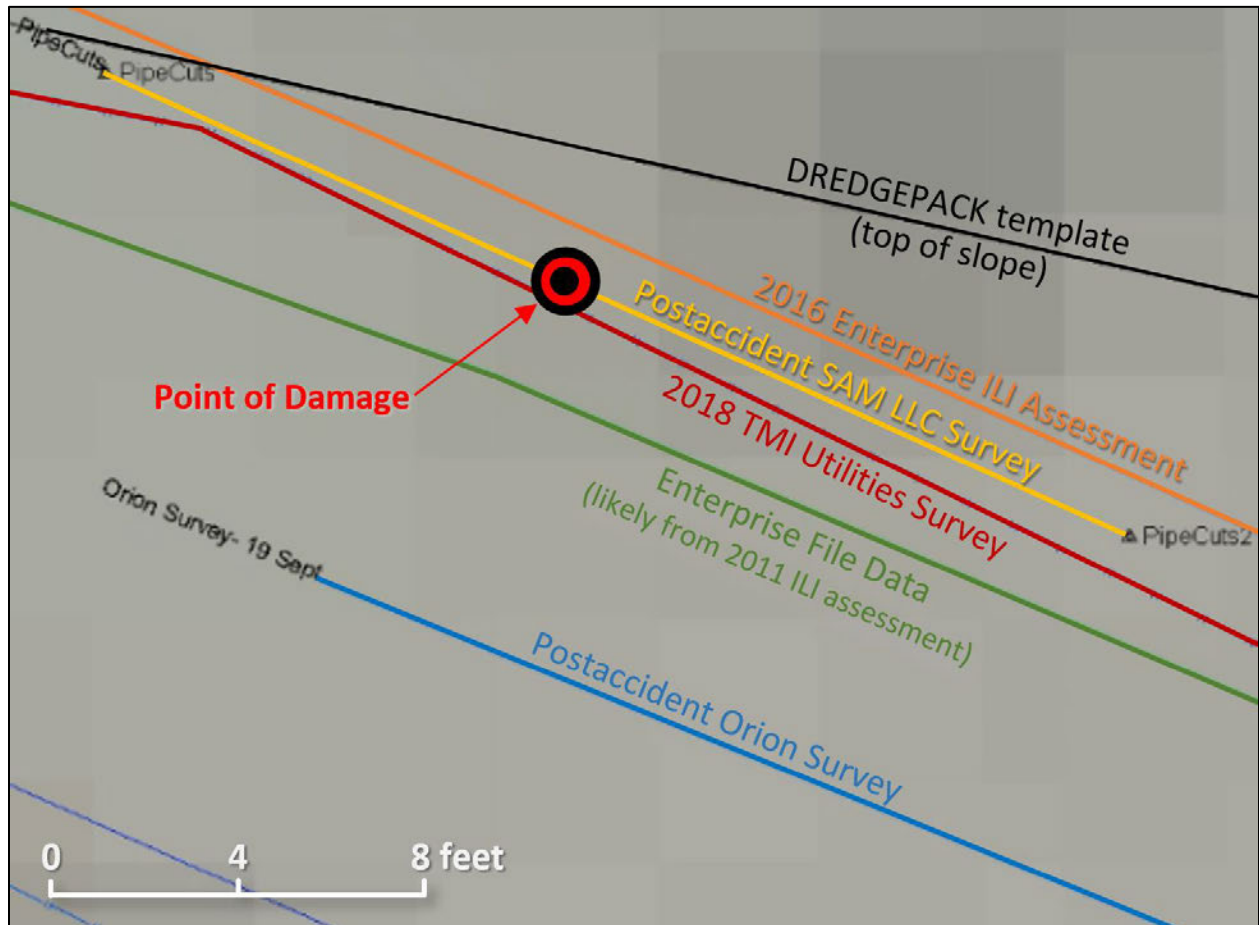
The NTSB obtained location data for pipeline TX219 from multiple sources, to include Enterprise Products in-line inspection (ILI) data, the 2018 TMI Solutions utilities survey, a postaccident survey performed by Orion Marine Group personnel, and a postaccident survey performed by Enterprise Products contractor SAM, LLC. The location data varied among all sources (see figure 32). At the point of damage to the pipeline, none of the data showed the pipeline within the DREDGEPACK dredge template in use by the *Waymon Boyd* at the time of the accident.

Figure 32. Sample of various pipeline location data near accident site.

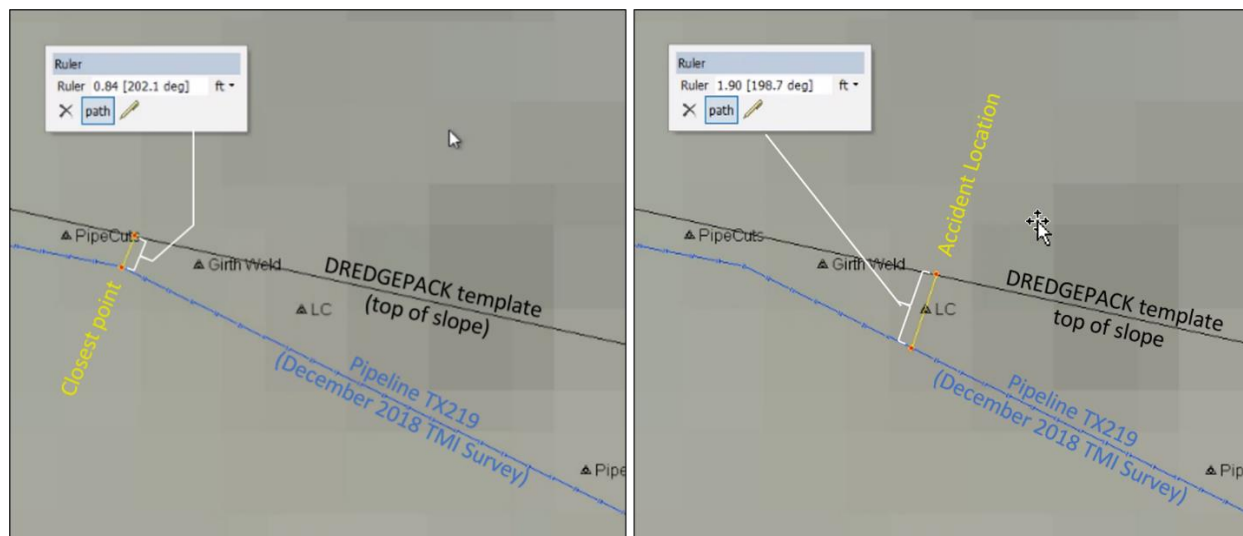
With the assistance of a HYPACK technical representative, NTSB investigators imported the TMI Solutions survey data (the data provided to Orion Marine Group and Schneider Engineering and Consulting for planning the EPIC dock project) into DREDGEPACK and used the system's tools to measure the distance between the center of pipeline TX219 and the outer edge (top of the slope) of the EPIC East Dock dredge template in use by the *Waymon Boyd* at the time of the accident. At its nearest point, the center of pipeline TX219 was 0.8 feet from the DREDGEPACK dredge template, and at the accident location, the pipeline was 1.9 feet from the template (see figure 33). A similar projection of the data from 2016 Enterprise ILI assessment (the most recent assessment by the pipeline owner), showed the distance from the pipeline's center to be 1.0 feet from the dredge template.

Figure 33. Screen captures from DREDGEPACK dredge template for the EPIC dock project, with imported location data for pipeline TX219 from 2018 TMI Solutions utilities survey. Left image shows distance between pipeline and template at closest point. Right image shows distance from pipeline to template at the accident location.
