# **National Transportation Safety Board**

### **Group Chairman's Factual Report of the Investigation**

**Natural Gas-Fueled Explosion During Routine Maintenance**

**Farmersville, Texas**

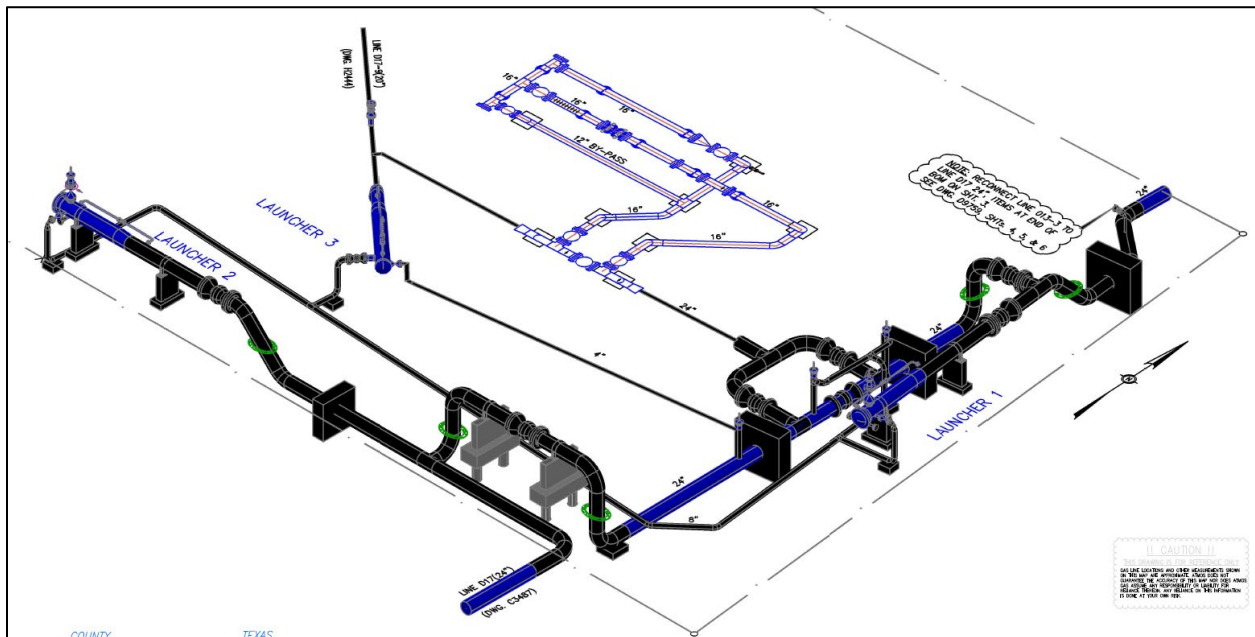
The accident occurred in Atmos Energy Corporation's (Atmos's) Line D17, Line D17-9, Line O13-3 Junction Lot (junction lot), about 5 miles northwest of Farmersville, Texas (Figure 1). The junction lot was gated and fenced, with three active pipelines, and three pig launchers.<sup>1</sup> The junction lot was in a Class 1 location that was preliminarily identified as a potential moderate consequence area (MCA) and did not fall within a high consequence area (HCA).<sup>2</sup> The launcher involved in this accident is shown in Figure 2.

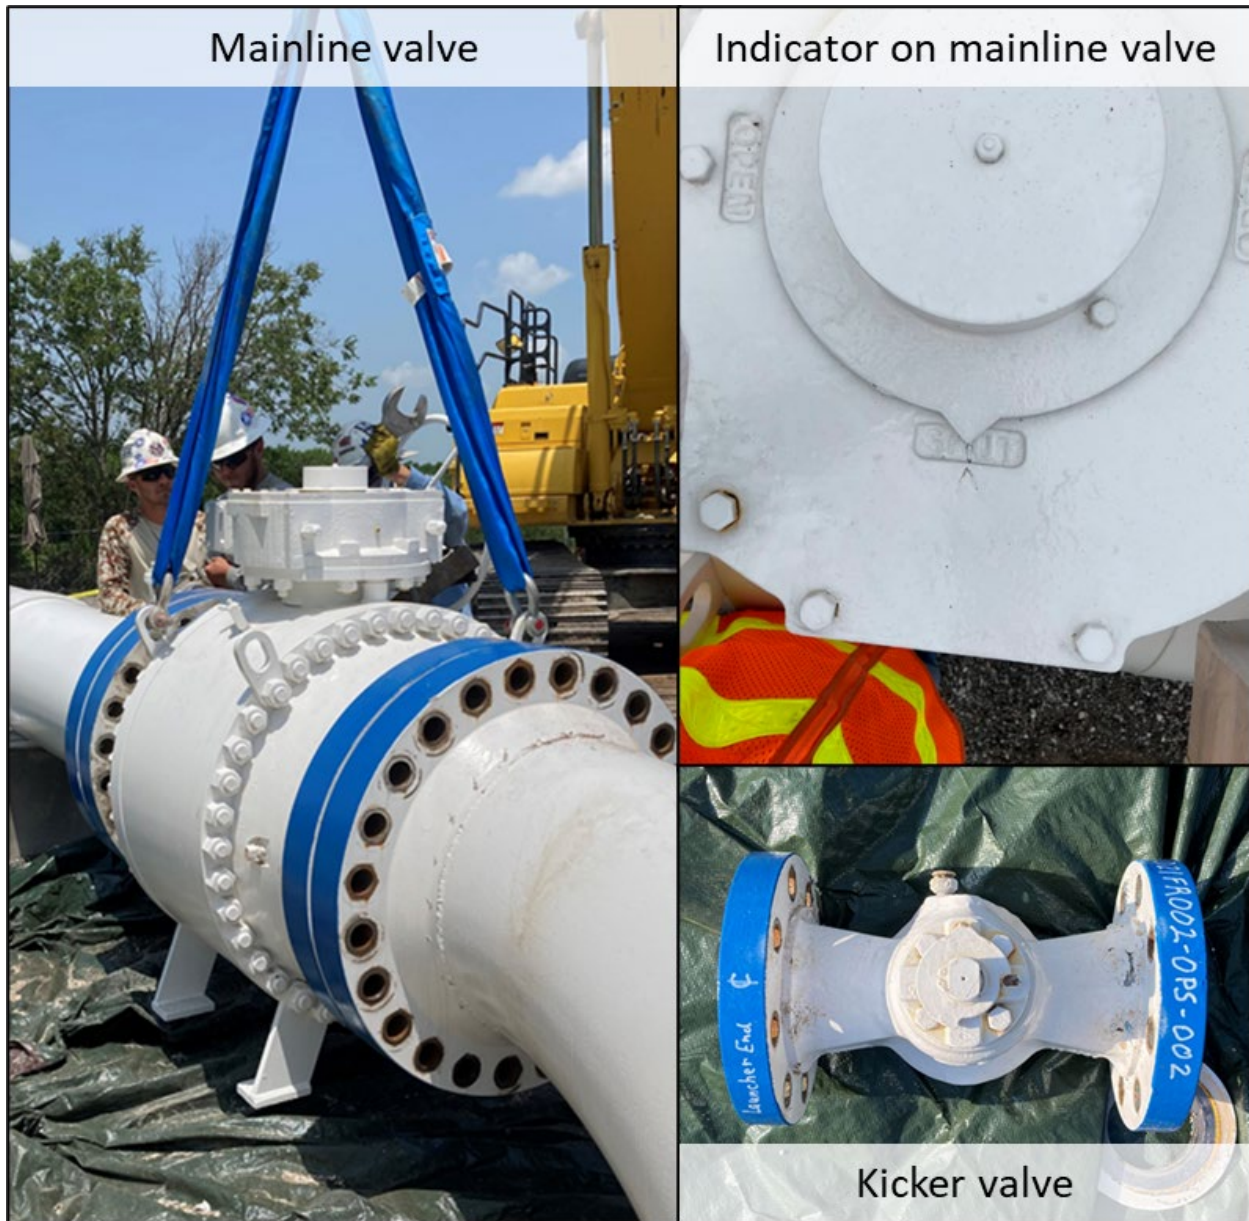
**Figure 9.** Evidence Removal, July 13, 2021 (Courtesy of RRC)

Between July 9, 2021 and July 13, 2021, the mainline and kicker valves were removed from the junction lot and transported to a secure storage location (Figure 9). These activities were completed by Atmos and their contractors with oversight by RRC (in-person) and NTSB (remotely). The RRC pipeline safety inspector made the following observations:<sup>50</sup>

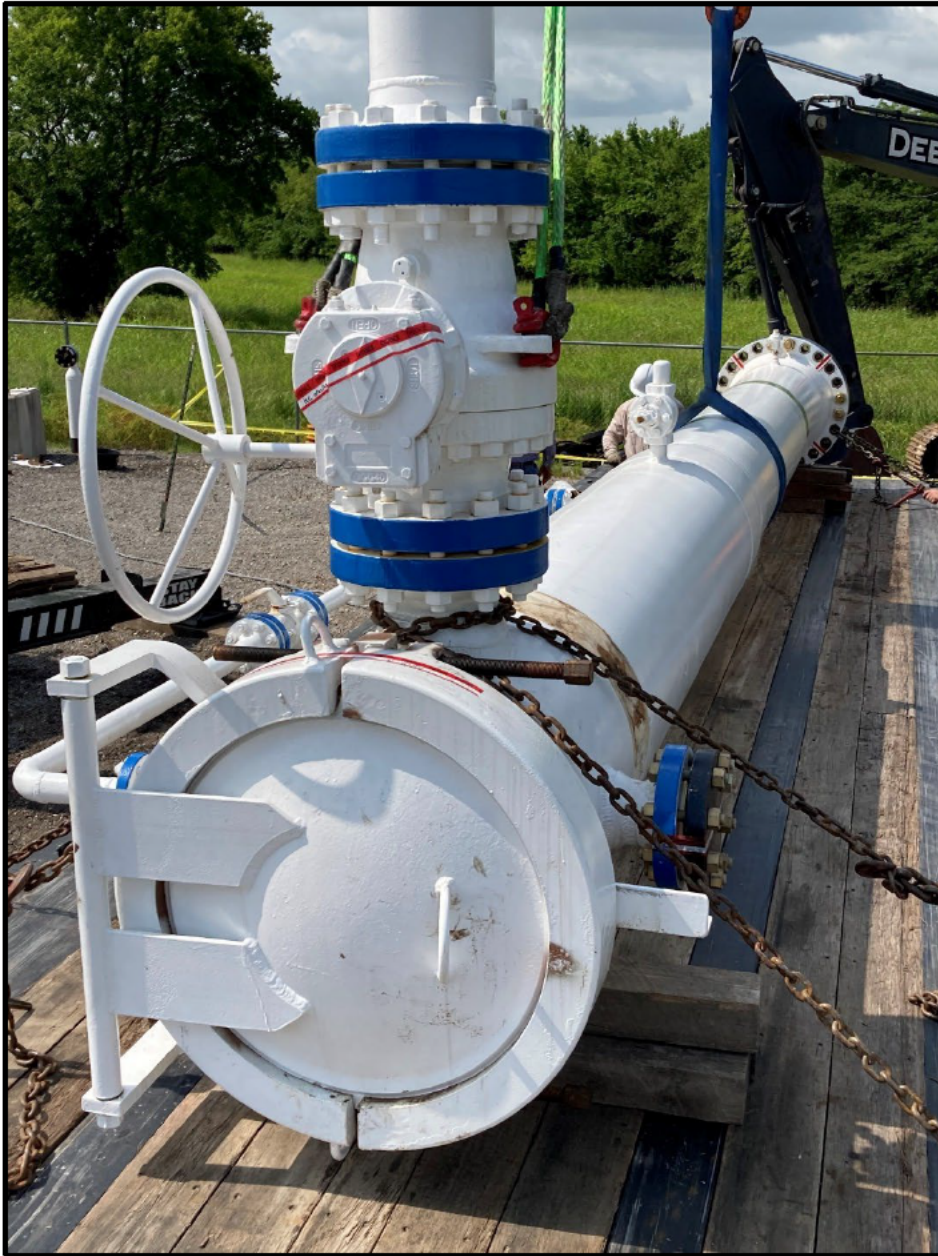
**Figure 10.** Launcher Removal, July 23, 2021 (Courtesy of RRC)

On July 23, 2021, the launcher was removed from the junction lot and transported to a secure storage location (Figure 10). The launcher removal was completed by Atmos and their contractors with oversight by RRC (in-person) and NTSB (remotely).

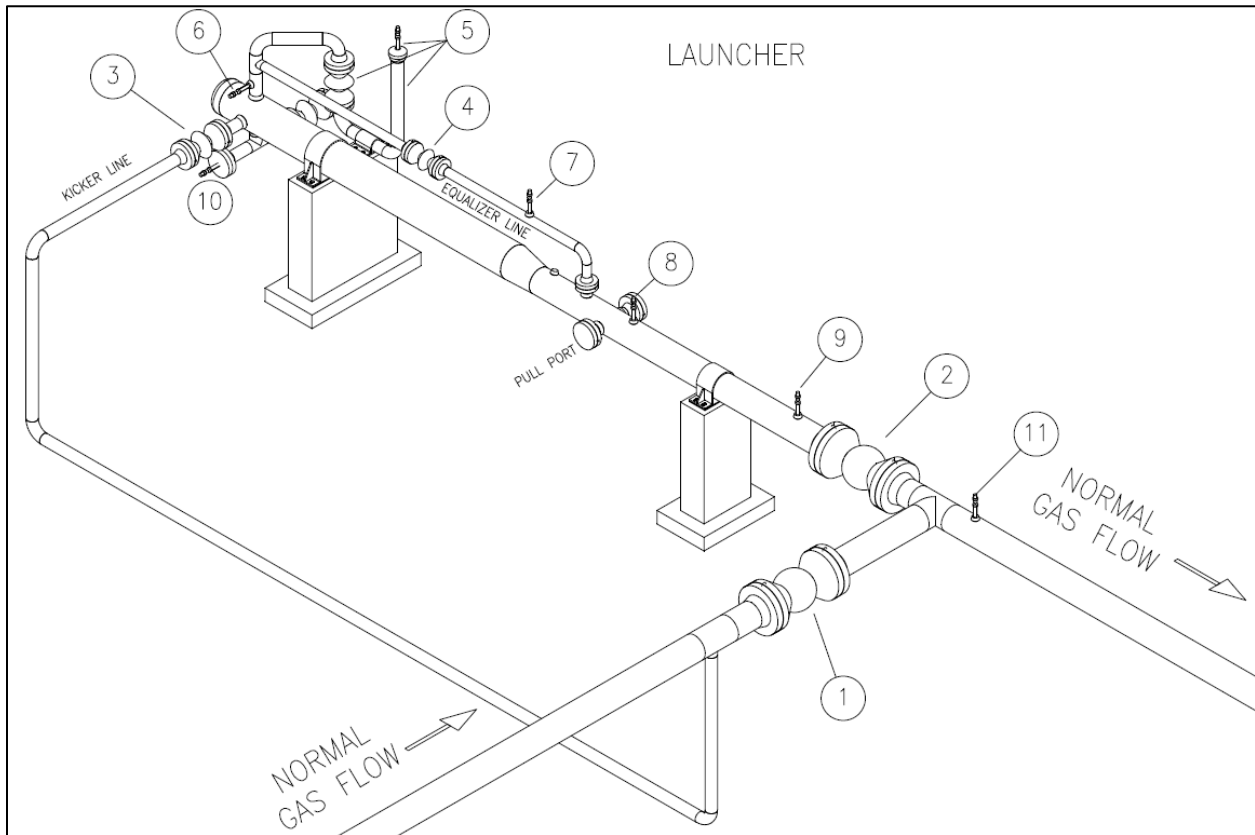
This procedure required all valves to be opened when depressurizing the launcher, except the launcher mainline valve, kicker valve, and vent valve (2, 3, and 11 in Figure 11). The procedure did not mention the use of a flare system.

**Figure 11.** Example pig launcher configuration used in Atmos procedure (Courtesy of Atmos)<sup>54</sup>
