Investigator:	Tim Rader	Date:	2/18/2020
Site Location:	37° 20' 5.7", -82° 23' 37.8"	Quad:	Hellier
LB #:	15505	County:	Pike

Richard Hipskind HP LB#15505
CSX Derailment
Pike County/ Hellier Quad.

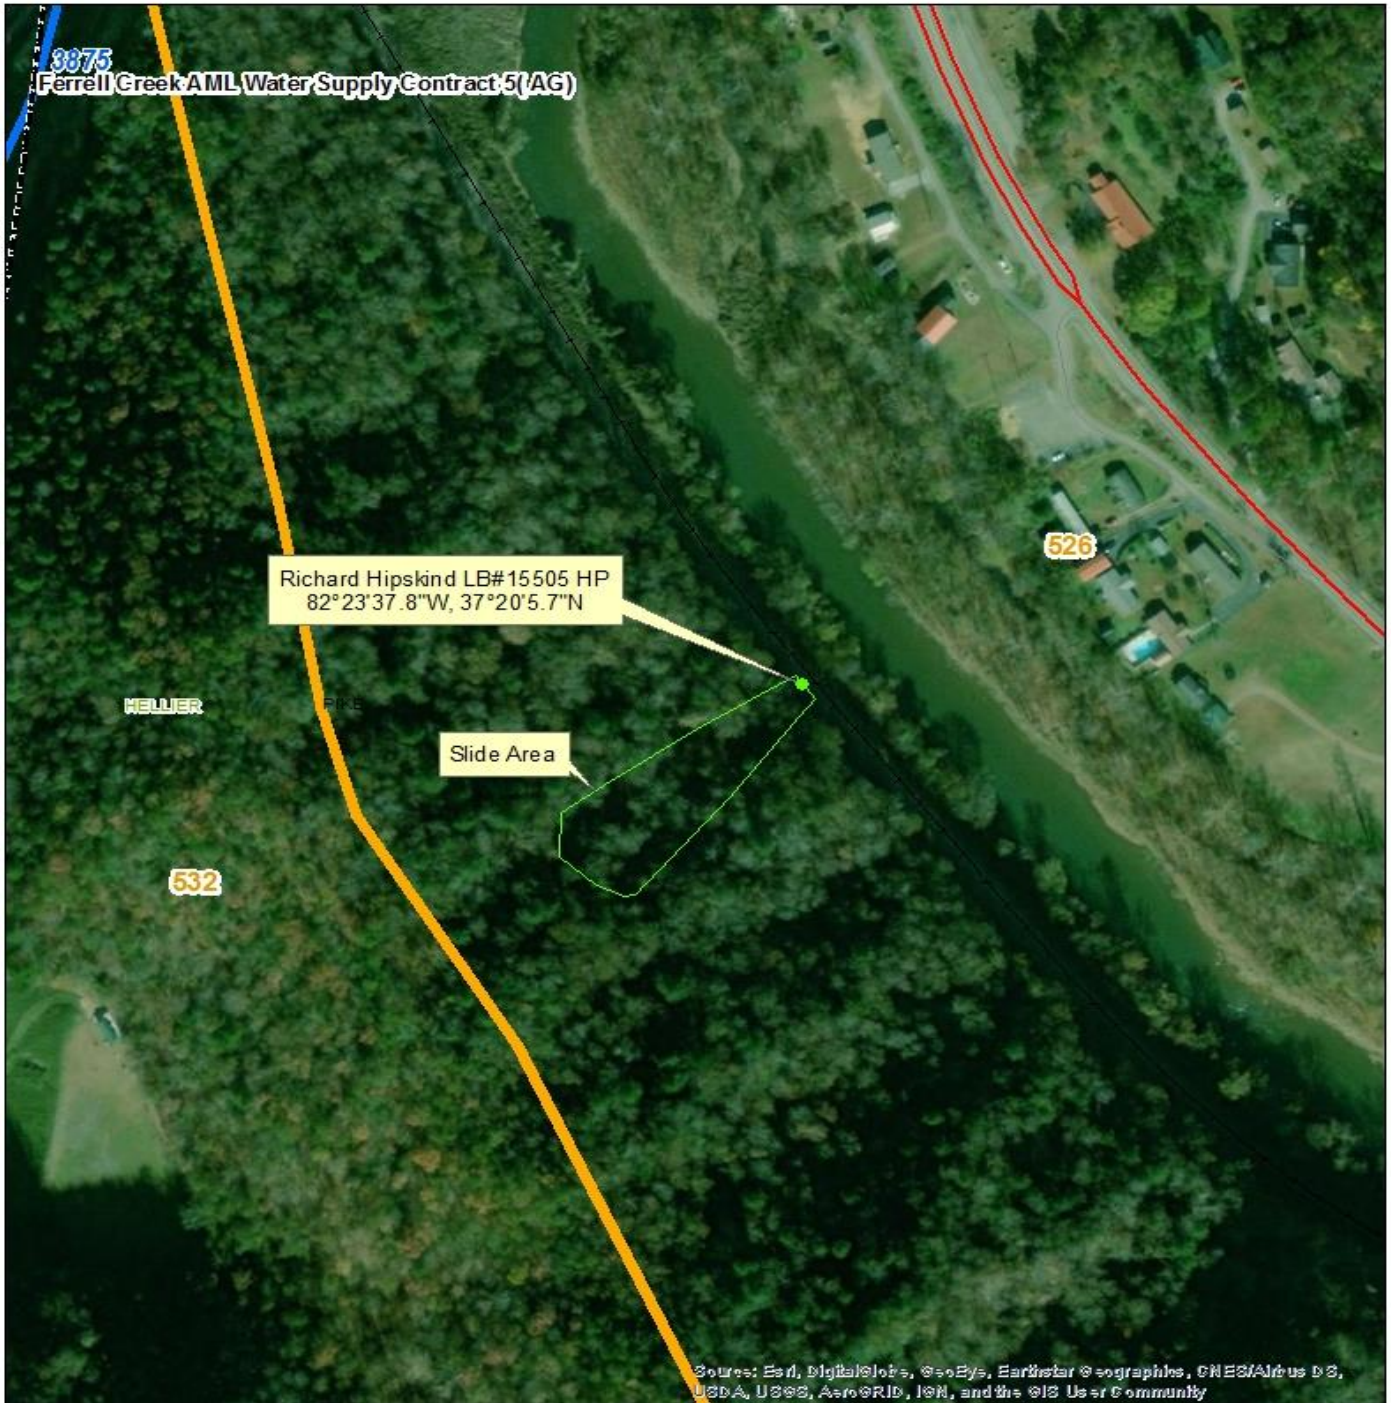
AML Nearby Complaints and Probkey Layers

Nearby AML Complaint History: <i>(If nearby Projects are found, include relevant Eligibility Memos, Maps, Old Mine Histories, and OSM Briefing Papers in Appendix II)</i>		
PU Number:	526- Russel Fork	
Is this complaint within an existing PAD: <i>(Identify the PA Number)</i>	No	
If so, are the individual problems already in the geodatabase? <i>(Identify by the AML Problem ID)</i>	None	
Nearby AML complaints:	LB # and Name	AML Complaints database 'Remarks' field <i>(Copy and insert text below, add rows as needed)</i>
		No Nearby Complaints

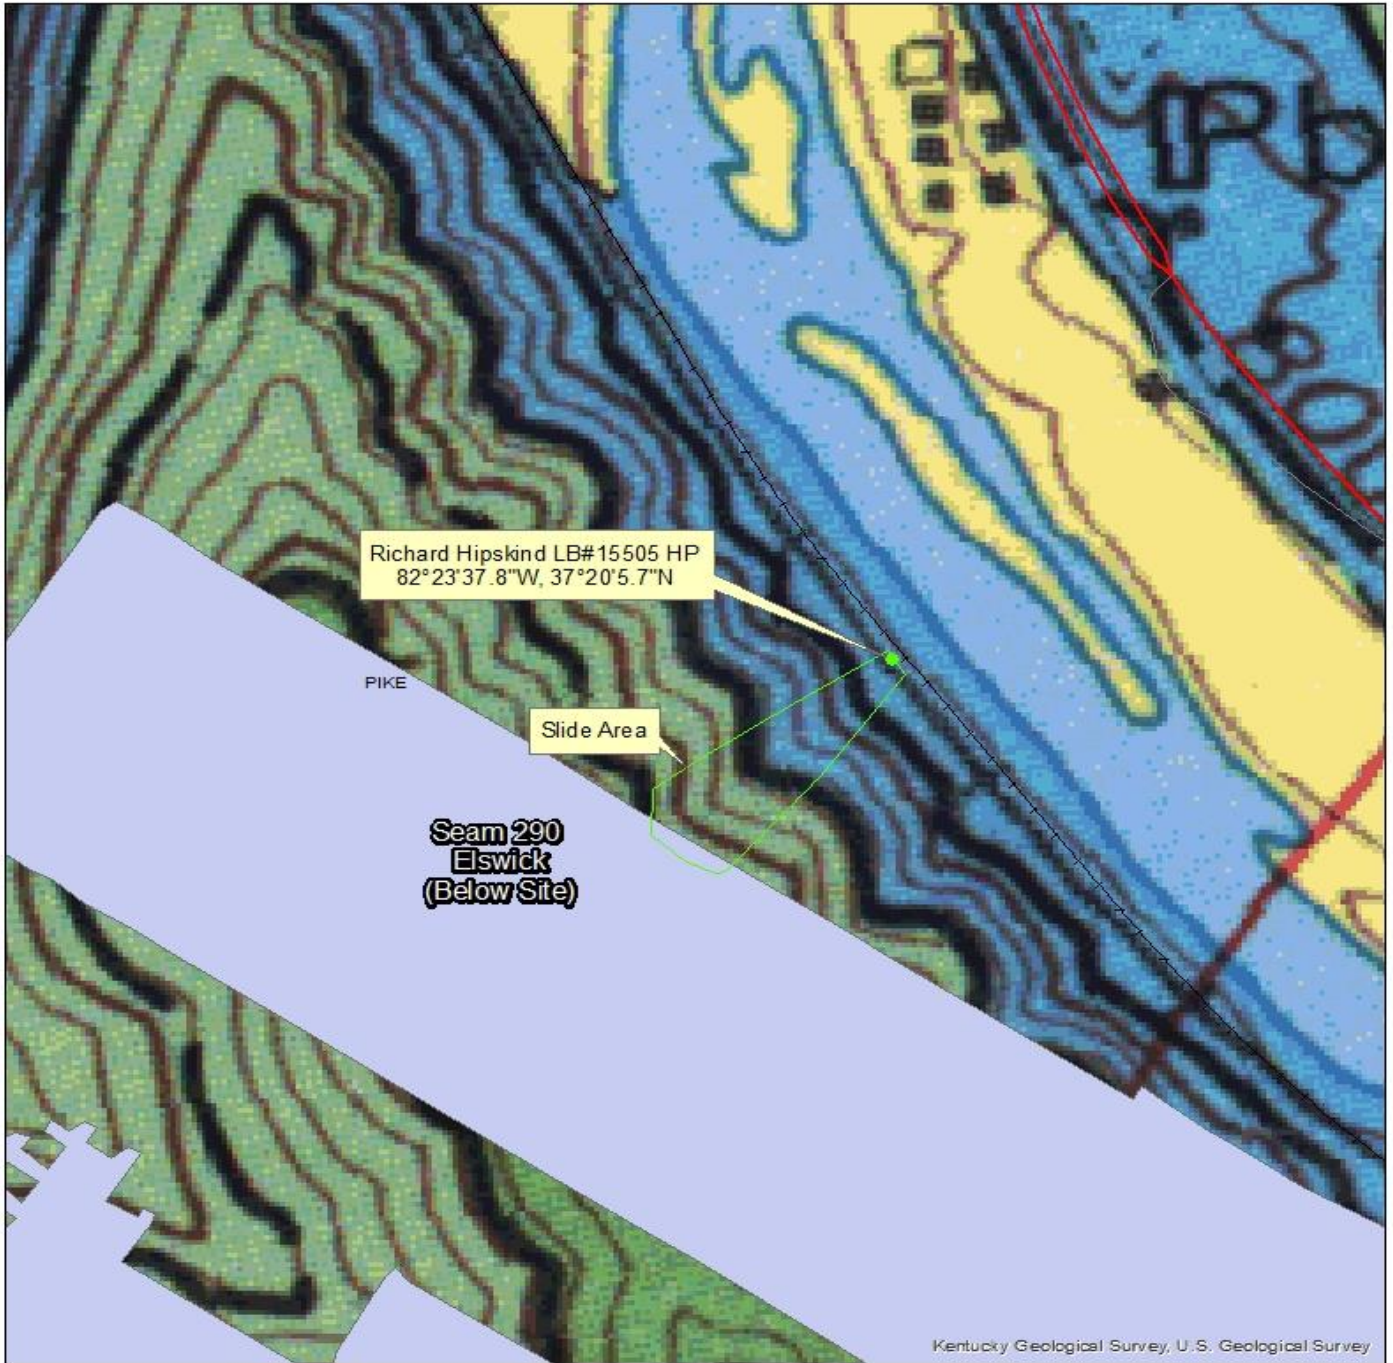
Mined Out Seams on
1971 USGS GQ Map

- No documented mining was found above the level of the railroad tracks.
- No surface disturbances were observed above the tracks when reviewing aerial imagery.
- The only documented mining in the immediate area is an underground mine in the Elswick coal seam which lies beneath the level of the slide and railroad tracks. This mine was in operation in the 1990's.

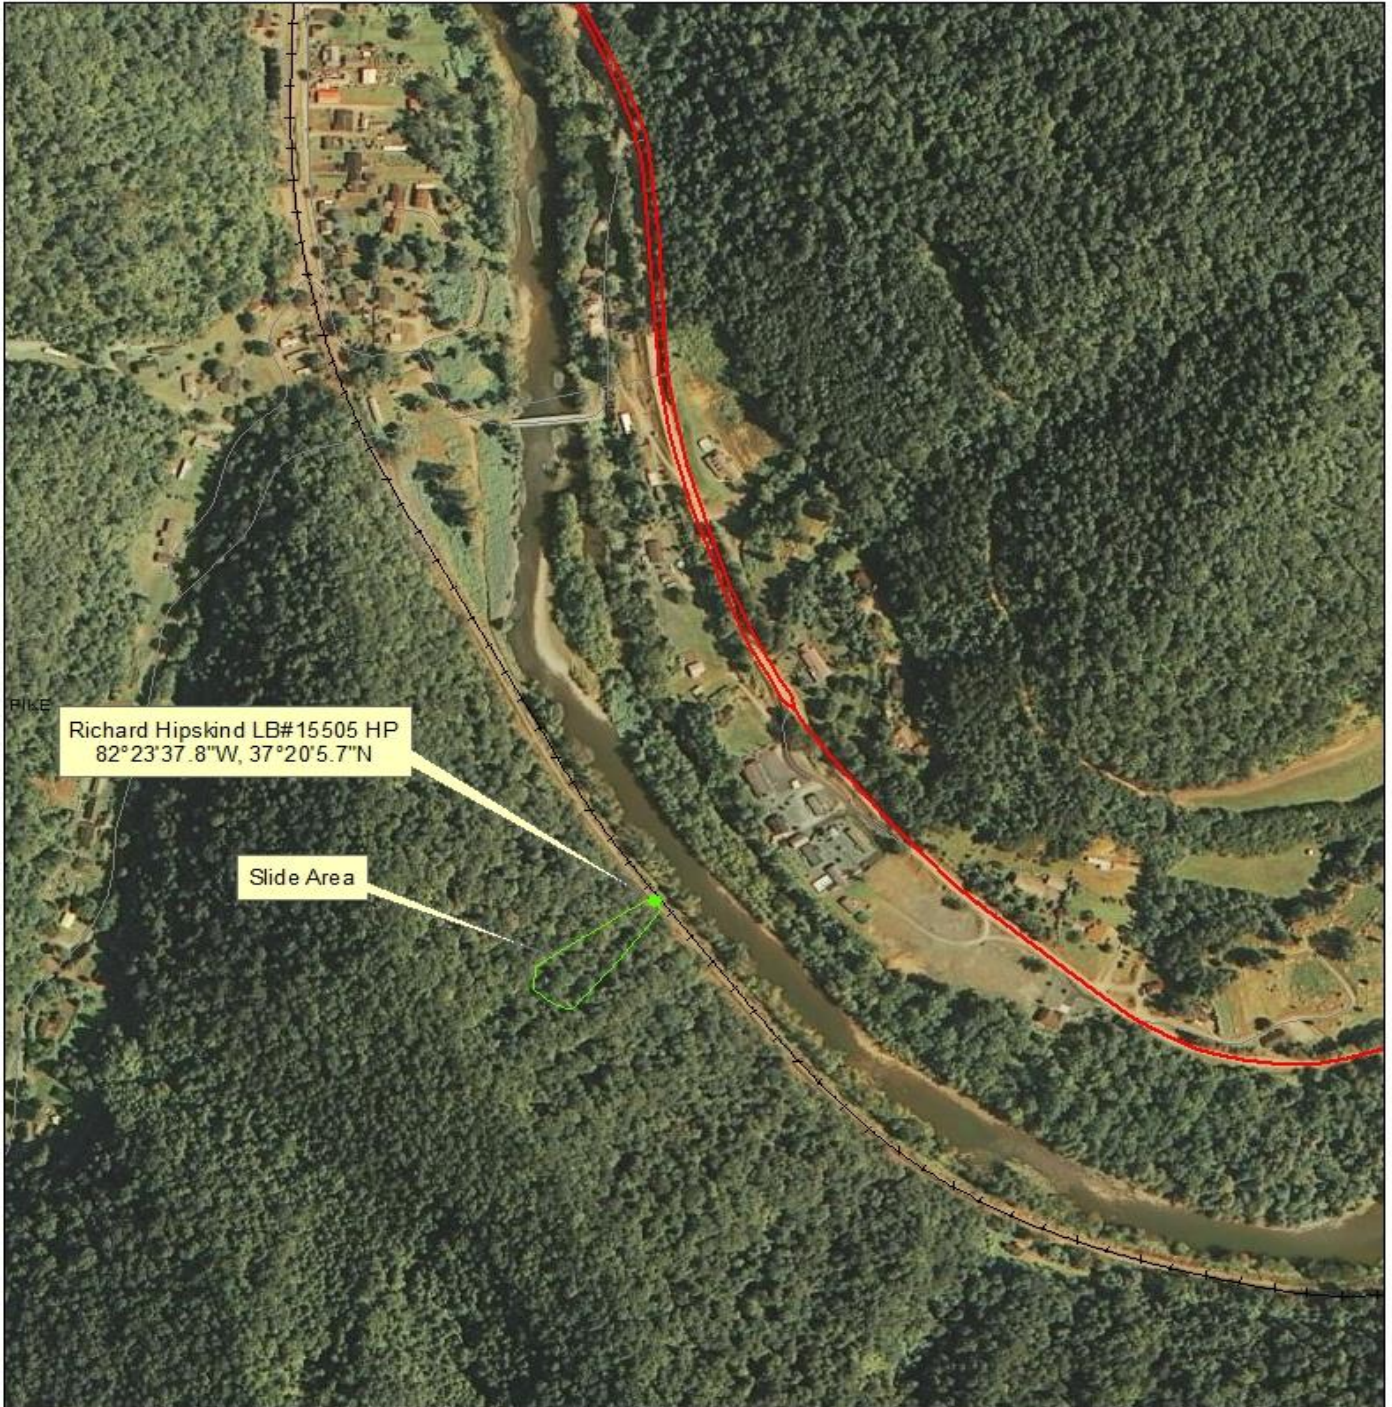
2006 Aerial

KY Trans. 1980's Aerial: <i>(9x9's in file room)</i>	No changes from 1976 on 1984 aerial.
DOQQ B&W Mosaic 1992-1999:	No disturbances on the 1995 aerial.
DOQQ B&W Mosaic 2001-2002:	No observed change.
FSA Color Imagery 2004:	No observed change.
FSA Color Imagery 2006:	No observed change.
FSA Color Imagery 2008:	No observed change.
FSA Color Imagery 2010:	No observed change.
FSA Color Imagery 2012:	No observed change.
FSA Color Imagery 2014:	No observed change.
FSA Color Imagery 2016:	No observed change.
ESRI World Imagery:	No observed change.
FSA Color Imagery 2018:	No observed change.
