MATERIALS EVALUATION REPORT

20FAE-033-PR

**METALLURGICAL INVESTIGATION OF A
 P_C SCROLL TO P_C FILTER TUBE
 ASSEMBLY, P/N 23065814, INSTALLED IN
 AN M250-C30P ENGINE, S/N CAE895054,
 OPERATED BY AIR EVAC EMS INC**

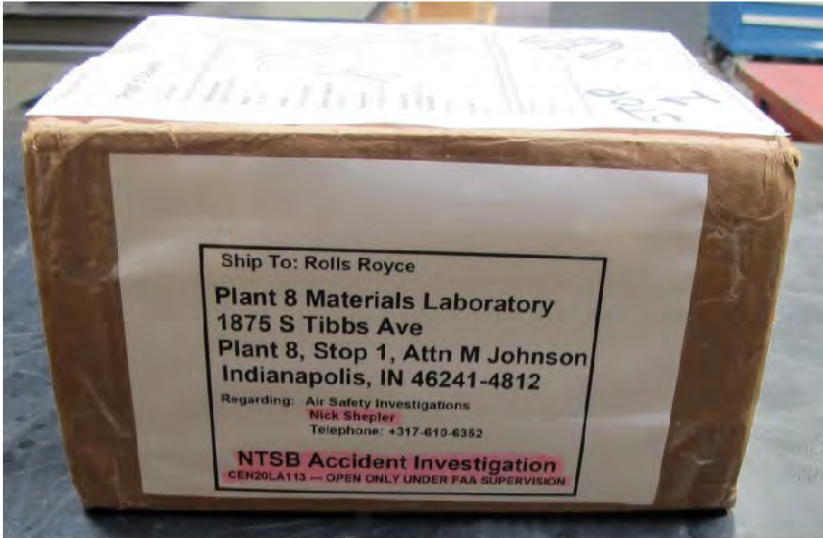
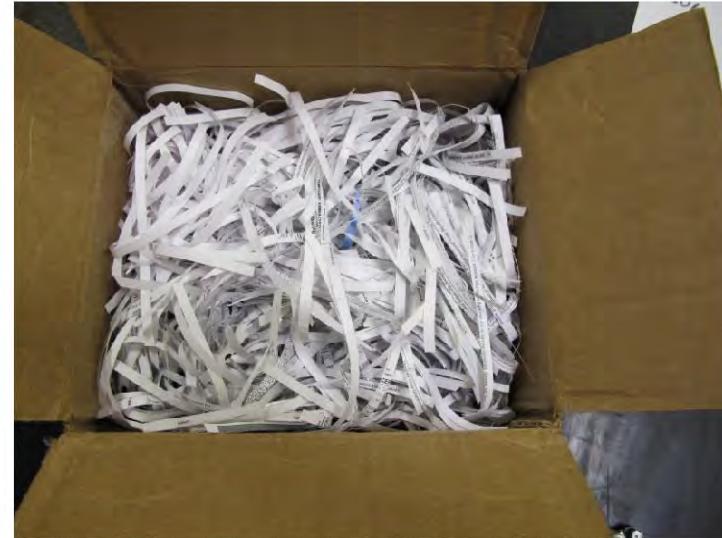
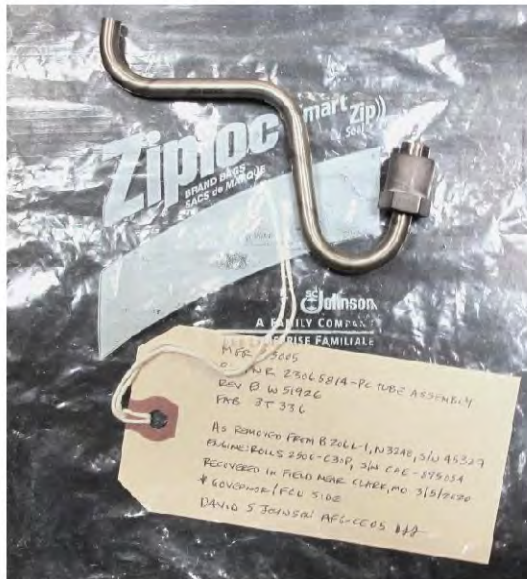
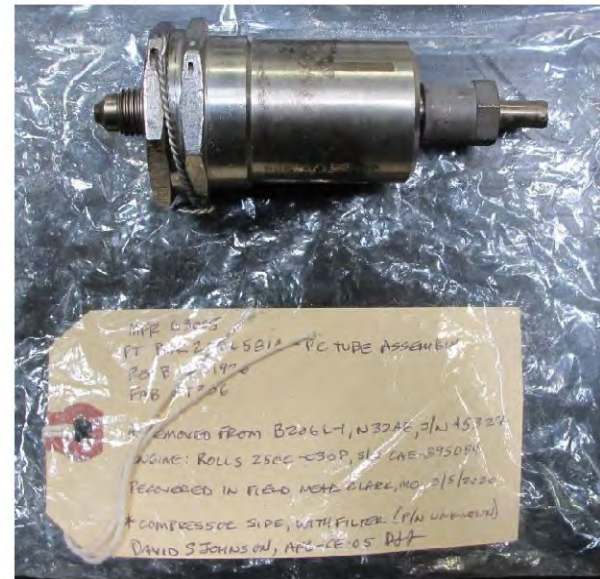
The Rolls-Royce Air Safety Investigator was present for the unboxing of the engine hardware, shown in Figure 2. The box contained two bags, one containing most of the tube assembly and the other containing the welded fitting at the end of the tube assembly and the affixed air filter.

Figure 2. Shipping container (top) and the fractured tube (bottom left) and filter with remainder of tube still attached (bottom right) as received to the laboratory and removed from the packaging. No scale provided.

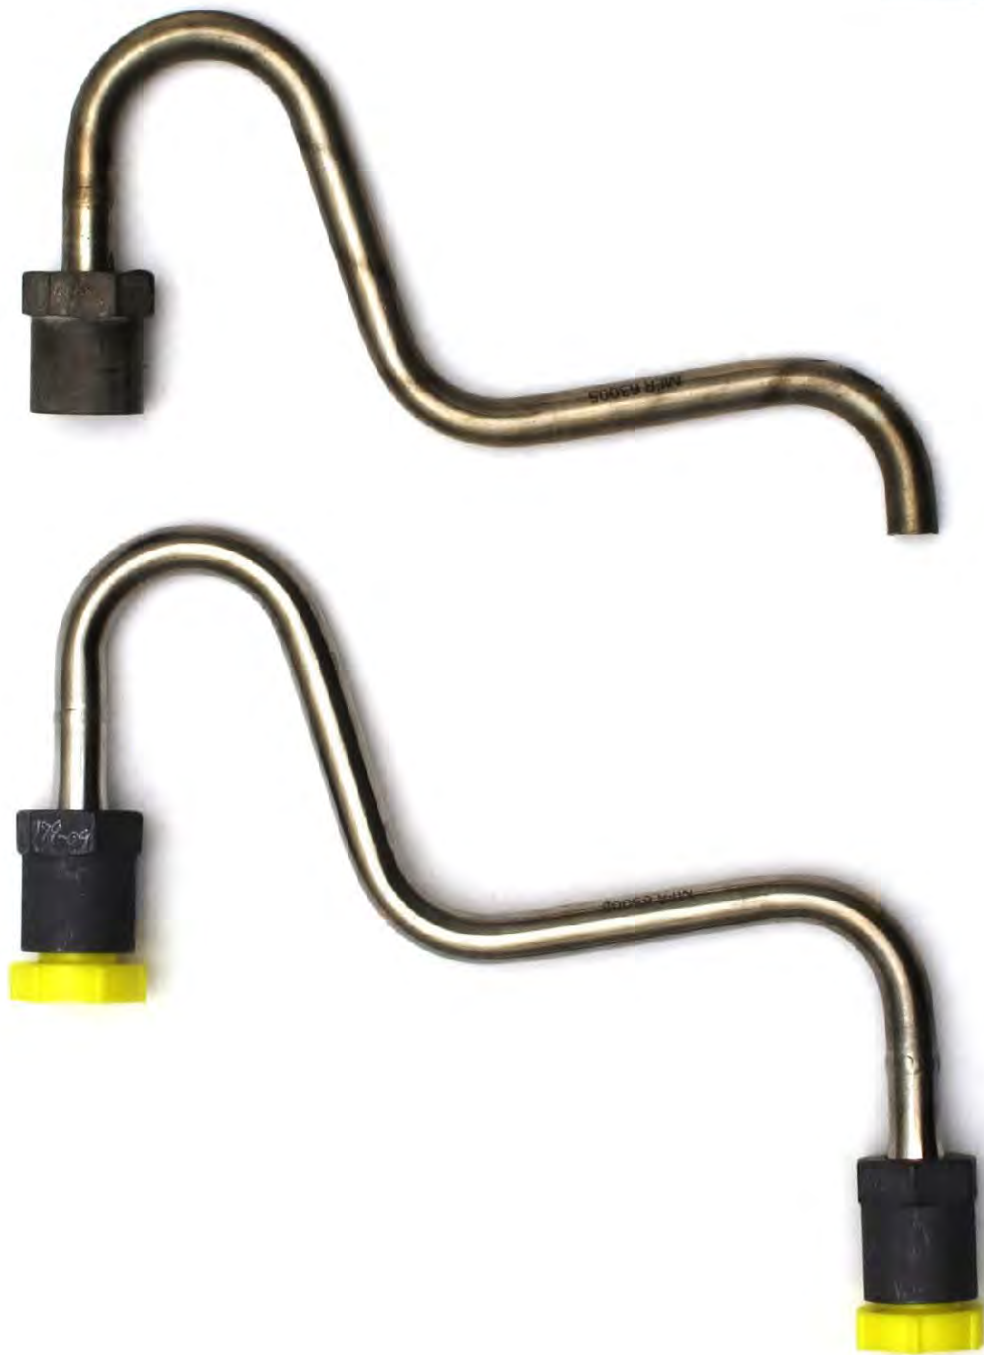
The as-received condition of the fractured tube (except for the fitting end on the opposite side of the fracture) is shown in Figure 3. The tube fractured and separated at the weld adjacent to the air filter fitting. The fractured tube was compared to a newly manufactured tube, Figure 4, which did not reveal any obvious discrepancies in shape or dimension between the tubes. On the outer radius of the bend near the fracture surface, the event tube exhibited a flat spot surrounded by scuffing and patchy dark discoloration as shown in Figure 5. Detailed inspection of the area revealed several adjacent parallel oval-shaped dark patches near the flat spot as shown in Figure 6. The major dimension of the dark patches decreased in size progressing away from the flat spot. Both the flat spot and the oval-shaped dark patches were subjected to confocal laser scanning microscopy (CLSM). Figure 7 illustrates the flattened surface in the flat spot. CLSM revealed that the parallel adjacent oval-shaped dark patches were grooves in the surface of the tube measuring up to 0.0012 inch deep as shown in Figure 8.

Figure 4. Comparison image showing the fracture tube (top) laid adjacent to a newly manufactured tube (bottom). There were no obvious discrepancies in the shape or dimensions between both tubes.

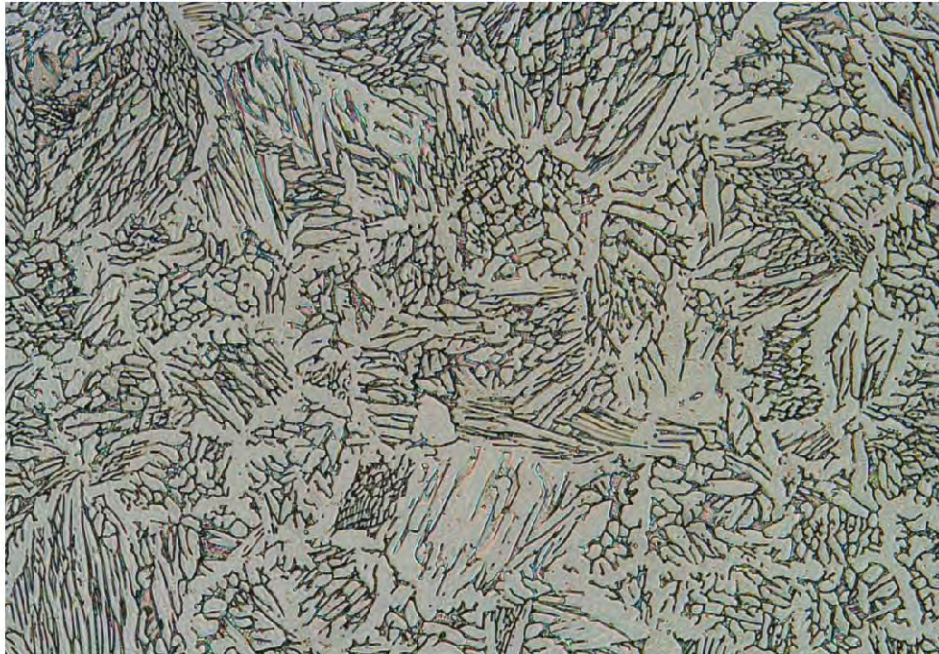
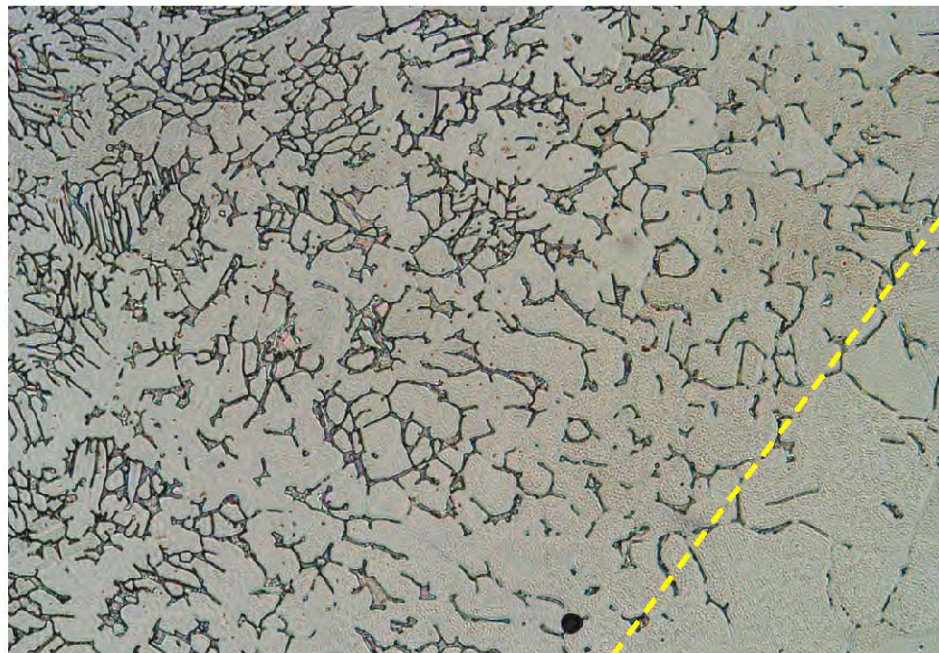
Detailed views showing the weld, HAZ, and base metal microstructures are shown in Figure 25 and Figure 26. The weld and base metal microstructures were both consistent with the materials required by the component definition. It could not be determined from the microstructure or EDS results whether the weld was integral or contained weld rod material, which is optional per the component definition.

Figure 25. Detailed views showing the weld metal (above yellow dashed line) and HAZ (below yellow dashed line) microstructures found on the tube weld. Etchant: Stainless No. 2.

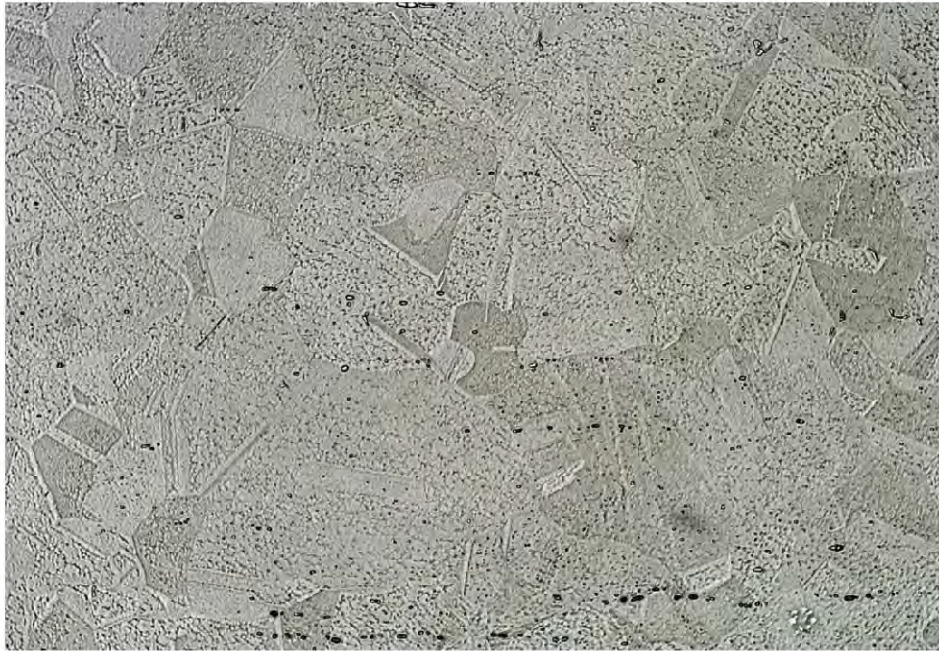
Figure 26. Detailed view showing the base metal microstructure. Etchant: Stainless No. 2.

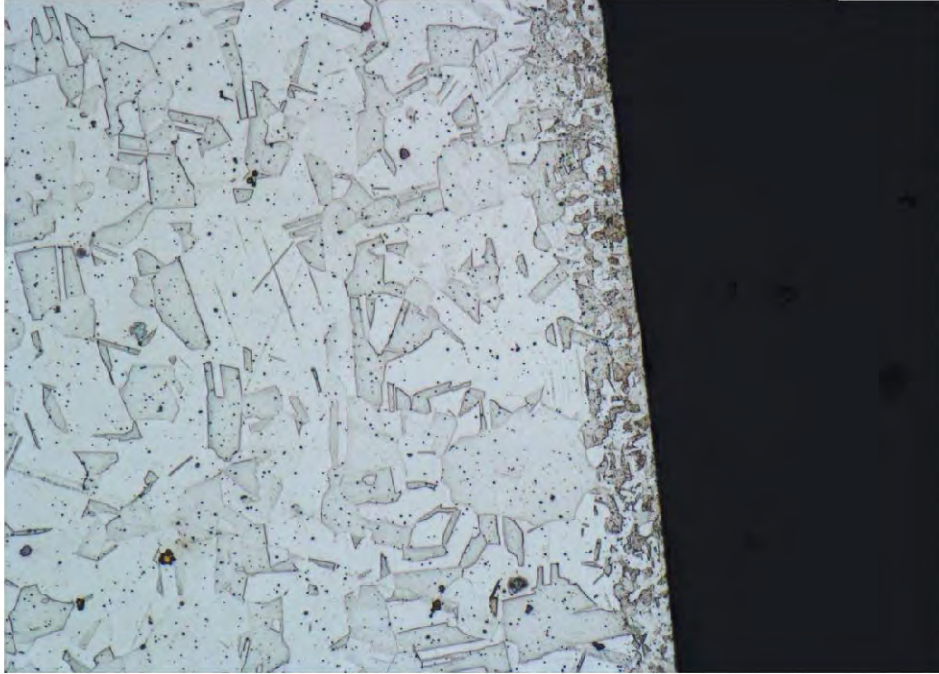
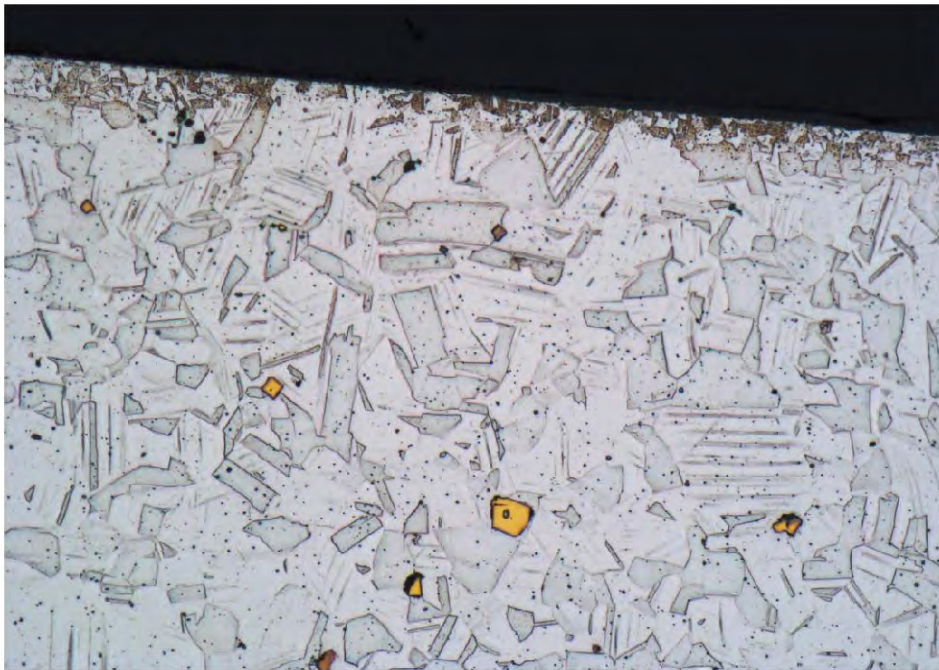
The mount was polished to plane 2 (Figure 6) and the resultant cross-section is shown in Figure 31. This section contained both the flat spot and the adjacent parallel grooves. In this plane of examination, the flat spot did not have any curvature, and there was no corresponding deformation on the inner diameter surface opposite either the flat spot or the grooves. The microstructure and oxide on the flat spot surface in this plane of examination was similar to that found in plane 1. A detailed view of the cross-section at the parallel grooves is shown in Figure 32, which revealed some oxides on the surface and some distortion of the microstructure when compared to the representative surface microstructures shown in Figure 30.

Figure 30. Detailed views showing representative surface microstructure away from the flattened area on plane 1. Etchant: Stainless No. 2.
