Accident / Incident Report

Report No.: 21-128

**Antonio L. Elias
Piper PA 46-500TP, N31062
Manteo, North Carolina, USA
July 6, 2021
PT6A-42A, RM0227**

**NTSB: ERA21LA287
TSB Identification: A21F0093
P&WC File No.: 21-128
RFA No.: 21SIE00236**

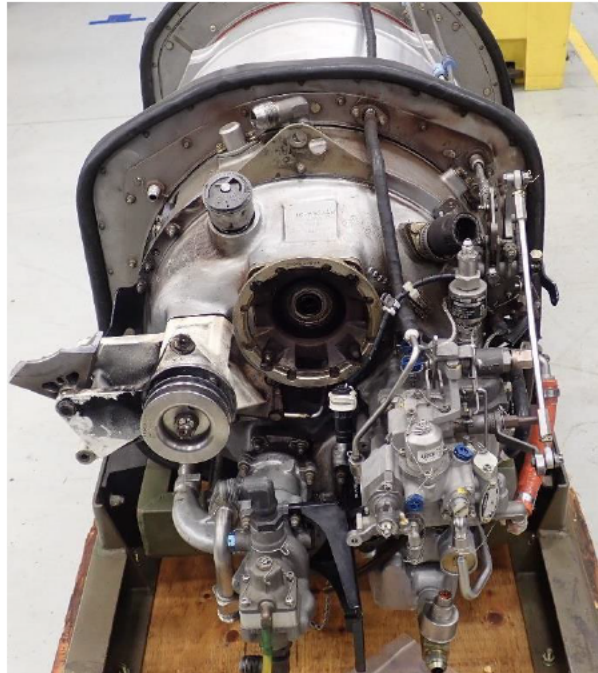
Photo No. 4, view of the rear of the engine

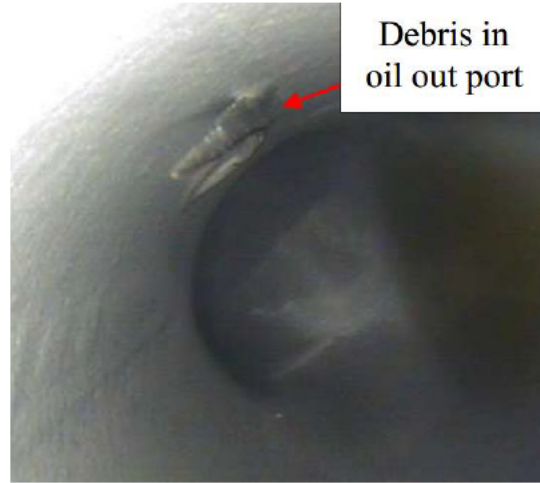
Photo No. 52

The FOHE was forwarded to the manufacturer for additional functional testing and investigation. The unit passed the oil bypass valve function tests. The slivers of debris that were collected were forwarded to the manufacturer for analysis. The thermal element was removed, and slivers were present on the bypass valve sleeve (Ref. Photo No. 49). The outside diameter of the oil bypass valve exhibited scuff marks (Ref. Photo No. 50). A Borescope inspection revealed that slivers of debris were present further down in the oil out port and in the FOHE core, when viewed from the drain port (Ref. Photos No. 51 & 52).

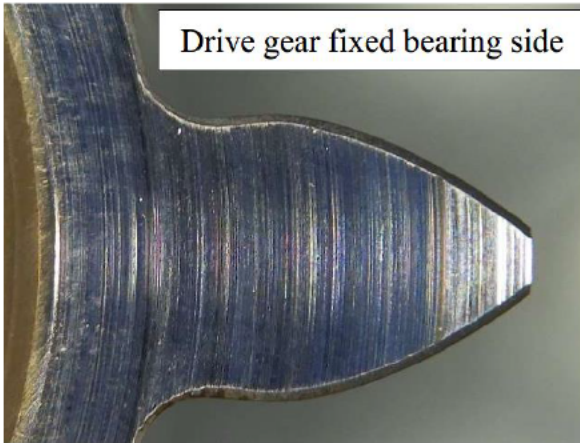
Photo No. 56

The pump was disassembled. The two drive side bearings and the driven side fixed bearing exhibited scoring marks on the face mating with the gears (Ref. Photos No. 54 & 55). The two drive side bearings showed some localized darkened area with the presence of scoring (Ref. Photos No. 54 & 55). A step groove was present in the fixed driven bearing from contact with the drive gear, as well as a step groove in the drive floating bearing from contact with the drive gear (Ref. Photos No. 54 & 55). The outside diameters of the two pressurized bearings displayed discoloration (Ref. Photo No. 56). The drive gear faces mating with the bearings were scored (Ref. Photos No. 57 & 58). Localized brown-blueish coloration was observed on the drive gear, as well as a circumferential scoring mark on the pressurized bearing side of the gear journal (Ref. Photos No. 58, red arrows & 59).

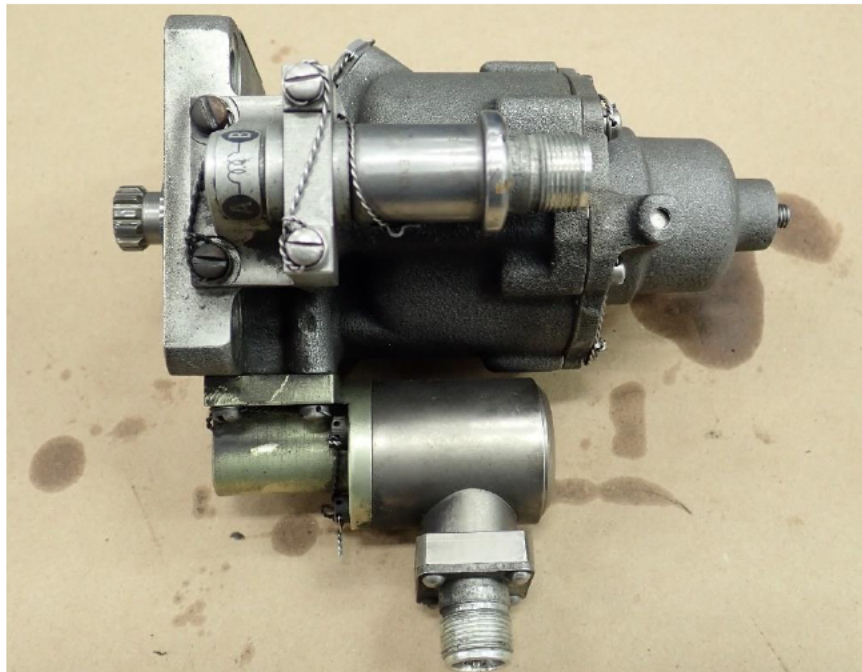
Photo No. 65

Overspeed Governor (OSG): The overspeed governor was in place and secured to its respective mounting pad on the reduction gearbox (Ref. Photo No. 65). The overspeed governor was forwarded to P&WC's Accessories Investigation and the manufacturer for functional testing and investigation. The manufacture testing showed some deviations that were related to field adjustments. The unit was re-calibrated within the manufacture's CMM requirements.

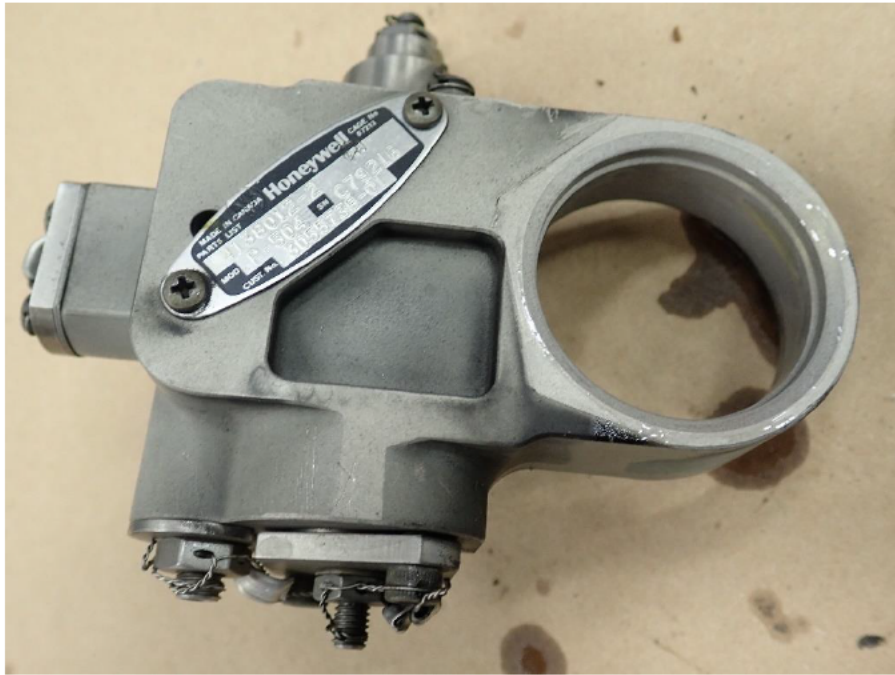
Photo No. 66

Torque Control Unit (TCU): The torque limiter was in place and secured to its respective mounting pad on the reduction gearbox (Ref. Photo No. 66). The torque limiter was forwarded to P&WC's Accessories Investigation for functional testing. The limiter was satisfactorily tested in accordance with the manufacture's CMM.
