# National Transportation Safety Board

## **MATERIALS LABORATORY**

Factual Report 22-038

On March 11, 2022, the Woodpat pipeline, a 22-inch-diameter hazardous liquids pipeline operated by Marathon Pipe Line, LLC (Marathon), ruptured in Edwardsville, IL. About 3500 barrels of crude oil were released, some of which entered Cahokia Creek, a tributary of the Mississippi River. No injuries occurred, and the crude oil did not ignite.

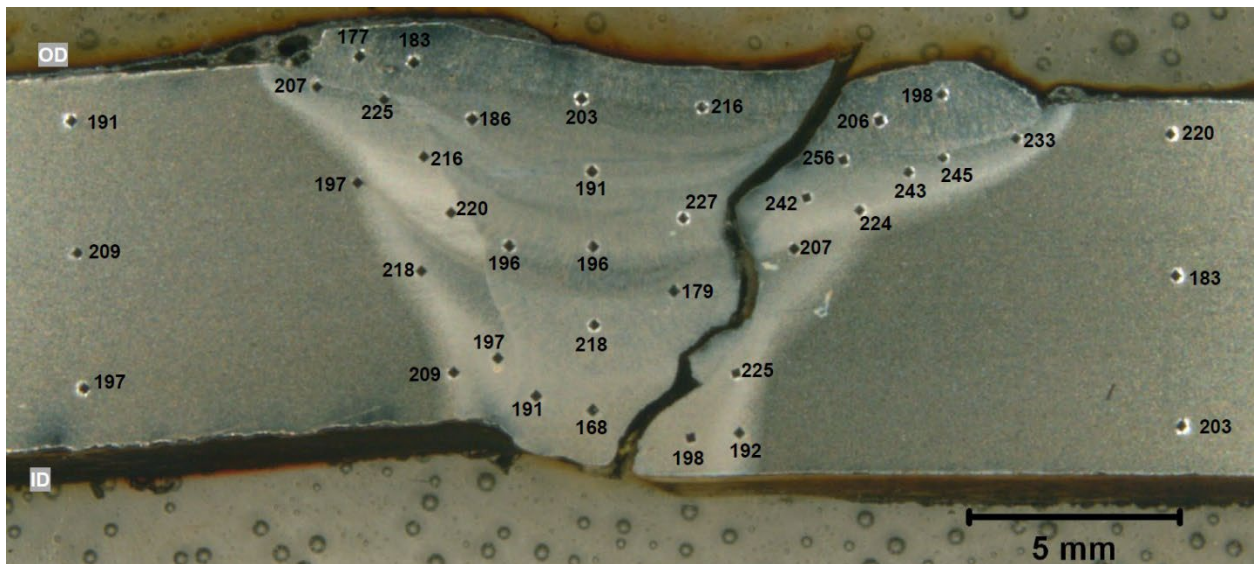
Figure 24. Bright-field (BF) optical micrograph of a cross-section through location M1\_5b, showing Vickers hardness indents and their respective hardness data (etched, 2% Nital), showing hardness values from 168 HV to 256 HV.

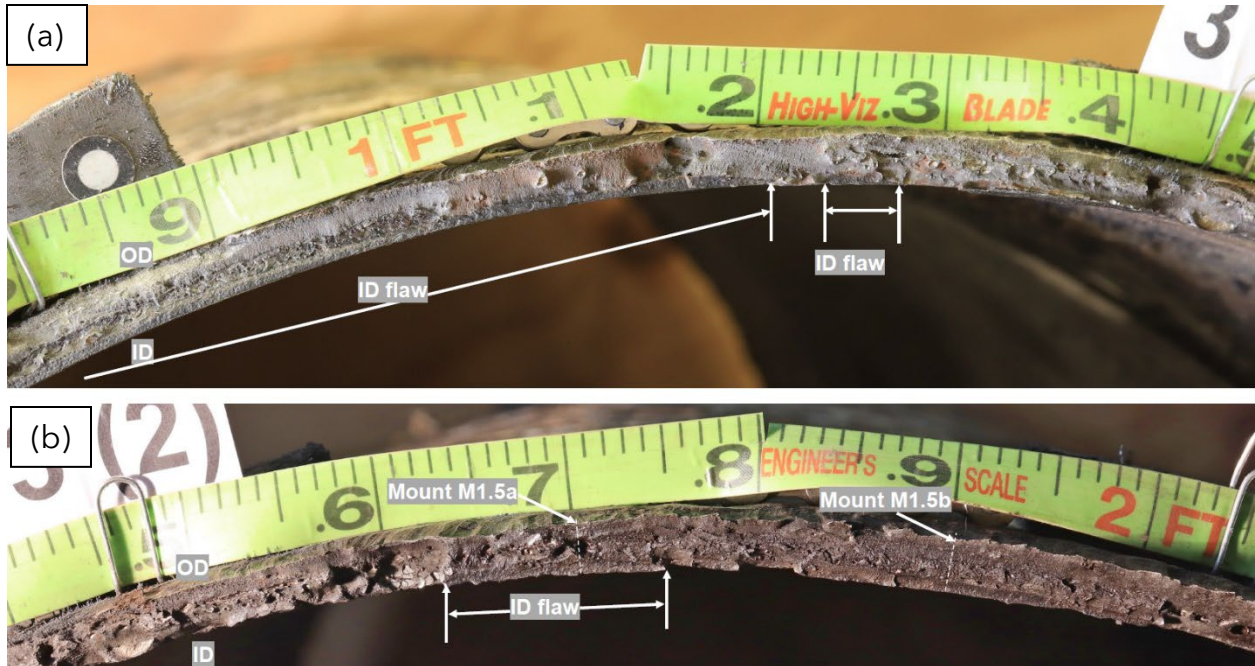
Figure 29. Closer views of Figure 27 and Figure 28, annotated to show (a) counterclockwise of 3 o'clock and two inner diameter flaws and (b) clockwise of 3 o'clock, showing a ID flaw and the location of two metallographic cross sections.

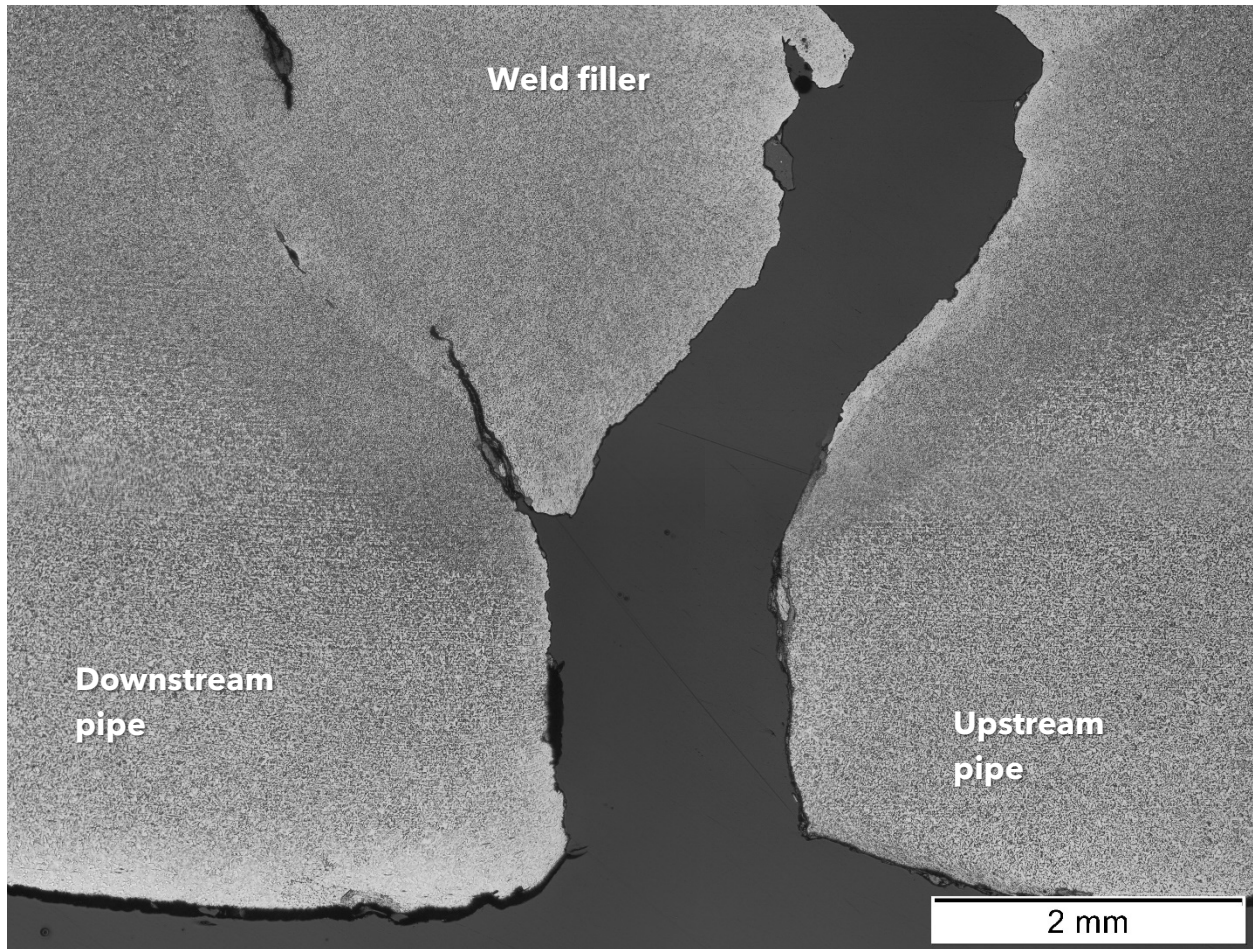
Figure 38. BF optical micrograph of the inner diameter portion of the fracture at M0\_6b (~25X, etched 2% Nital)

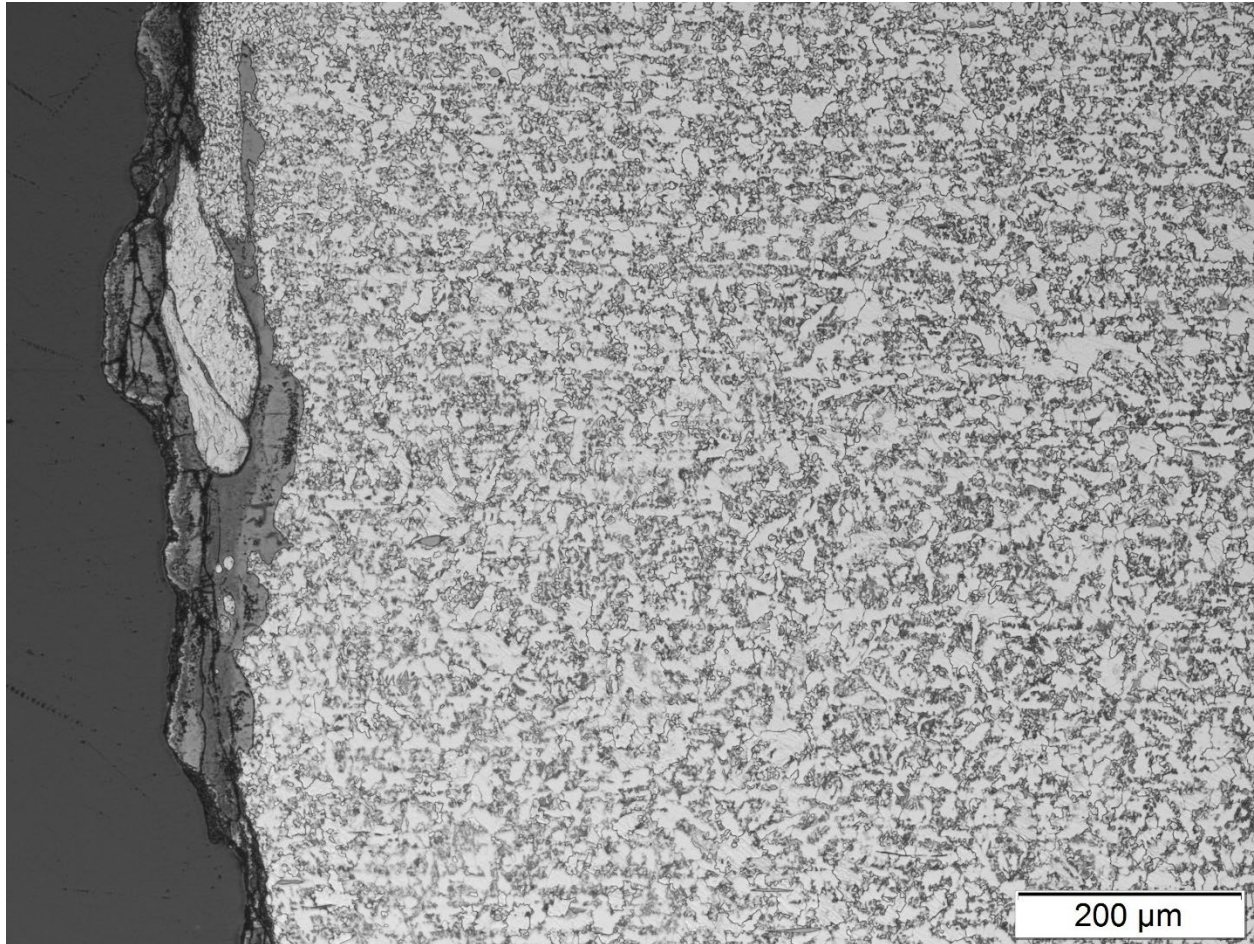
There was also a change in contrast around the area, consistent with microstructural changes from welding. Figure 39 shows an area near the crack face. The microstructure consisted of a ferrite/pearlite mixture oriented linearly in the longitudinal pipe direction. The fracture surface on the figure's left exhibited undulating nonmetallic layers, consistent with surface oxidation. Figure 40 shows the difference in the weld filler metal and the heat-affected base metal, with the base metal exhibiting more carbon-rich phases, consistent with its higher carbon content. This oxide layer on the fracture face was inconsistent with the nonmetallic material near the weld (Figure 41, from the upper left in Figure 38). This nonmetallic material exhibited a dendritic structure, indicating that it has solidified from a molten condition. These features were consistent with slag formed during welding.

Figure 39. BF optical micrograph of the crack face on the right on M0\_6b from Figure 38, near the ID, showing surface oxide (~100X, etched 2% Nital).

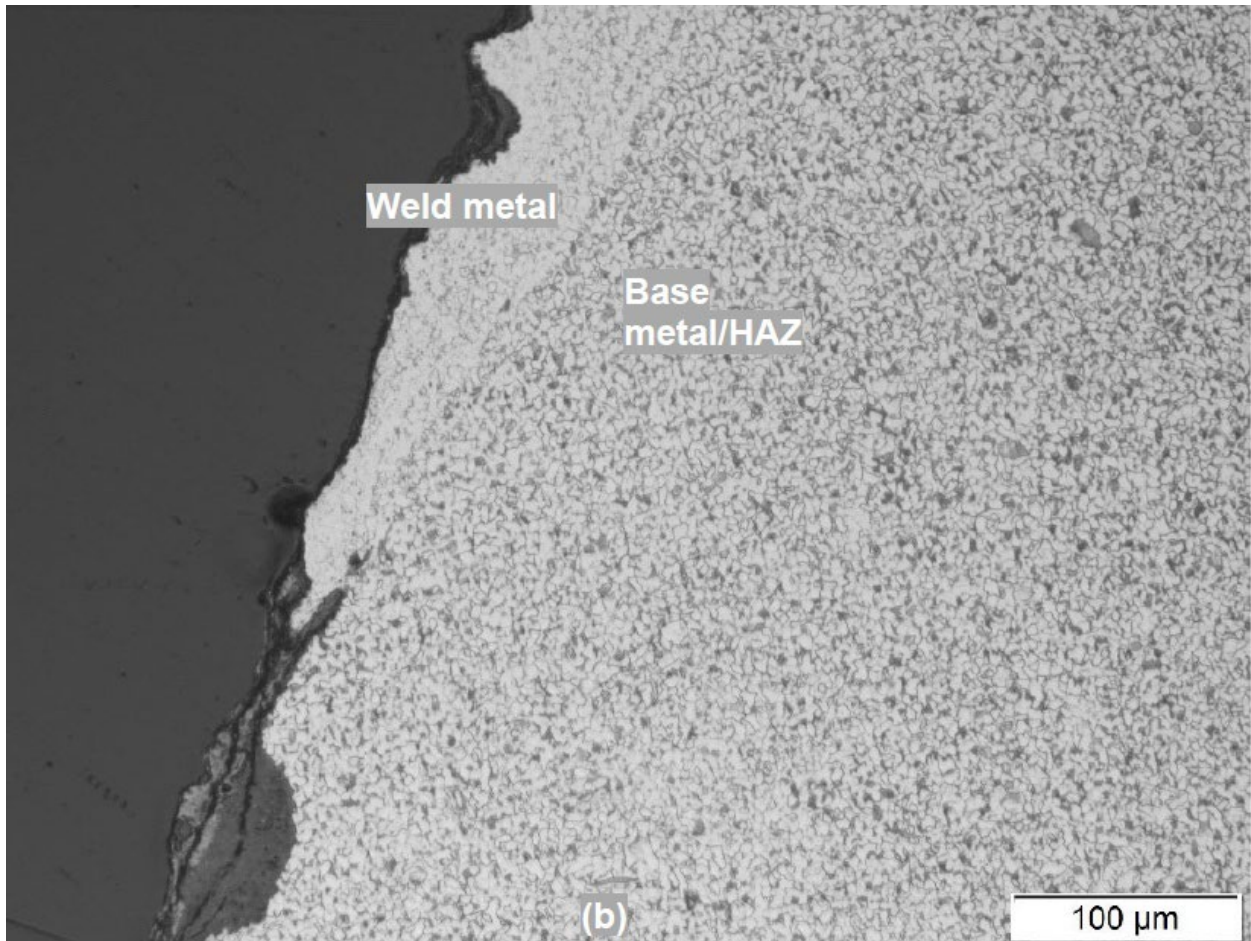
Figure 40. BF optical micrograph of the area above that in Figure 39, showing the delineation between the weld metal and the heat-affected zone of the base metal (~100X, etched 2% Nital).

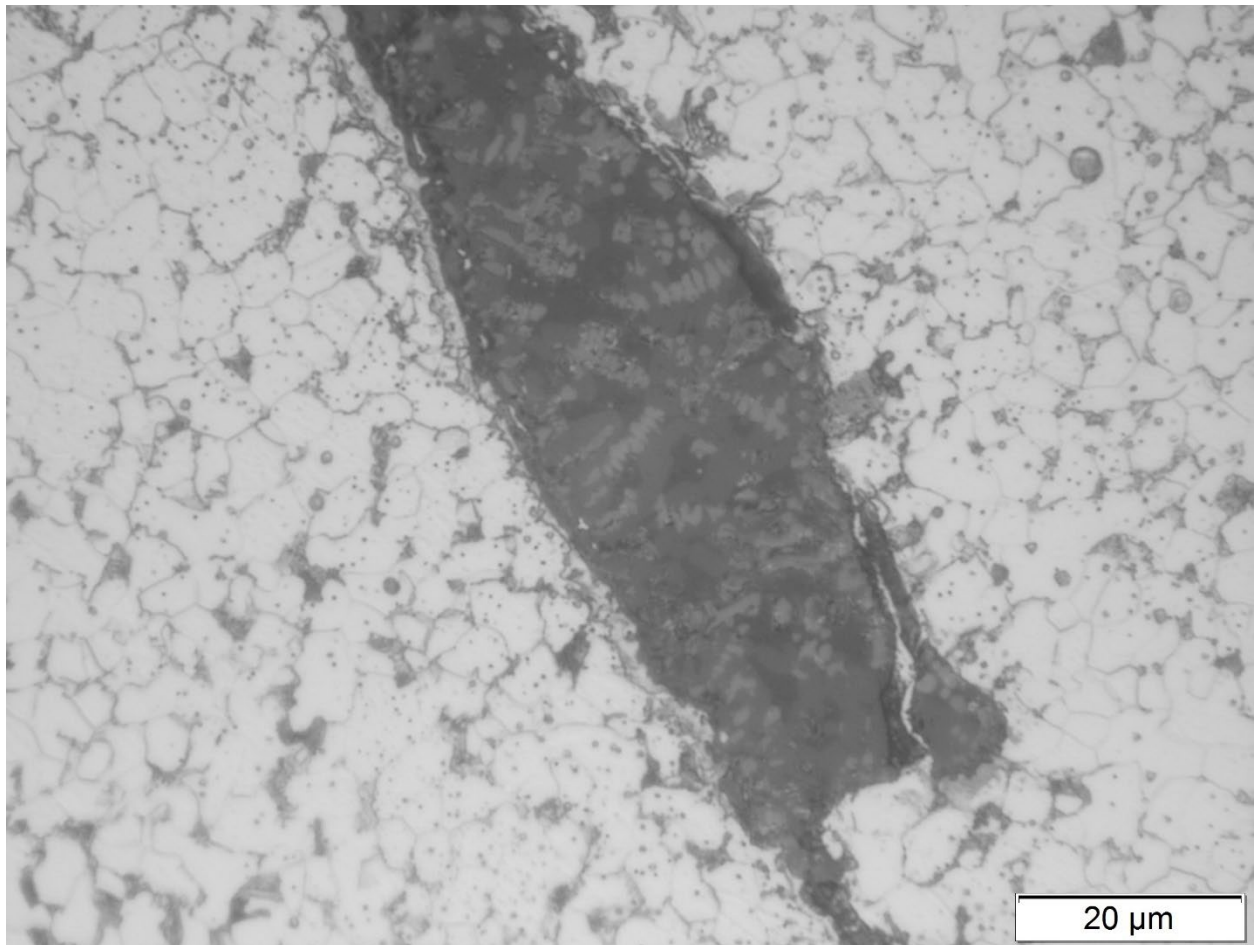
Figure 41. BF optical micrograph of an area of oxide near the weld in M0\_6b, showing a dendritic structure (~400X, etched 2% Nital).

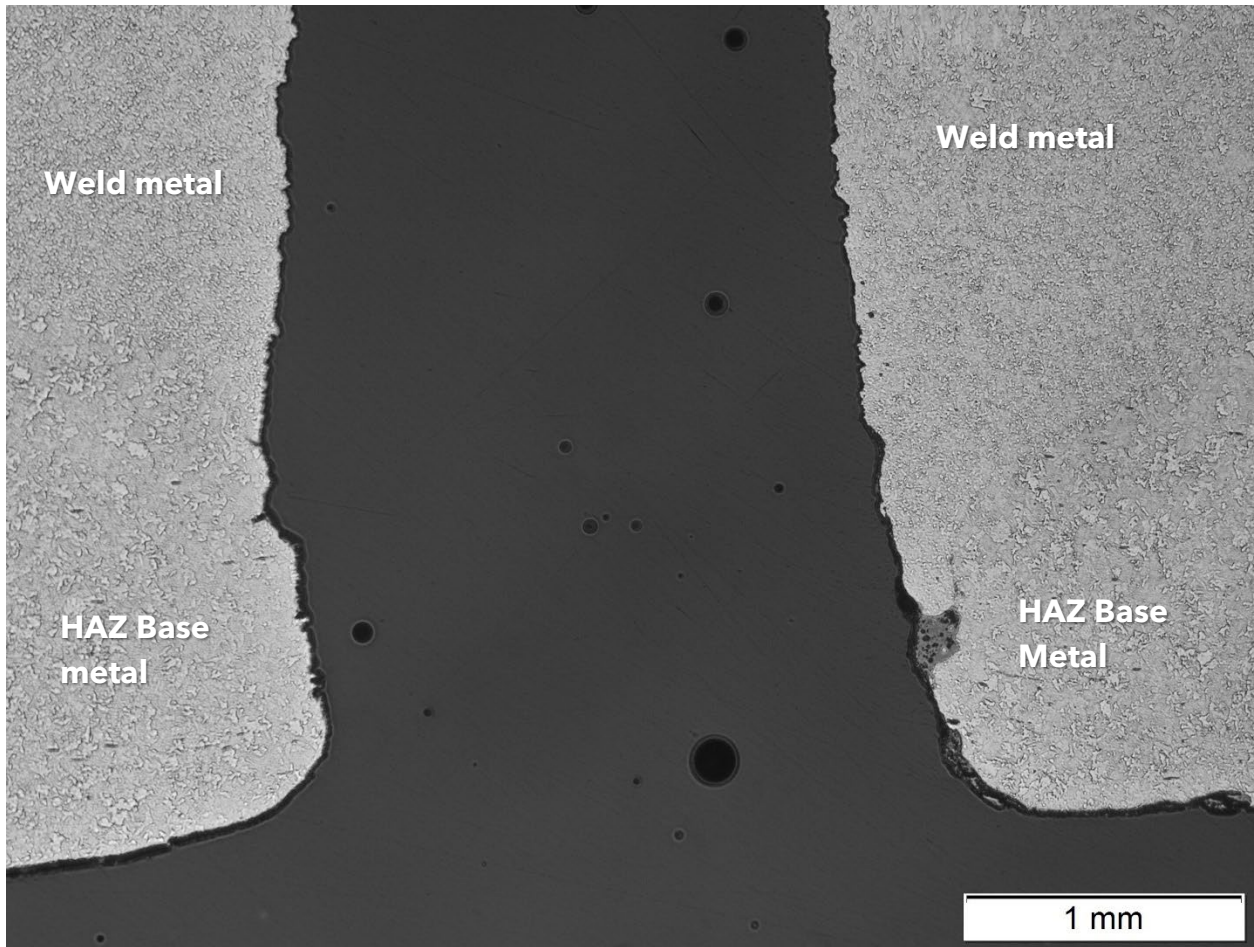
Figure 42 shows a cross-section of the fractured weld at M0\_6c, located just clockwise of the seam weld shown in Figure 3. This fracture completely bisected the weld filler, with a perpendicular orientation near the inner surface (figure bottom) and a curved, angled direction along the outer weld bead. Figure 43 shows the fracture on the inner side of the pipeline. This side of the fracture exhibited nonmetallic material along part of the surface closest toward the inner surface. This oxide was not layered but rather blocky and located at discontinuities in the metal surface.

Figure 43. BF optical micrograph of the inner diameter of the fracture in location M0\_6c (25X, etched 2% Nital).

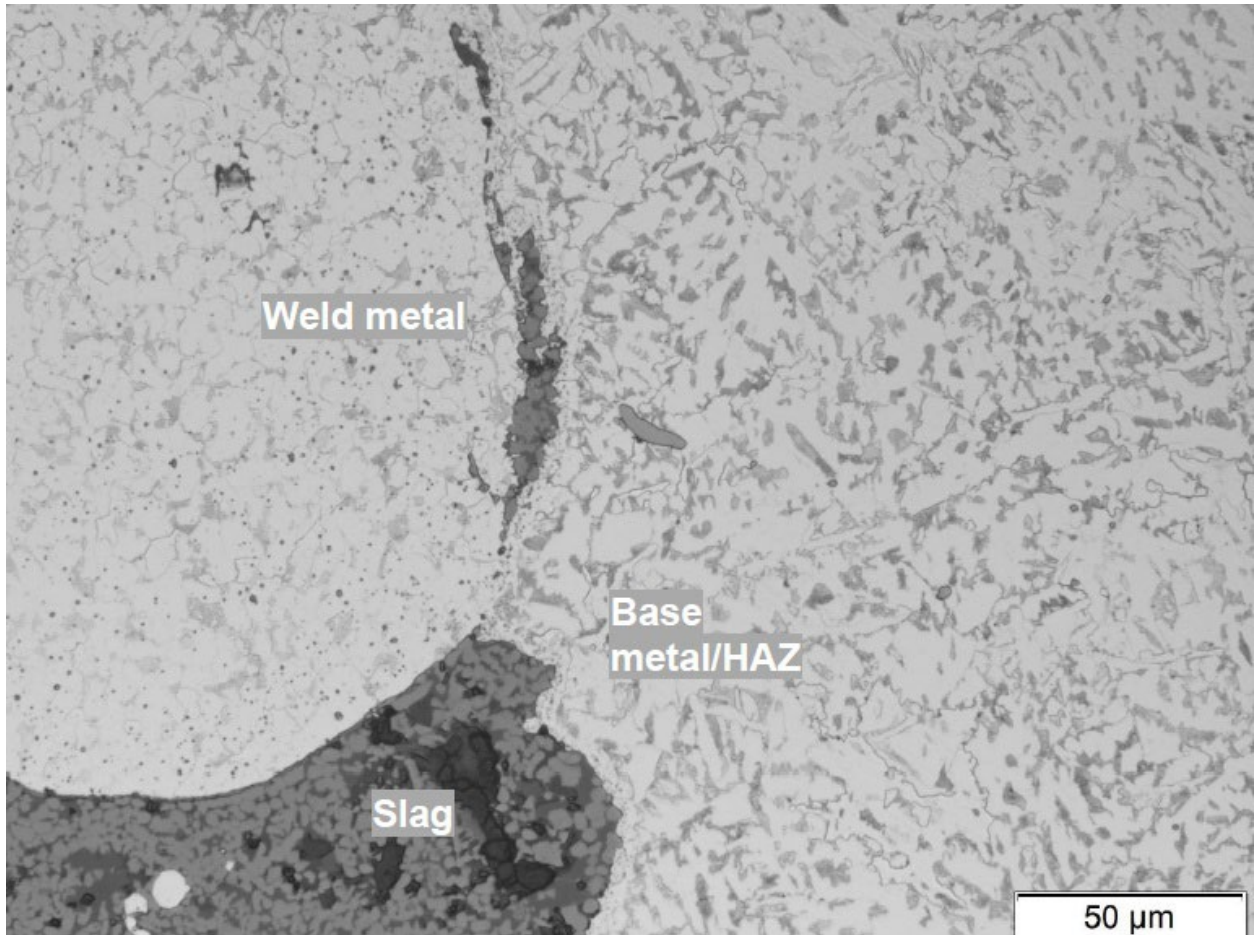
Figure 44 shows a closer view of these nonmetallic materials, annotated to show their depth from the inner surface. The larger blocky oxide in the figure was 717  $\mu\text{m}$  (0.028 in) from the surface, whereas the outermost oxide was found at 1.41 mm (0.056 in). Figure 45 shows a closer view of the oxide, exhibiting an alternating contrast consistent with a dendritic structure indicative of slag solidifying from the molten weld deposits. The slag manifest between the innermost weld bead and the base metal. These features were consistent with incomplete fusion at this location.

Figure 45. BF optical micrograph of the boxed area in Figure 44, showing the delineation between the weld and base metals, with intermediate slag (~500X, etched 2% Nital).

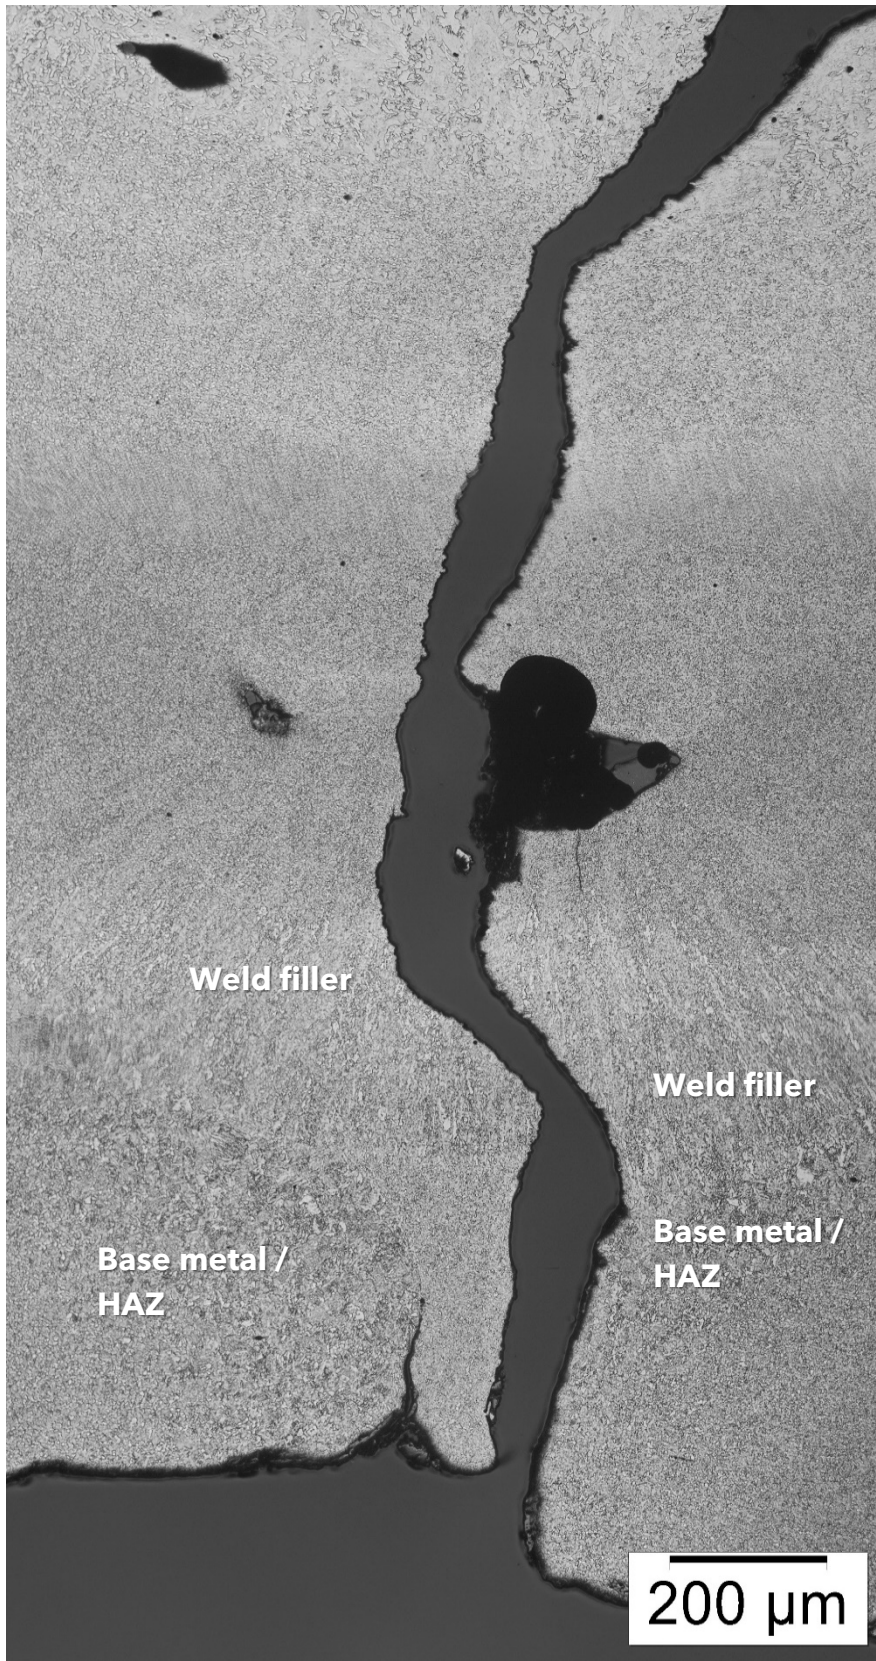
Figure 46 shows the fracture through weld location M1\_5a, denoted in Figure 4 near some detected undercut around the 4 o'clock position. This fracture morphology was more angled, perpendicular to the pipe circumferential direction toward the inner surface. Figure 47 shows this inner surface corner of the fracture, along with an internal triangular-shaped feature. Figure 48 shows a closer view of the interior corner of the fracture, exhibiting rounded laps from the welding process and vertical discontinuities consistent with cracking. The crack was present between weld passes and had emanated from a pit-like feature on the interior, which exhibited nonmetallic material. The fracture surface also revealed nonmetallic material on the surfaces near the inner pipe surface, most notably on the right mating side in Figure 48.

Figure 47. BF optical micrograph montage of the fracture through weld M1\_5A (~25X, etched 2% Nital).

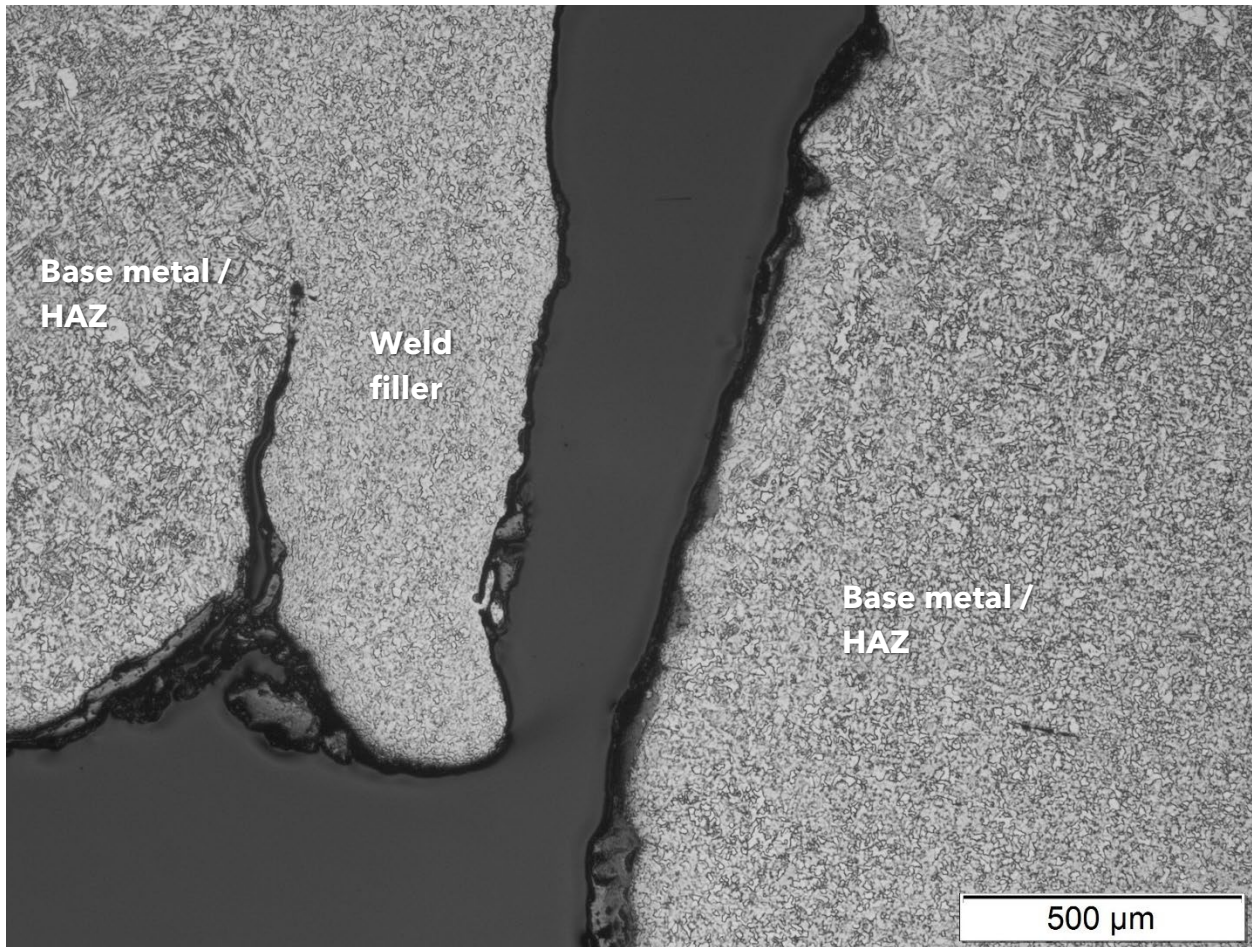
Figure 48. BF optical micrograph of weld laps and oxides on the inner diameter surface of weld M1\_5a (50X, etched 2% Nital).

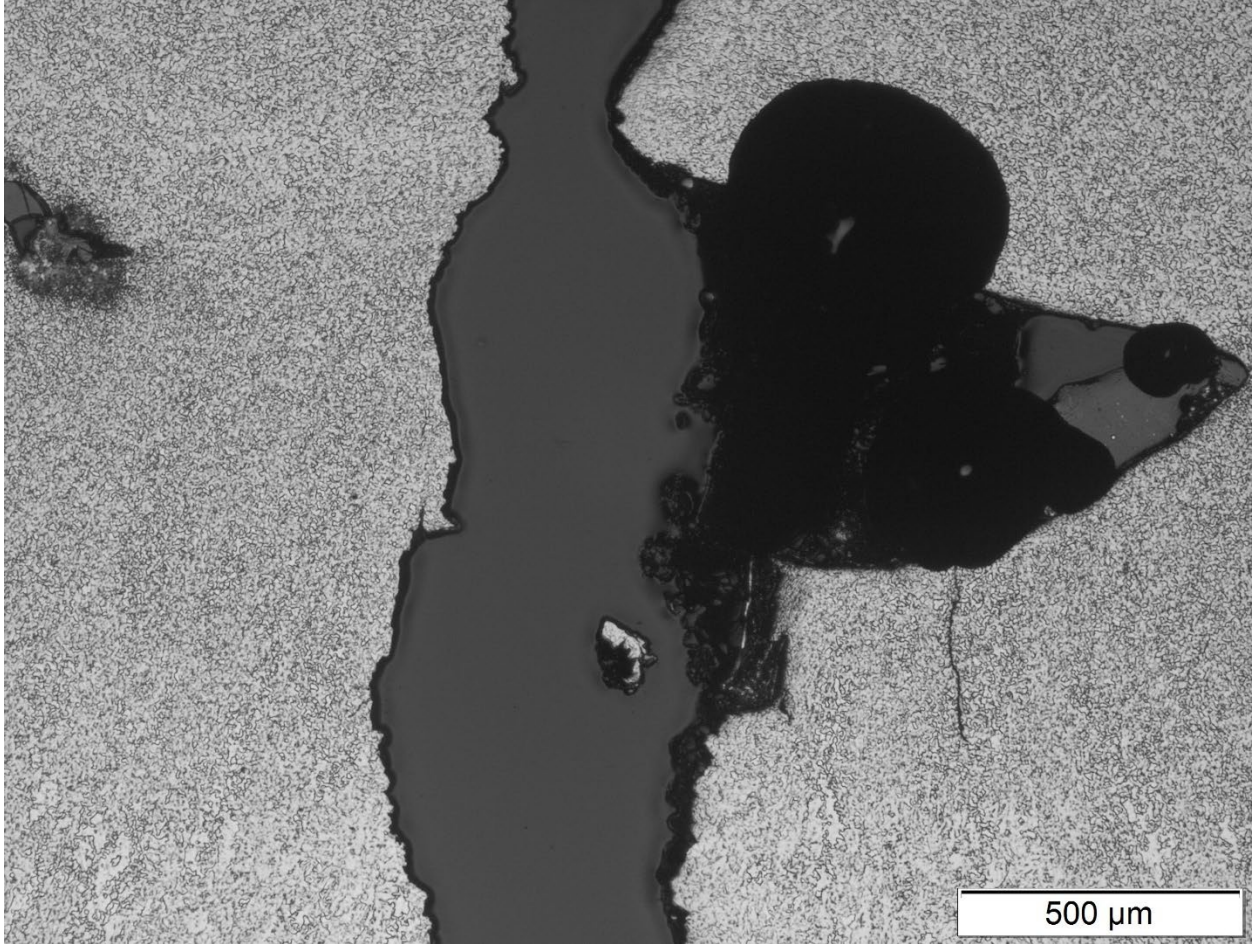
The internal feature in location M1\_5a is highlighted in Figure 49, showing its triangular and rounded compound shape. This feature exhibited black and dark gray areas consistent with void space and nonmetallic material, respectively. These features were consistent with porosity and nonmetallic slag that had formed during the welding process. Several cracks emanated from the void, as highlighted in Figure 50 the largest one. This crack had developed, growing inward in a transgranular manner. Figure 51 shows a closer view of the nonmetallic material, revealing a dendritic structure. This structure was consistent with solidification from a molten state, consistent with slag created during the welding process.

Figure 49. BF optical micrograph of the void and oxide in the center of the cross section inside the weld filler from Figure 47 (50X, etched 2% Nital).

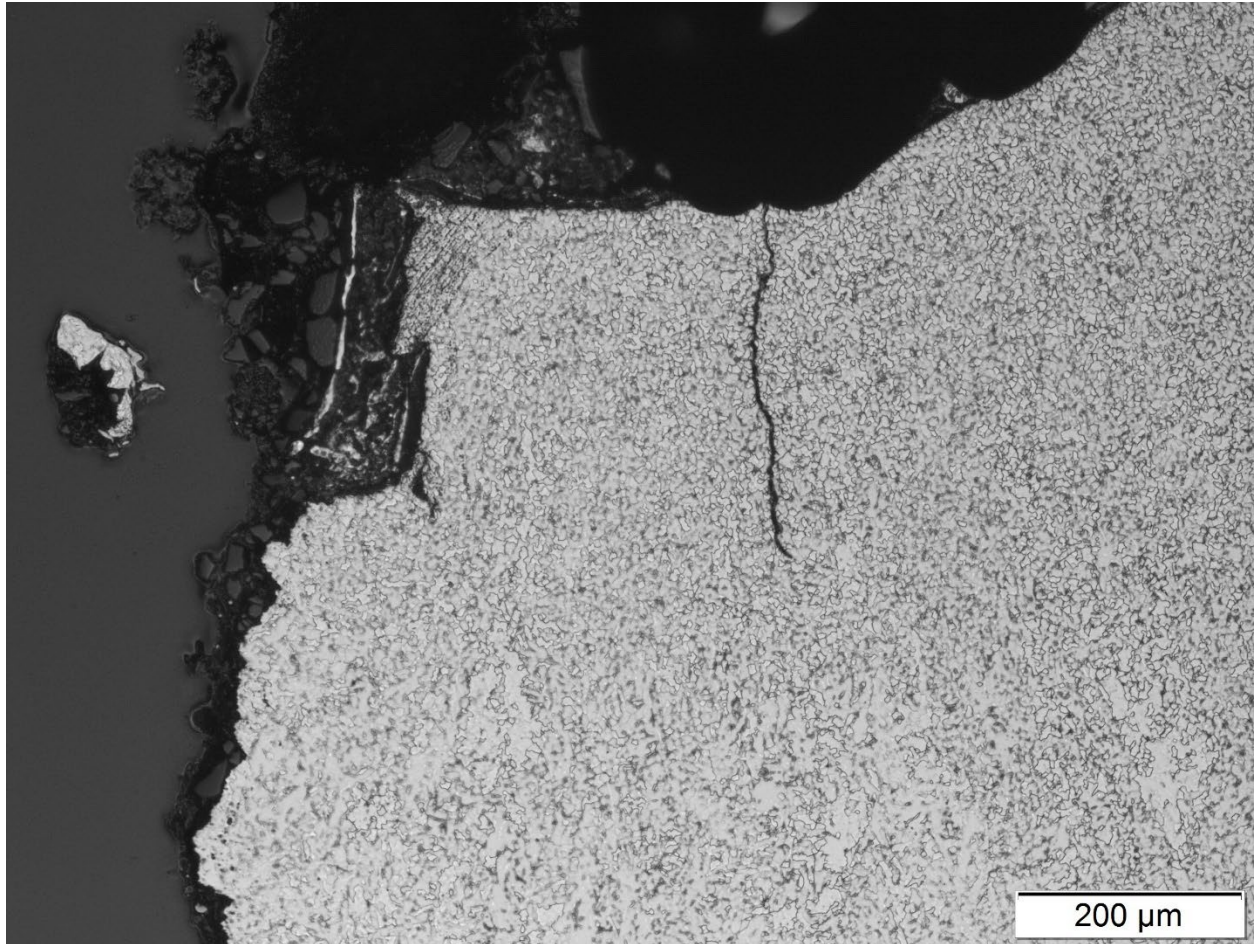
Figure 50. BF optical micrograph of the crack propagating from a void in Figure 49 (100X, etched 2% Nital).

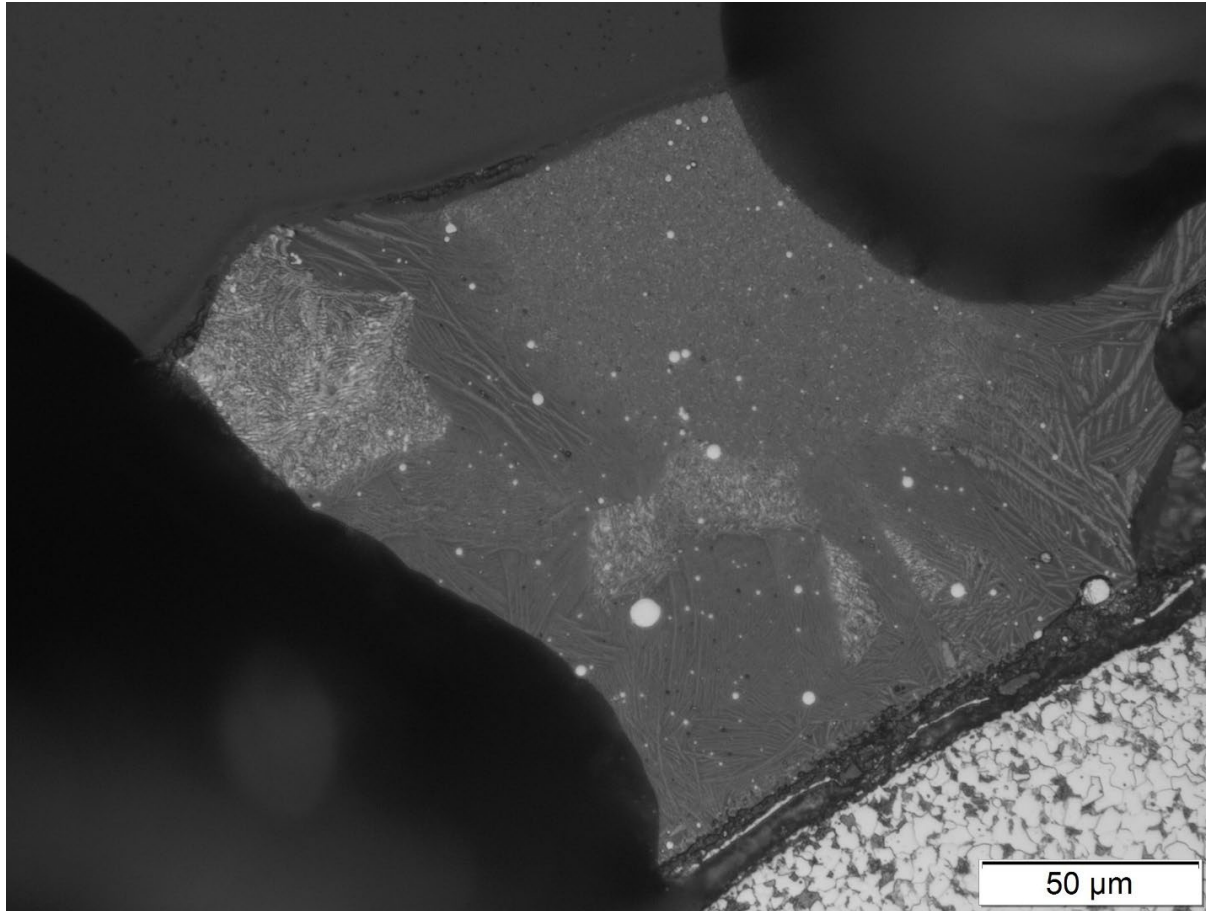
Figure 51. BF optical micrograph of dendritic compounds in the void of Figure 49 (400X, etched 2% Nital).

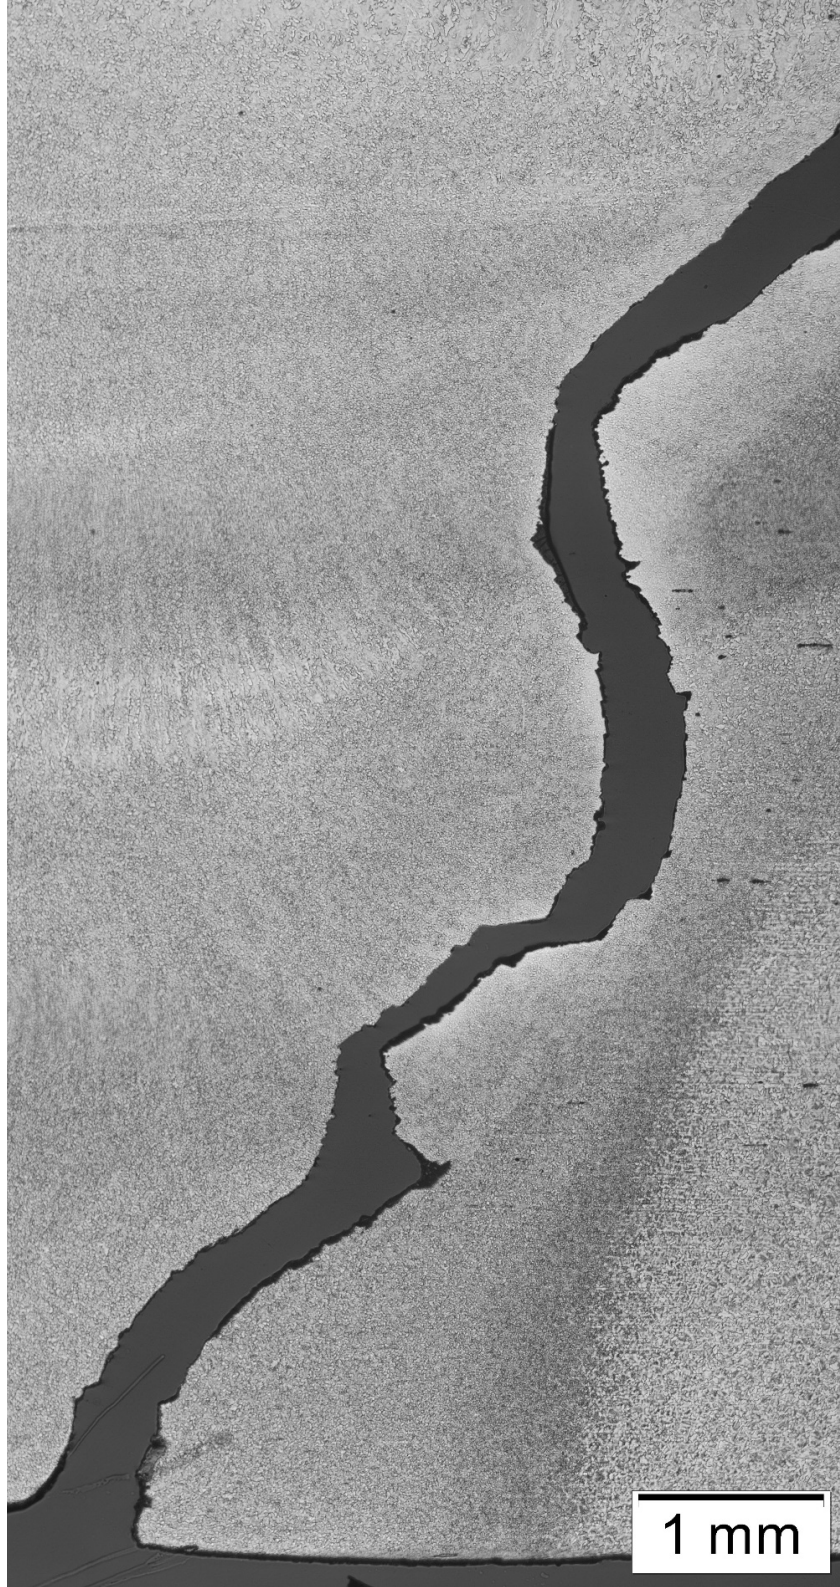
Figure 52 shows the fractured weld at location M1\_5b, several inches clockwise of M1\_5a. The location of this fracture was biased toward one side of the weld, located on the right in the figure. Figure 53 shows a montage of the inner part of the crack, which was located along one of the weld pass boundaries, except for a small area in the lower right. The figure also demonstrates the changing microstructure from the welding process. As indicated in Figure 54, the fracture surfaces exhibited a thin nonmetallic oxide layer, with blocky material area near the weld's inner surface. Figure 55 shows a closer view of this oxide, exhibiting a dendritic morphology. Figure 55 also shows the difference in microstructure between the weld and the HAZ, with the former exhibiting more ferrite and an acicular morphology of the carbon-rich phase and the latter having more cementite present.

Figure 53. BF optical micrograph montage of the fracture through weld M1\_5b (~25X, etched 2% Nital).

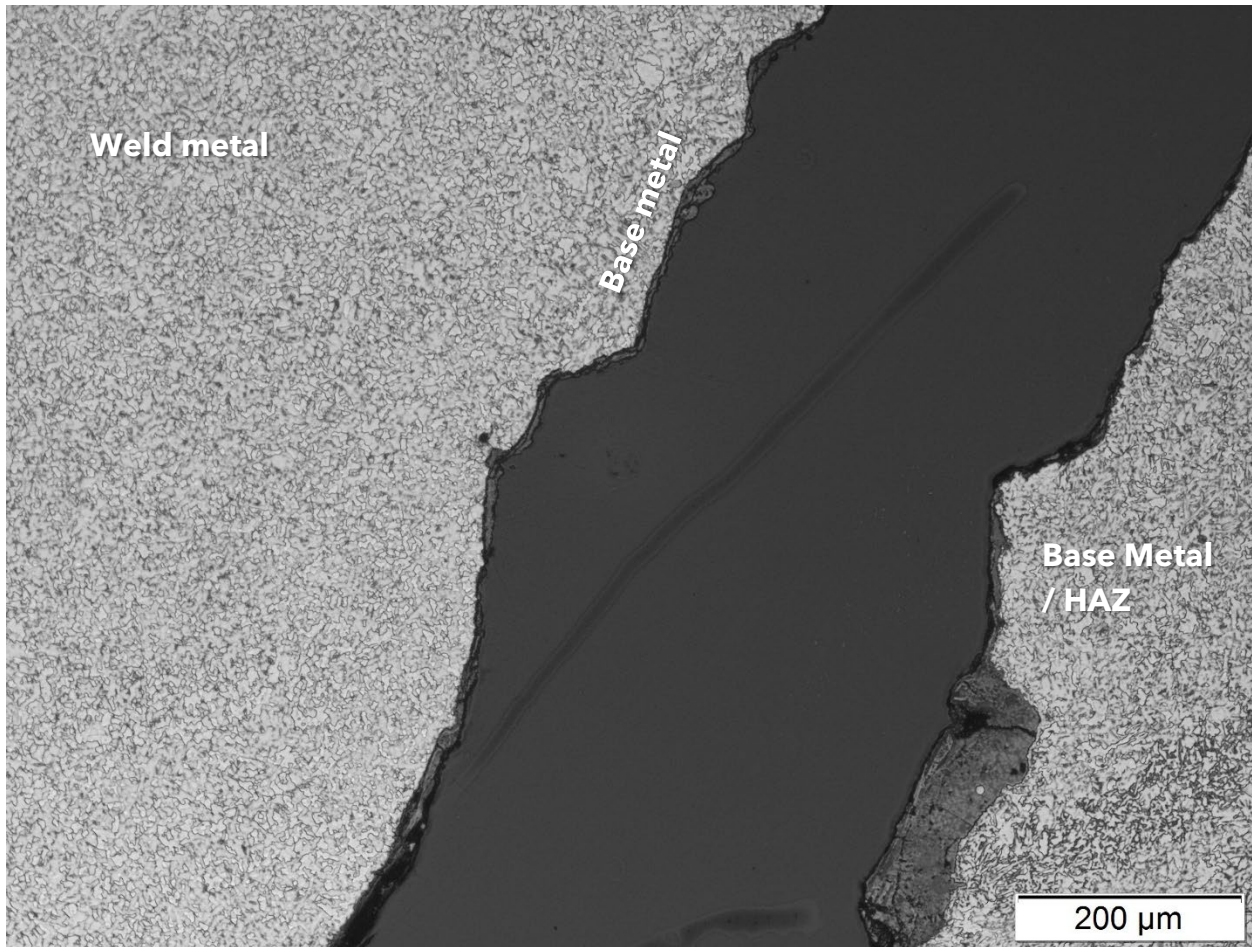
Figure 54. BF optical micrograph of oxide films along the fracture in Figure 53 (~100X, etched 2% Nital).

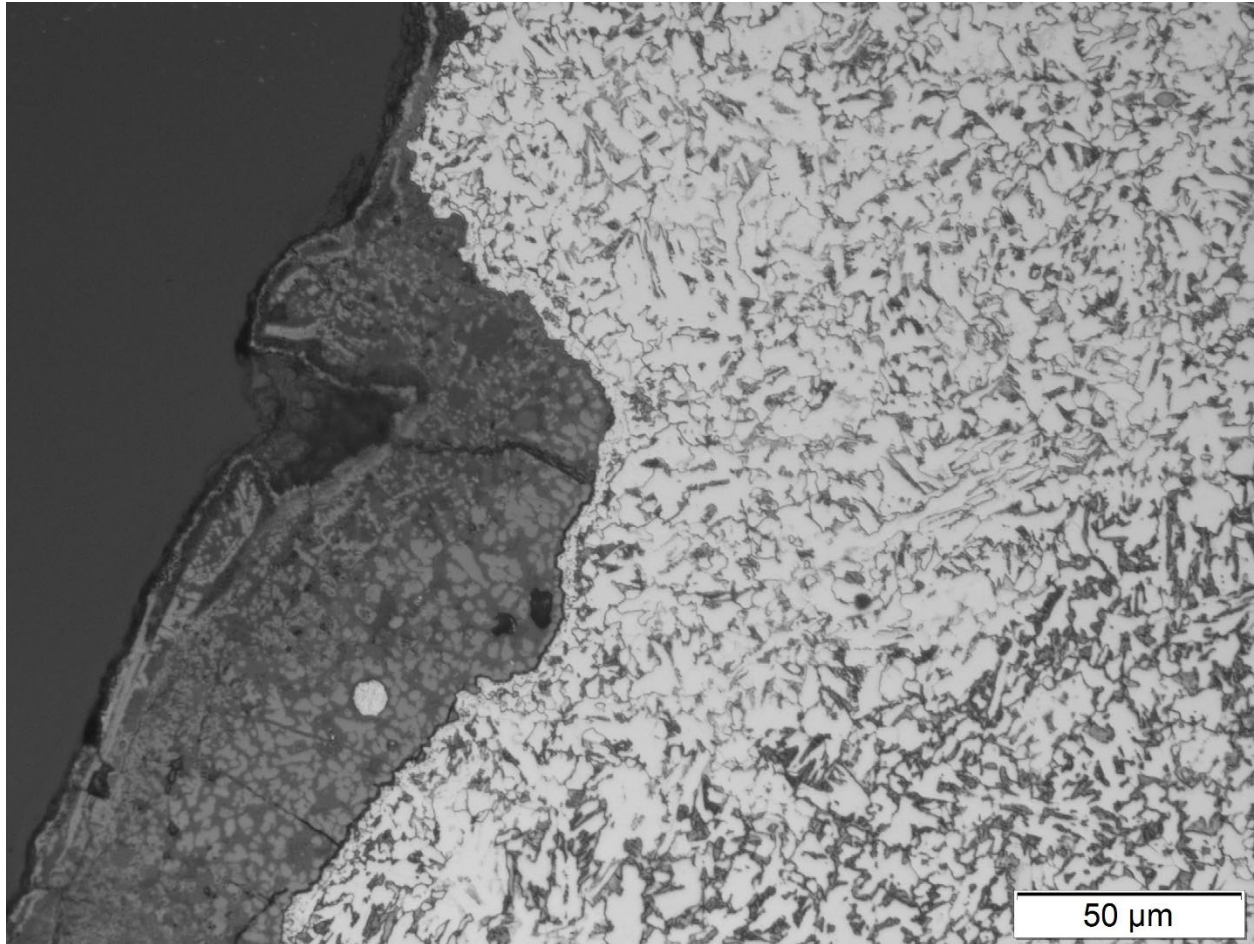
Figure 55. BF optical micrograph of the oxide globule to the right in Figure 54 (~400X, etched 2% Nital).

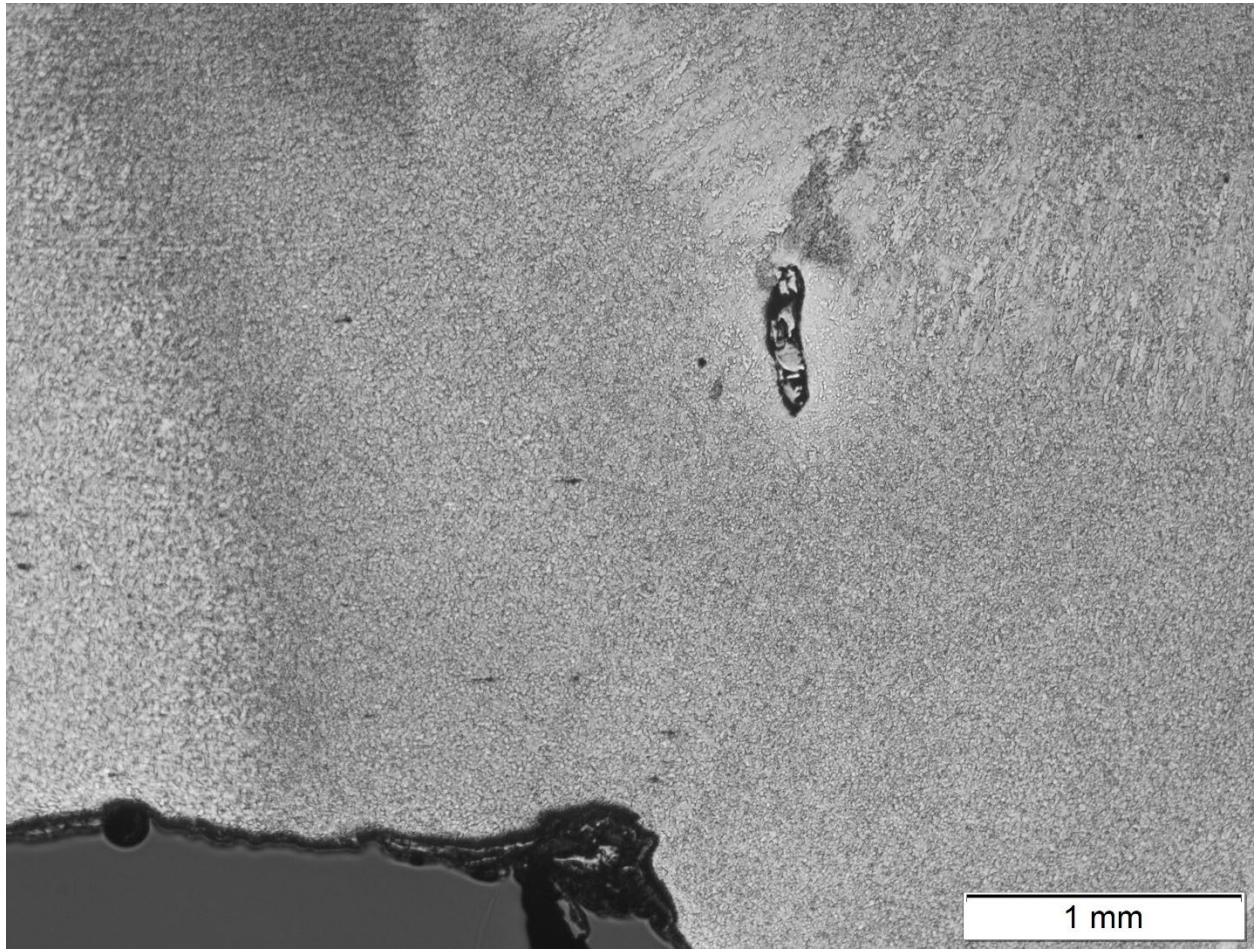
Figure 57. BF optical micrograph of an inclusion below a weld pass in Figure 56 (~25X, etched 2% Nital).

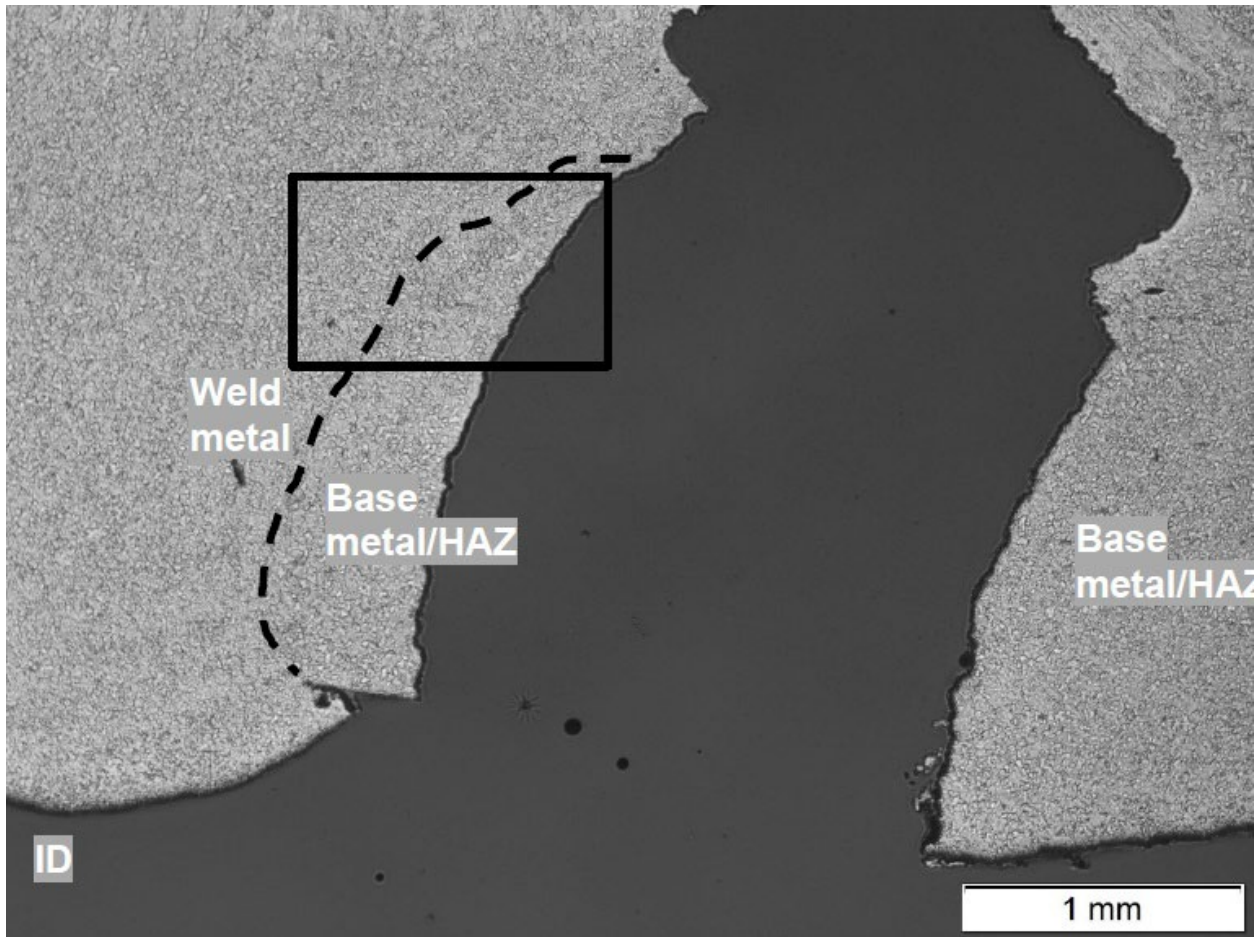
Figure 58. BF optical micrograph of the ID area of the fractured weld in Figure 57, showing the delineation of weld and base metal. The boxed area is shown in Figure 60 (~25X, etched 2% Nital).
