# National Transportation Safety Board

## **MATERIALS LABORATORY**

Factual Report 22-038

On March 11, 2022, the Woodpat pipeline, a 22-inch-diameter hazardous liquids pipeline operated by Marathon Pipe Line, LLC (Marathon), ruptured in Edwardsville, IL. About 3500 barrels of crude oil were released, some of which entered Cahokia Creek, a tributary of the Mississippi River. No injuries occurred, and the crude oil did not ignite.

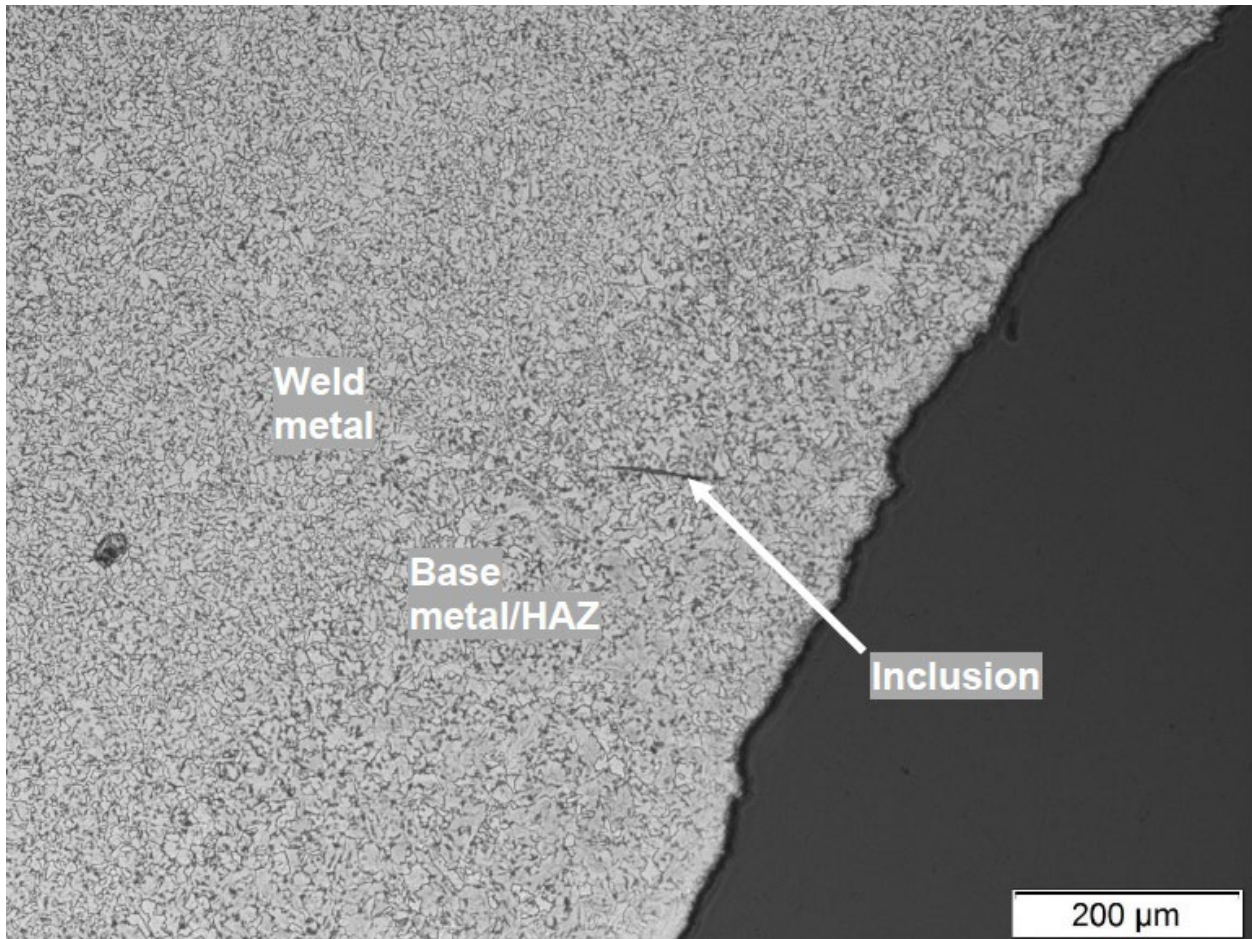
Figure 59. BF optical micrograph of the boxed area in Figure 58, showing a linear inclusion in the base metal (~100X, etched 2% Nital).

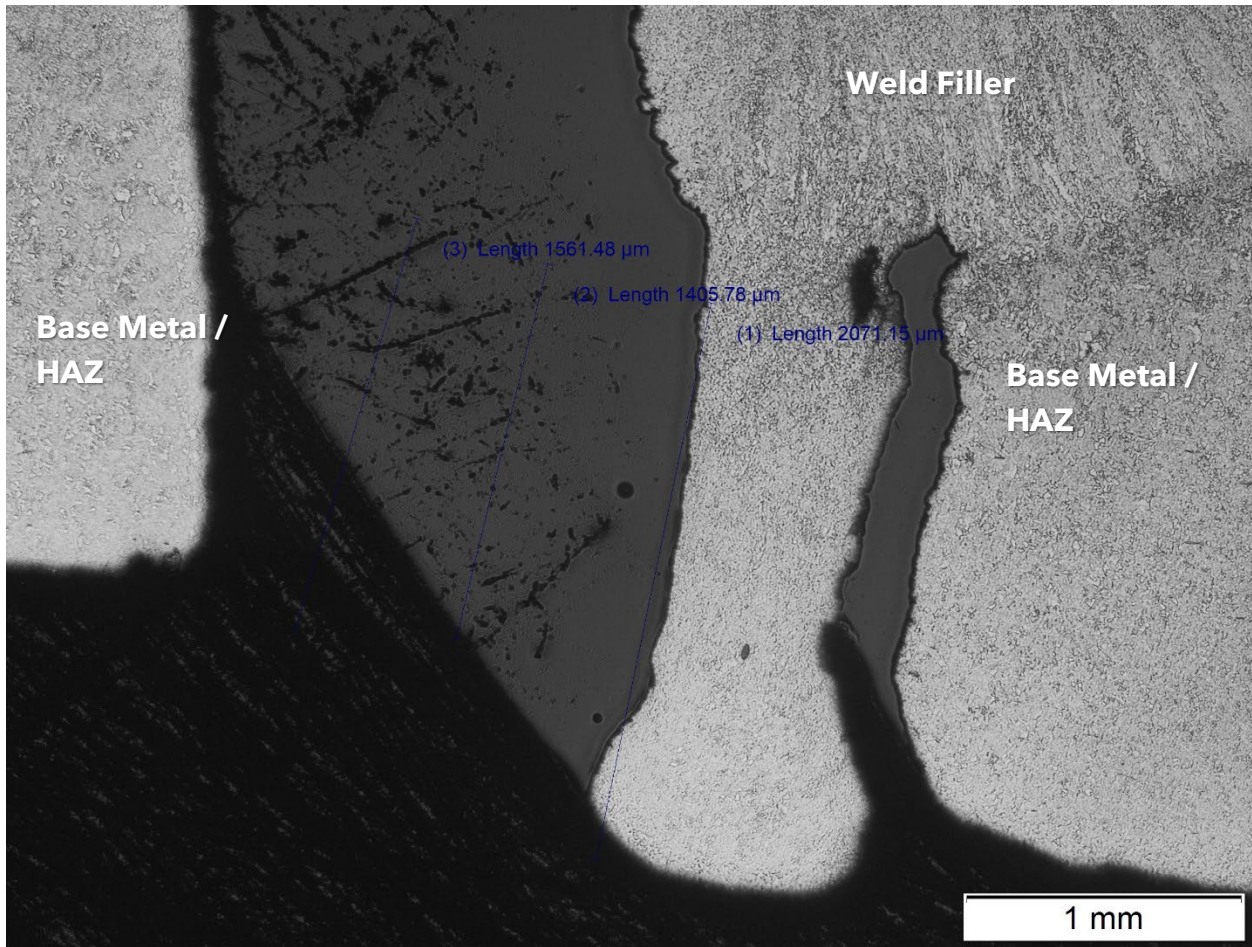
Figure 61. BF optical micrograph of weld laps on the inner diameter surface of weld M5\_2 (25X, etched 2% Nital).

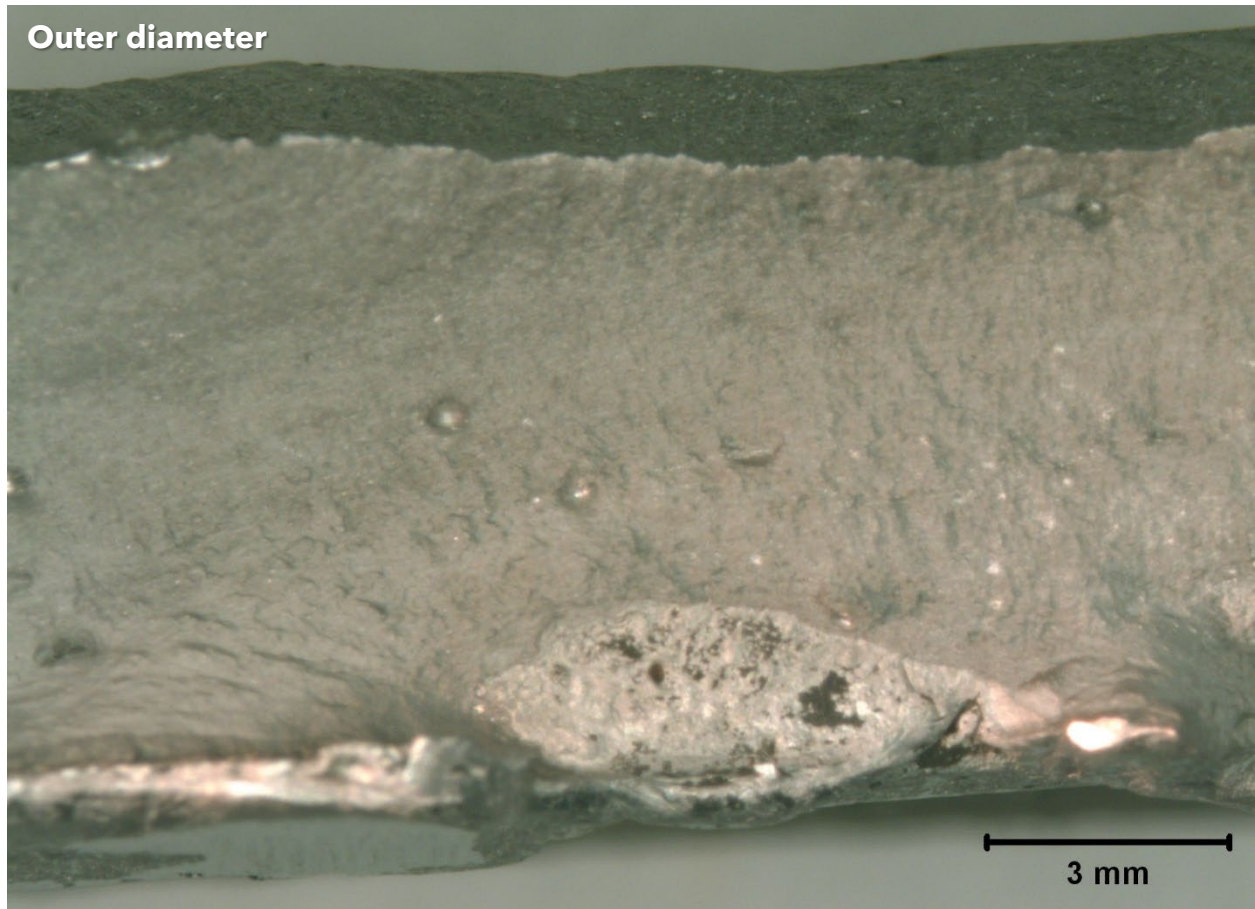
Figure 78 shows another area on the fracture surface that exhibited a flatter, more reflective area on the inner surface corner. This thumbnail-shaped region measured about 6 mm by 3 mm (0.22 in by 0.11 in). The area was examined before and after final surface oxide removal, and the location of the micrographs taken are annotated in Figure 79 and Figure 80 for those conditions, respectively.

Figure 78. Area of the Pipe 2 fracture surface with a convex discontinuity near the ID edge.

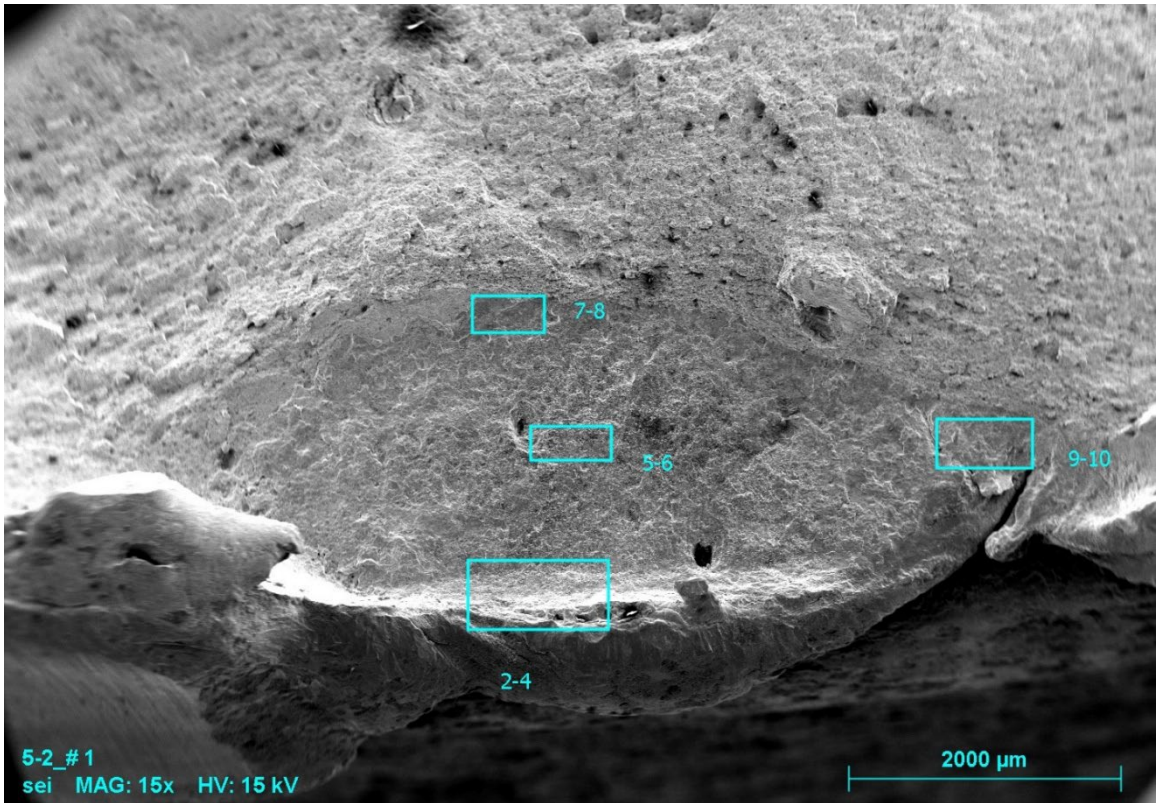
Figure 79. SE micrograph of the area in Figure 78 examined prior to surface oxide removal.

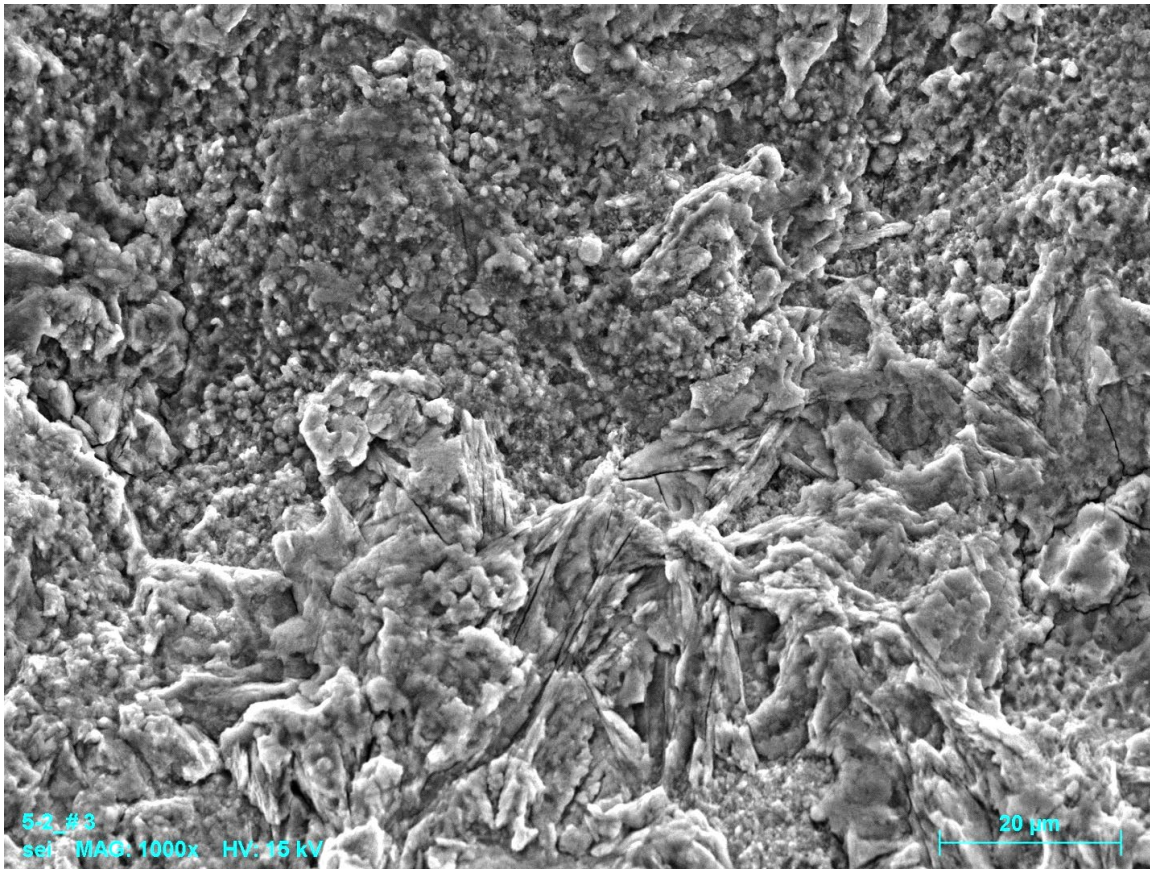
Figure 81 shows some of the different surface oxide morphologies on the fracture surface, with areas of small globular features in the top of the figure, and more pronounced, acicular features in the bottom. This figure was taken from the corner protruding outward in Figure 79. Neither of these oxide patterns were consistent with known underlying fracture features. Figure 82 shows the same area after oxide

Figure 81. SE micrograph of location 3 in Figure 79, prior to oxide removal.

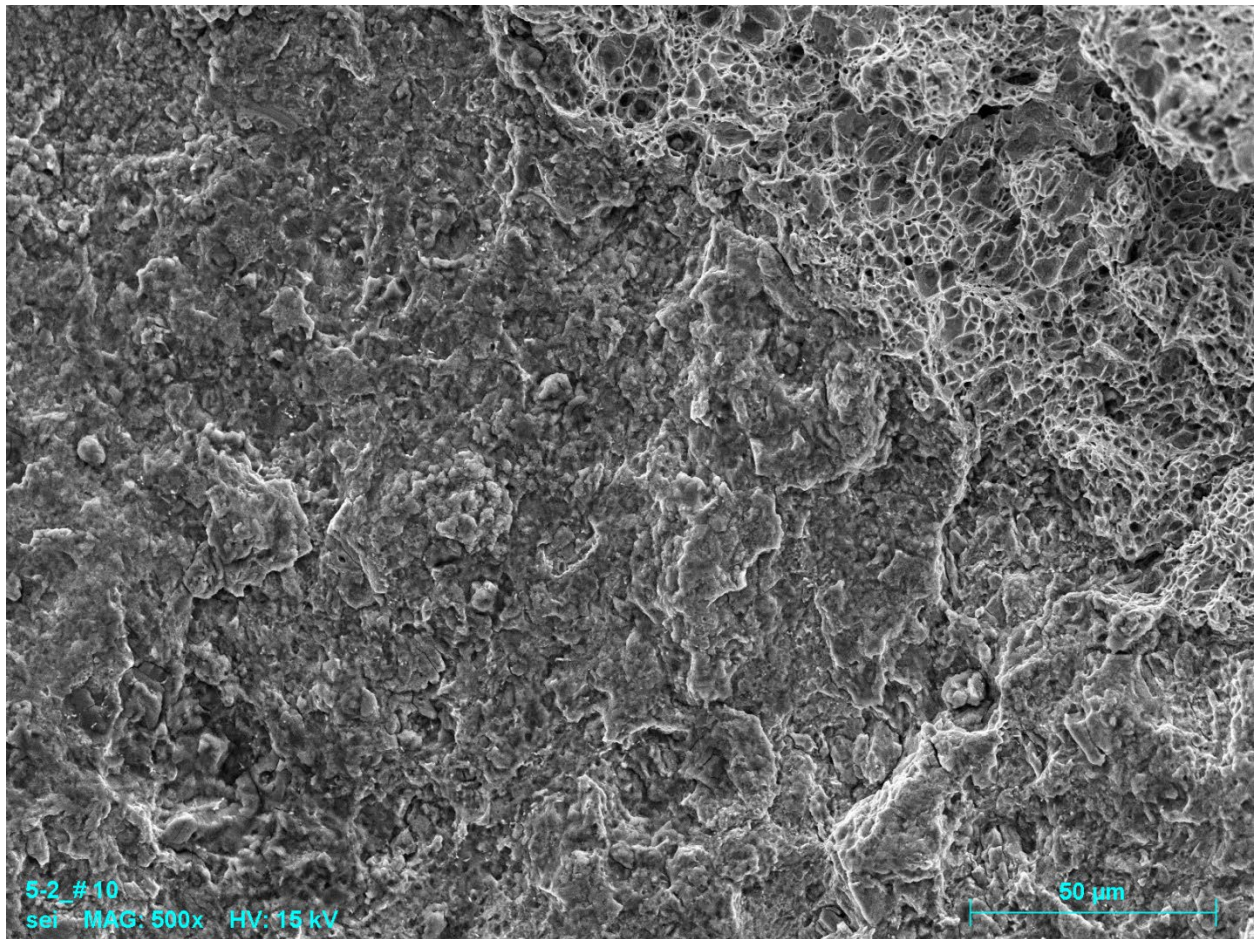
Figure 83 shows an area of the thumbnail feature near its edge. The figure shows an area of dimpled rupture in the upper right. After cleaning, the area appeared similar to the previous location, exhibiting underlying pockmarked features (Figure 84). Similar features were revealed in an upper area of the clamshell feature (location 13) after oxide removal. The surface showed pock marks and features consistent with underlying dimpled rupture. Figure 85 shows a nearby location post cleaning, which also exhibited the pock-mark surface morphology consistent with post-fracture corrosive attack.

Figure 83. SE micrograph of location 10 in Figure 79, prior to oxide removal.

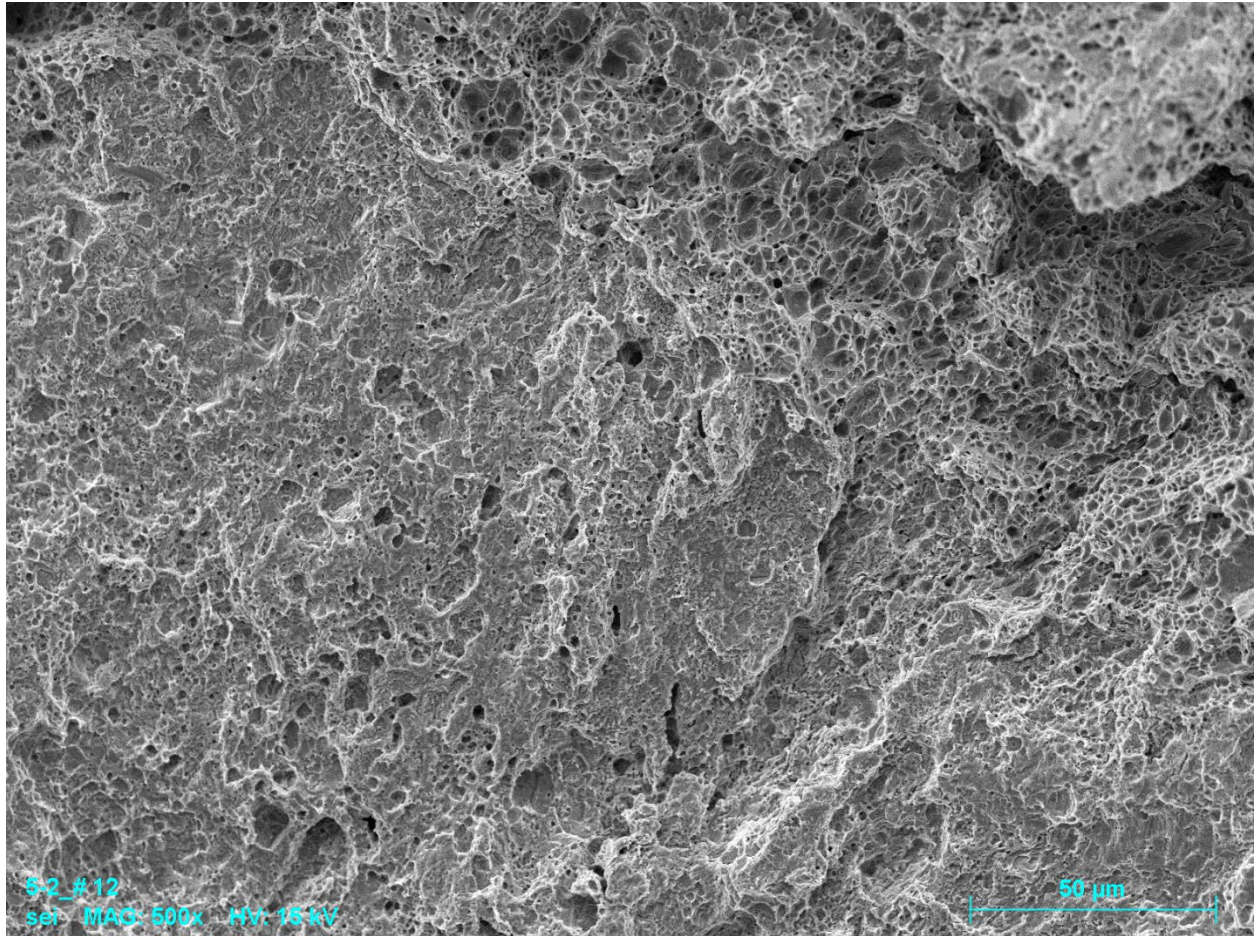
Figure 84. SE micrograph of location 12 in Figure 80, after oxide removal.

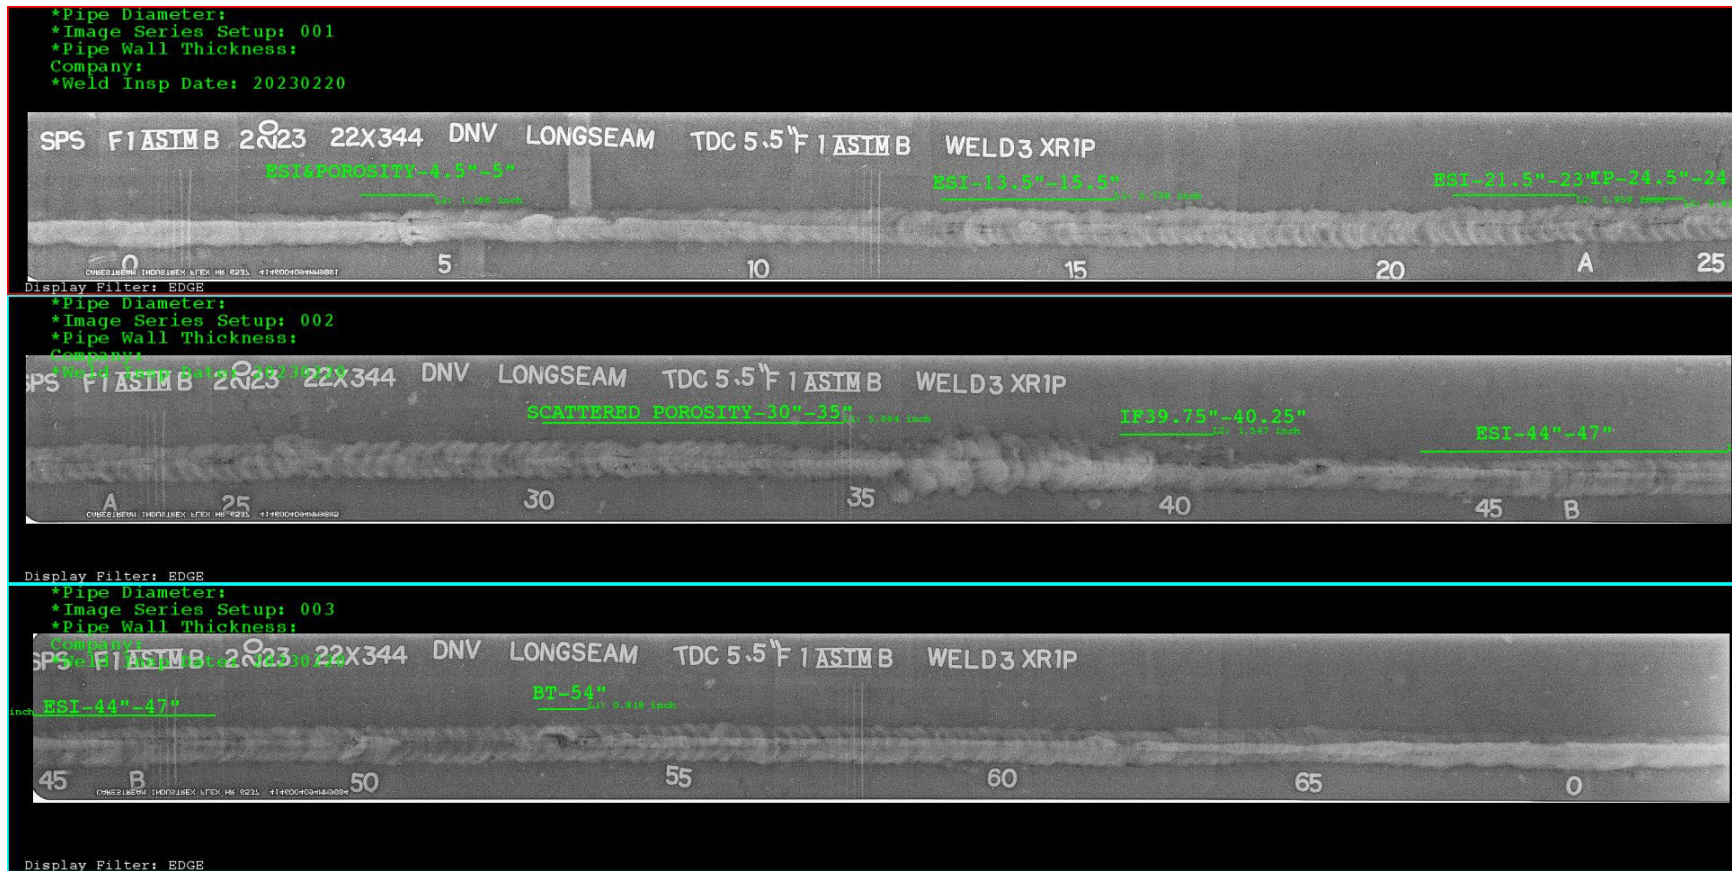
The intact girth weld of the third pipe section was examined using radiography by a third-party contractor, Shaw Pipeline Services.<sup>7</sup> A montage of the complete girth weld radiographs is shown in Figure 87. This examination found areas of entrapped porosity, typically in linear concentrations of 4 to 45 inches in length. Other imperfections included:

Figure 87. Montage of the radiographs from the girth weld of Pipe 3. The 0 represents 12 o'clock top dead center, with the remaining numbers indicating distances clockwise in inches. The seam welds are visible between the 5 and 10 locations.

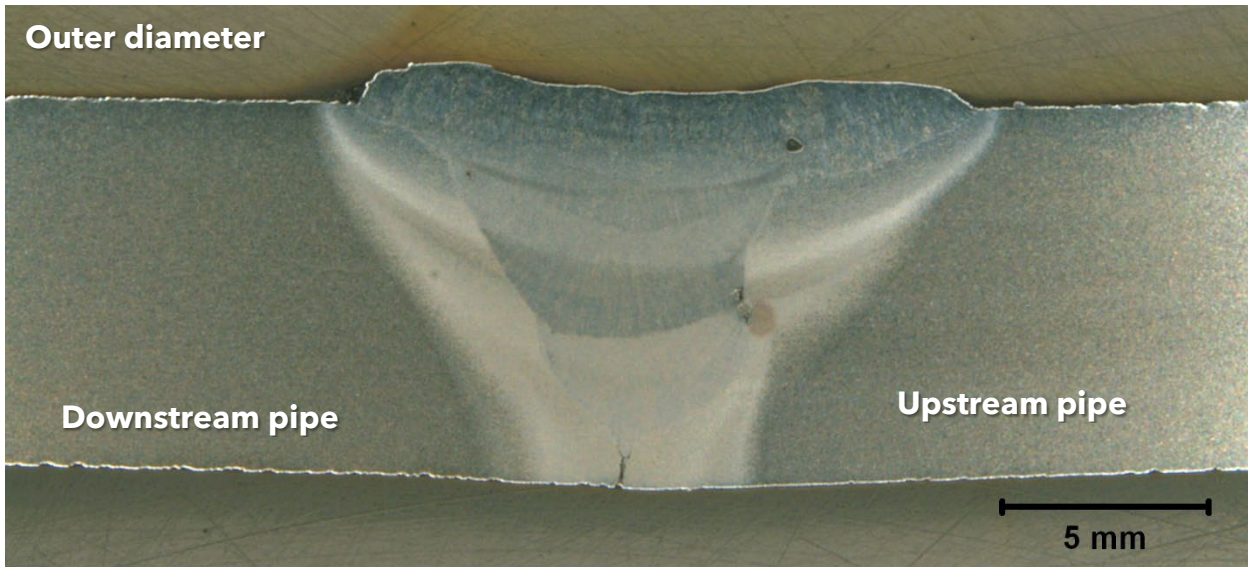
Several cross-sections were taken through the girth weld in Pipe 3. Figure 88 shows a cross-section through the weld location of M3\_1. This area reveals an intact weld exhibiting a lack of complete fusion. The incomplete fusion manifest as a branched crack along the inner surface corner, highlighted in Figure 89. Primarily located along the edges of the weld filler, the crack was as deep as 1.2 mm (0.047 in). The crack was filled with a nonmetallic material, consistent with oxide buildup from service since assembly. Figure 90 shows a closer view of the upper portion of the crack oxide, revealing a dendritic structure. This microstructure would be consistent with solidification from a molten state, indicative of welding slag.

Figure 88. BF optical micrograph of the Pipe 3 girth weld at location M3-1, removed 1.06 clockwise of 12 o'clock top dead center (5X, etched 2% Nital).

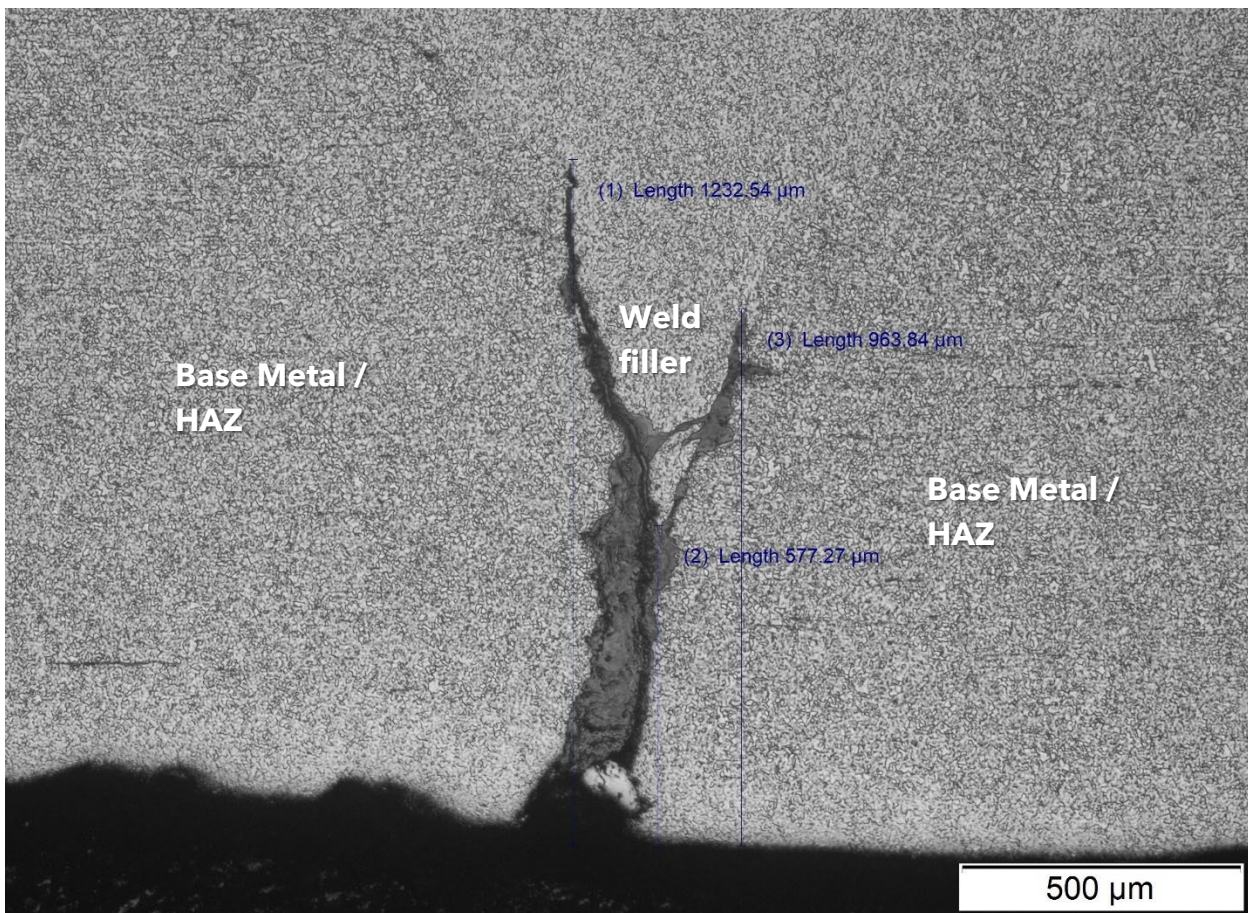
Figure 89. BF optical micrograph of the weld interior and cracking in M3-1, annotated showing distances from the inner diameter surface (~50X, etched 2% Nital).

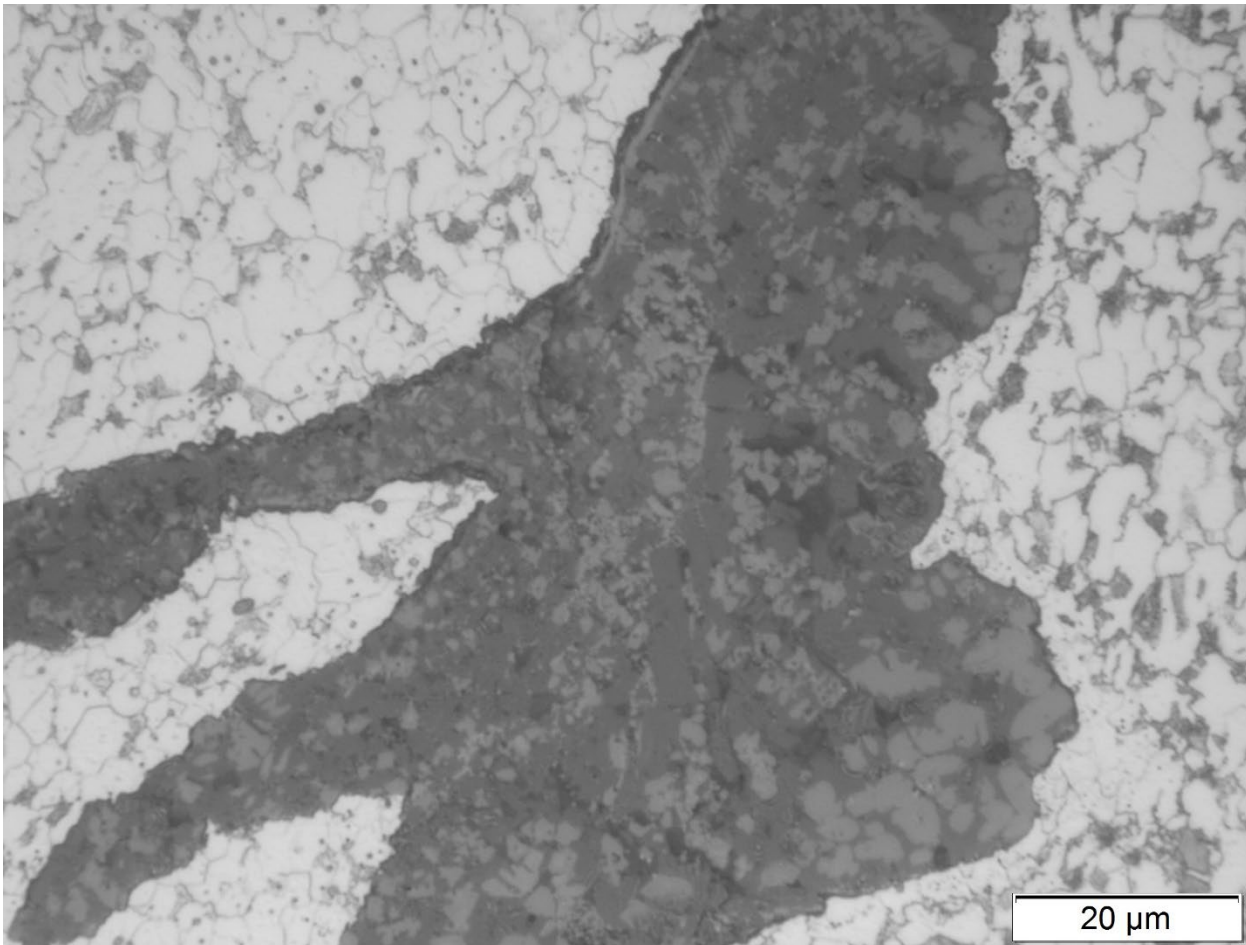
Figure 90. BF optical micrograph of the slag within the crack in Figure 89 (1000X, etched 2% Nital).

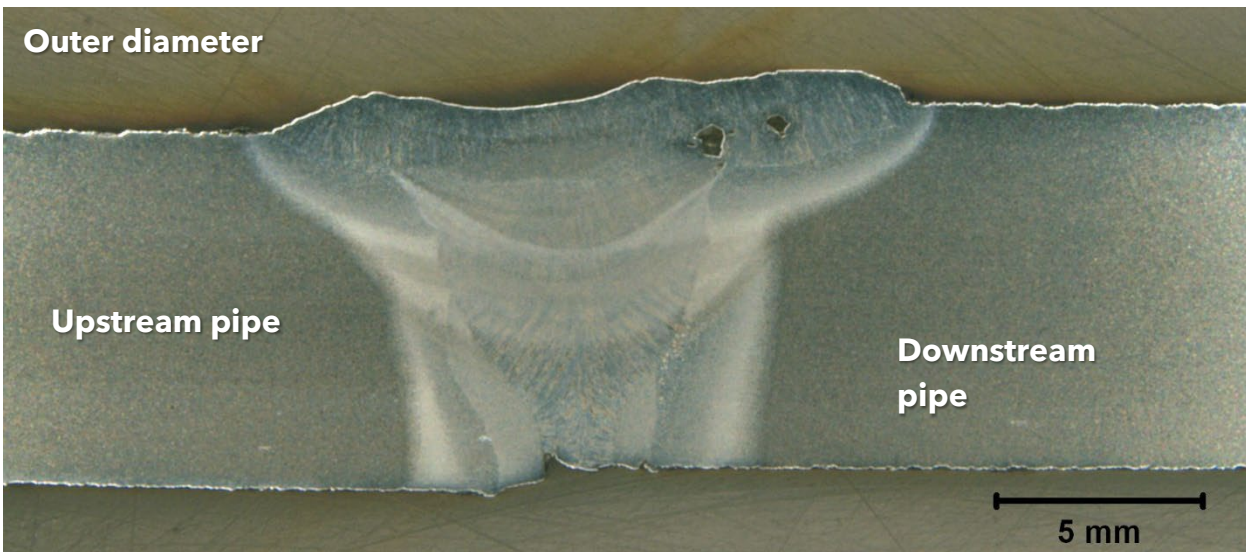
Figure 91 shows a cross-section through a weld area that exhibited porosity in the radiographic inspection, labeled M3\_2. This weld also shows a “high-low” mismatch between the opposite sides of the pipe joint. This mismatch was collocated with some uneven internal undercut features along the inner surface. The porosity, under 1 mm in diameter, was located within 1 to 2 mm of the outer surface of the weld.

Figure 91. BF optical micrograph of the Pipe 3 girth weld at location M3-2, sectioned 2.08 feet clockwise of top dead center (~5X, etched 2% Nital).

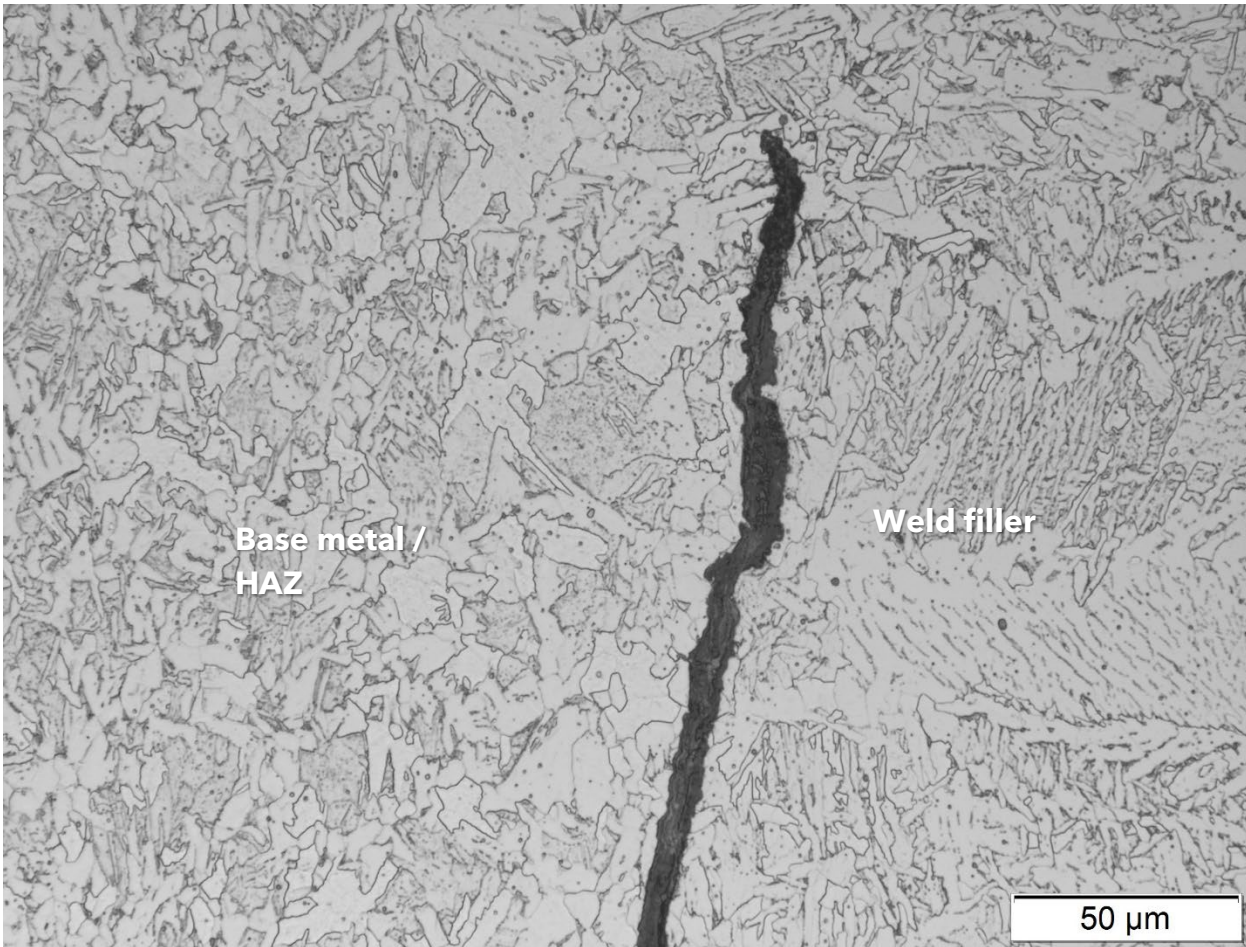
Figure 92 shows a closer view of the inner surface of the weld at M3\_2, showing the dendritic structure of the filler material and the adjacent cracks in the undercut area. The crack to the left of the weld filler had propagated to 0.16 mm (0.006 in), located along the transition between the filler and heat-affected pipe material. Figure 93 shows the tip of this crack, which had progressed in a transgranular manner. The crack also contained layered, concentric-appearing nonmetallic material consistent with surface oxide forming during crack growth.

Figure 93. BF optical micrograph of the crack tip from Figure 92 (~400X, etched 2% Nital).

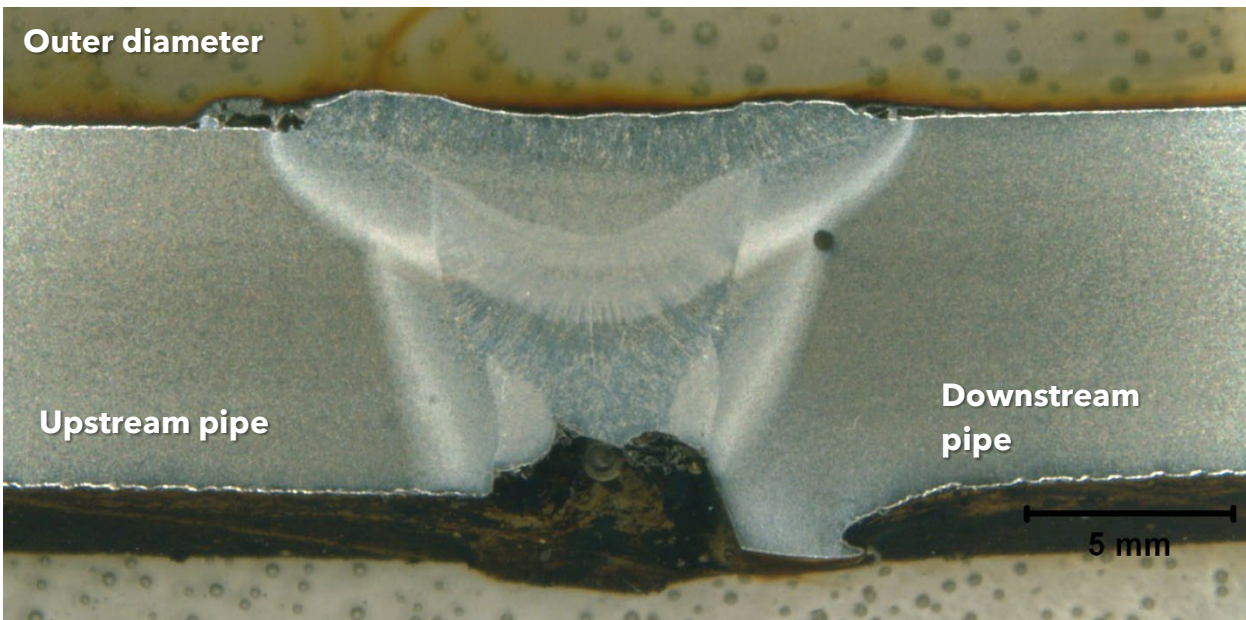
Figure 94 shows another cross-section of the Pipe 3 weld, which exhibited a broader and deeper imperfection than in Figure 91, consistent with burn through. This location was labeled as M3\_5. The amount of burn through was 5 mm by 3 mm deep (0.20 inch by 0.12 inches). Like the other imperfections of this girth weld, this cross-section showed outward-oriented sharp corners (Figure 95). However, these locations had not spawned cracks (see Figure 96). Figure 95 shows the right side of the weld filler transition to the heat-affected zone. This area exhibited some nonmetallic material, consistent with the buildup and oxidation of the metal of the pipe's inner surface.

Figure 94. BF optical micrograph of the Pipe 3 girth weld at location M3-5, 4.4 feet clockwise of 12 o'clock (~5X, etched 2% Nital).

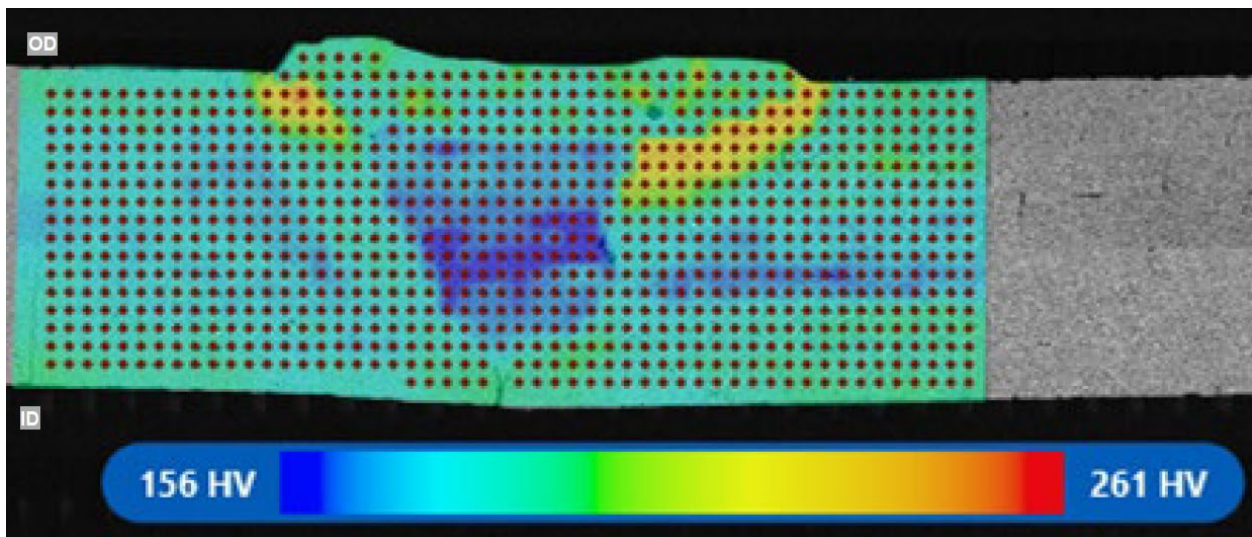
Figure 97 shows a microindentation hardness map of the girth weld cross section of location M3\_1. The map shows an increase in hardness values in the heat affected zone adjacent to the interface between the weld and base metal, located near the outer surface weld toes. In contrast, the center of the weld bead along the centerline exhibited the lowest hardness values. This cross-section location, however, did exhibit a root bead imperfection, which can influence the local properties of the weld and HAZ.

Figure 97. Microindentation hardness map of the girth weld cross section of M3\_1, shown in Figure 88, showing values between 156 HV and 261 HV, represented by blue and red colors, respectively.
