# National Transportation Safety Board

ERA22FA279

## **MATERIALS LABORATORY**

Factual Report 23-005

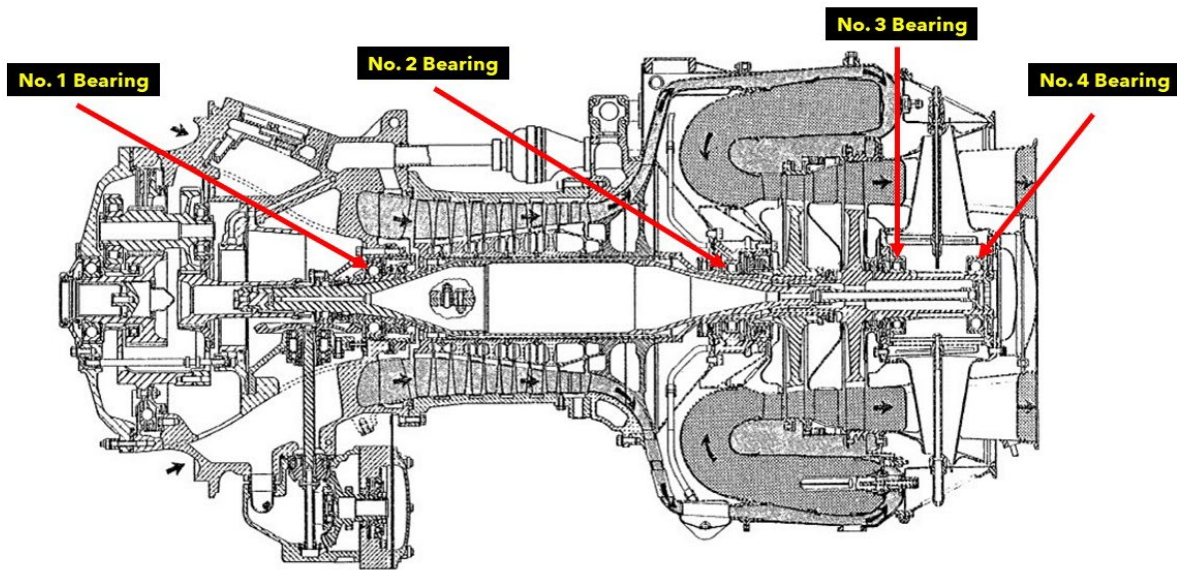
**Figure 6.** Diagram of a T53-L-11 engine sectioned longitudinally. Unlabeled black arrows indicate the direction of air flow through the engine.

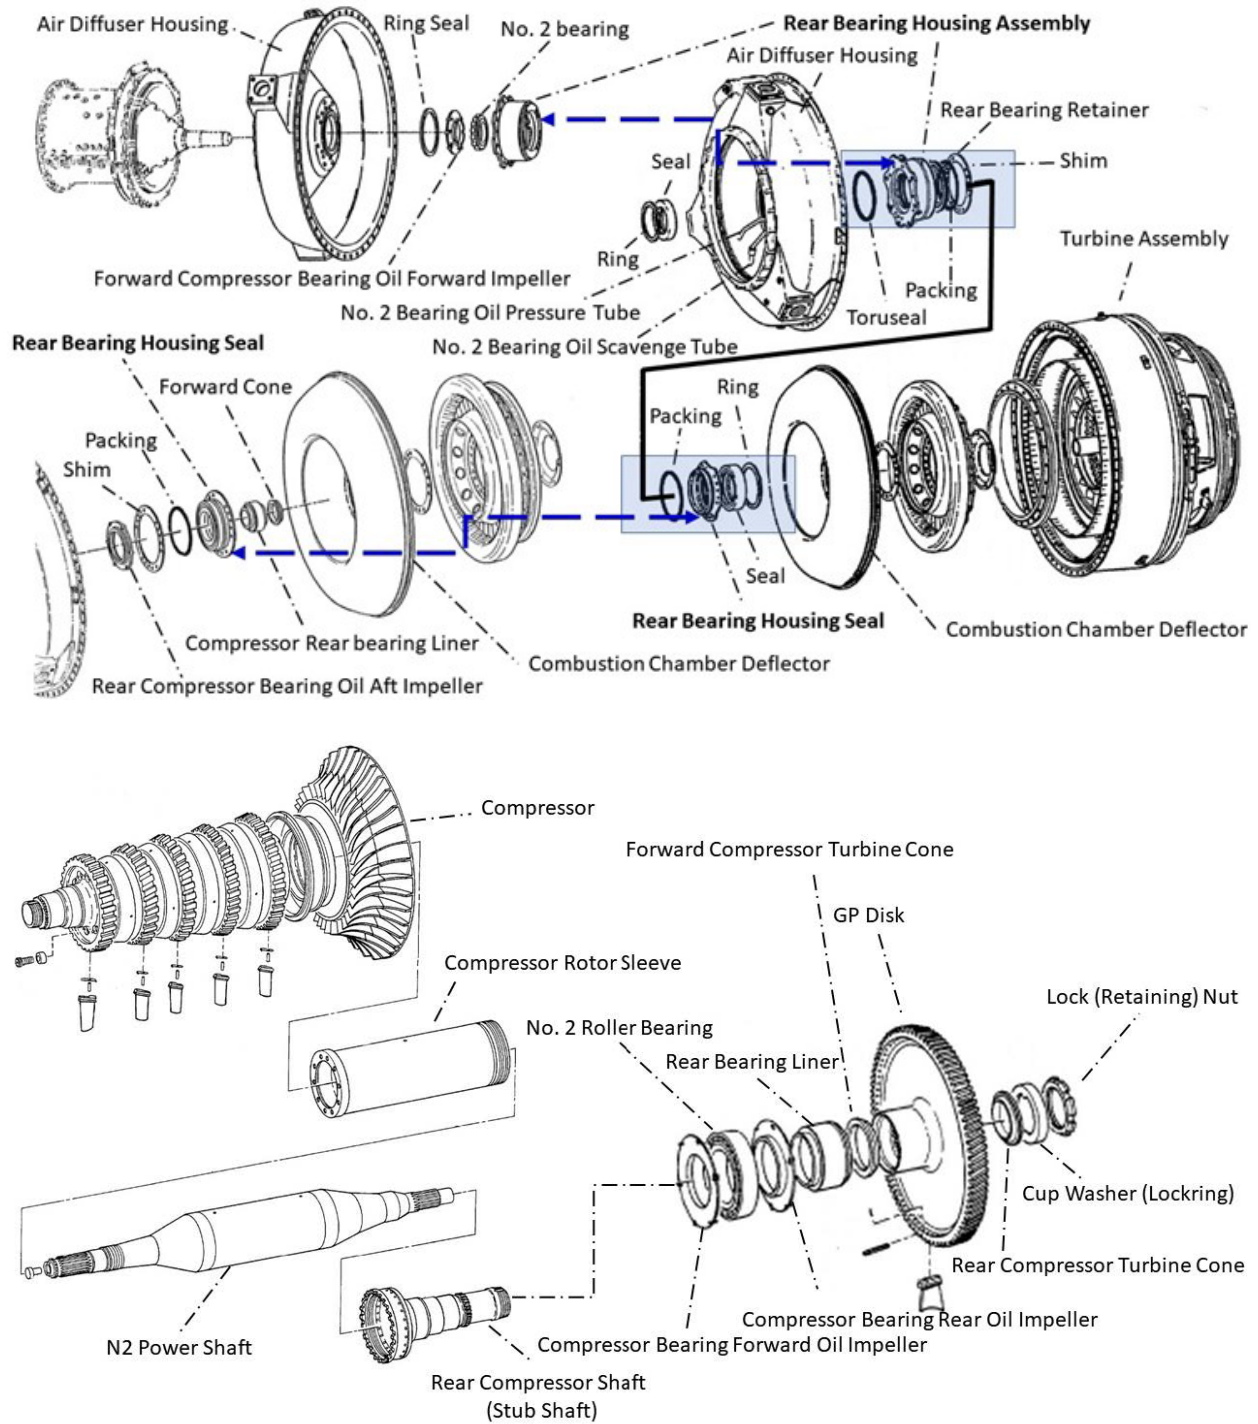
The components were from an Ozark Aeroworks (formerly Honeywell, Allied Signal, and Textron Lycoming) model T-53-L-11D turboshaft engine. (The civil variant of the engine is the model T53L11A.) A diagram of the engine cross-section is shown in figure 6, where the air flow and bearing locations are indicated. Exploded parts diagrams of the number 2 bearing and associated components are shown in figure 7.

**Figure 7.** Assembly part diagrams of the number 2 bearing and associated non-rotating parts (above) and rotating parts (below). (Provided courtesy of Ozark Aeroworks and modified by NTSB.)

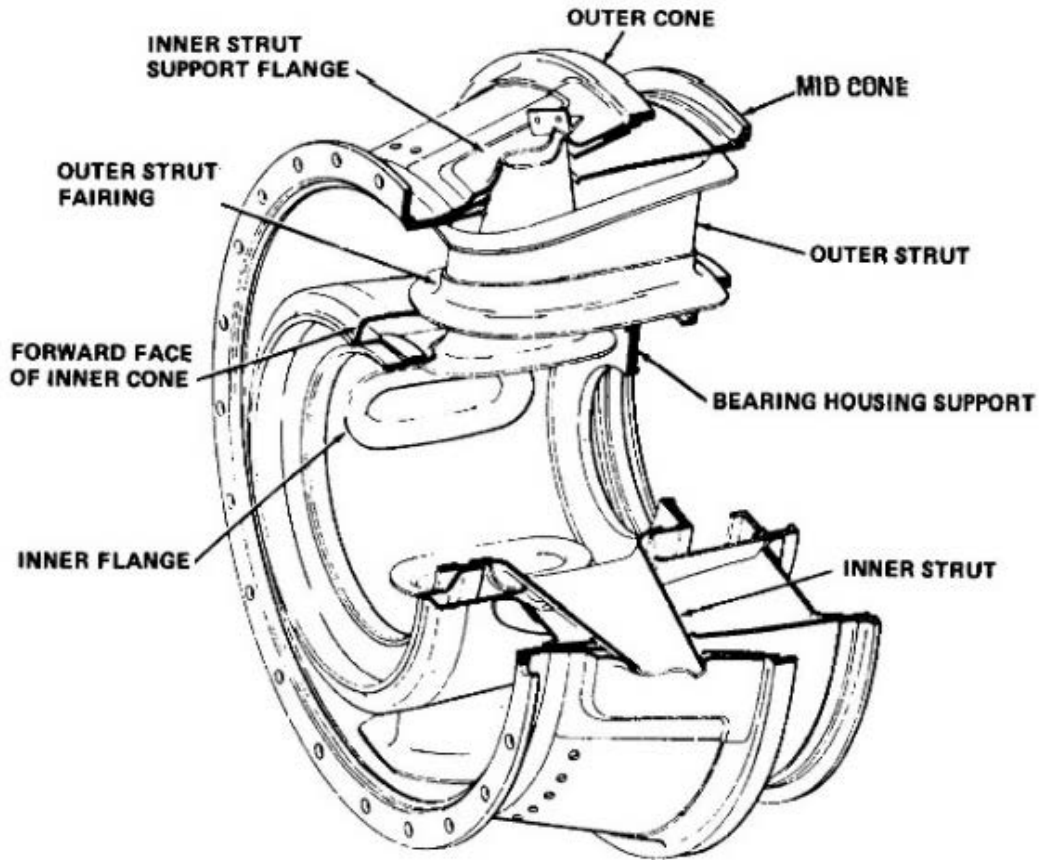
Views of the forward side of the exhaust diffuser are shown in figures 4 and 19, and a cutaway diagram labeling components of the diffuser is shown in figure 20. As shown in the diagram, the exhaust diffuser consisted of an outer cone and a mid cone that were attached at the forward outer flange and an inner cone that was attached to the forward end of the bearing housing support. The outer cone was connected to the bearing housing by four inner struts, and the inner struts were surrounded by an outer strut that was attached to the mid cone and could slide radially within the outer strut fairing on the inner cone.

**Figure 20.** Exhaust diffuser cutaway diagram. (Provided courtesy of Ozark Aeroworks.)
