Aircraft Accident/Incident Report No.: 191003

NTSB File No.: CEN20FA001

Aircraft: TBM700C2

Written by: Les Doud
Air Safety Investigator

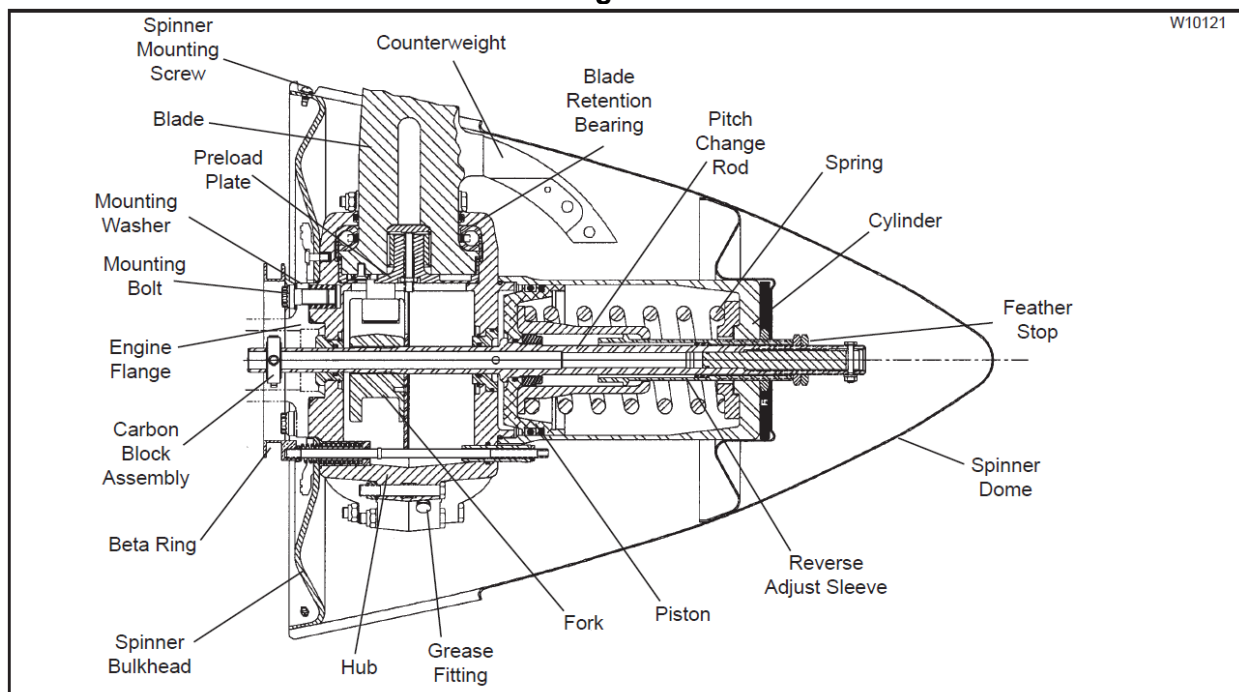
Figure 2

General Comments: The propeller on the accident airplane is a 91.0" diameter, 4-blade, single-acting, hydraulically operated constant speed model with feathering and reverse pitch capability. Oil pressure from the propeller governor is used to move the blades to the low pitch (blade angle) direction. Force from a feathering spring and twisting moments from the blade counterweights are used to move the blades to the high pitch/feather direction in the absence of governor oil pressure. The propeller incorporates a Beta mechanism that actuates when blade angles are lower than the flight idle position. The propeller utilizes an aluminum hub with aluminum blades. Rotation is clockwise as viewed from the rear. A cross section sketch of the propeller is shown in Figure 2.
