National Transportation Safety Board

Office of Highway Safety

HWY23FH010

FACTUAL REPORT OF INVESTIGATION

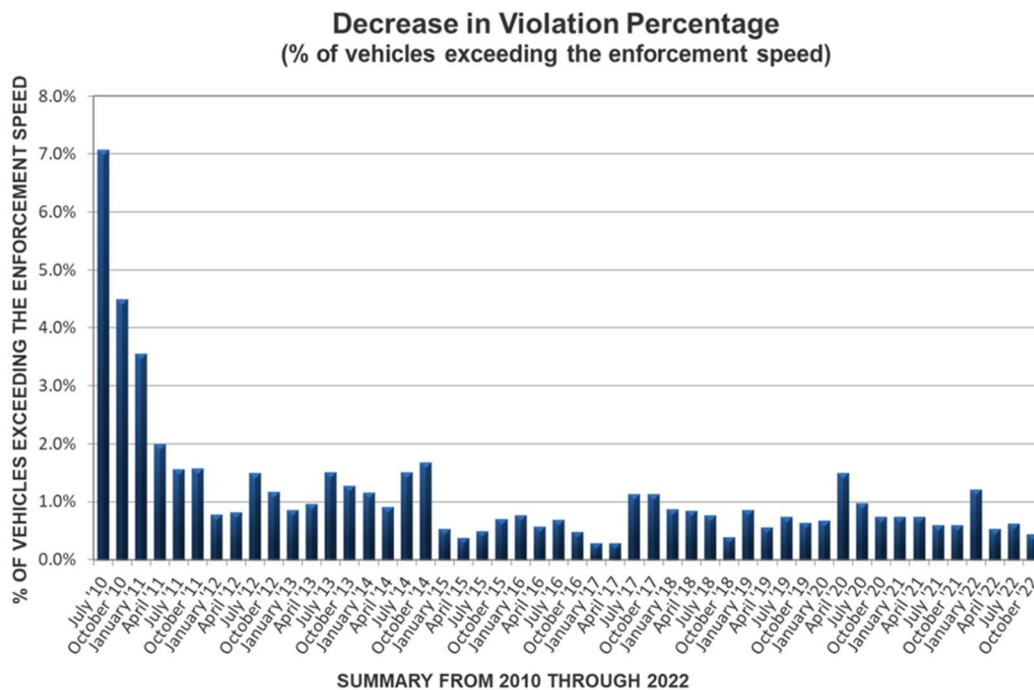
Shortly after the implementation of the ASE program in 2009, MDSHA observed a substantial reduction in work zone speed violations. **Figure 9** depicts a graph provided by MDSHA illustrating the percentage of vehicle exceeding the work zone enforcement speed after the introduction of ASE.

Figure 9: MD State Highway Administration graph illustrating the percentage of vehicles violating the work zone enforcement speed since the introduction of ASE. (MDSHA)
