Vehicle Attachment – 2004 International Specifications

Clarendon Hills, IL

HWY22MH009

Technical Service Information

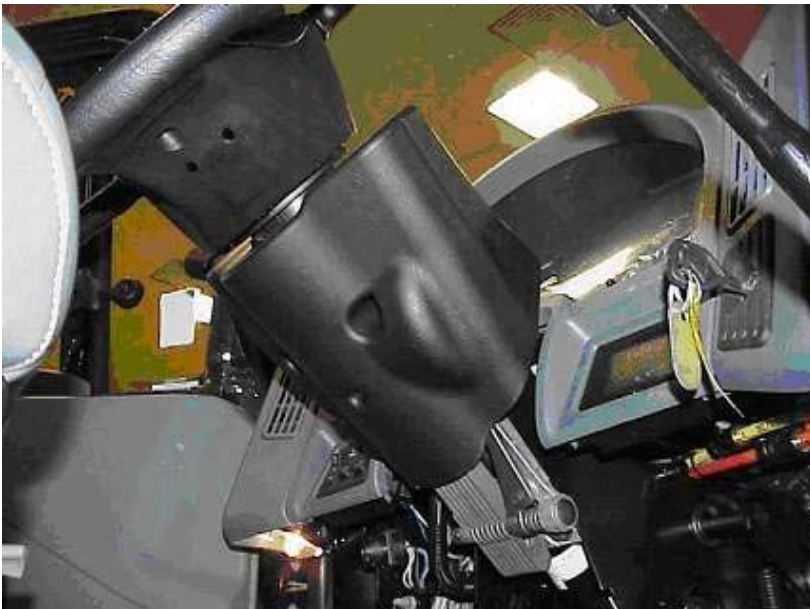
Figure 1 Remove Steering Column Lower Cover

To remedy this , International Truck and Engine Corporation has implemented a program to inspect the current instrument cluster for software version level, and if found to be version 11.0 or 17.0, to replace the instrument cluster rear cover with a new design cover that has an interceptor circuit board attached.

1. Disconnect the negative cable and ECM ground from the battery.
2. Remove fasteners and the steering wheel lower column (Figure 1).
