**Modjeski and Masters Modeling of the Fern Hollow Bridge**

**Pittsburgh, PA**

**HWY22MH003**

DATE: 5/19/2023  
TO: Mr. Dennis Collins, NTSB  
FROM: Modjeski and Masters, Inc.  
RE: Analytical Modeling of the Fern Hollow Bridge

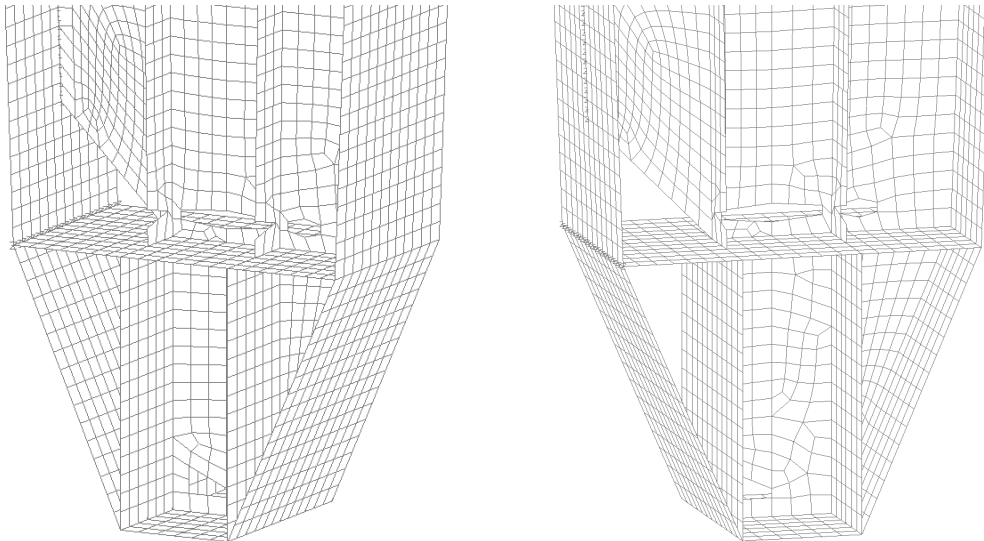
**Figure 8 – Views of mesh at base of local FEA model of frame leg for as-inspected model**

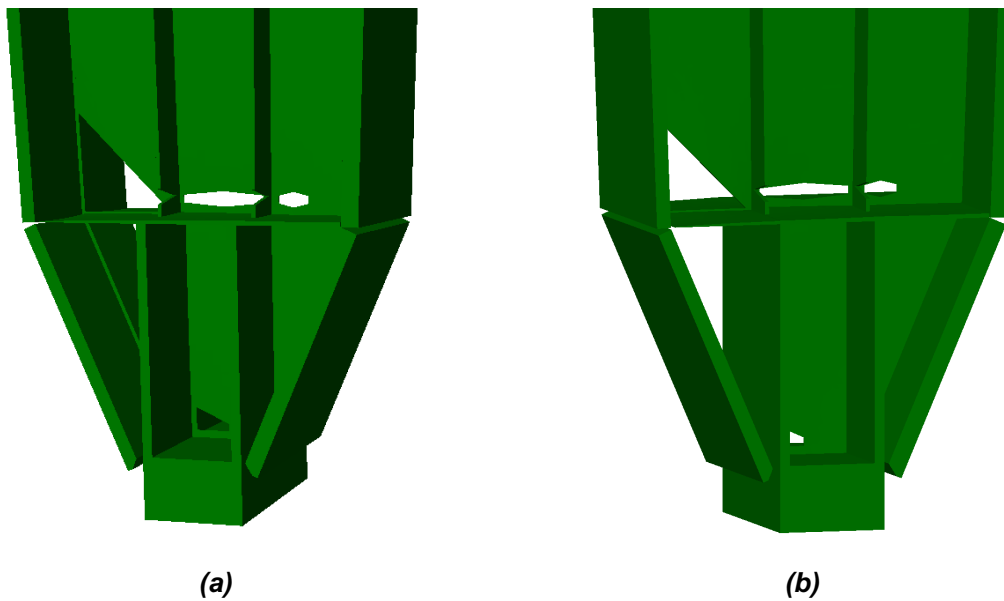
**Figure 10 – Fleshed views of base of local FEA model for as-inspected condition**

For the inboard downhill (span 2) side of the tie plate, the failure appeared to have occurred through the thinnest remaining section of the tie plate (approximately 0.05 in.), as the weld was still intact. As such, the joint elements at this location were assumed to have elastic-plastic behavior up until the moment of fracture, thereafter the force in the joint element reduces to near zero with increasing displacement. While the force-displacement behavior beyond the peak load is not indicative of actual behavior, where all force would be removed instantaneously upon fracture, a more gradual reduction from peak force and minimum load above zero is required for convergence of the nonlinear structural analysis. The force-displacement behavior is based on the stress-strain test data for the tie plate acting over a length of 1 inch with a thickness of 0.05 inches and assuming a 30% reduction in ductility due to the corrosion present (refer to [7]). The force-displacement behavior for the inboard downhill (span 2) side of the tie plate is shown in Figure 12.

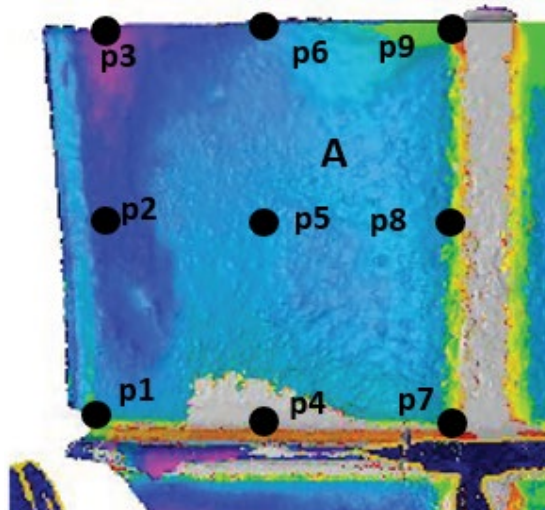
Each component was split into panels according to how they were divided by other components, as shown in Figure 15 for tie plate panels A through F and Figure 16 for web plate panels A through F. For each of these panels, a three-by-three grid of thickness measurements was taken, resulting in nine total data points. An example of this process is shown in Figure 17. These data points were used to fit a mathematical function which could then be input as a thickness variation within LUSAS. The general form of the function was as follows:

**Figure 17 – Measurement points for determining thickness variation in tie plate panel A (refer to Figure 15 for location of tie plate panel A)**
