Re: Tamarack Aerospace Group's Petition for Reconsideration and Modification of Findings and Determination of Probable Cause and Request for Oral Presentation — Accident ID CEN19FA036, Memphis, IN – November 30, 2018, Aviation Accident; NTSB Aviation Accident Final Report Published on November 1, 2021

Tamarack Aerospace Group (Tamarack) hereby petitions the National Transportation Safety Board (NTSB) pursuant to 49 CFR § 845.32, to reconsider and modify its findings and determination of probable cause in the above-referenced matter. The basis of this petition is that the NTSB has made erroneous findings that are unsupported by the factual record, inconsistent with engineering principles, or proven to be physically impossible.

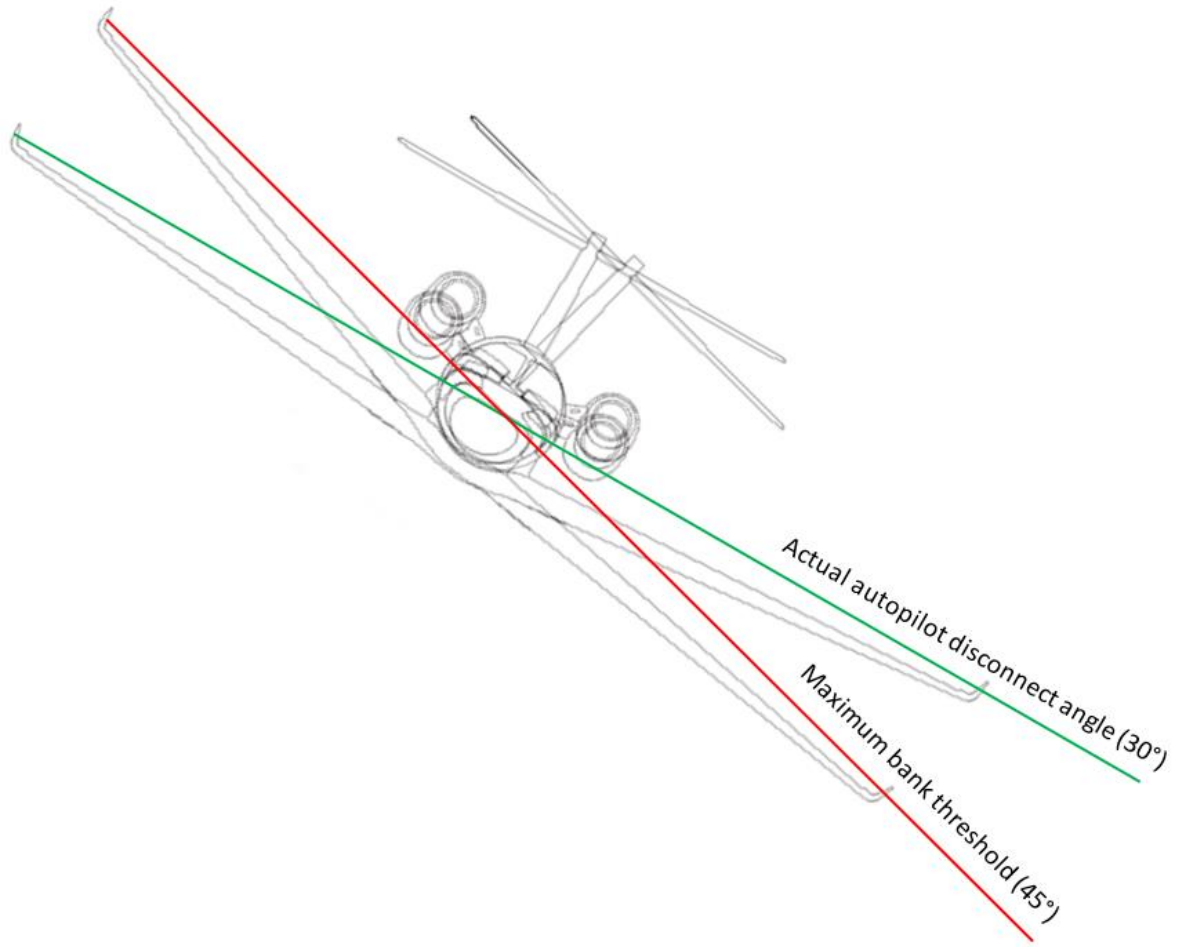
autopilot to disconnect is 45°. ⁵ The autopilot therefore did not disconnect due to excessive bank angle.

Comparison of N525EG autopilot disconnect angle vs. maximum bank threshold

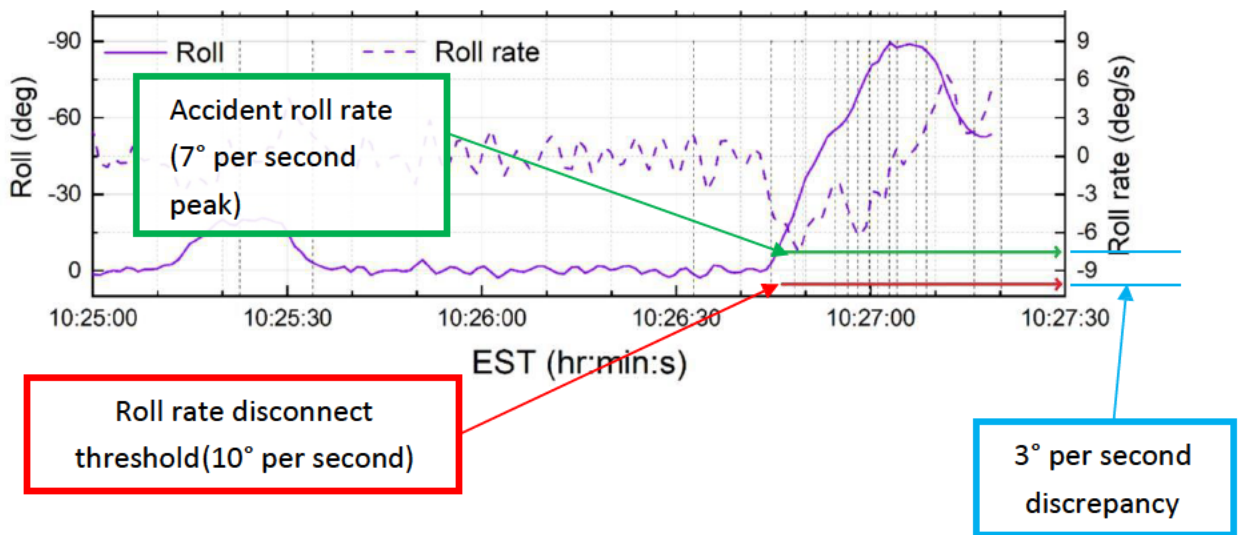
The Report also identifies a roll rate disconnect threshold of 10° per second.⁶ However, the airplane was rolling at an average rate of 5° per second throughout the uncommanded roll event, with a peak roll rate of approximately 7° per second according to the NTSB’s Performance Study.⁷ The autopilot therefore did not disconnect because of excessive roll rate. The figure below provides a comparison of the peak roll rate determined by the NTSB for the accident aircraft with the autopilot disconnect threshold of 10° per second indicated in the Report. As the figure shows, the accident roll rate only reached 7° per second at the time the autopilot automatically turned off and the pilot resumed flying the aircraft. At no point during the accident sequence did the roll rate reach 10° per second.⁸

Comparison of N525EG peak roll rate vs. roll rate disconnect threshold

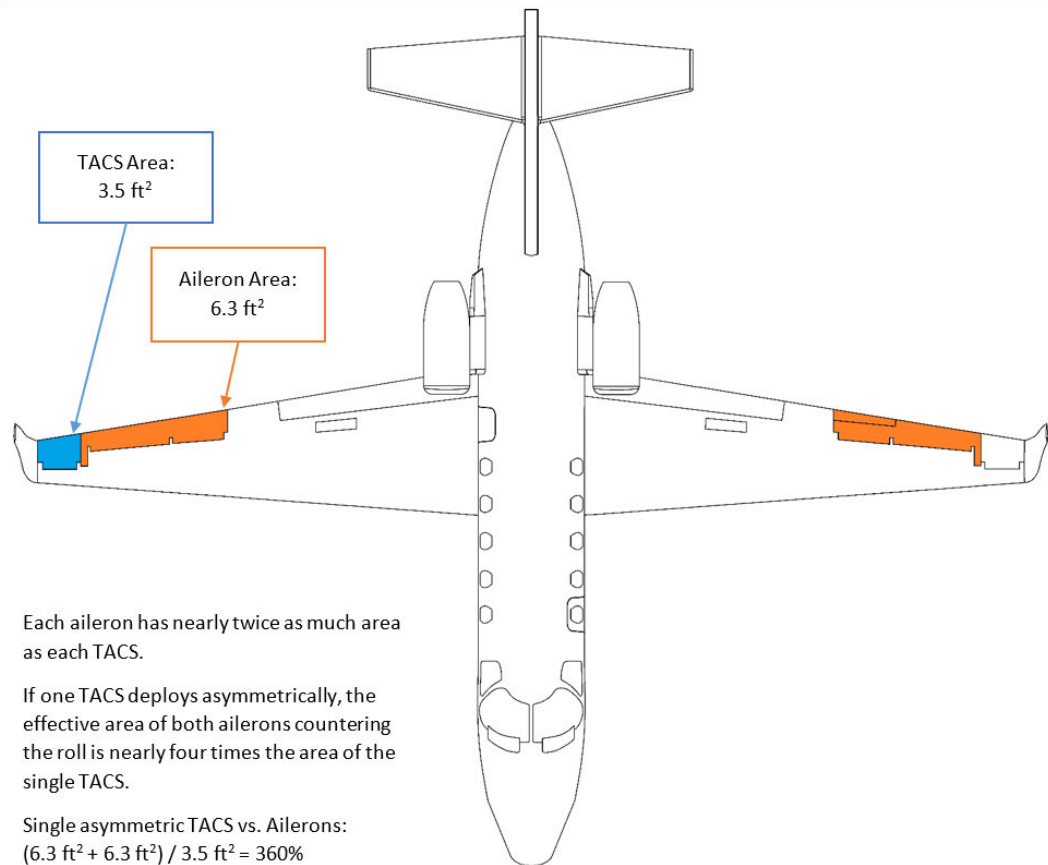
flight condition. The following graphic depiction compares the area of the TACS vs. the ailerons and is offered to show the ability of the ailerons to counter uncommanded roll events. As the graphic description states, each aileron has nearly twice as much surface area as each TACS. If one TACS deployed asymmetrically, the effective surface area of both ailerons would clearly overcome the asymmetrical TACS deflection.

Comparison of aileron area to TACS area
