SURVEY REPORT

Report No. 23101344

ALLISION BETWEEN ASSIST TUG "OLYMPIC SCOUT"

AND THE "HYLEBOS RIVER BRIDGE WEST BASCULE FENDERING"

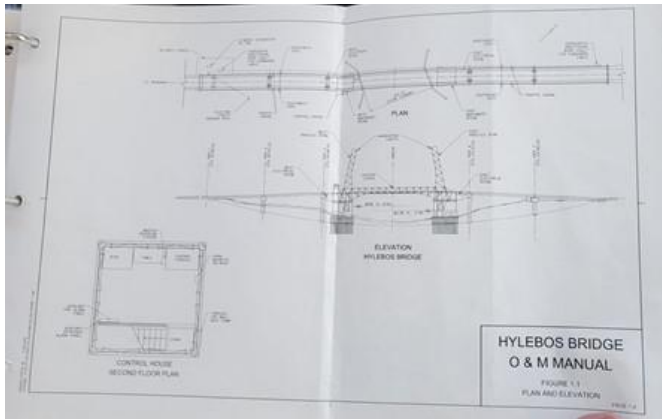
The West Bascule Span is constructed of wooden fendering and measures approximately 142’ in total length. It is comprised of three (3) sections, the two (2) outer sections measuring approximately 35’ and 50’ respectively, and the centre section – under the bridge – measuring approximately 53’ in length. The termination, and joining areas, of the three (3) sections are tied to four (4) marine dolphin cluster piles comprising of wooden timber piles surrounded a timber pile core and secured by means of wire rope wraps. The reported length of the wooden piles is 200’.

17. Hylebos bridge schematic

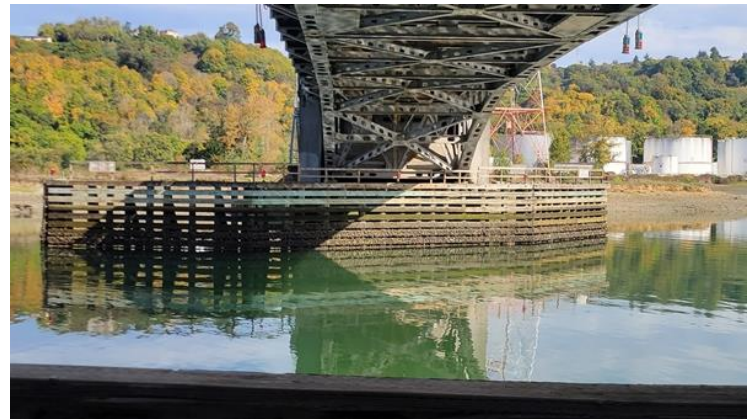
18. Undamaged east fendering

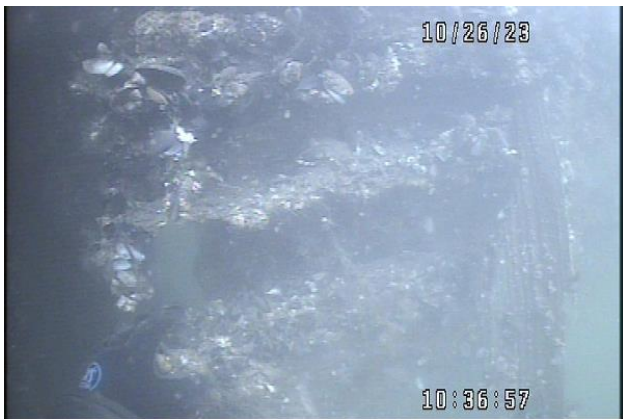
- No. 1 Batten – A end – end rot with approximately 90% loss over 6’.

25. No 1 Batten with end rot and loss

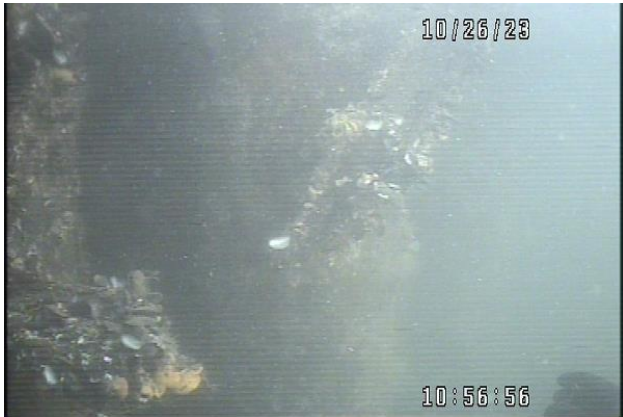
27. No 1 BC Interface - section missing

- No. 1 Batten – B to C interface – No C board section at interface.
- No. 1 Batten – C end – board completely failed over length of 20'. The South end in visually satisfactory condition.

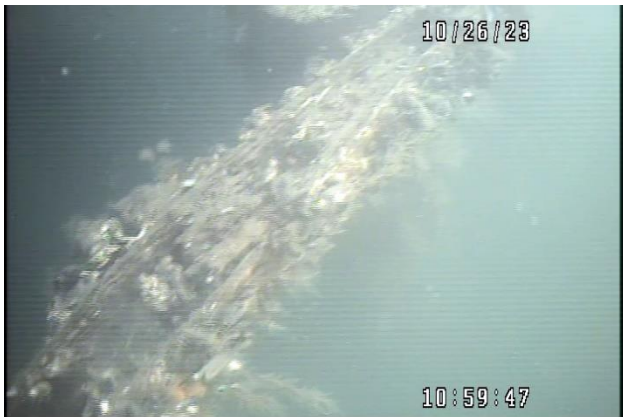
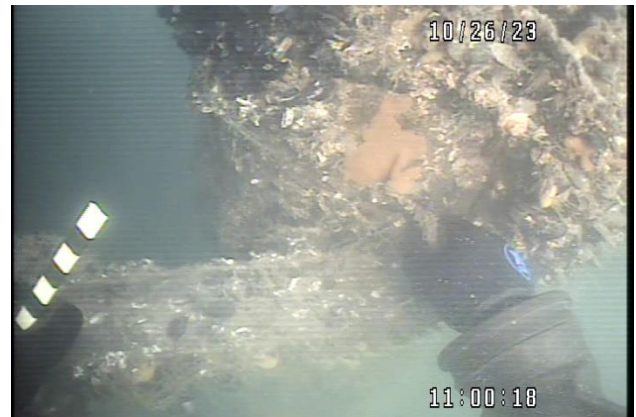
29. No 1 C batten remains

30. No 1 C batten remains

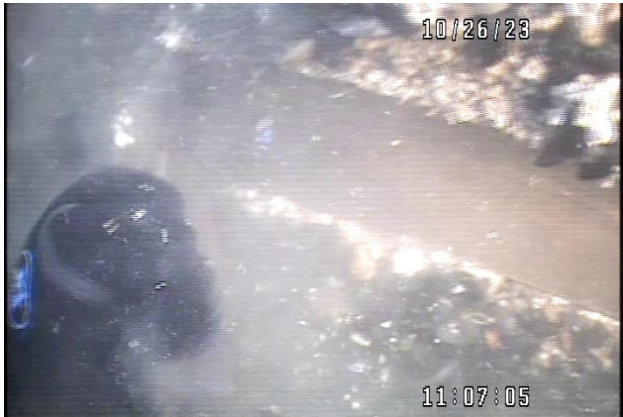
- No. 1 Batten – D end – approximately 60% of board loss over length with up to 90% loss at E end over 6'.

31. No 1 D batten complete core loss

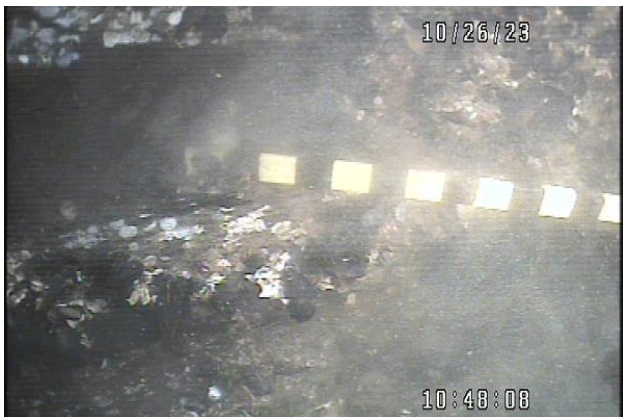
- No. 1 Batten – E end – detached from pile. Loss of approximately 90% over 6’.
- No. 1 Batten – G to F – all visually satisfactory
- No. 2 Batten – A end – end rot with approximately 90% loss over 4’.
- No. 2 Batten – B end – end rot with exposed securing hardware. Up to 50% loss of carriage bolt head, no threads remaining. Approximately 90% section loss of batten over 6’.

33. No 2 Batten B end with end rot

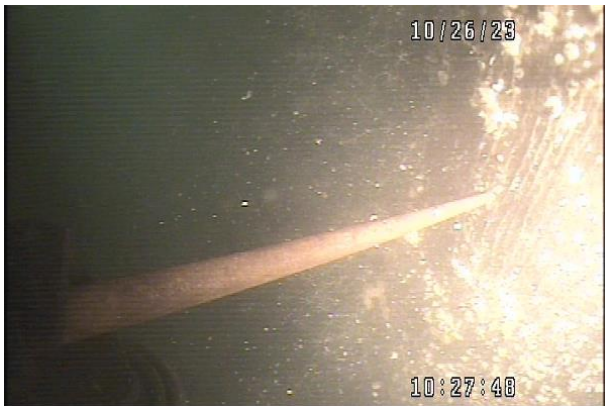
- Northern Mooring Pile – East Side: Fair condition visually. Moderate to heavy marine growth sighted on mooring pile. Less than 1/16” penetration during test.

35. N. Dolphin < 1/16” penetration

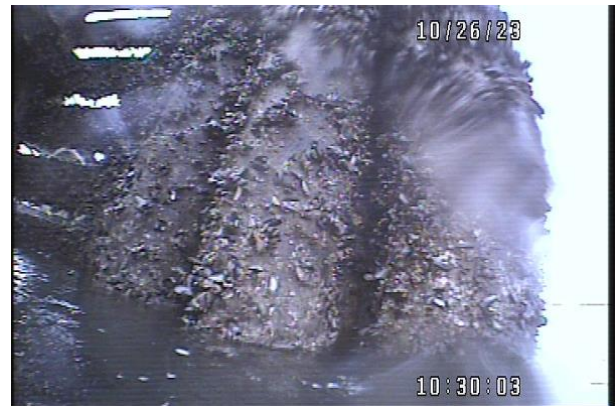
36. N. Dolphin at waterline

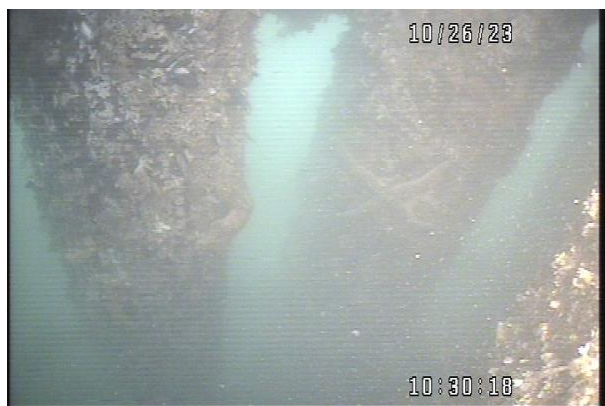
37. N. Dolphin – looking down

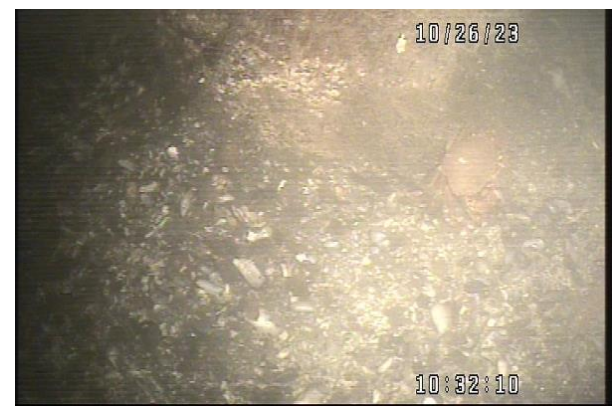
38. N. Dolphin – pile to mudline interface

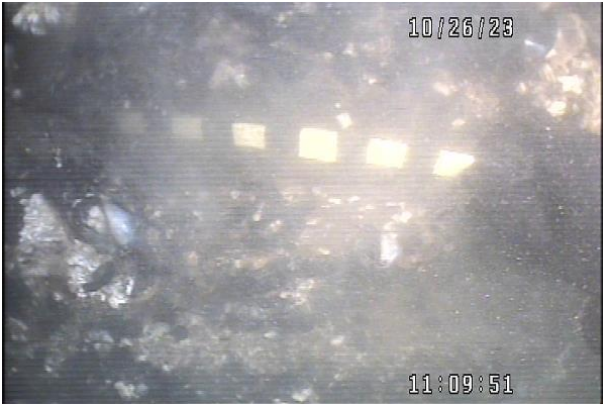
- No. 2 pile – Fender and batter pile visually satisfactory. Northern horizontal brace – 90% section loss over 4’ with hardware exposed. South horizontal brace – 50% section loss over complete length.

39. Horizontal brace section loss.

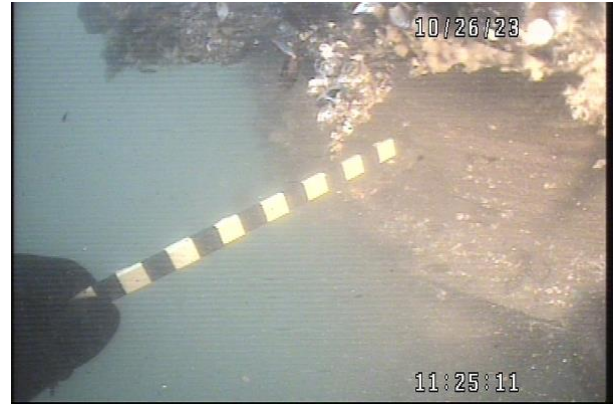
40. Securing hardware exposed.

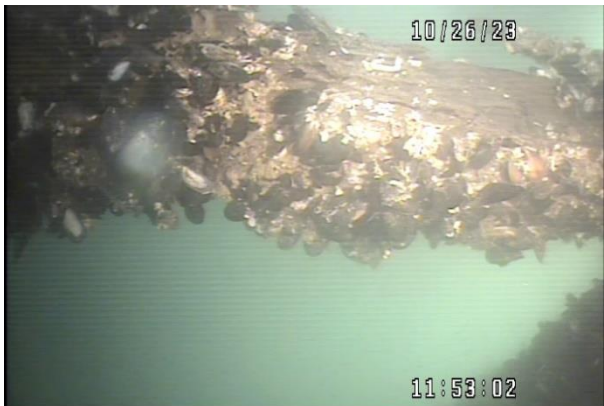
- No. 3 pile – Fender pile visually satisfactory.
- No. 4 pile - Fender pile, batter pile and horizontal braces - visually satisfactory.
- No. 5 pile – Fender pile visually satisfactory.
- No. 6 pile – Fender pile and batter pile visually satisfactory. North horizontal support missing, securing hardware exposed. South horizontal – 60% section loss over length.

41. No 6 pile – south support

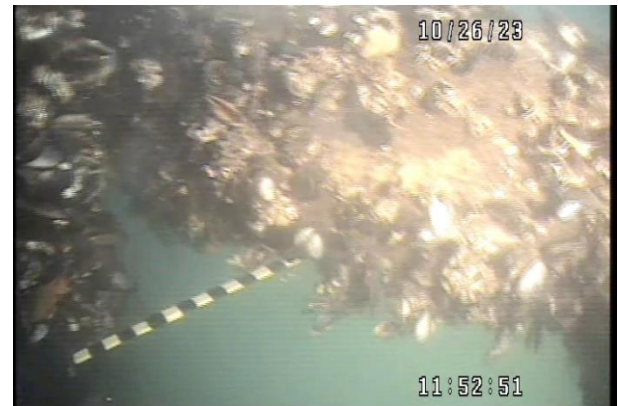
42. No 6 pile – heavy marine growth

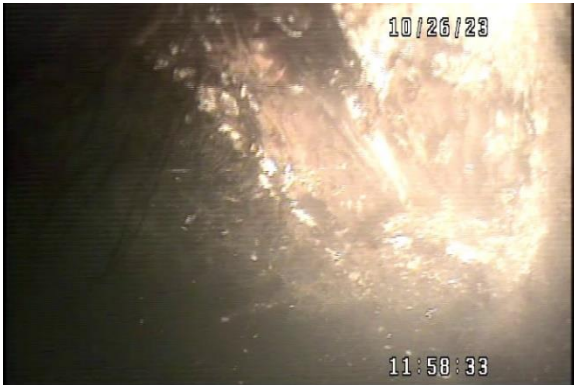
- No. 8 pile – Fender pile visually satisfactory. Batter pile – 90% section loss commencing 6’ up from mudline and extending up over 4’, above this an additional 90% section loss over 1’. North horizontal support – 90% section loss over 50% of length. South horizontal support – 90% section loss over 1’. Heavy Teredo worm tracks sighted.

43. No 8 batter pile – bottom section loss

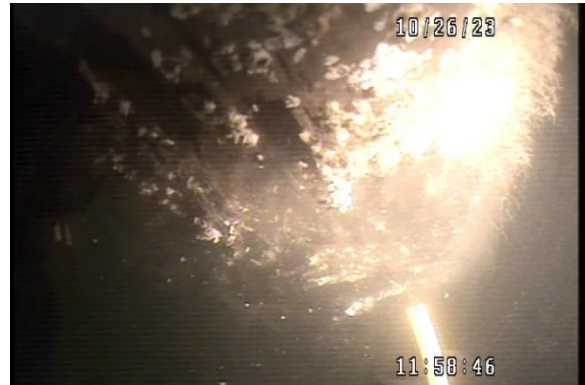
44. No 8 batter pile – worm tracks and rot

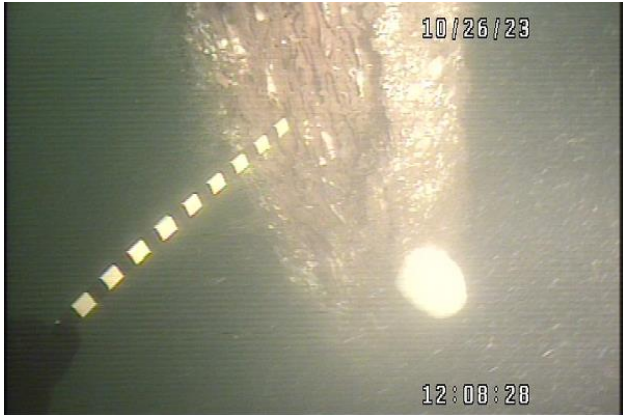
Extensive borer worm tracks sighted. North horizontal support – 50% section loss over 2'. South horizontal support – visually satisfactory condition.

45. No 16 batter pile – south support

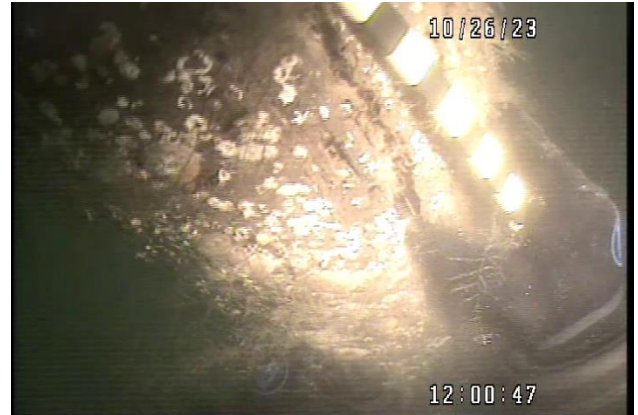
- No. 15 pile – Fender pile in visually satisfactory condition.
- No. 16 pile – Fender pile in visually satisfactory condition. Batter pile – 60% section loss from mudline extending up over 15’.

46. No 16 batter pile – worm tracks and rot

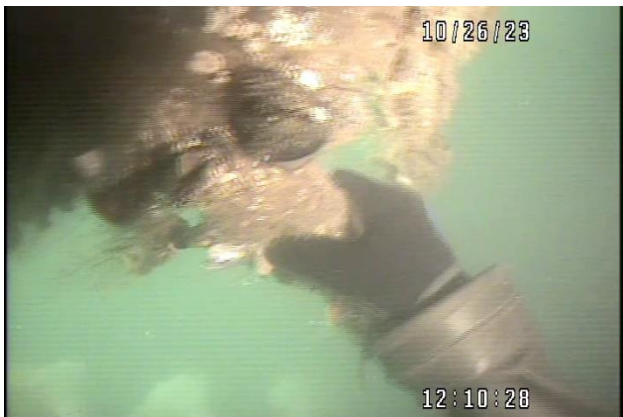
- No. 17 pile – Fender pile – lower 16' missing.

47. No 17 pile – lower section missing

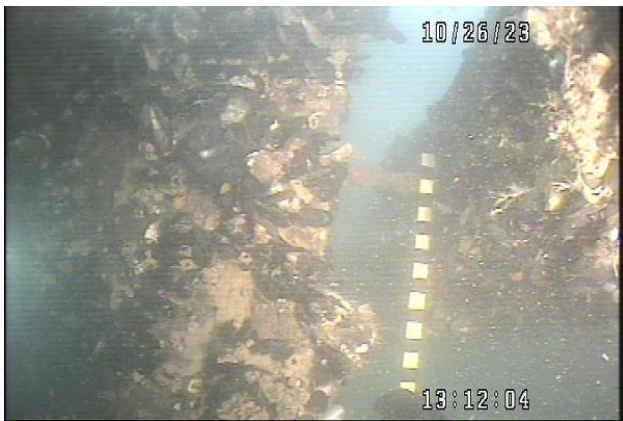
- No. 24 pile – Square vertical pile – gap of 7” between pile and cap timber. Visually satisfactory condition.

49. No 24 pile – gap between pile cap and timber

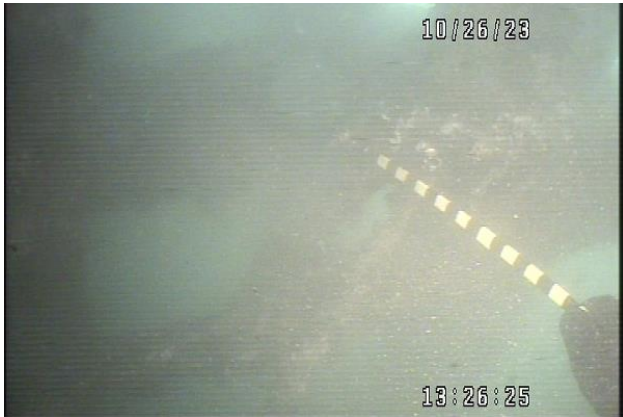
- No. 25 pile - Fender cluster No. 3 – seven (7) surrounding and one (1) center pile – pile closest to channel completely deteriorated with approximately 19’ lost.
- SE pile – approximately 70% section loss from mudline extending up over 10’. Remainder of piles visually satisfactory.

51. No 25 pile – pile deteriorated with bottom section loss

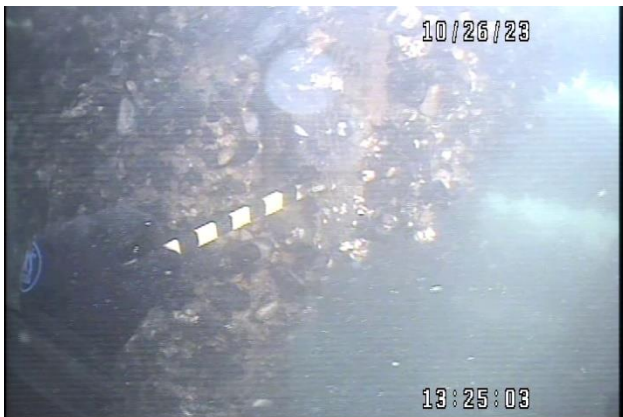
- No. 26 pile – Fender pile in visually satisfactory condition.
- No. 27 pile – Fender pile in visually satisfactory condition. Batter pile separated at 29' depth – no base. North horizontal support – end rot with wastage of approximately 50% over 12". Lower north and south horizontal supports – completely failed.

53. No 27 pile – north horizontal support end rot

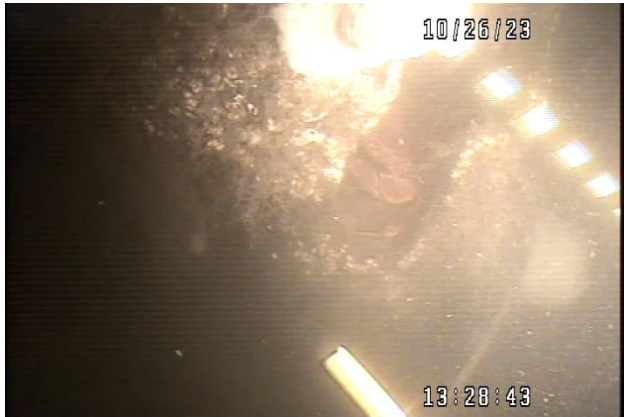
55. No 27 batter pile – fractured at mudline

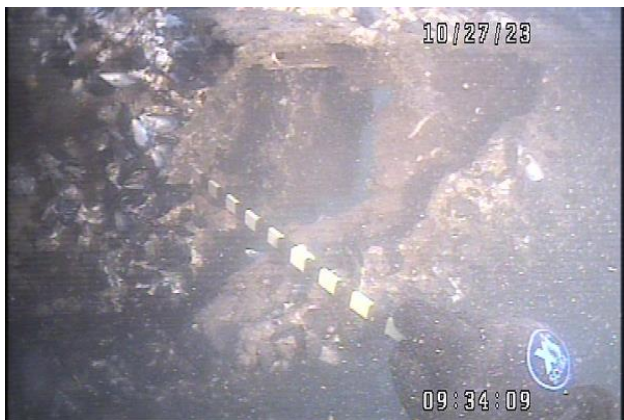
- Batten 1C – end loose and continues offshore into channel.
- Batten 2A – free/loose at either end and attached only in middle.
- Batten 2C – sighted with what appears to be impact damage.
- Batten 2G – end rot sighted – 50% core loss over 2’.
- Batten 3A – missing.
- Batten 3 D-E section – apparent impact damage.
- Batten 4 – E section – disconnected from pile no. 23 and waterlogged with age.
- Batten 5 – E section - disconnected from pile no. 23 and waterlogged with age.
- Battens at section G to F displaying heavy end rot. South section of G missing.

57. Batten 2A – 90% section loss on end

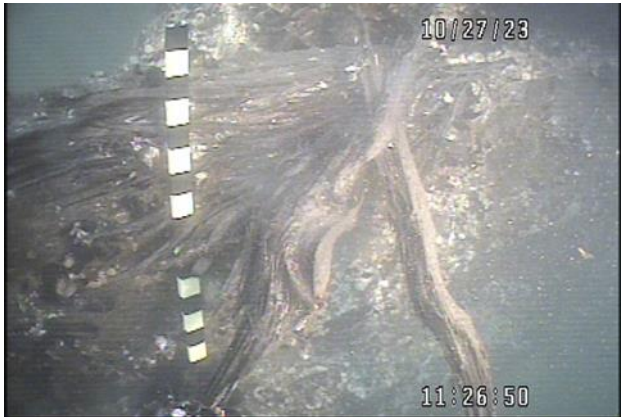
59. Batten 3 D-E section – apparent impact damage.

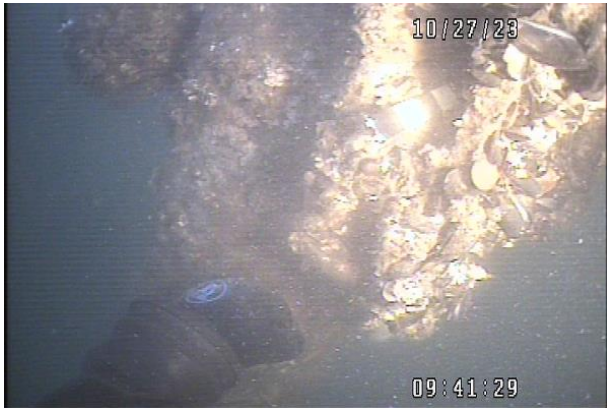
61. No 4 pile – horional with core loss

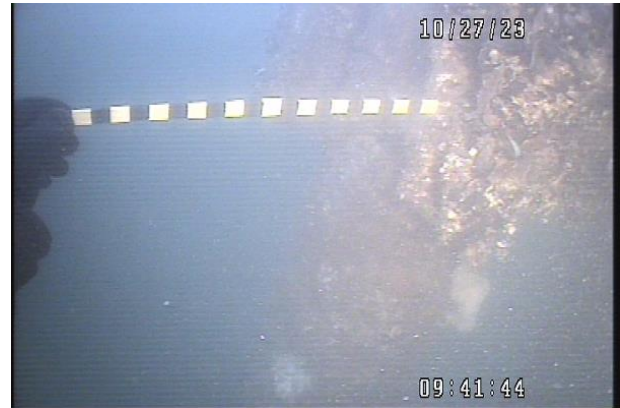
62. No 4 pile – horizontal core loss

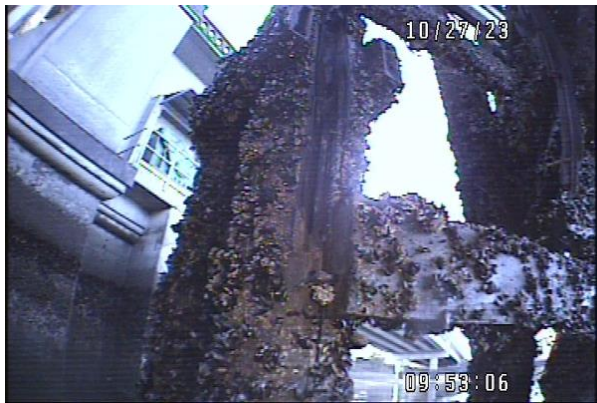
63. No. 6 pile – rotten above waterline

- No. 6 pile – Fender pile sighted with noticeable rot of approximately 80%, extending upward by 6' from HW line. Fender is pushed over from vertical by approximately 30° - sighted displaced in mudline. Batter pile – visually satisfactory condition, sighted pushed over in mudline. North and south horizontal supports – approximately 60% loss over length of 4'.
- No. 7 pile – Fender pile observed with stress flowering at base of pile due to apparent internal degradation.
- No. 8 pile – Fender pile observed broken at base above mudline. Pile visually appears rotten over 70% of base.

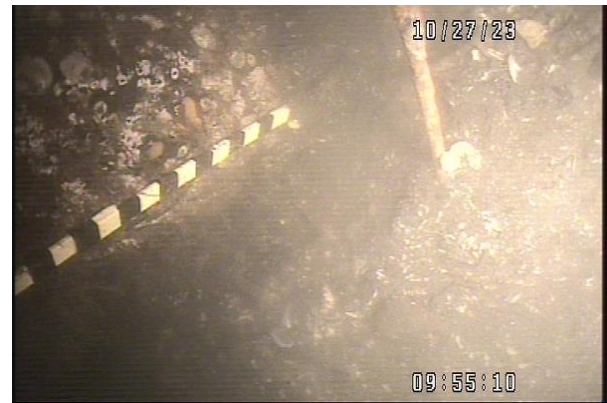
64. No. 6 batter pile – shifted in soil and erosion

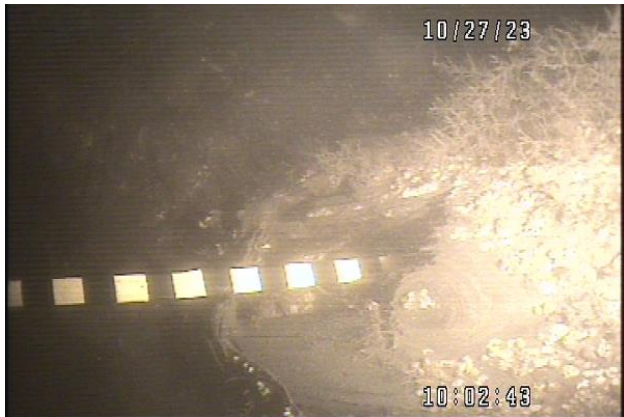
Batter pile sheared at base – pile visually appears internally rotten with heavy Teredo worm and bore worm spores. North and south horizontal supports – approximately 60% loss over length.

65. No. 8 batter pile – rotten at base

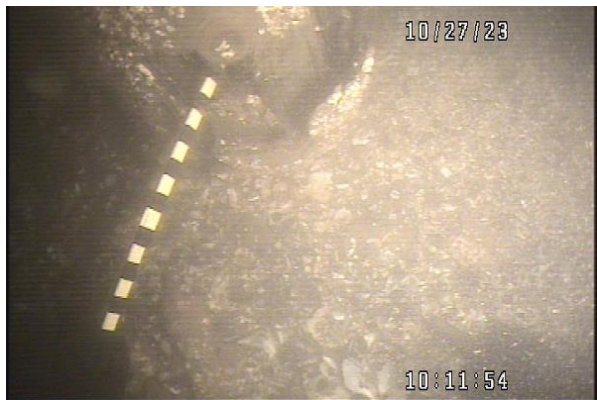
- Fender cluster No. 2 – five (5) surrounding and one (1) center pile. NW pile – severed – core of bottom half of pile visually appears to be rotted out. S pile – Severed – top half visually displays heavy internal rot with Teredo worm tracks. No core strength retained in bottom section. SW pile – fractured – heavy core rot in bottom half – estimated 80% core loss in top half. SE pile – 3” deep checks on bottom along with stress pressure flowing due to internal core rot. Center pile fractured and shifted – lying on SE pile.

67. No. 2 pile cluster – N pile – rotted base

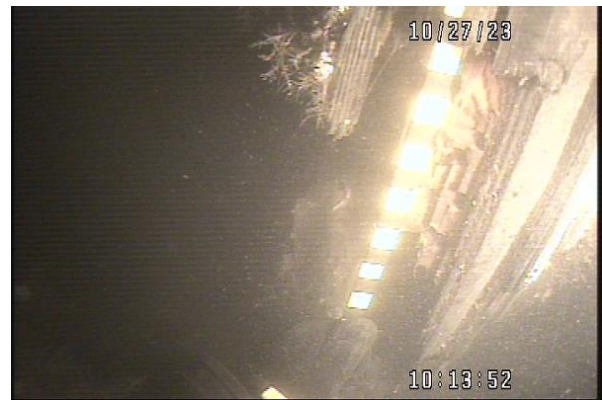
68. No. 2 pile cluster – NW pile – severed and with heavy worm tracks

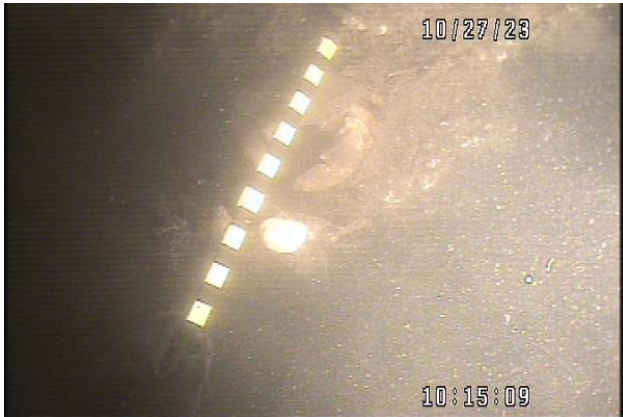
69. No. 2 pile cluster – SW pile - rotten

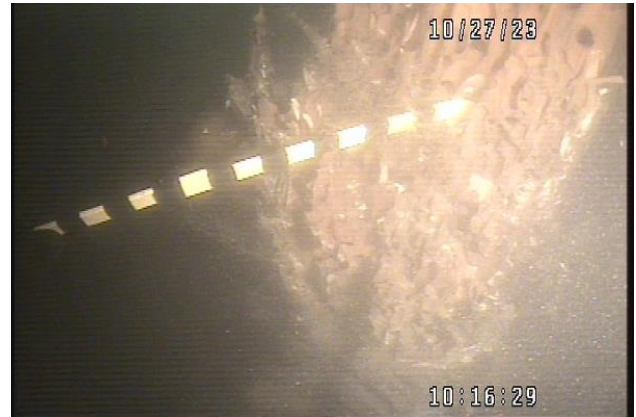
70. No. 2 pile cluster – SW pile rotten – looking down

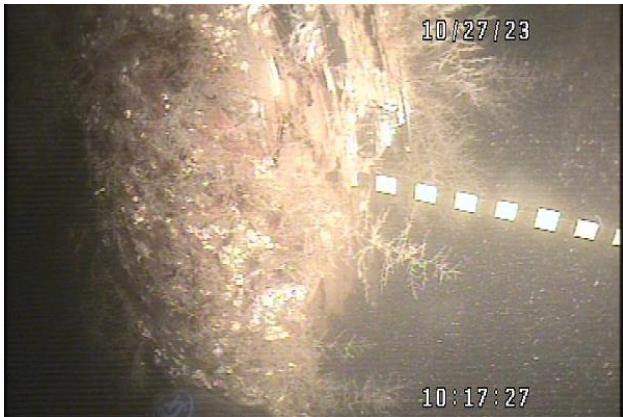
71. No. 2 pile cluster – SE pile – rot with worm tracks

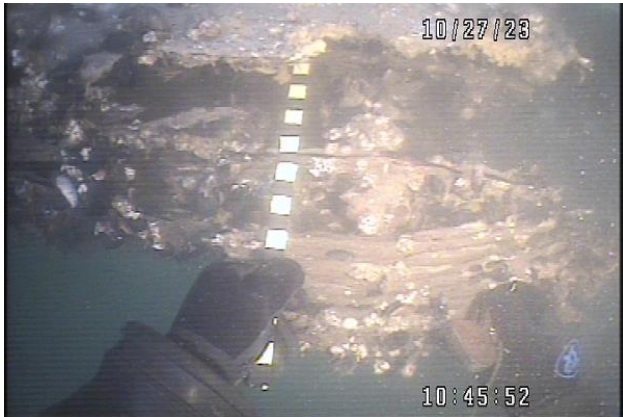
- No. 9 pile – Fender pile (square post) – visually satisfactory condition but pushed over from vertical by up to 45°.
- No. 10 pile – Fender pile sighted set over from vertical at a 60° angle to the North. Heavy core rot sighted above water. Heavy checking sighted below waterline with the mudline interface flowered out due to rotted center core.

73. No. 10 pile – horizontal cap timber – heavy rot

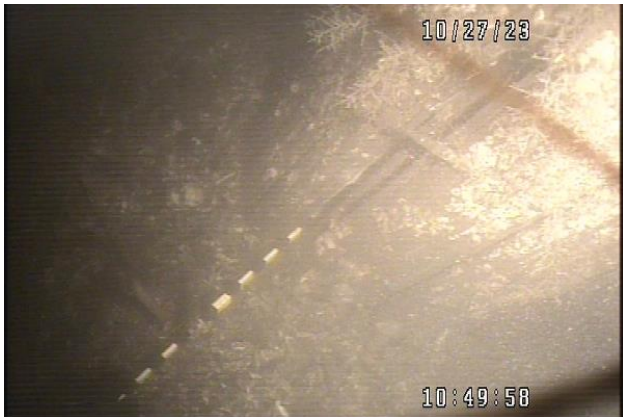
75. No. 10 pile – heavy checking below waterline – possible internal core rot

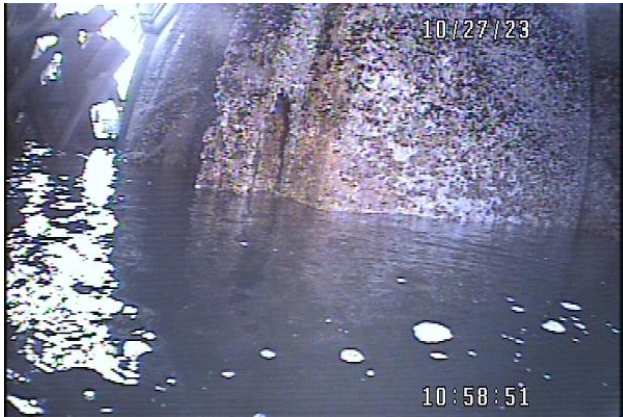
- No. 11 pile – Fender pile in visually satisfactory condition. Sighted displaced in mudline and set over, from vertical, to the north. Fender pile in visually satisfactory condition. Sighted displaced in mudline and set over, from vertical, to the north.
- No. 12 pile – Fender pile in visually satisfactory condition. Sighted displaced in mudline and set over, from vertical, to the north. A bracing timber – from pile to bridge displays heavy timber rot. Vertical timber fitted to bridge base also sighted with heavy rot and with timber core reduced.

77. No. 12 pile – pier connected board rot

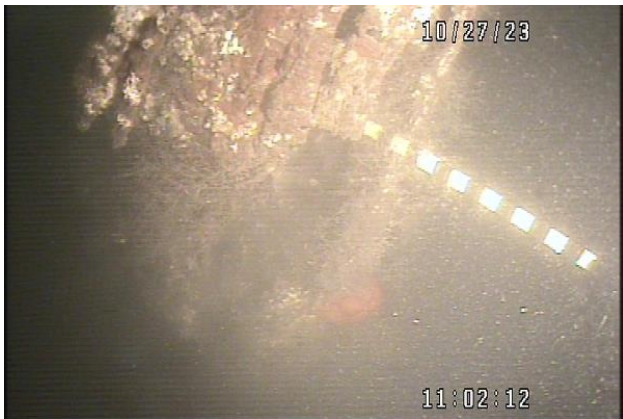
- No. 13 pile – Fender pile in visually satisfactory condition. Sighted displaced in mudline and set over, from vertical, to the north.
- No. 14 pile – Fender pile, from mudline interface extending up over 15' – approximately 90% core loss. Pile completely severed with 19" separation between sections. Sections visually sighted as hollow with no core strength.

79. No. 14 pile – rot at 15' down with 90%
section loss

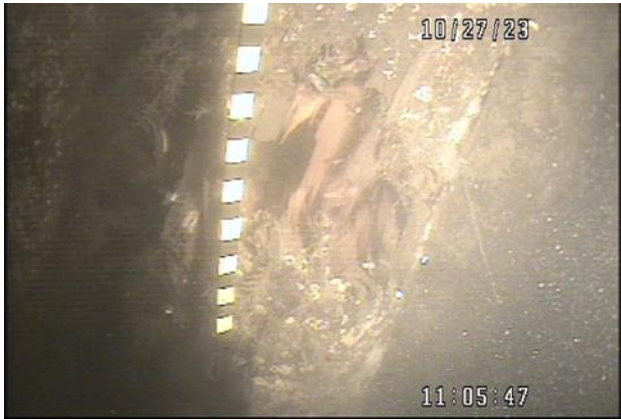
- No. 15 pile – Fender pile broken and hollowed out at height of 15'.

81. No. 15 pile – broken with over 90% core loss at 22’

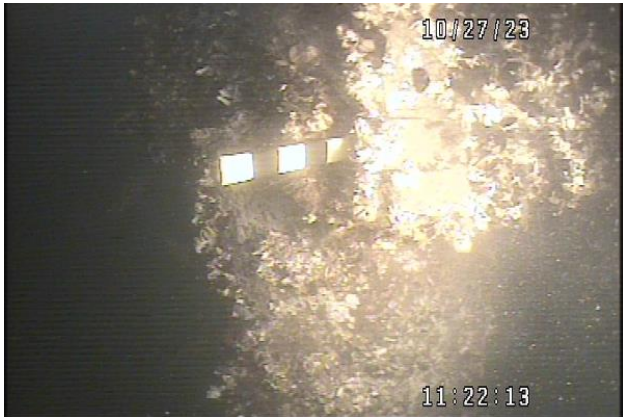
- No. 19 pile – Fender pile in generally satisfactory condition, but set over from vertical to north. Pressure flowering sighted at mudline interface.
- No. 20 pile – Fender pile in generally satisfactory condition, but set over from vertical to north. Pressure flowering sighted at mudline interface. Batter pile completely separated at 27’ with heavy core rot observed. North horizontal support – minor surface rot. South horizontal support – approximately 60% loss over 4’.

83. No. 20 pile – south horizontal support end rot with 60% core loss over 4’

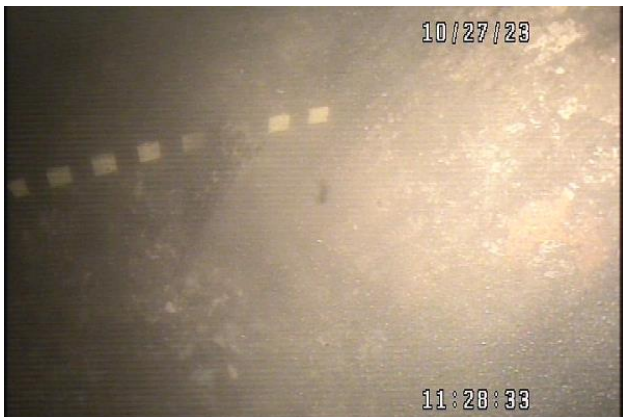
- No. 21 pile – Fender pile fractured at mudline interface with checks and stress flowering sighted on surface.

85. No. 21 pile – fractured at mudline interface with checks and stress flowering sighted on surface.

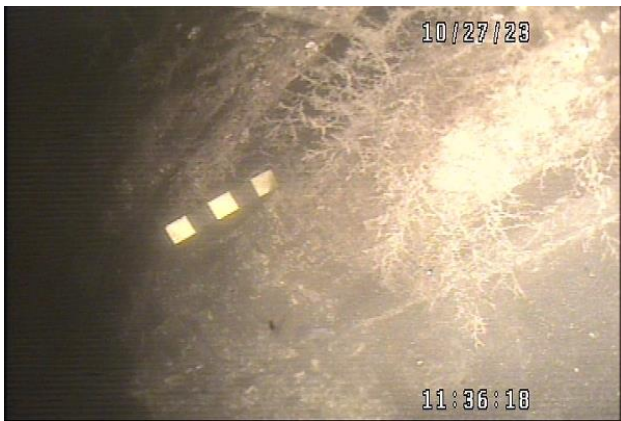
87. Fender Cluster 3 NE pile – broken at mudline interface

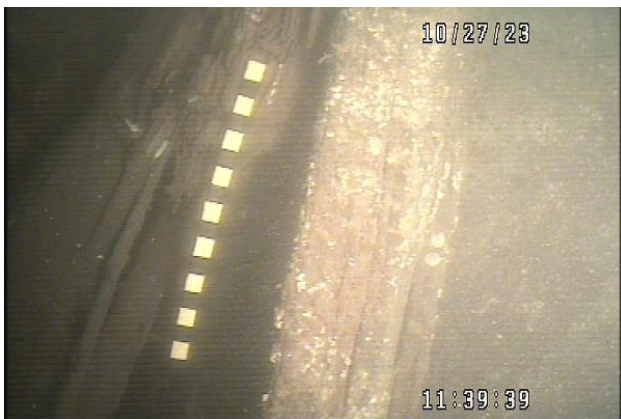
89. Fender Cluster 3 SE pile – broken with heavy rot

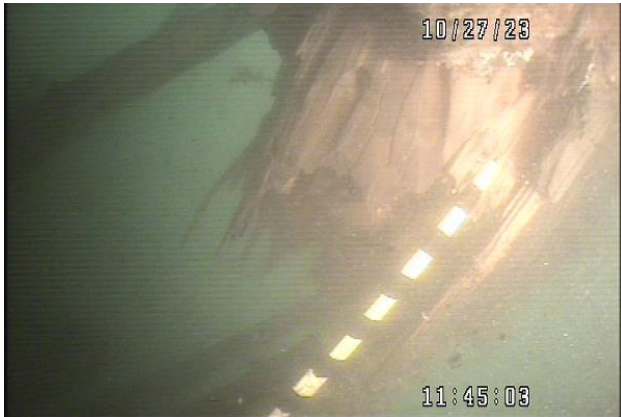
91. Fender cluster 3 SE pile – broken with heavy rot

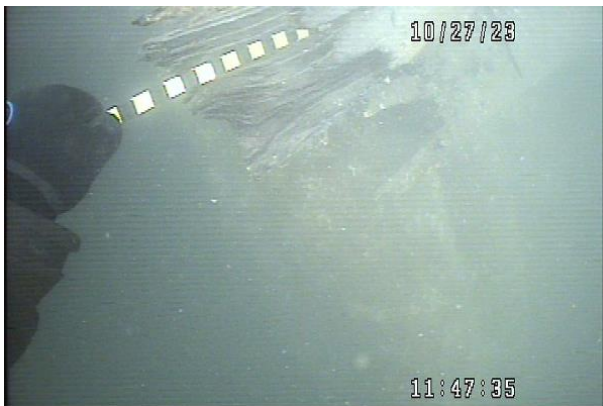
93. Fender cluster 3 – connecting fenders rotten and broken off

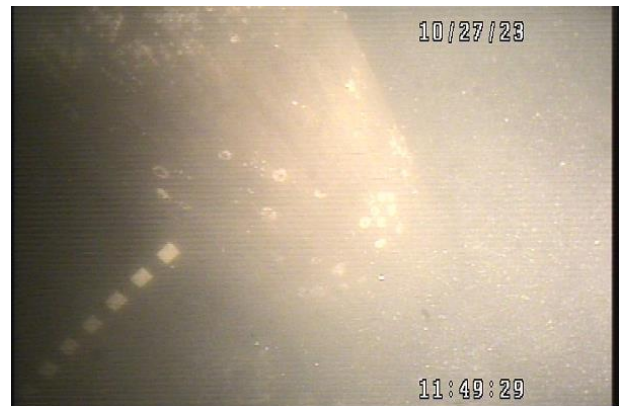
94. Fender cluster 3 W pile – pressure flowering at mudline

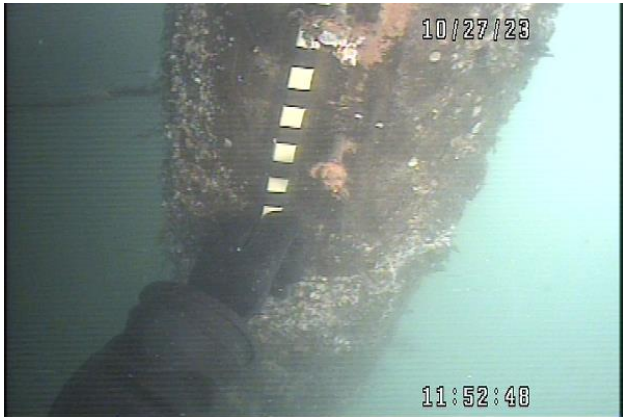
- No. 24 pile – Fender pile in visually satisfactory condition except very top of pile split open. Core, where sighted, appears to be without rot. Batter pile sighted displaced in mudline interface and in visually satisfactory condition. North and south horizontal supports missing.

95. No. 24 pile – north and south horizontal supports missing

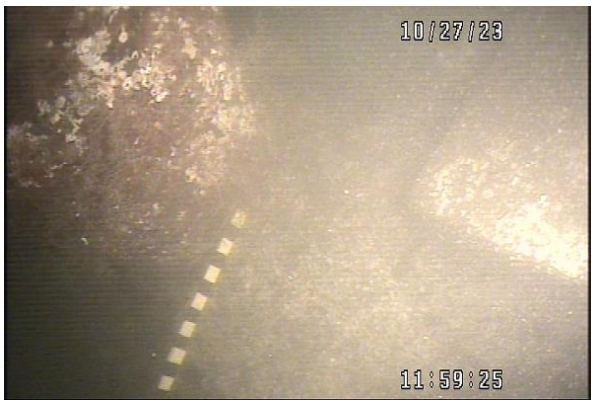
97. No. 26 pile – surface checking and pressure flowering at mudline interface

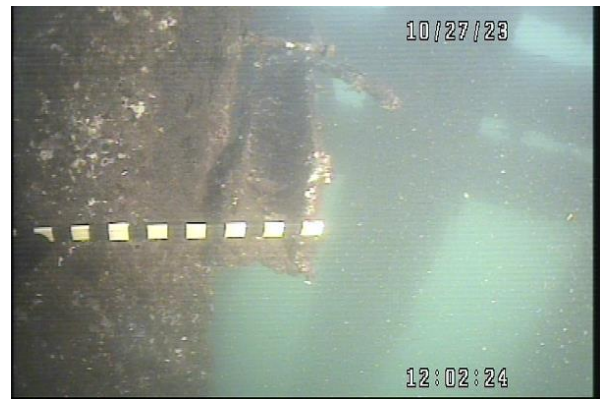
- No. 25 pile – Fender pile sighted with underwater surface section loss of approximately 10%. Surface checking and pressure flowering at mudline interface also observed.
- No. 26 pile – Fender pile and batter pile sighted with surface checking and pressure flowering at mudline interface. Batter pile also sighted with surface loss due to borers. North horizontal support – missing. South horizontal support – approximately 90% loss over full length.

98. No. 26 pile – south horizontal section loss of 90% over length

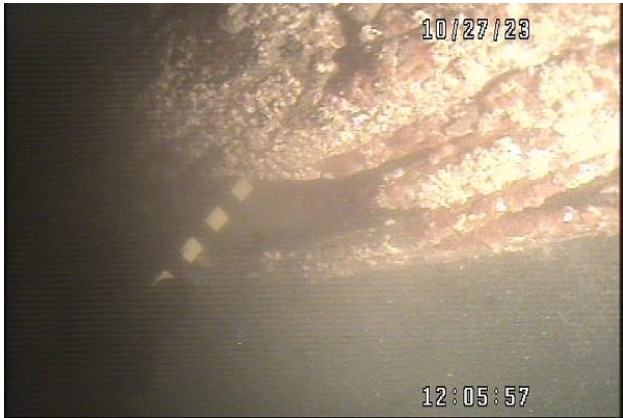
- No. 28 pile – Fender pile sighted with checking and surface section loss. Batter pile – approximately 90% section loss and core hollowed out at mudline interface. North horizontal support – approximately 90% section loss over length. South horizontal support – missing.

99. No. 28 batter pile – approximately 90% section loss and core hollowed out at mudline interface.
- No. 29 pile – Fender pile in visually satisfactory condition with only light surface checking observed.

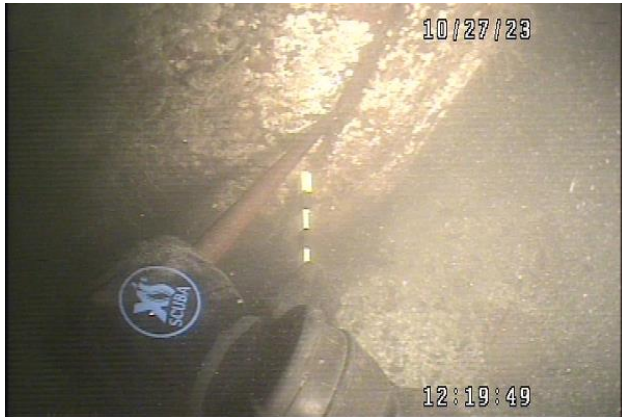
100. Fender cluster 4 – S pile – core rot measured at 11” at base with rot extending up to half of pile height

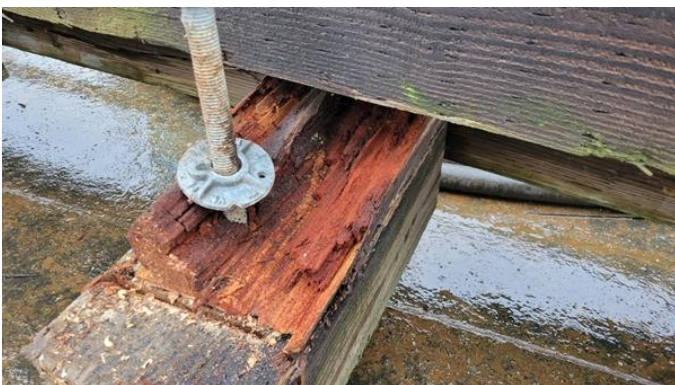
120. Catwalk timber – soft and powdery

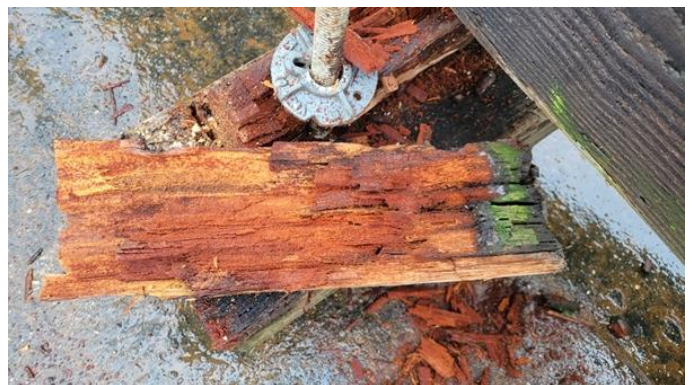
121. Catwalk timber soft and powdery

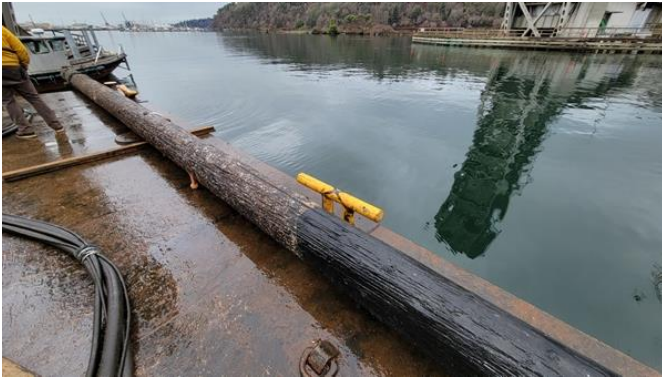
0904hrs – Catwalk from South wing wall landed on barge.
0910hrs – Prep pile no. 25 for removal.
0917hrs – commence pulling pile.
0946hrs – Pile no. 25 free
0948hrs – Pile no. 25 landed on barge deck. Observed with approximately 10% section loss.
The underwater survey originally indicated surface section loss of approximately 10%. Surface checking and pressure flowering at mudline interface)

122. Pile No 25 on barge

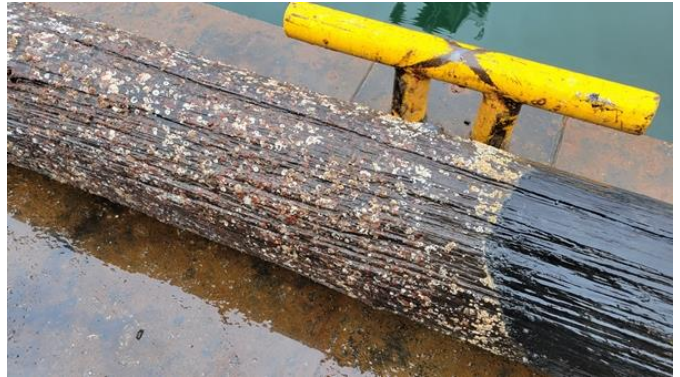
123. Pile 25 – surface checking

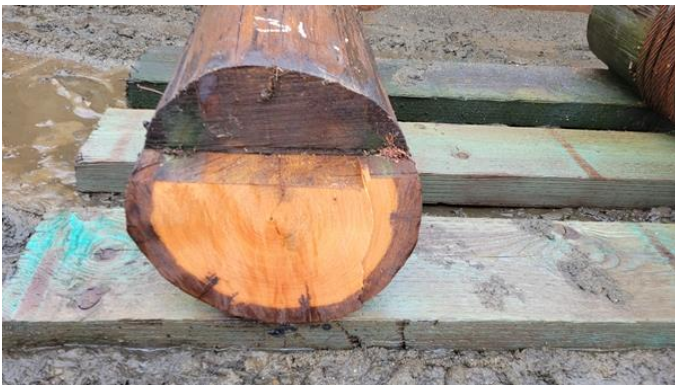
- Top section pile 31 – good condition. The underwater survey originally indicated pressure flowering at mudline interface.
- Top section pile 30 – section loss observed over length – rotting in core. The underwater survey originally indicated approximately 15% surface section loss at mudline interface due to borers.
- Top section batter pile 30 – fair condition. The underwater survey originally indicated approximately 10% surface section loss at mudline interface due to borers. North horizontal support – rotted and separated – full loss over length. South horizontal support – missing.

124. Top of pile No 31 – visually satisfactory

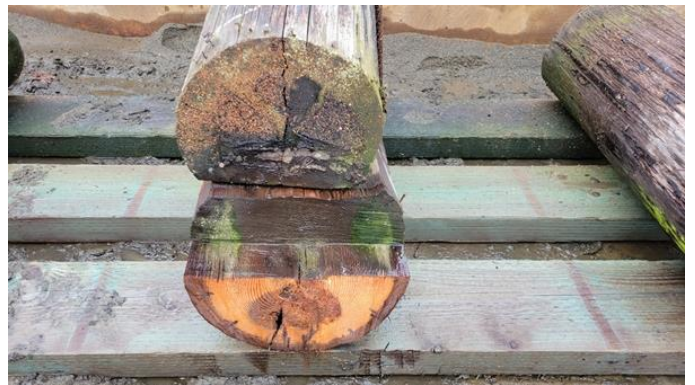
125. Top of pile No 30 – rotting of core section

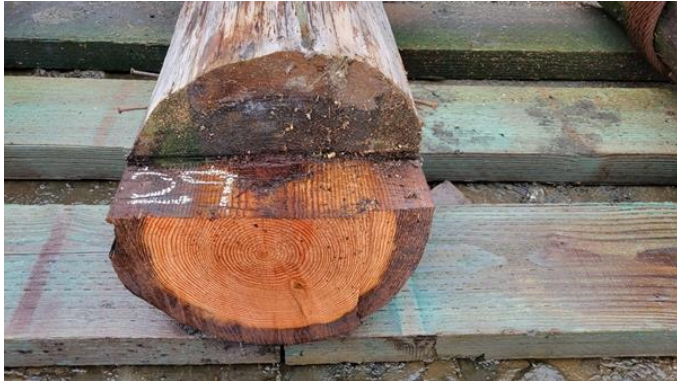
- Top section pile 29 – fair condition. The underwater survey originally indicated fender pile in visually satisfactory condition with only light surface checking.

126. Top of Pile No 29 – visually satisfactory

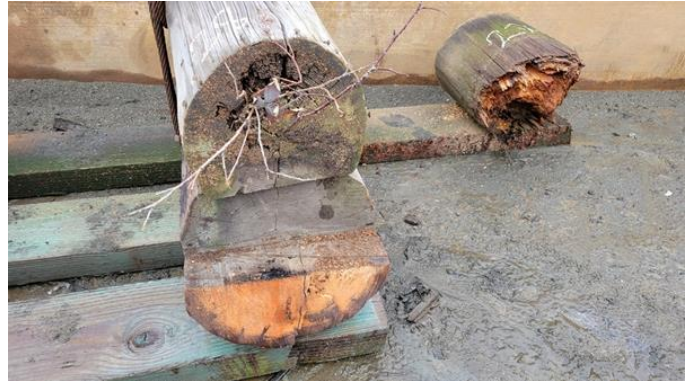
- Top section pile 28 – core deterioration observed. The underwater survey originally indicated fender pile sighted with checking and surface section loss.

127. Top of Pile No 28 – core deterioration visually observed

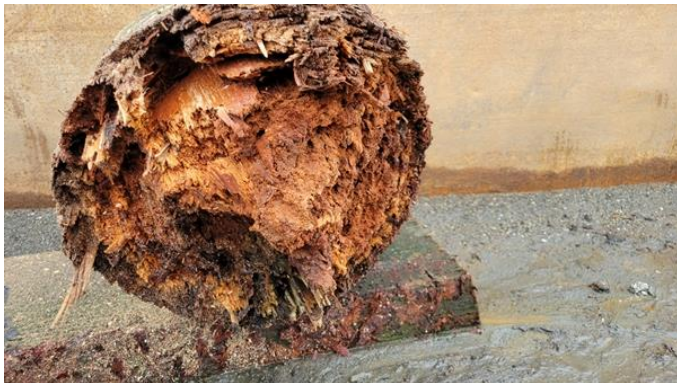
- Top section pile 27 – poor condition, core rotten, very powdery. The underwater survey originally indicated fender pile sighted with approximately 10% surface lost – remainder in visually satisfactory condition.

128. Top of Pile No 27 – visually poor condition, core rotten, very powdery

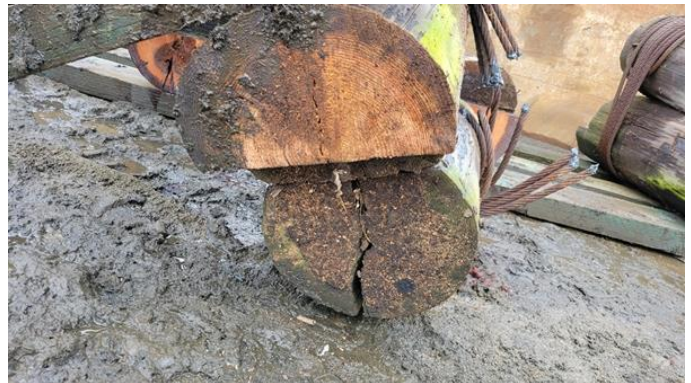
- Top section Pile 26 – fair condition. The underwater survey originally indicated Fender pile and batter pile sighted with surface checking and pressure flowering at mudline interface.

129. Top of Pile No. 26 – visually fair condition

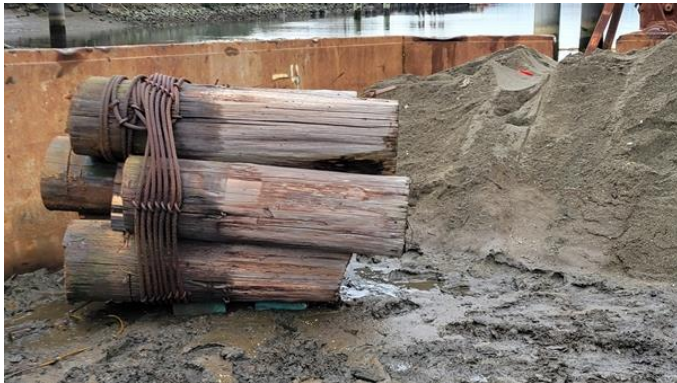
130. Top of No 4 cluster – general view

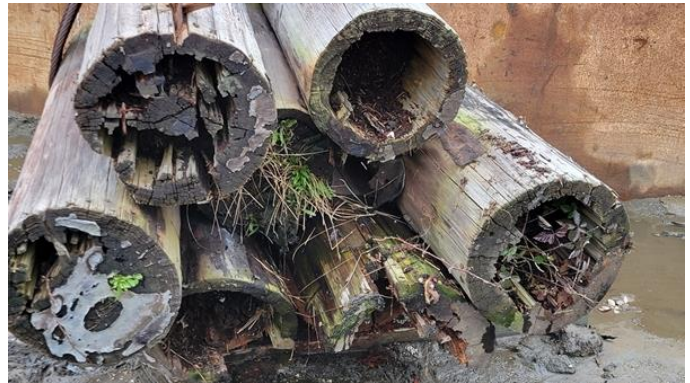
1113hrs – Prep number 4 pile cluster for lifting - South cluster South Wing Wall. Top 5 ft cropped for removal.
1205hrs – Commence pulling cluster.
1210hrs – Number 4 pile cluster top section landed on barge - tops of all seven (7) clusters visually observed with extensive core deterioration. Bottom section of three (3) of seven (7) clusters with rotting observed. The underwater survey originally indicated six (6) surrounding and one (1) center pile. NW pile – sighted with checking and pressure flowering at mudline interface. N pile – sighted with checking and pressure flowering at mudline interface, along with heavy worm tracks. NE pile – approximately 10% surface section loss. Center pile – sighted with checking and pressure flowering at mudline interface. S pile – at mid-pile height – tapping on pile indicated hollow section with potential full core rot and no remaining core strength.

131. Top of No 4 cluster – extensive core deterioration observed

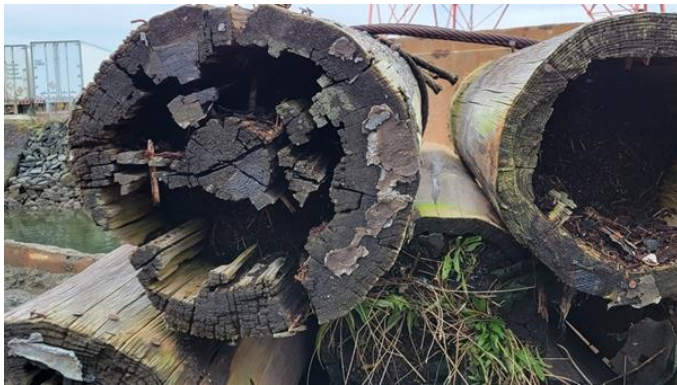
132. Top of No 4 cluster – extensive core deterioration observed

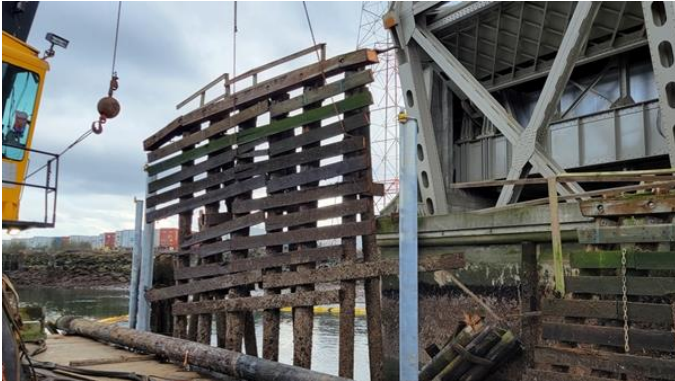
134. Rear section – center wing wall – being lifted

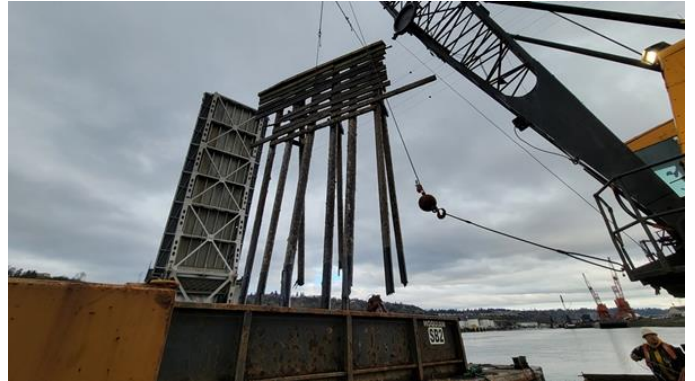
135. Rear section – center wing wall – being lifted

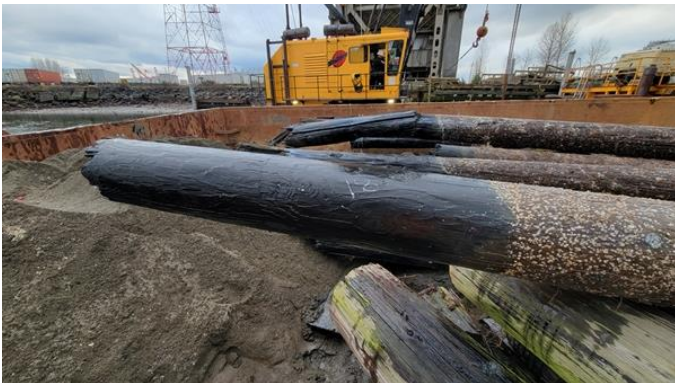
136. Pile No 18 – broken off below mudline

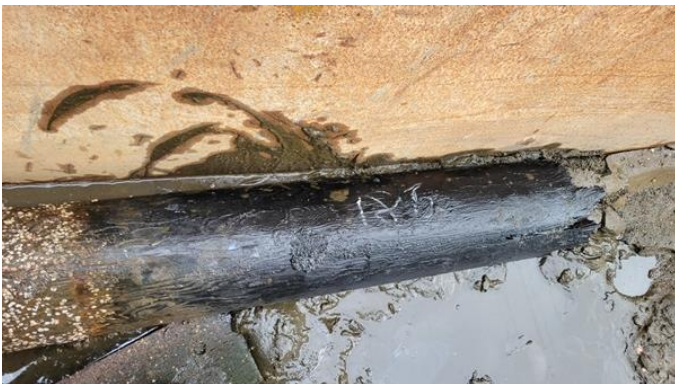
138. Pile 18 batter pile – broken off below mudline

The underwater survey originally indicated No. 18 fender pile No. 18 in a visually satisfactory condition and No. 18 batter pile sighted set over from vertical towards north. Pressure flowering sighted at mudline interface. North and south horizontal supports sighted with core and end rot of approximately for approximately 50% loss over full length.

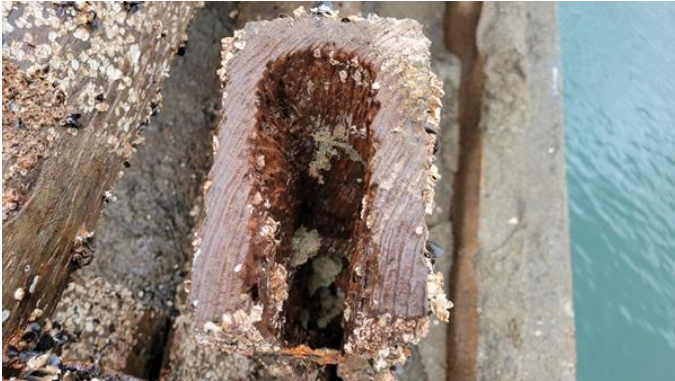
140. Pile No 18 lower horizontal support
– extensive core wastage noted.
