SURVEY REPORT

Report No. 23101344

ALLISION BETWEEN ASSIST TUG "OLYMPIC SCOUT"

AND THE "HYLEBOS RIVER BRIDGE WEST BASCULE FENDERING"

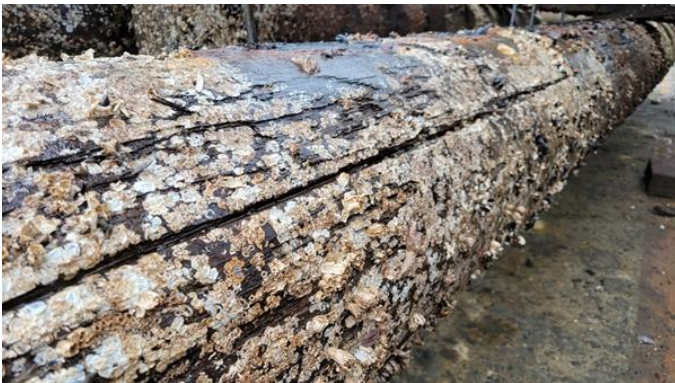
142. Pile No 19 – cracks observed over
length of pile

The underwater survey originally indicated No. 19 fender pile in generally satisfactory condition but set over from vertical to north. Pressure flowering sighted at mudline interface.

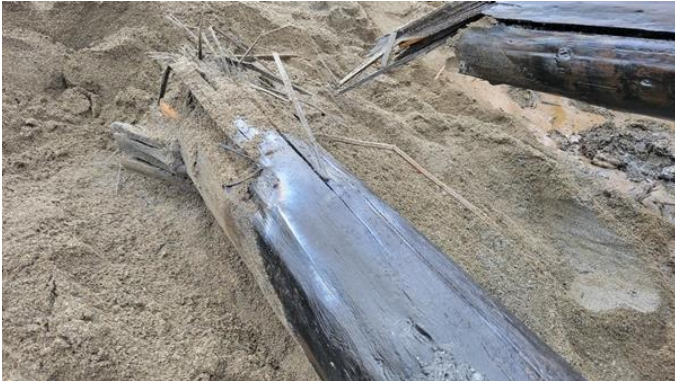
144. Pile No 20 – broken off below mudline

The underwater survey originally indicated No. 20 fender pile was in generally satisfactory condition but set over from vertical to north. Pressure flowering was sighted at mudline interface.

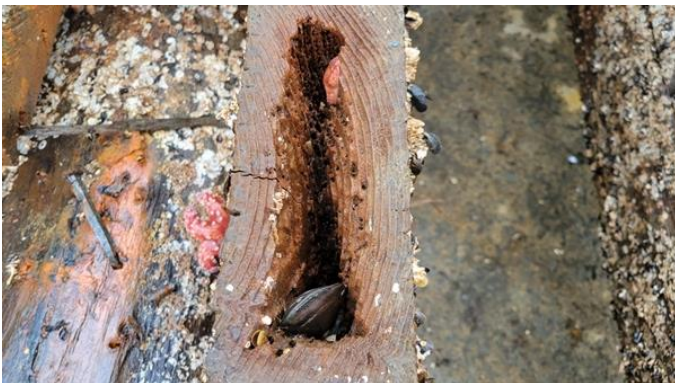
The batter pile was completely separated at 27' with heavy core rot observed. The north horizontal support displayed minor surface rot. The south horizontal support displayed approximately 60% loss over 4'.

146. Pile No 20 horizontal support with core loss.

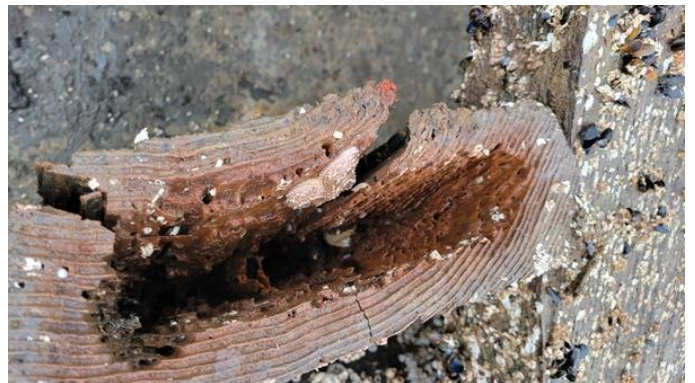
147. Pile No 20 horizontal support with core loss.

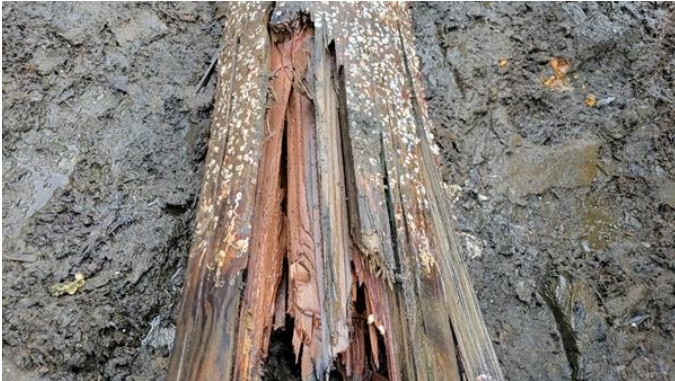
148. Pile No 20 batter pile – broken off at mudline – wastage of core and heavy worm tracks noted

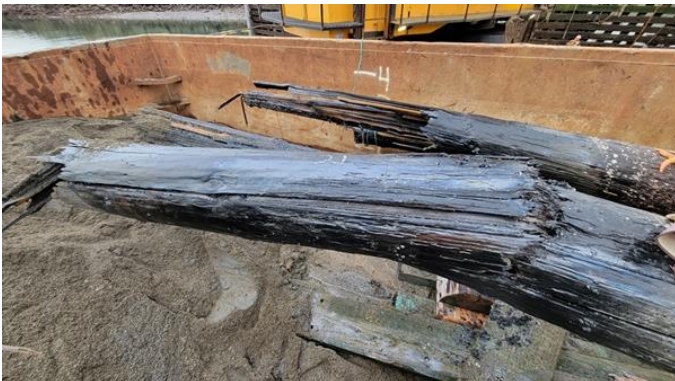
150. Pile No 21 – broken off below mudline

The underwater survey originally indicated No. 21 fender pile fractured at the mudline interface with checks and stress flowering sighted on the pile surface.

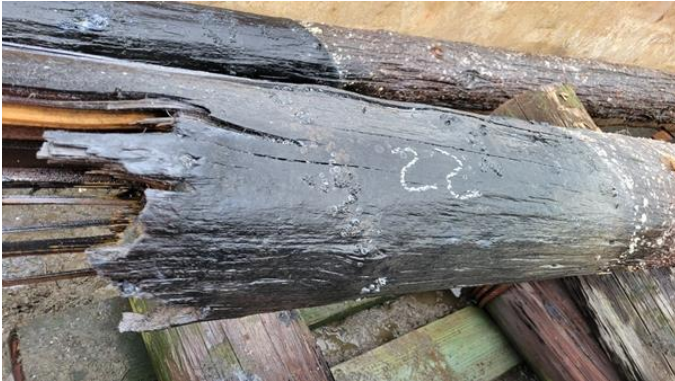
152. Pile No 22 – broken off at mudline –
wastage of core observed

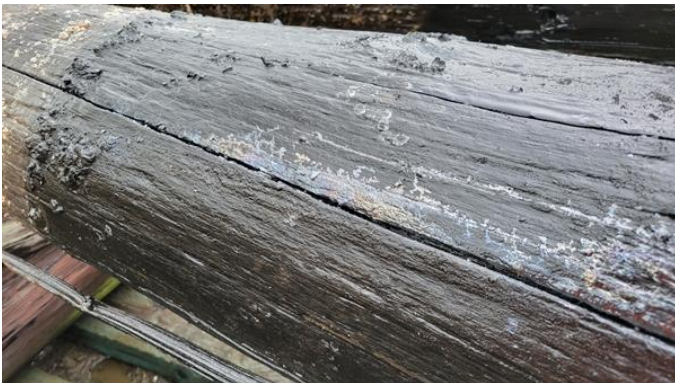
154. Pile No 22 – surface checking

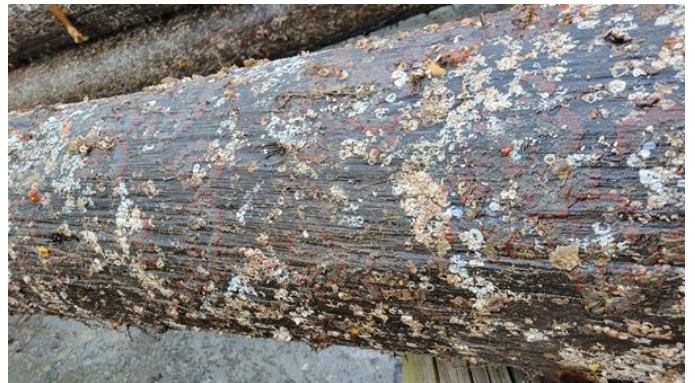
155. Pile No 22 – surface checking

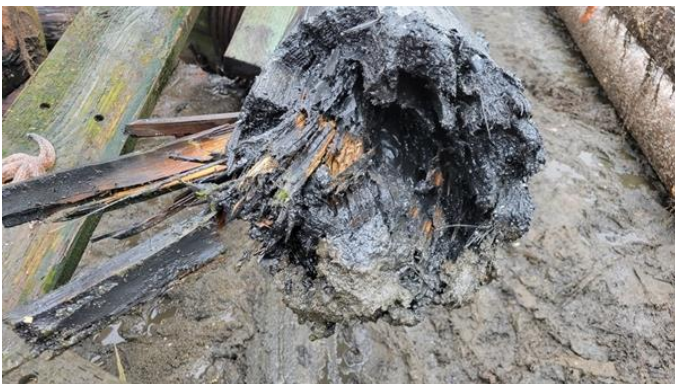
156. Pile No 22 batter pile – wastage of
core

The underwater survey originally indicated No. 22 batter pile was in visually satisfactory condition. North horizontal support – core rot over approximately 60% over full length.

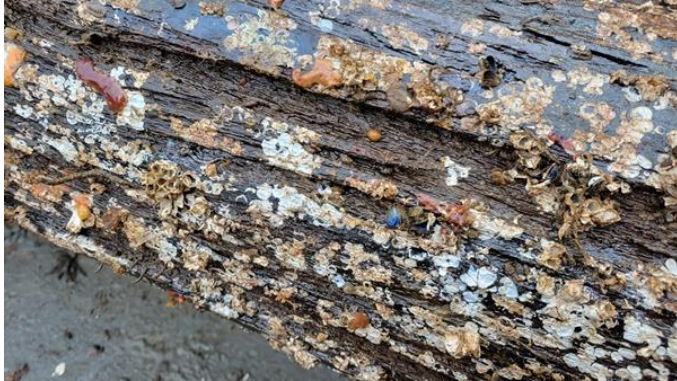
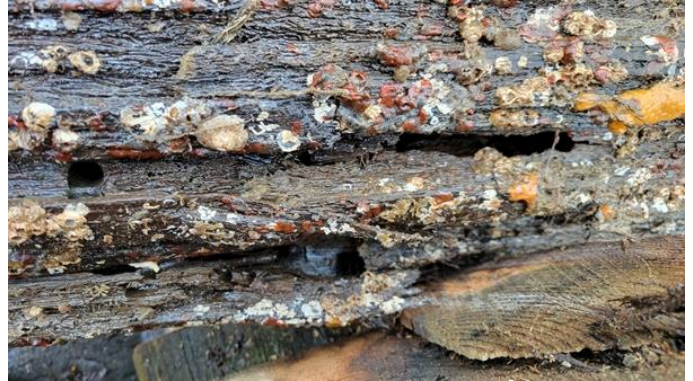
158. Pile No 23 – core loss due to borers

159. Pile No 23 – core loss due to borers

The underwater survey originally indicated No. 23 fender was observed with approximately 10% surface loss due to borers over full length and set over from vertical to the north. Stress flowering sighted at base at mudline interface.

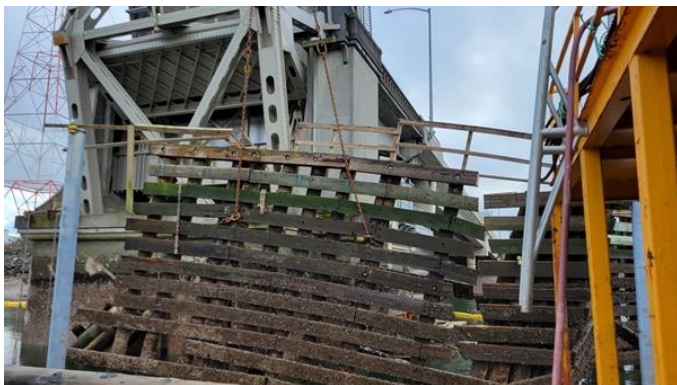
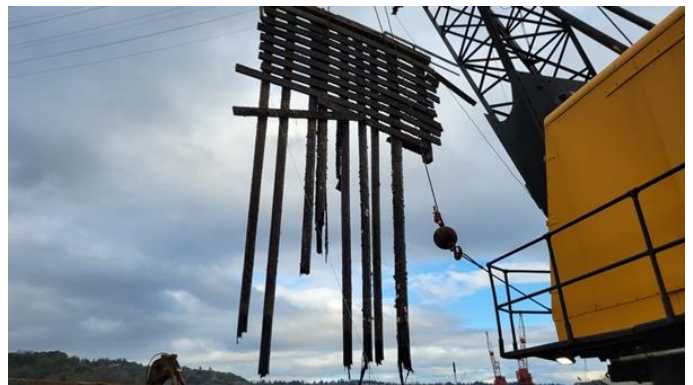
160. Center wing wall removal

161. Center wing wall removal

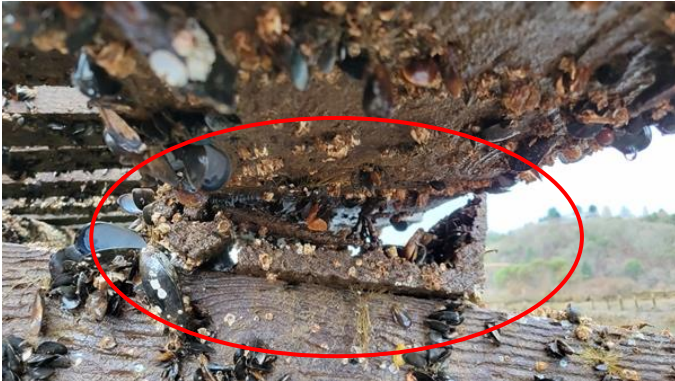
162. Pile No 9 – fender pile with core degradation

No. 9 fender pile was observed with extensive core degradation. The underwater survey originally indicated No. 9 fender pile (square post) was in visually satisfactory condition but pushed over from vertical by up to 45°.

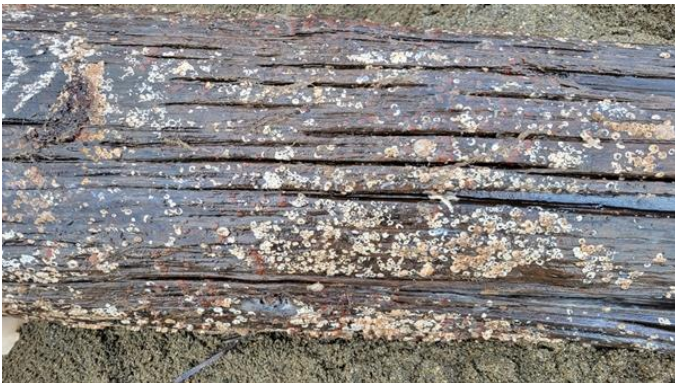
164. Pile No 10 – fender pile with surface checking

The underwater survey originally indicated No. 10 fender pile was sighted set over from vertical at a 60° angle to the North. Heavy core rot was sighted above water. Heavy checking was sighted below the waterline with the mudline interface flowered out due to a rotted center core.

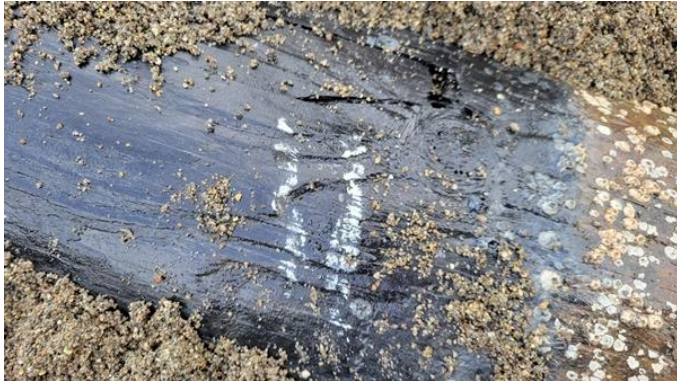
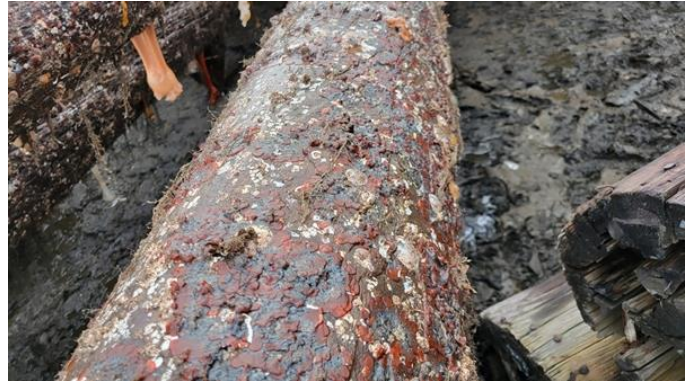
166. No 11 fender pile – satisfactory

167. No 11 fender pile - satisfactory

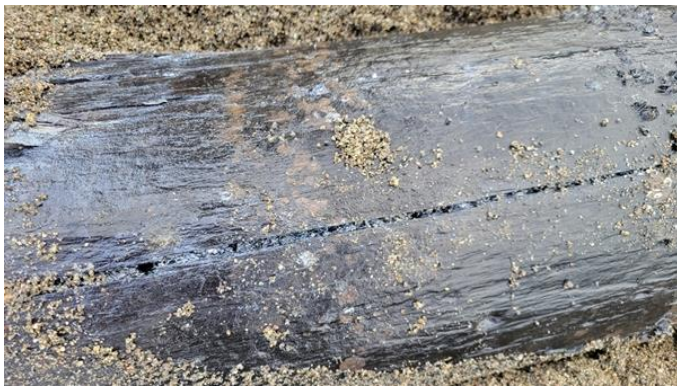
168. No 12 fender pile – broken off below
mudline and with surface checking

The underwater survey originally indicated No. 12 fender pile was in visually satisfactory condition. Sighted displaced in mudline and set over, from vertical, to the north.

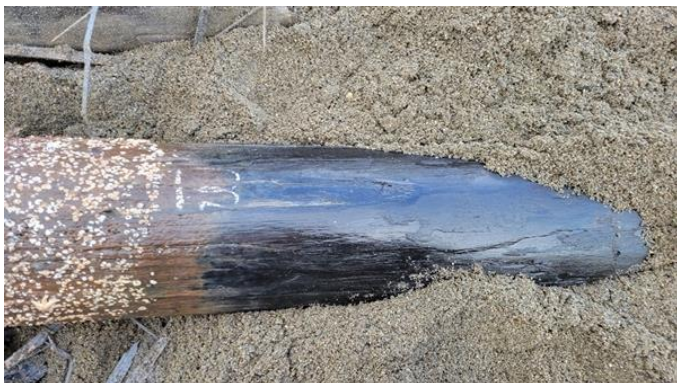
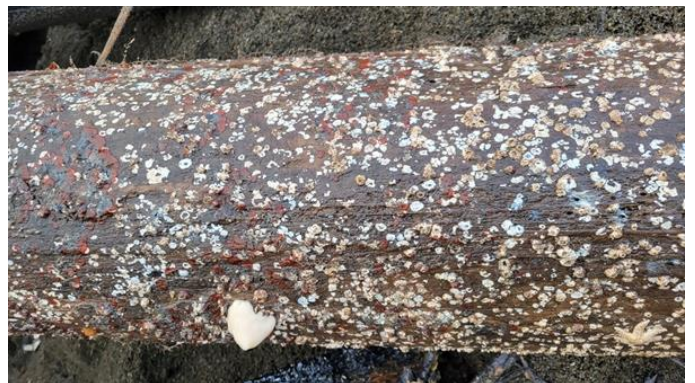
170. No 13 fender pile – satisfactory

171. No 13 fender pile – satisfactory

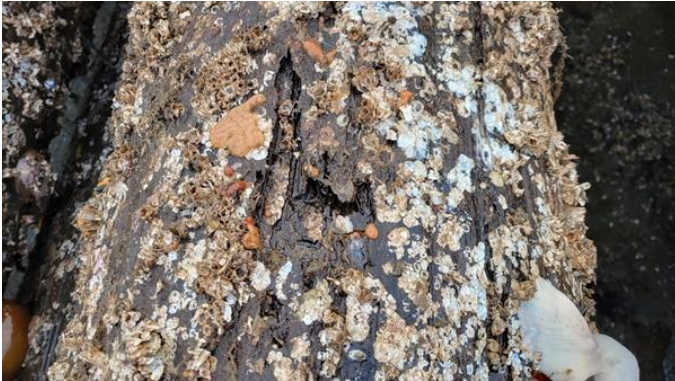
172. No 14 fender pile – surface degraded and with worm tracks

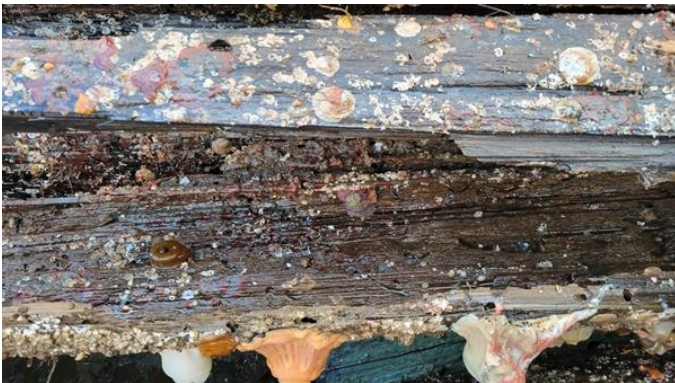
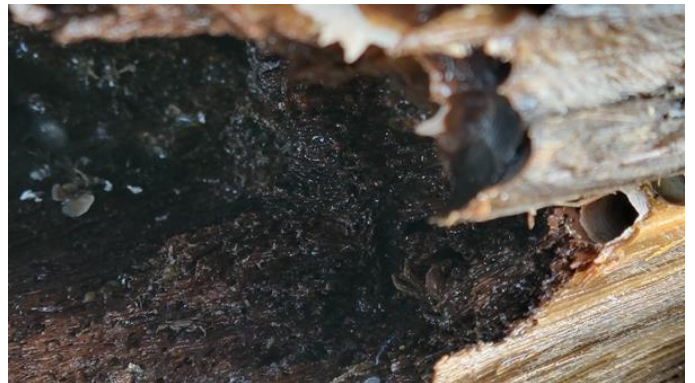
174. No 14 fender pile – hollow with no core strength

175. No 14 fender pile – hollow with no core strength

The underwater survey originally indicated No. 14 fender pile displayed approximately 90% core loss. Pile completely severed with 19” separation between sections. Sections visually sighted as hollow with no core strength.

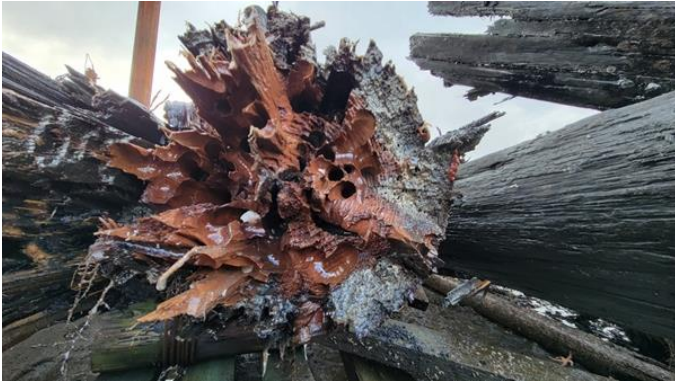
176. No 15 fender pile – broken with heavy core loss and worm tracks

The underwater survey originally indicated No. 15 fender pile broken and hollowed out at height of 15’.

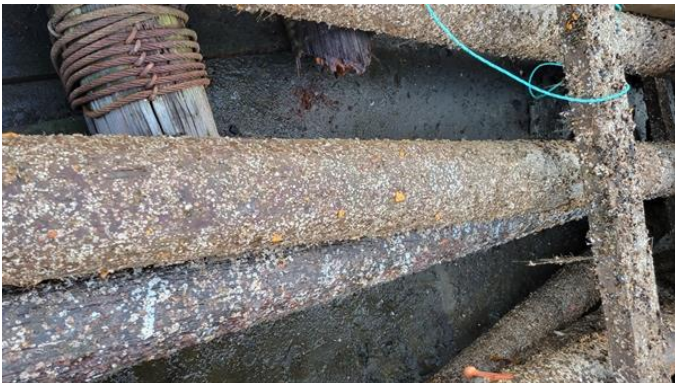
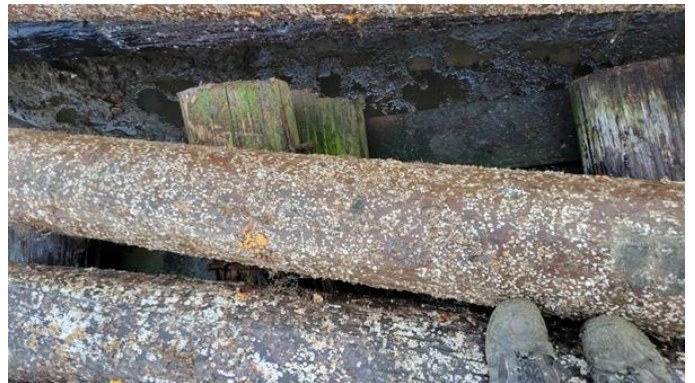
178. No 16 fender pile – satisfactory

179. No 16 fender pile – satisfactory

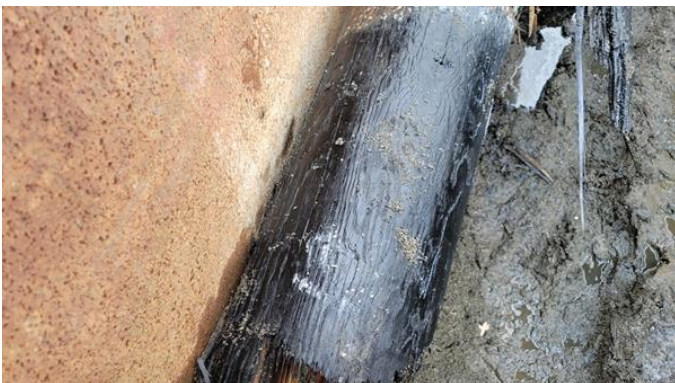
180. No 17 fender pile – surface checking and pressure flowering

The underwater survey originally indicated No. 17 fender pile with minor checking and with pressure flowering at mudline interface.

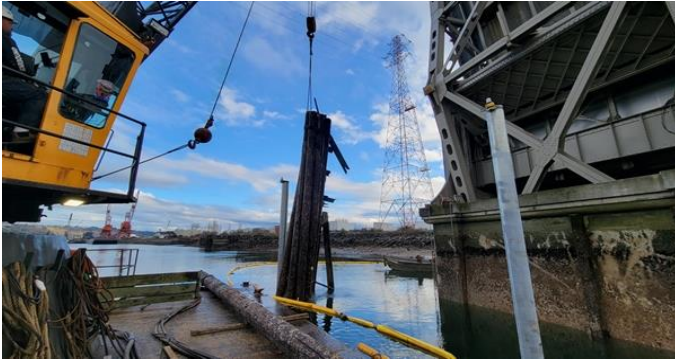
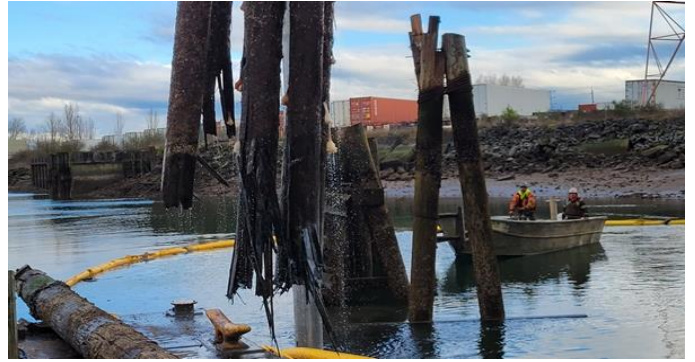
182. Remove No 3 pile cluster

183. Remove No 3 pile cluster

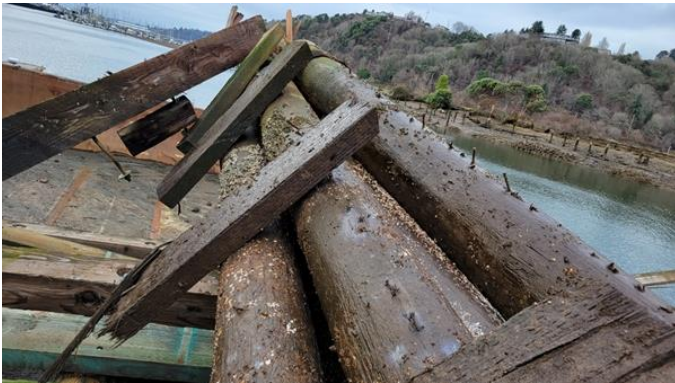
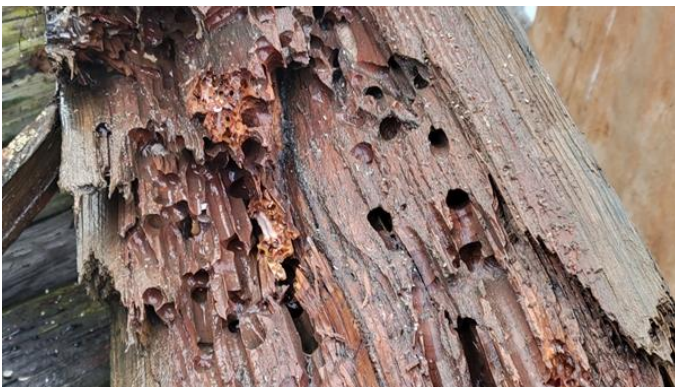
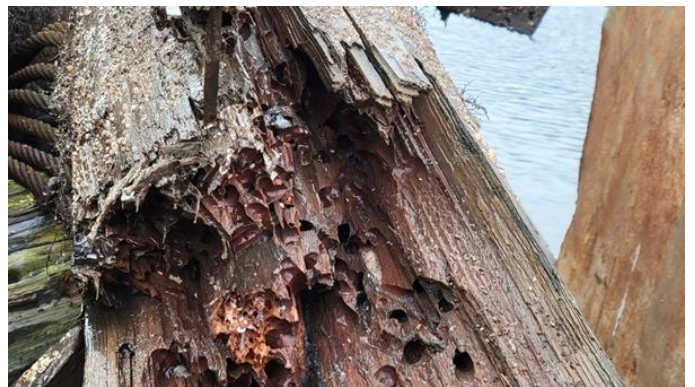
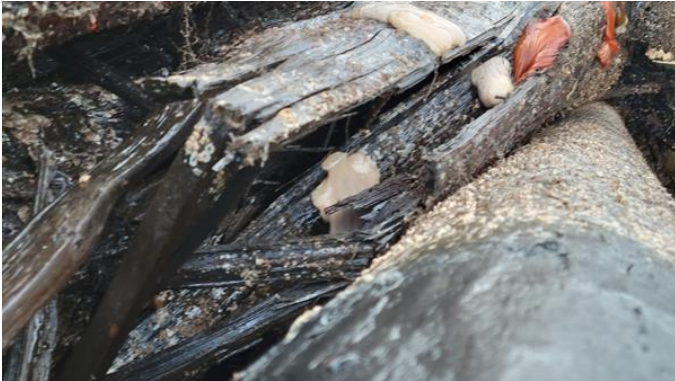
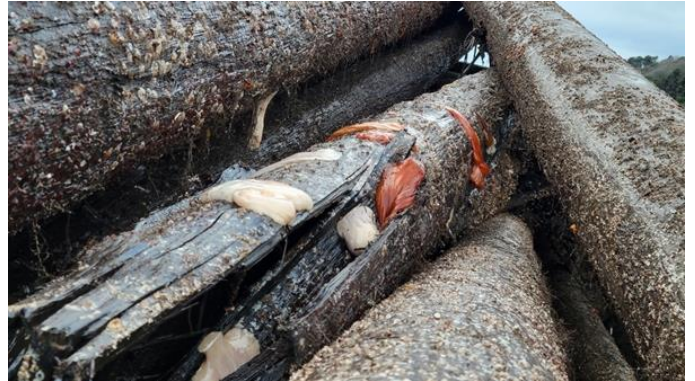
184. No 3 pile cluster

185. No 3 pile cluster – heavy degradation

186. No 3 pile cluster – worm tracks

187. No 3 pile cluster – worm tracks

188. No 3 pile cluster – broken and with hollow cores

189. No 3 pile cluster – broken and with hollow cores

The underwater survey originally indicated No. 3 pile cluster consisted of seven (7) surrounding and one (1) center pile. NE pile – sighted as broken and with hollow core. SE pile – sighted as broken with heavy rot and Teredo worm tracks. S pile – sighted as broken with heavy rot and Teredo worm tracks. SW pile – broken at midwater at 15’ height. Wood sighted as rotten and with heavy Teredo worm tracks. Pile is also severed above mudline. Remainder of pile core hollowed out. W pile – set over from vertical to north. Sighted with checking and stress flowering at mudline interface. Remainder of pile cluster not accessible.

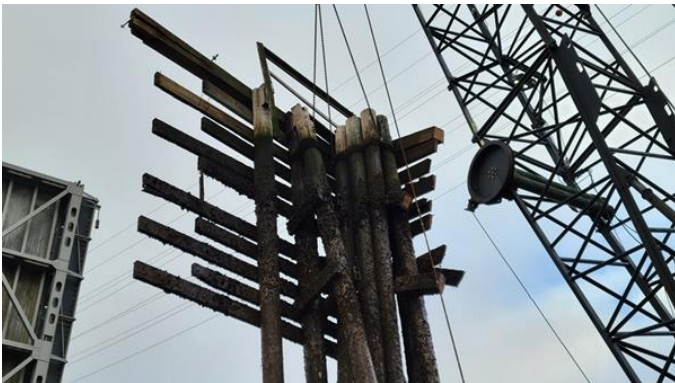
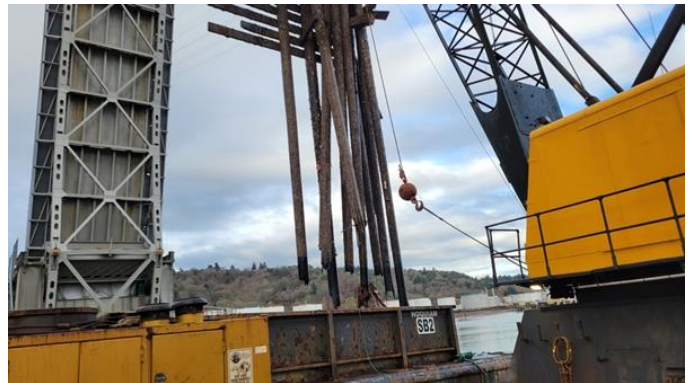
190. Lift and remove no. 2 pile cluster

191. Lift and remove no. 2 pile cluster

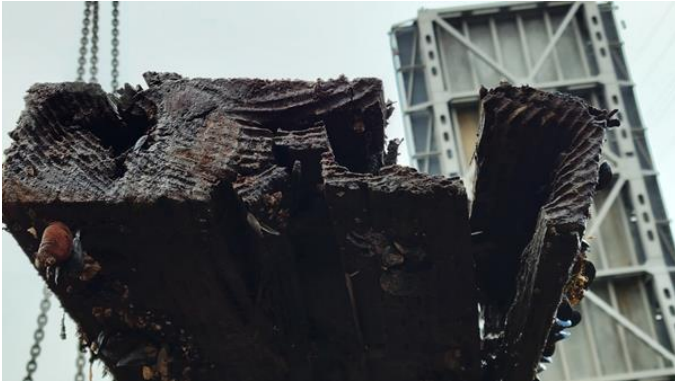
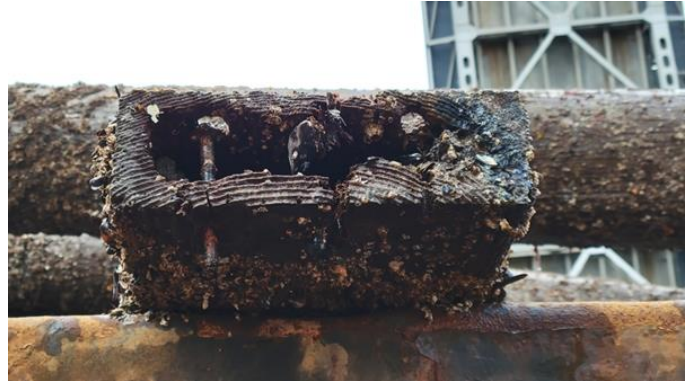
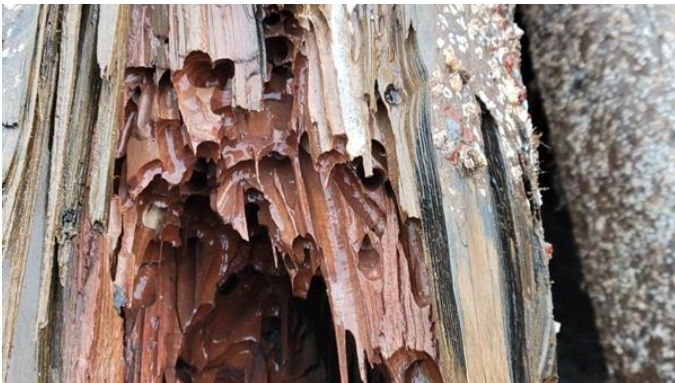
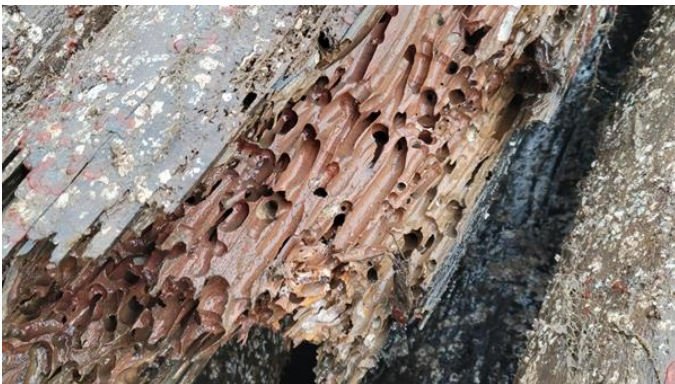
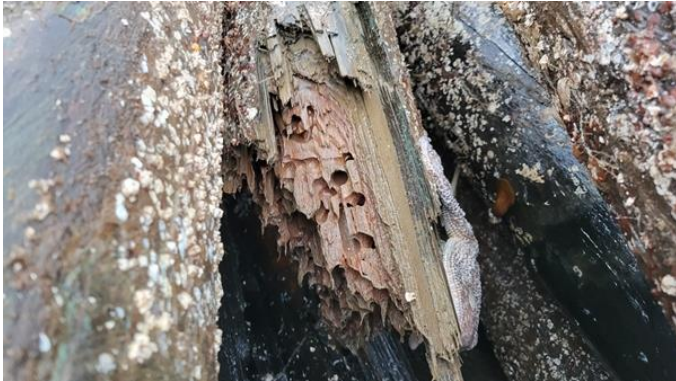
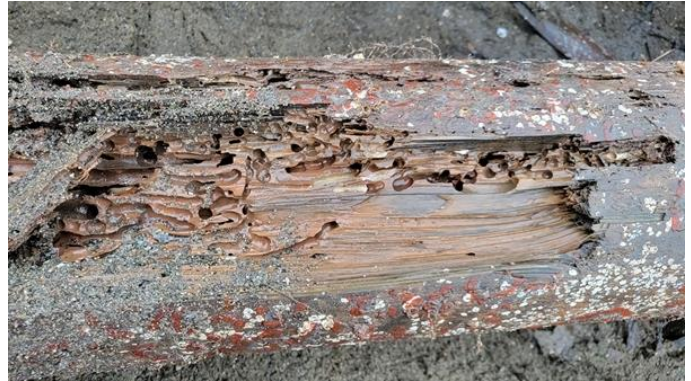
192. No 2 pile cluster – fender board with internal core degradation

193. No 2 pile cluster – fender board with internal core degradation

194. No 2 pile cluster – core degradation and worm tracks

196. No 2 pile cluster – core degradation and worm tracks

198. No 2 pile cluster – core degradation and worm tracks

199. No 2 pile cluster – core degradation and worm tracks

The underwater survey originally indicated No. 2 pile cluster consisted of five (5) surrounding and one (1) center pile. NW pile – severed – core of bottom half of pile visually appears to be rotted out. S pile – Severed – top half visually displays heavy internal rot with Teredo worm tracks. No core strength retained in bottom section. SW pile – fractured – heavy core rot in bottom half – estimated 80% core loss in top half. SE pile – 3” deep checks on bottom along with stress pressure flowing due to internal core rot. Center pile fractured and shifted – lying on SE pile.

- No. 9 Fender Pile – Observed with extensive core degradation. Estimated 50% ~ 75% core strength loss. [Photograph Nos. 162-165]
- Fender Cluster No. 2 – five (5) surrounding and one (1) center pile. NW pile – severed – core of bottom half of pile visually appears to be rotted out. S pile – Severed – top half visually displays heavy internal rot with Teredo worm tracks. No core strength retained in bottom section. SW pile – fractured – heavy core rot in bottom half – estimated 80% core loss in top half. SE pile – 3” deep checks on bottom along with stress pressure flowing due to internal core rot. Center pile fractured and shifted – lying on SE pile. Cluster overall estimated at up to 75% core strength loss. [Photograph Nos. 192-199]

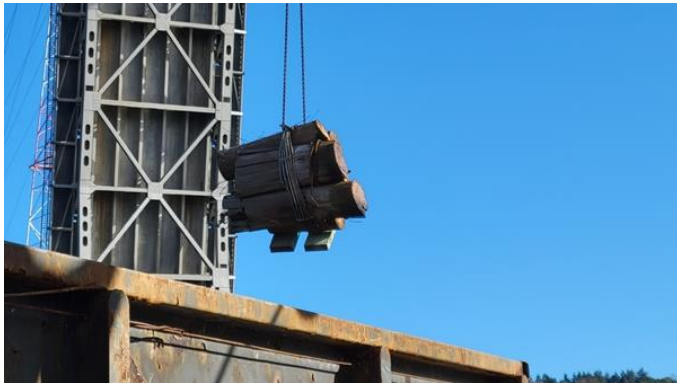
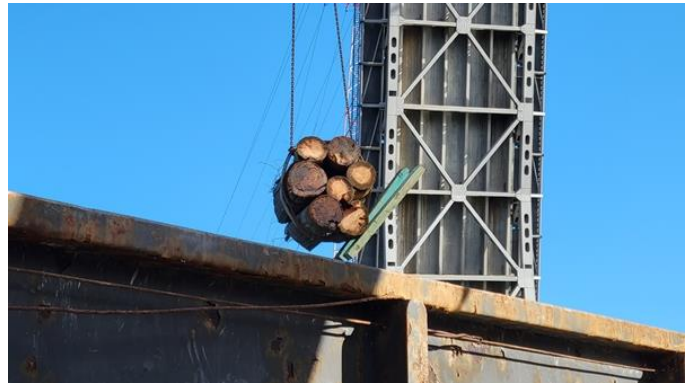
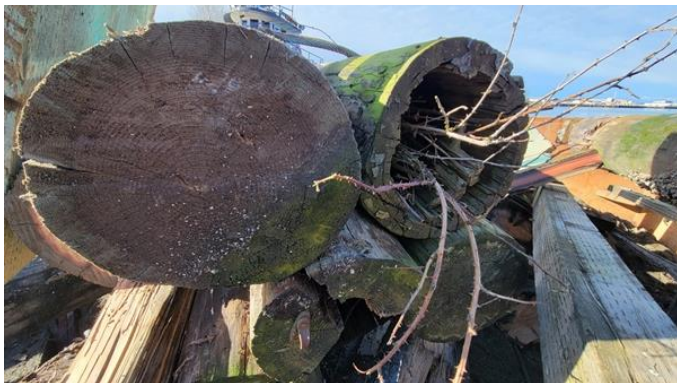
200. North wing wall top section removal

201. North wing wall top section removal

202. Hollow core of top section

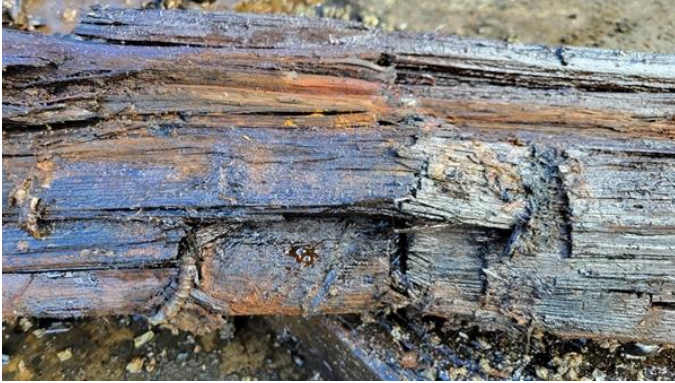
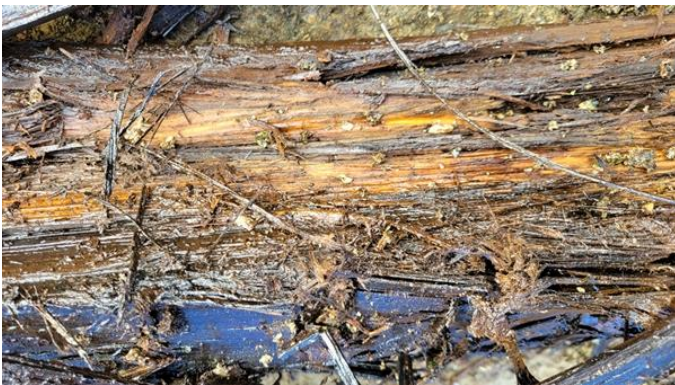
204. Pile cluster No 1 top – timber deteriorated

206. Pile cluster No 1 top – timber deteriorated

The underwater survey originally indicated No. 1 pile cluster consisted of six (6) surrounding piles and one (1) center pile, with approximately 5% surface loss due to marine borers. The remainder of cluster visually in good condition. Upon removal the pile cores were observed as being heavily deteriorated.

- Northern Mooring Pile Cluster No. 1 – six (6) and one (1) center pile. Subsequent to removal – estimated approximately 50% core strength loss due to core degradation and worm tracks [Photo Nos. 204-215]

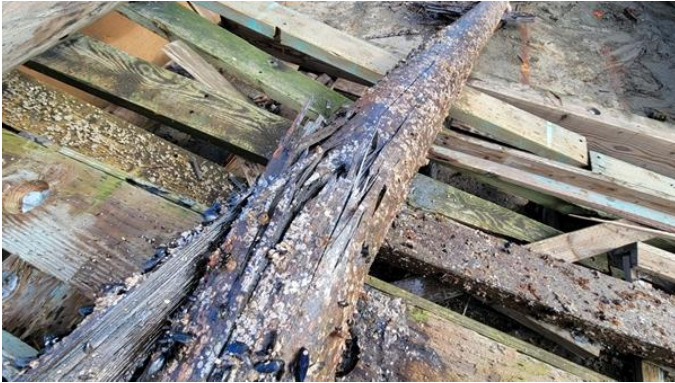
208. No 4 batter pile – checking over surface area

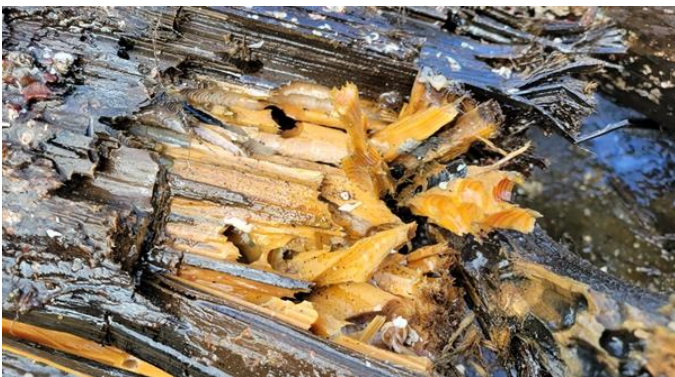
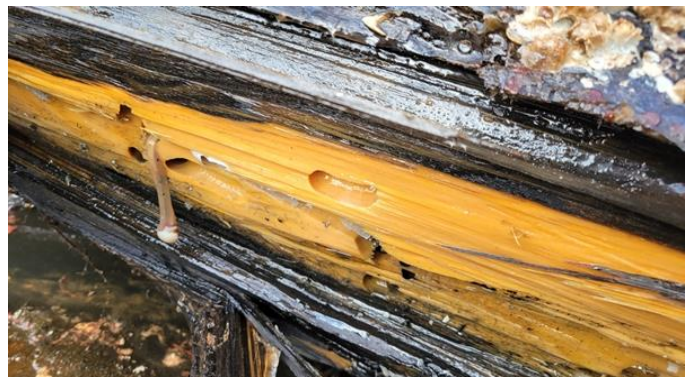
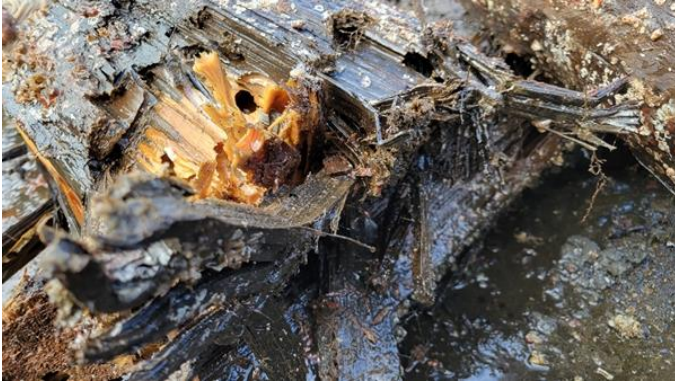
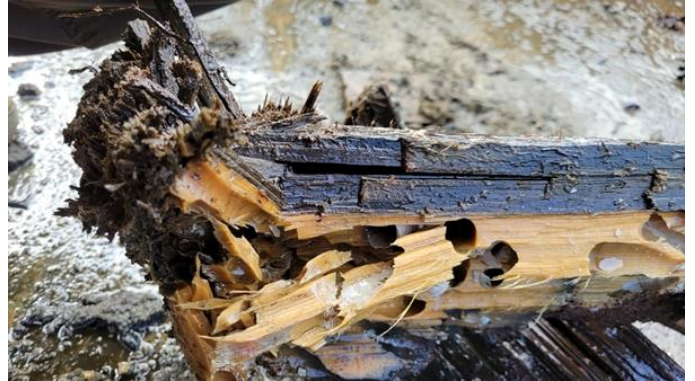
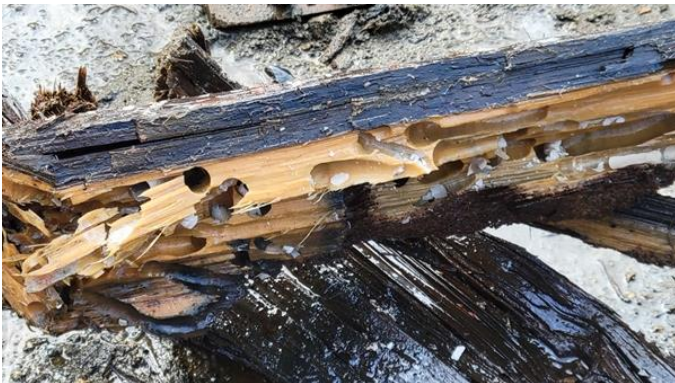
210. No 1 cluster pile – core degradation and extensive worm tracks

211. No 1 cluster pile – core degradation and extensive worm tracks

212. No 1 cluster pile – core degradation and extensive worm tracks

213. No 1 cluster pile – core degradation and extensive worm tracks o 24 fender pile – visually generally satisfactory

214. No 1 cluster pile – core degradation and extensive worm tracks

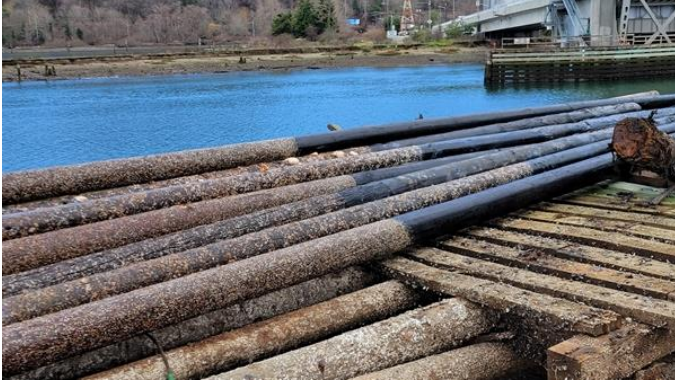
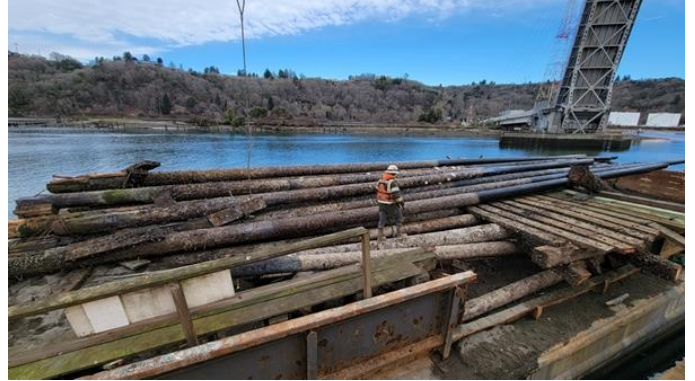
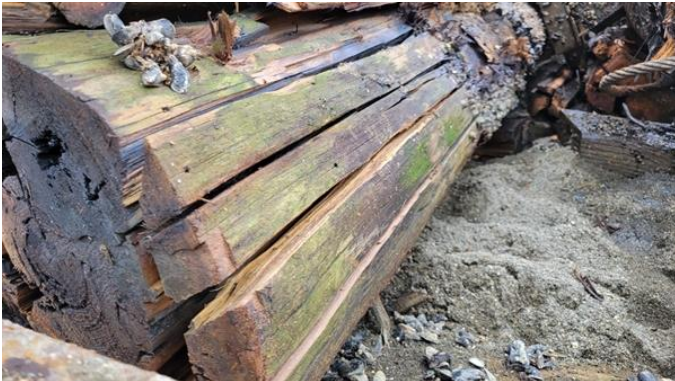
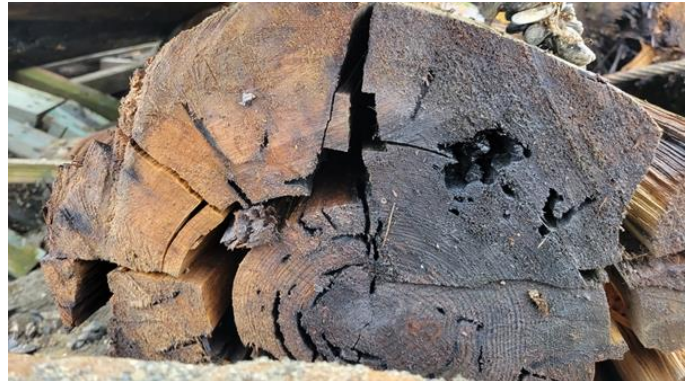
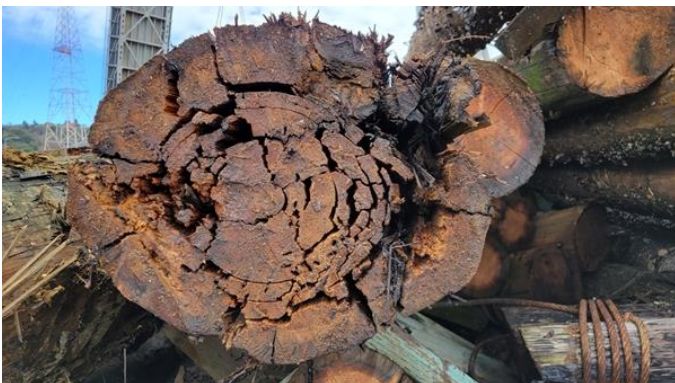
218. Pile Nos 1-6 – general deterioration

219. Pile Nos 1-6 – general deterioration

220. Pile Nos 1-6 – general deterioration

The underwater survey originally noted the following conditions for pile Nos. 1-6:

- No. 1 pile - Fender pile in visually good condition
- No. 2 pile - Fender pile and batter pile in visually good condition. North horizontal support - approximately 50% loss over 12". South horizontal support - visually good condition.
- No. 3 pile - Fender pile in visually good condition.
- No. 4 pile - Fender pile in visually good condition. Batter pile - approximately 1/4" wide checking over surface area. North horizontal support - visually good condition. South horizontal support - approximately 60% loss at end over 3'.

- No. 5 pile – Fender pile visually in satisfactory condition but pushed over from vertical by approximately 30° - sighted displaced in mudline.
- No. 6 pile – Fender pile sighted with noticeable rot of approximately 80%, extending upward by 6’ from HW line. Fender is pushed over from vertical by approximately 30° - sighted displaced in mudline. Batter pile – visually satisfactory condition, sighted pushed over in mudline. North and south horizontal supports – approximately 60% loss over length of 4’.

- Nos. 1-6 Fender Pile – Initially in generally satisfactory condition, except for Pile No. 6. Extensive core degradation of horizontal supports observed. Subsequent to removal, cores observed fractured, deteriorated, or hollowed out, with core loss variously estimated at 25%~50%. Fender pile No. 6 noted with core loss estimated at 80% due to rot, extending upward by 6’ from HW line. [Photograph Nos. 216-225]

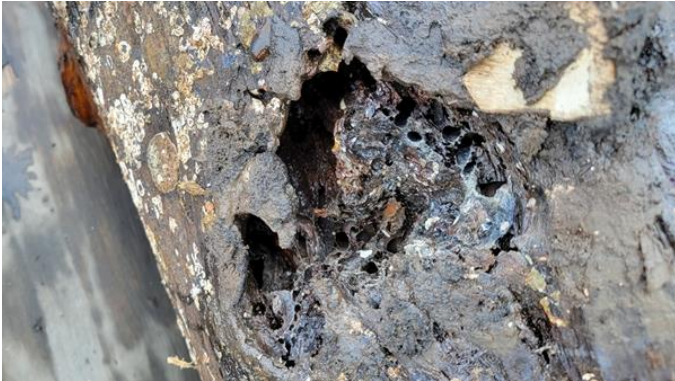
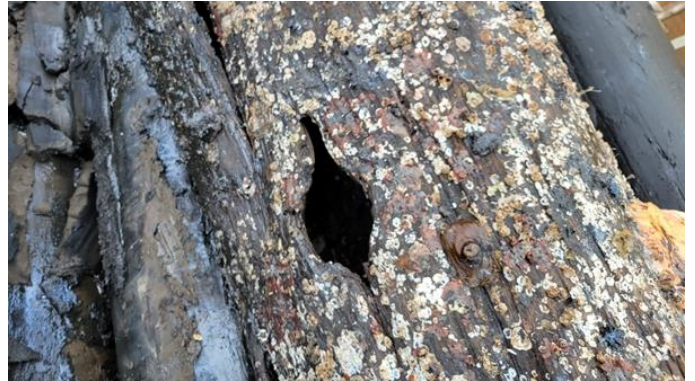
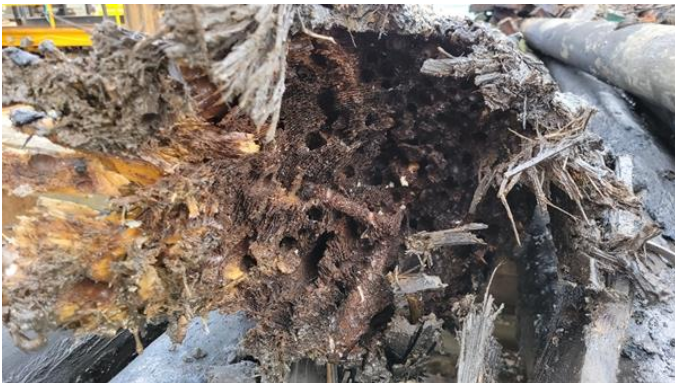
222. Heavily deteriorated core and worm tracks

223. Core hollowed out

224. Heavily deteriorated core and worm tracks

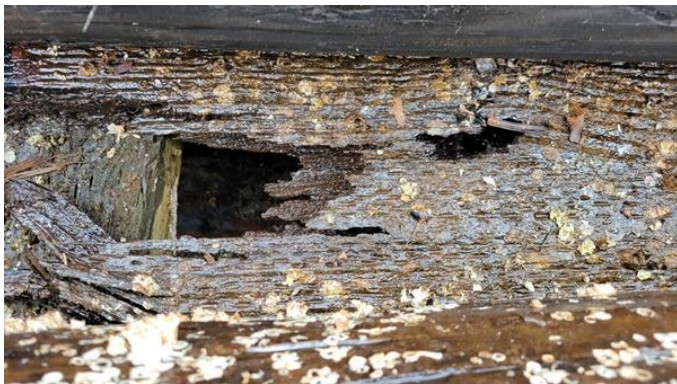
226. No 28 batter pile – core hollowed out at mudline interface

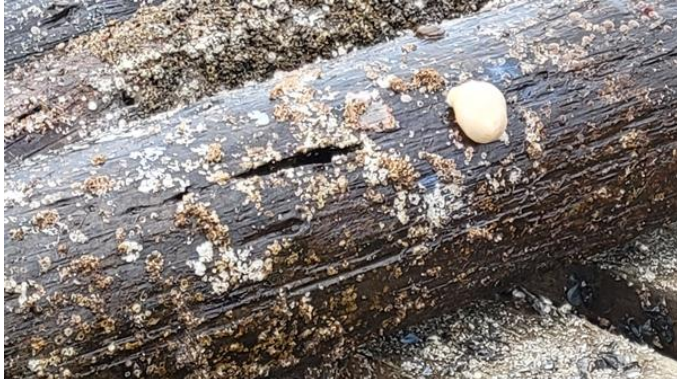
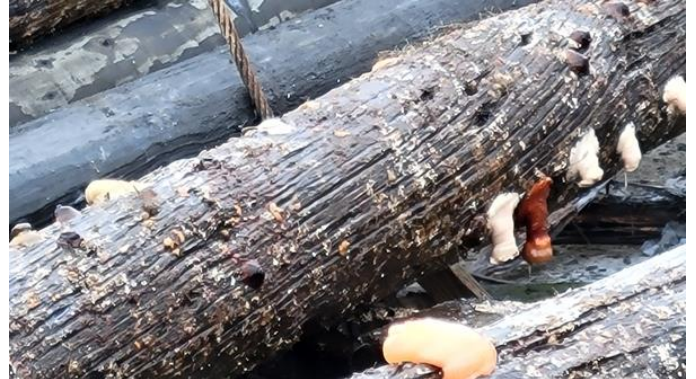
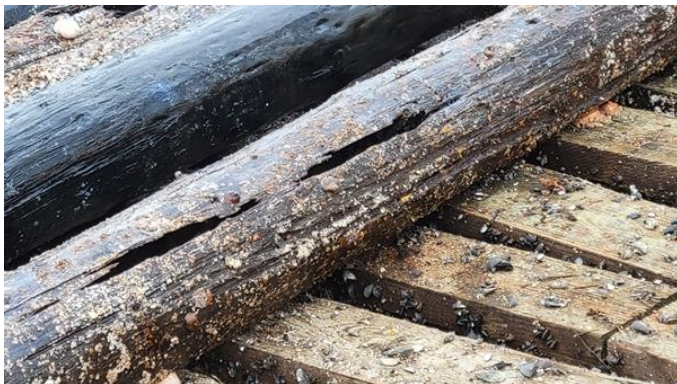
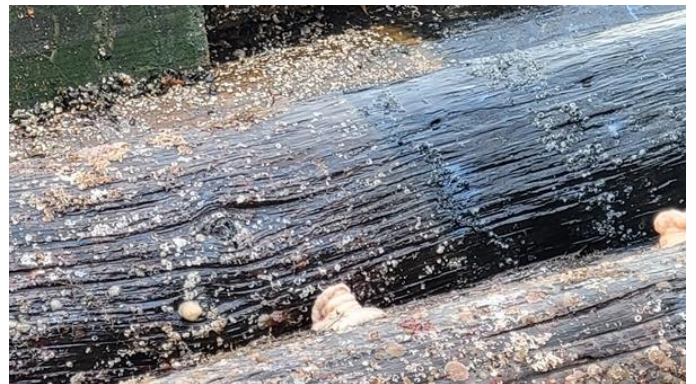
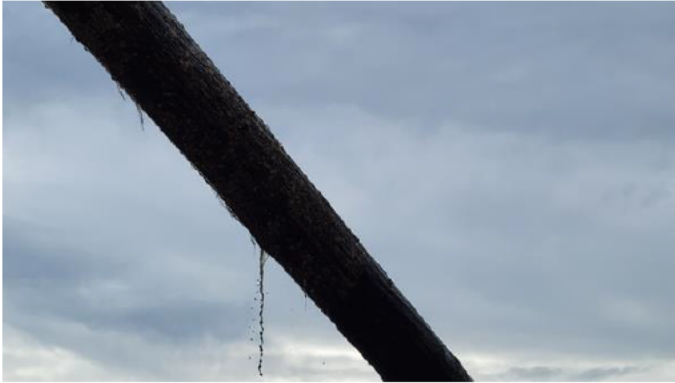
228. No 5 pile 4th cluster – checking on surface.

229. Center pile 4th cluster – heavy worm tracks

230. No 4 pile 4th cluster – hollow core

231. No 6 pile 4th cluster – heavy worm tracks

232. No 3 pile 4th cluster – water leaking during lifting due to hollowed core

The underwater survey originally noted the following conditions for No. 4 cluster:

Fender cluster No. 4 – six (6) surrounding and one (1) center pile. NW pile – sighted with checking and pressure flowering at mudline interface. N pile – sighted with checking and pressure flowering at mudline interface, along with heavy worm tracks. NE pile – approximately 10% surface section loss. Center pile – sighted with checking and pressure flowering at mudline interface. S pile – at mid-pile height – tapping on pile indicates hollow section with potential full core rot and no remaining core strength. SW pile – approximately 15% surface section loss. Heavy worm tracks sighted at mudline interface.

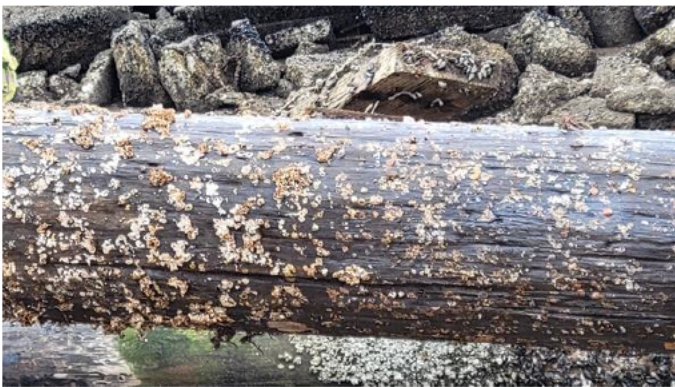
234. No 31 fender pile – light surface checking

The underwater survey originally noted No. 31 fender pile was sighted with pressure flowering at the mudline interface with the remainder being in visually satisfactory condition.

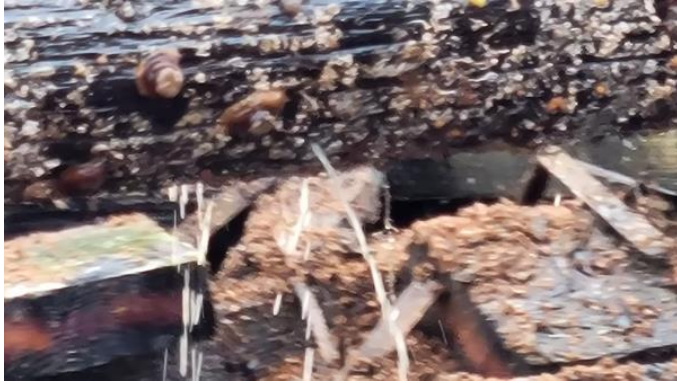
236. No 30 fender pile – leaking water from hollowed core

The underwater survey originally noted No. 30 fender pile was sighted with approximately 15% surface section loss at mudline interface due to borers.

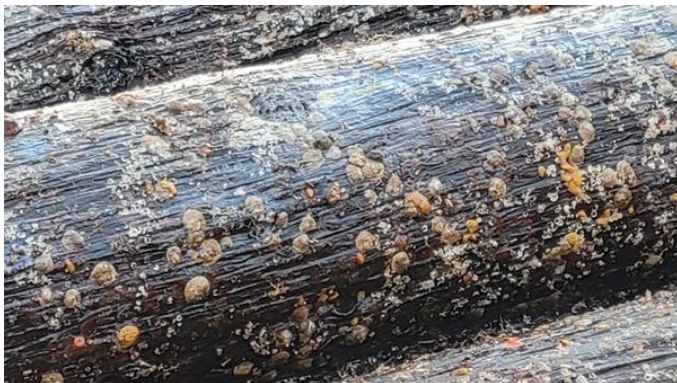
238. No 29 fender pile – generally satisfactory with light surface checking

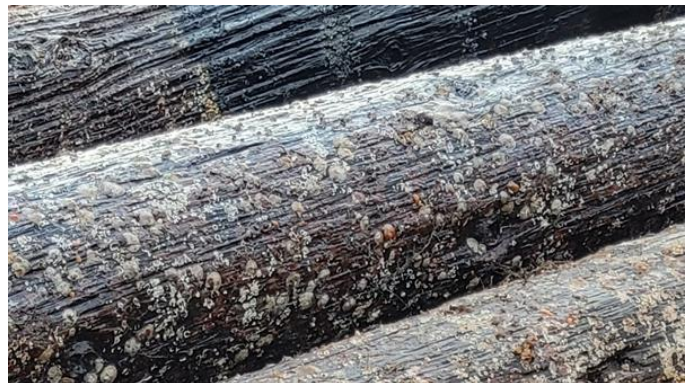
239. No 29 fender pile – generally satisfactory with light surface checking

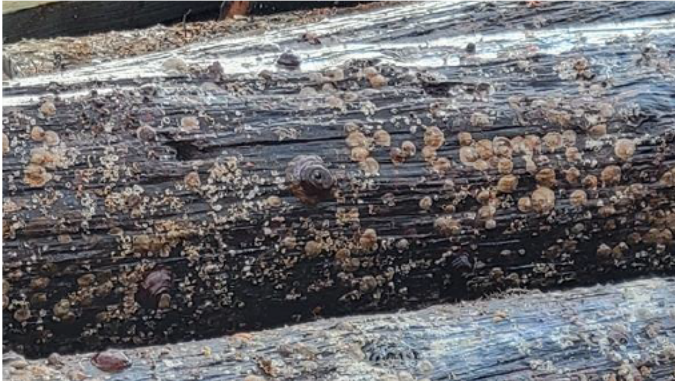
240. No 28 fender pile – generally satisfactory with light surface checking

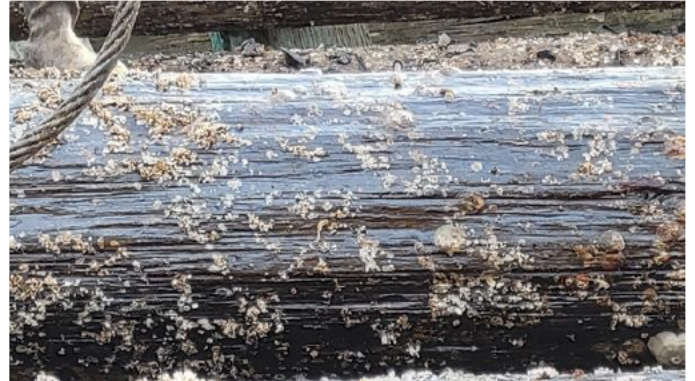
241. No 28 fender pile – generally satisfactory with light surface checking

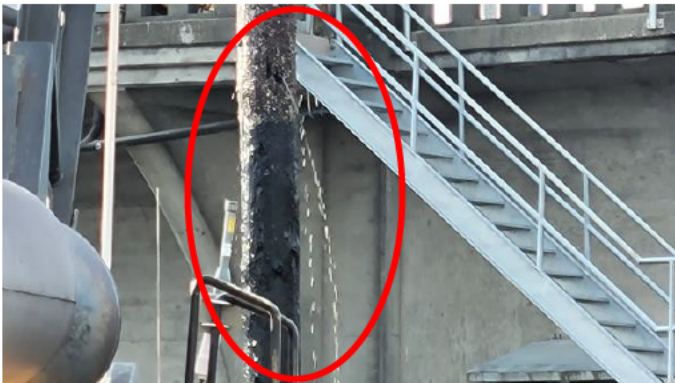
242. No 26 fender pile – leaking water due to hollow sections in core

The underwater survey originally noted No. 26 fender pile was sighted with with surface checking and pressure flowering at mudline interface. Batter pile also sighted with surface loss due to borers. North horizontal support – missing. South horizontal support – approximately 90% loss over full length.

- No. 26 Fender Pile – sighted with surface checking and pressure flowering at mudline interface. Observed leaking water on removal due to hollow sections in core. Estimated core strength loss up to 25%. [Photograph Nos. 242-243]
