SURVEY REPORT

Report No. 23101344

ALLISION BETWEEN ASSIST TUG "OLYMPIC SCOUT"

AND THE "HYLEBOS RIVER BRIDGE WEST BASCULE FENDERING"

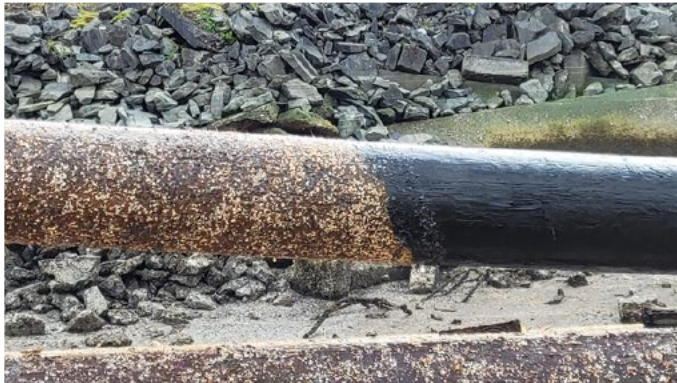
244. No 24 fender pile – visually generally satisfactory

The underwater survey originally noted No. 24 fender pile was in visually satisfactory condition except very top of pile split open.

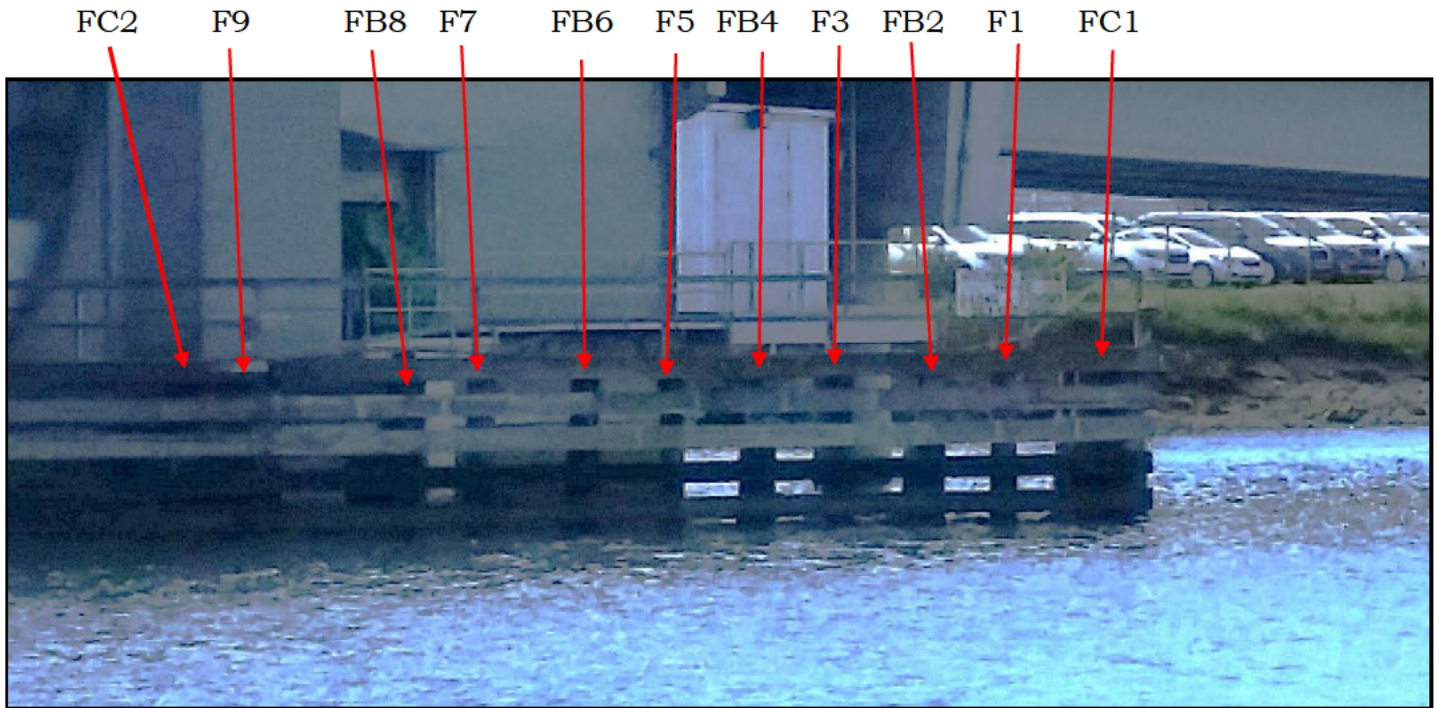
Picture 2: Representative Picture of North Wing Wall (Photograph Prior Incident)

- Northern Mooring Pile Cluster No. 1 – six (6) and one (1) center pile. Subsequent to removal – estimated approximately 50% core strength loss due to core degradation and worm tracks [Photo Nos. 204-215]

- Nos. 1-6 Fender Pile – Initially in generally satisfactory condition, except for Pile No. 6. Extensive core degradation of horizontal supports observed. Subsequent to removal, cores observed fractured, deteriorated, or hollowed out, with core loss variously estimated at 25%~50%. Fender pile No. 6 noted with core loss estimated at 80% due to rot, extending upward by 6’ from HW line. [Photograph Nos. 216-225]

- No. 7 Fender Pile – Fender pile observed with stress flowering at base of pile due to apparent internal degradation. Estimated 15% core strength loss.

- No. 8 Fender Pile – Fender pile observed broken at base above mudline. Pile visually appears rotten over 70% of base. Batter pile sheared at base – pile visually appears internally rotten with heavy Teredo worm and bore worm spores. Estimated 50% core strength loss.

- No. 9 Fender Pile – Observed with extensive core degradation. Estimated 50% ~ 75% core strength loss. [Photograph Nos. 162-165]
- Fender Cluster No. 2 – five (5) surrounding and one (1) center pile. NW pile – severed – core of bottom half of pile visually appears to be rotted out. S pile – Severed – top half visually displays heavy internal rot with Teredo worm tracks. No core strength retained in bottom section. SW pile – fractured – heavy core rot in bottom half – estimated 80% core loss in top half. SE pile – 3” deep checks on bottom along with stress pressure flowing due to internal core rot. Center pile fractured and shifted – lying on SE pile. Cluster overall estimated at up to 75% core strength loss. [Photograph Nos. 192-199]

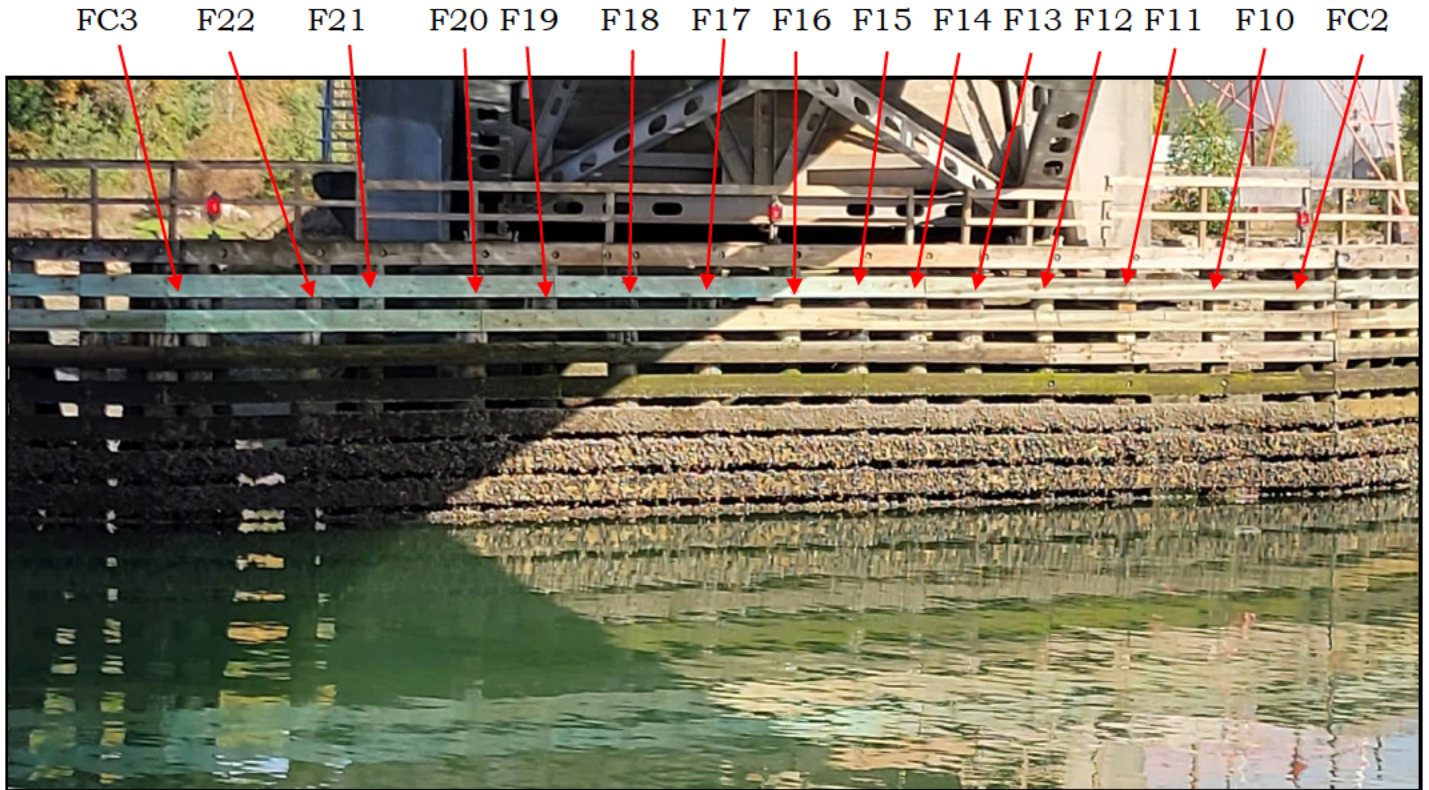
Picture 3: Representative Picture of Center Wing Wall

- No. 10 Fender Pile – heavy core rot was sighted above water. Heavy checking was sighted below the waterline with the mudline interface flowered out due to a rotted center core. Estimated 50% core strength loss. [Photograph Nos. 164-165]
- Nos. 11-13 Fender Piles – condition generally satisfactory. Estimated minimal core strength loss. [Photographs 166-171]
- No. 14 Fender Pile – pile severed with 19” separation between sections. Sections visually sighted as hollow with no core strength. [Photograph Nos. 172-175]

- No. 15 Fender Pile - underwater survey originally indicated No. 15 fender pile broken and hollowed out at height of 15'. Estimated 50% ~ 75% core strength loss. [Photograph Nos. 176-177]

- Nos. 16 Fender Pile – condition generally satisfactory. Estimated minimal core strength loss. [Photographs 178-179]
- No. 17 Fender Pile – minor checking and pressure flowering. Estimate 25% core strength loss.

- No. 18 Fender Pile – generally satisfactory. Minimal core strength loss [Photograph Nos. 140-141]
- No. 19 Fender Pile – generally satisfactory, but pressure flowering observed. After removal, fracturing of surface observed. Estimate up to 25% core strength loss. [Photograph Nos. 142-143]

- No. 20 Fender Pile – set over from vertical due to fracturing below mud line. Pressure flowering observed during dive survey. Estimated up to 25% core strength loss. The batter pile completely separated at 27' with heavy core rot observed – no core strength remaining. Horizontal supports estimated up to 75% core strength loss. [Photograph Nos. 144-149]

- No. 21 Fender Pile – fractured at mudline with surface checks and stress flowering. Heavy worm tracks and interior degradation observed. Estimate 50%~75% core strength loss. [Photograph Nos. 150-151]

- No. 22 Fender Pile – sheared at mudline. Surface checking and wastage of core observed. Estimate 25% ~ 50% core strength loss. [Photograph Nos. 152-157]

- Fender Cluster No. 3 – seven (7) surrounding and one (1) center pile. NE pile – sighted as broken and with hollow core. SE pile – sighted as broken with heavy rot and Teredo worm tracks. S pile – sighted as broken with heavy rot and Teredo worm tracks. SW pile – broken at midwater at 15' height. Wood sighted as rotten and with heavy Teredo worm tracks. Pile is also severed above mudline. Remainder of pile core hollowed out. W pile – set over from vertical to north. Sighted with checking and stress flowering at mudline interface. Remainder of pile cluster not accessible. Cluster overall estimate at up to 75% core strength loss. [Photograph Nos. 182-189]

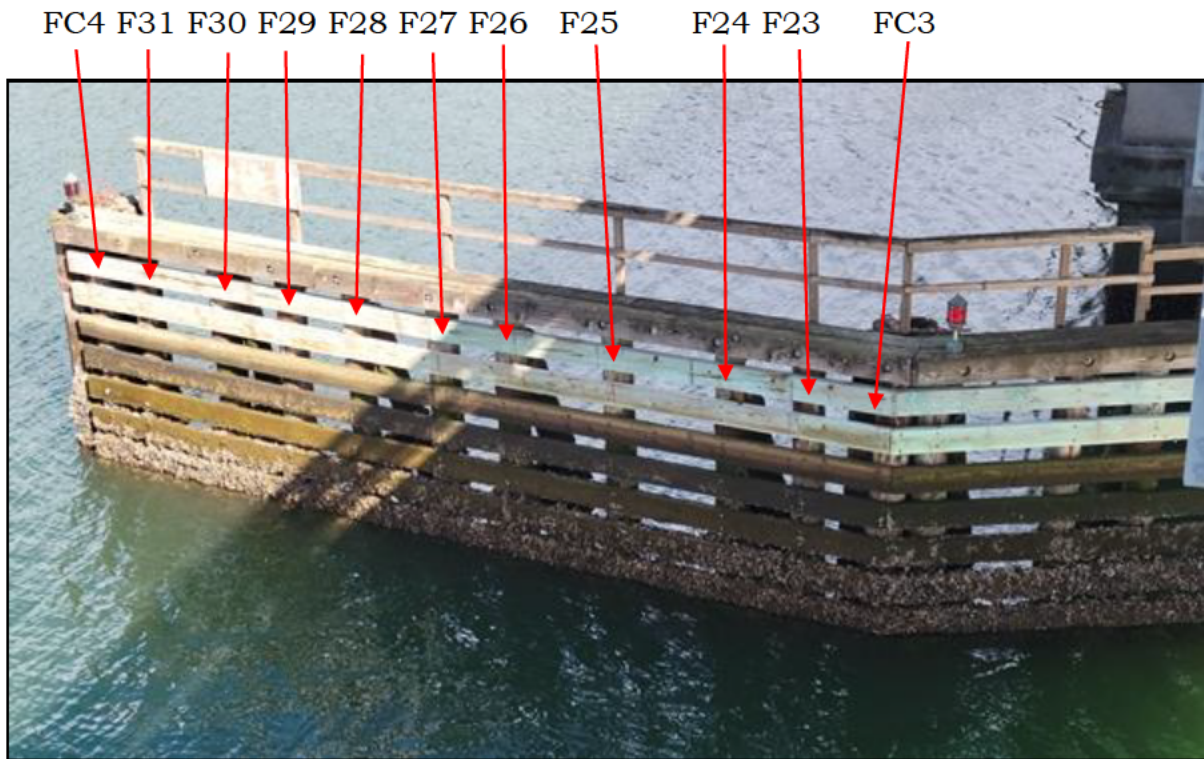
Picture 4: Representative Picture of South Wing Wall

- No. 23 Fender Pile – initially observed with approximately 10% surface loss due to borers over full length and set over from vertical to the north. Stress flowering sighted at base at mudline interface. After removal core loss observed due to marine borers. Estimated 25%~50% core strength loss. [Photograph Nos. 158~159]
- No. 24 Fender Pile– condition generally satisfactory. Estimated minimal core strength loss. [Photograph Nos. 244-245]
- No. 25 Fender Pile – condition generally satisfactory. Observed with approximately 10% section loss. Estimated minimal core strength loss. [Photograph Nos. 122-123]

- No. 26 Fender Pile – sighted with surface checking and pressure flowering at mudline interface. Observed leaking water on removal due to hollow sections in core. Estimated core strength loss up to 25%. [Photograph Nos. 242-243]

- No. 27. Fender Pile – top section of pile observed to be in poor condition, with the core rotten and powdery. The underwater survey originally indicated fender pile sighted with approximately 10% surface lost – remainder in visually satisfactory condition. Estimated core strength loss up to 25% [Photograph No. 128]
