United States
Coast Guard

Commanding Officer
United States Coast Guard
Marine Safety Center

Subj: POST-SINKING STABILITY ANALYSIS OF TUG JACQUELINE A (O.N. 638353)

Enclosure: (1) Explanation of Analysis & Assumptions
(2) MSC GHS Output, 31 Jan 2024

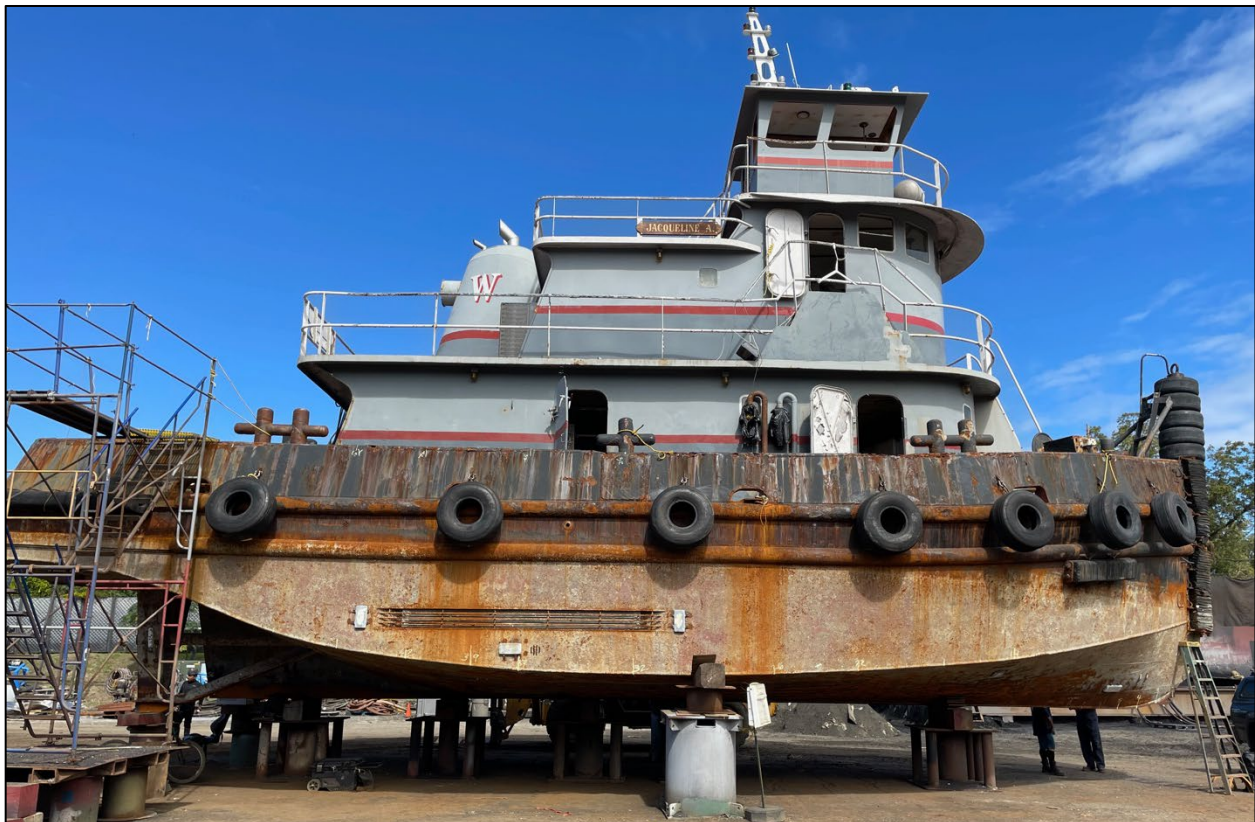
Figure 1: JACQUELINE A at the Steven's Towing Yard on 19 Oct 2023

LiDAR points on the starboard quarter showed some inconsistency due to scaffolding next to the vessel in this area (shown in Figure 1). The port side points were used in this area with the assumption that the vessel is symmetric about the centerline.
