## 7219 WHEEL MOVEMENT INVESTIGATION

Revision: 2

July 27<sup>TH</sup>, 2023

**HATCH LTK**

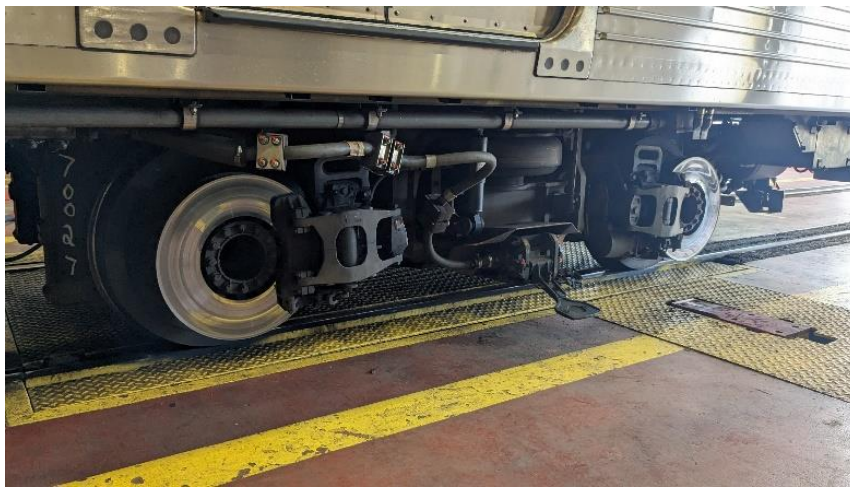
Figure 6: Installed Truck SN 70027

After the inspection was completed, and the measurements were verified, truck shop personnel removed and replaced the front truck. The installed truck was original to car 7014 (SN 70027). The truck was removed from 7014 due to a wheel size issue (WO 17960826). Axles 1 and 2 in truck SN 70027 are both original. The axle information can be found in Table 4.

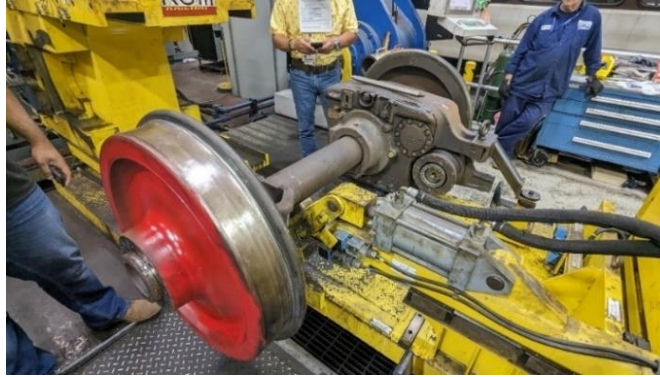
Figure 8: MDZ-1423

The teardown was performed at Brentwood on July 19<sup>th</sup>. During the teardown, only the Gearbox and Motor Side wheels were removed. No other components of the wheelset assembly were pressed off at the time of this investigation. Both wheels on the axle were fitted with hydraulic assist ports. However, hydraulic assist was not used to press the wheels off.

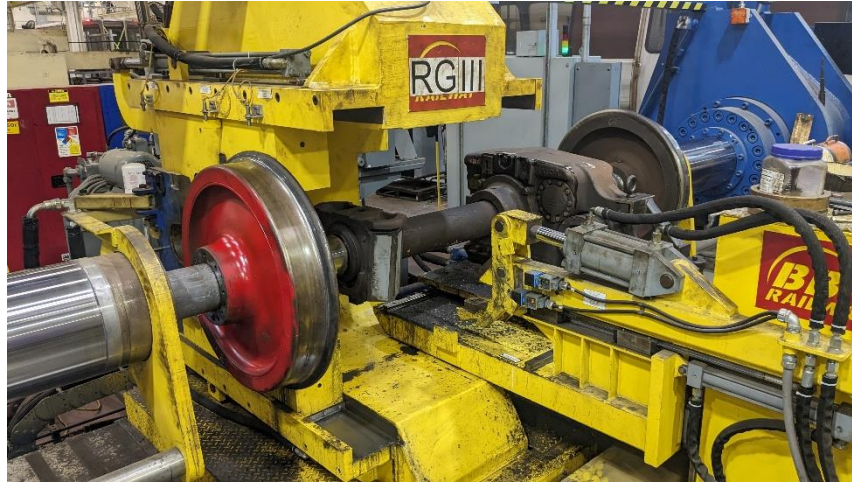
Figure 10: MDZ-1423

Wheel	Dismount Force (tons)
<b>Left Wheel</b> (GBX End)	110
<b>Right Wheel</b> (Free/Motor End)	128

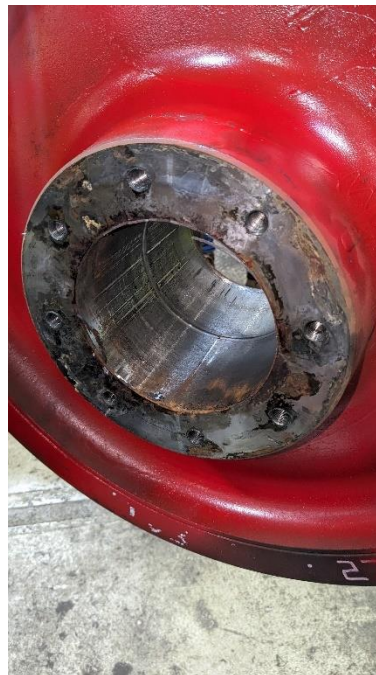
Figure 16: Motor Side Outboard

The visual inspection of the Motor Side Wheel showed rust on the inboard taper similar to the Gear Side Wheel as seen in Figure 15. This rust is along the circumference of the edge. The lateral lines in the bore are from the residual Molykote used during the wheel press on at ORX. After the bore was cleaned, these lines were not present as seen in Figure 16. Black bands remained at the inboard side of the wheel bore. Similar to the Gearbox Side Wheel.

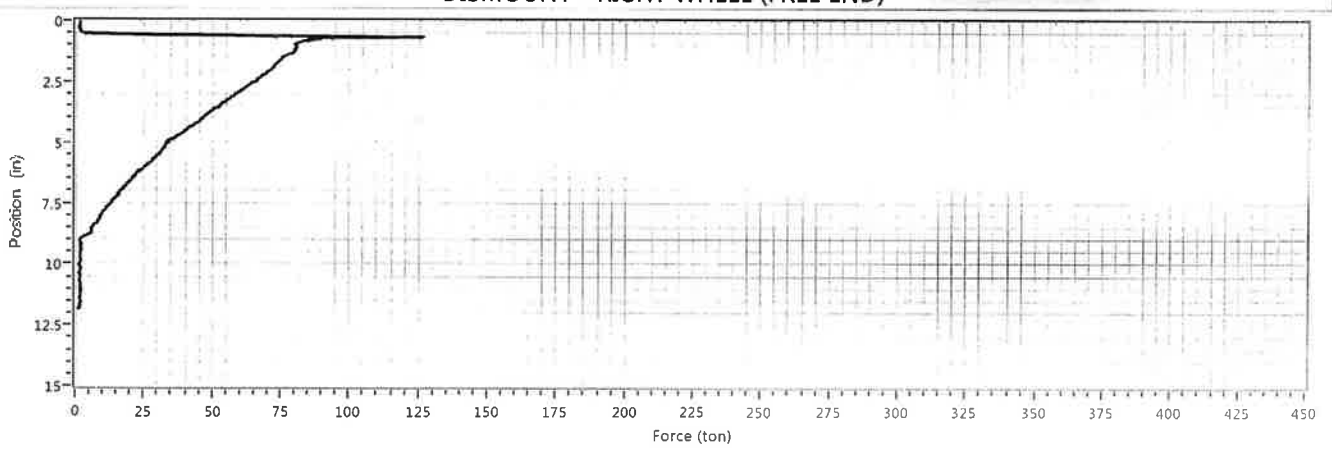
DISMOUNT - RIGHT WHEEL (FREE END)

The Motor Side Wheel tonnage value was observed on the computer during the dismount, and extrapolated from the *Dismount – Right Wheel (Free End)* chart found in Appendix G. The BBM Press Machine does not supply this value on the dismount charts. The Gearbox Wheel chart is found in Appendix G as well.
