National Transportation Safety Board

HWY24MH005

TECHNICAL RECONSTRUCTION

Group Chair's Factual Report

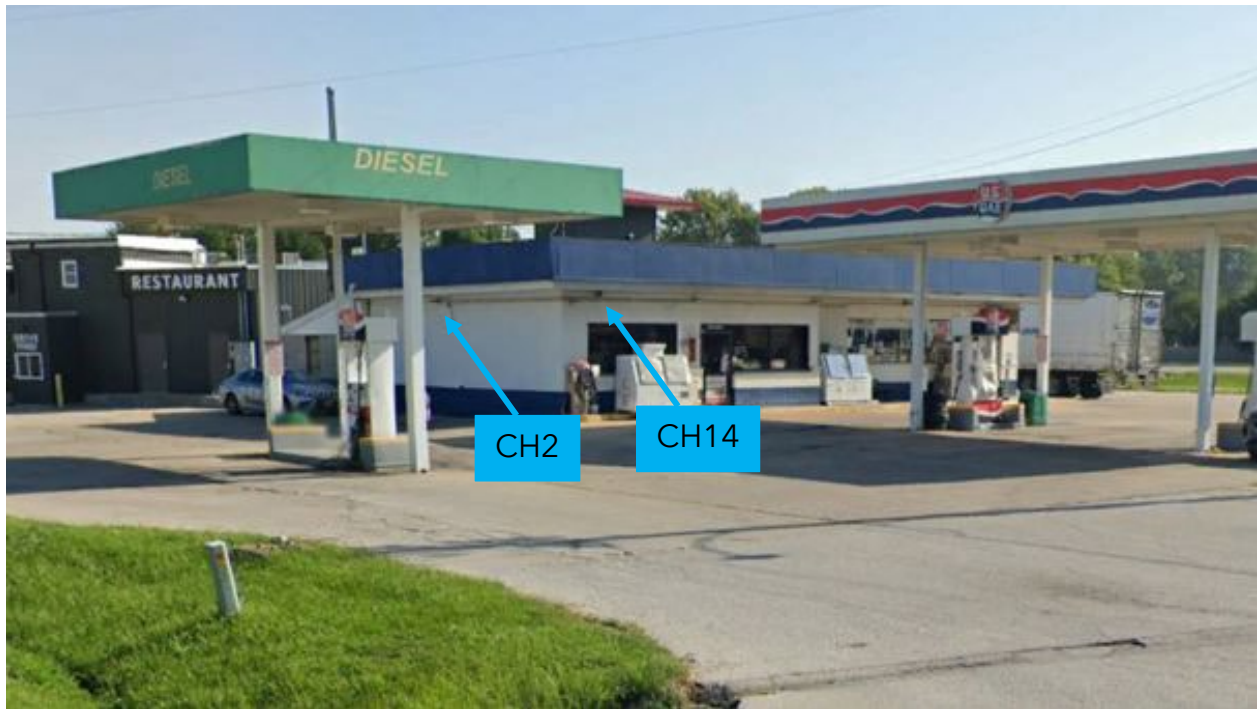
Figure 14. Location of security cameras. (Source: Google Earth revised by NTSB)

The videos were recorded by security cameras that were located on the south side, identified as CH14, and west side, identified as CH2, of the store. During the review of the recordings clock drift was observed between the time displayed on an attached monitor and the time displayed on a mobile phone. Utilizing the time on the mobile phone as the reference time the exported video was 3 minutes and 23 seconds faster. Both cameras captured the pre-impact travel of the combination, a witness, and first responders traveling to the collision. Figure 14 below shows the location of the two security cameras that recorded the videos.

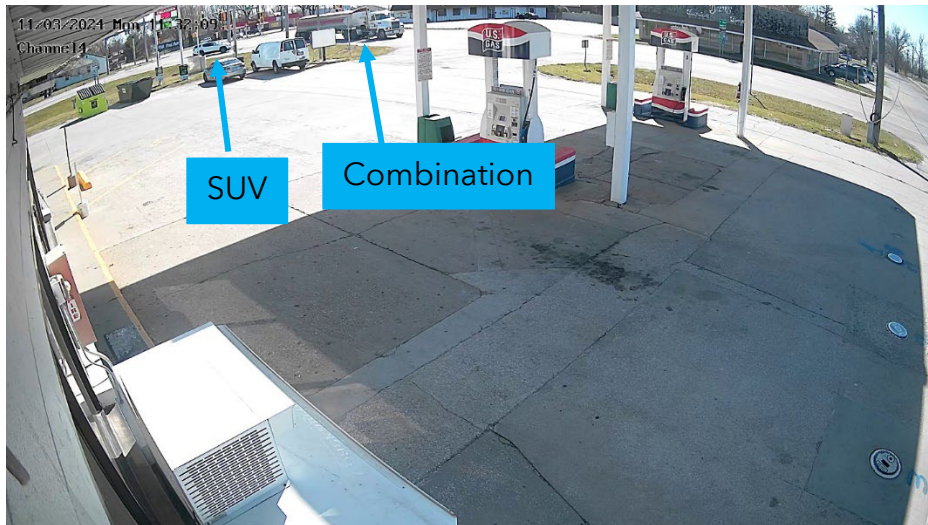
Figure 15. Screen capture from surveillance video showing combination traveling west on US 24.

Figure 15 is a screen capture of the combination traveling west on U.S. Route 24. The combination traveled through the intersection at approximately 11:28:46 CDT. The headlights on the combination were illuminated. There was a white sport utility vehicle (SUV) traveling south on Route 67. After the combination passed through the intersection the SUV turned right onto westbound U.S. Route 24. At approximately 11:28:50 CDT the combination cleared the cameras field of view.

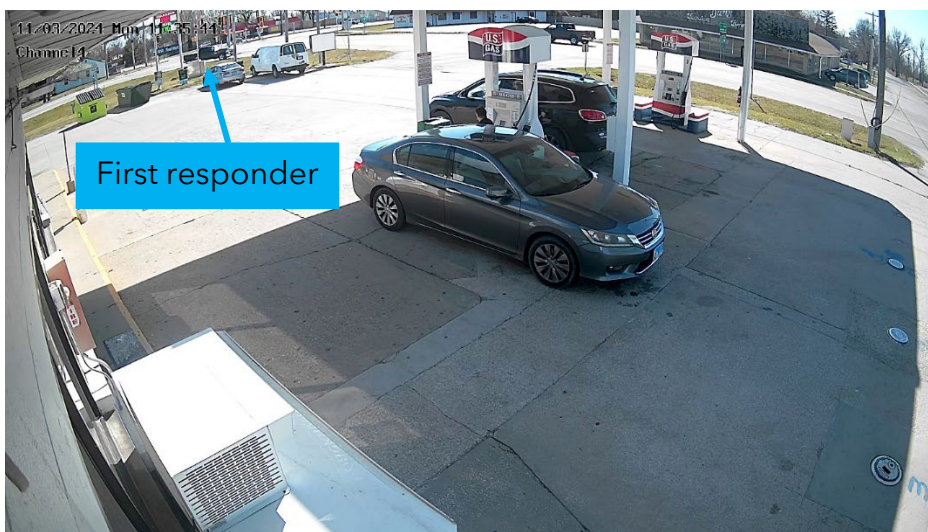
Figure 16. A screen capture from CH14 at 11:32:21.

Approximately 4 minutes later at 11:32:21 the first emergency responder vehicle, black pick-up truck, turned right from southbound Route 67 to westbound U.S. Route 27 (Figure 16).

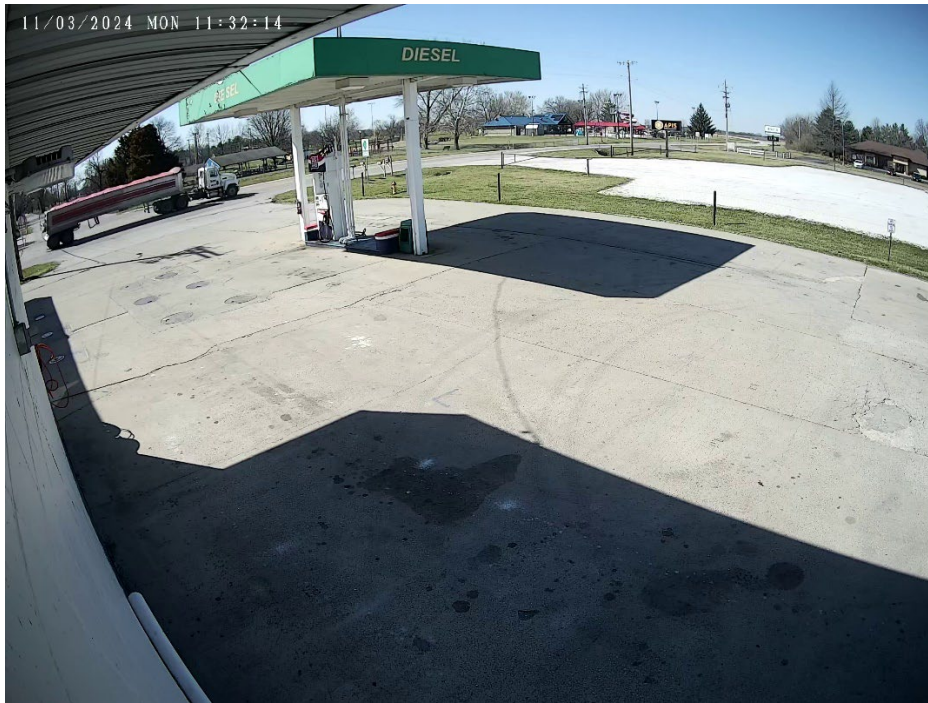
Figure 17. A screen capture from CH2 at time 11:28:51.

Figure 17 is a screen capture from CH2 when the combination was completely visible. The combination continued traveling west on U.S. Route 24.

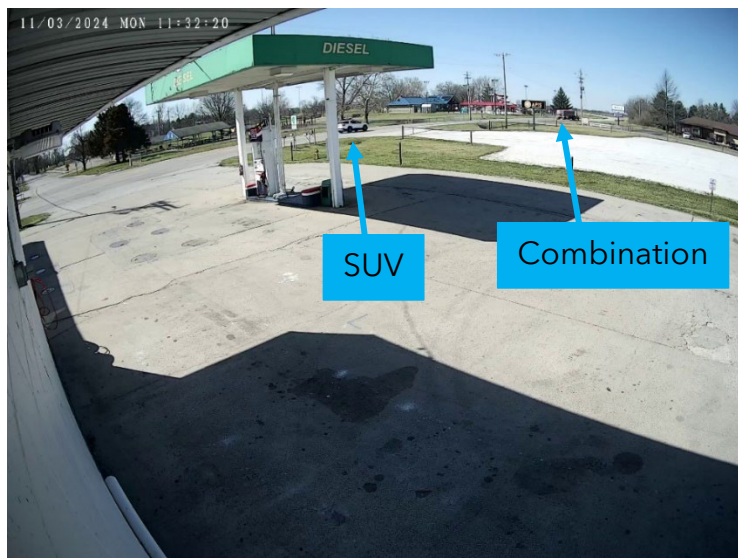
Figure 18. A screen capture from CH2 at time 11:28:57.

Figure 18 shows the combination traveling west with the white SUV traveling behind it. The white SUV was identified as a witness and interviewed by NTSB investigators.¹⁰ The combination negotiated the leftward curve leaving the camera view as it traveled behind a tree. At 11:29:33 smoke was visible rising from behind the tree and the white SUV was stopped in the westbound travel lane.
