Simon Forensic, LLC

Re: Moorage System Failure
Barge SM3
Your File No. DV 3148
S.F. Report No. 4132

2. Visual Examination

3. Fractographic Examination

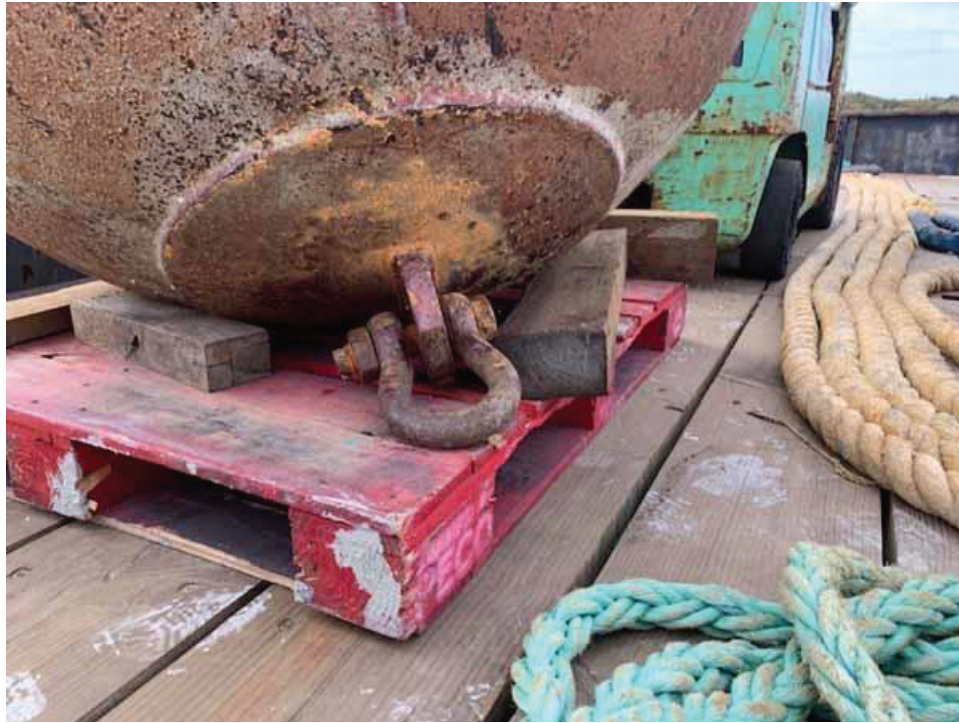
Attachment 2

View of the subject buoy (bottom side). Image courtesy of Mr. McFarland.

1. Examine (visually and mag. particle or dye-penetrant) the bottom side padeye for evidence of cracking.

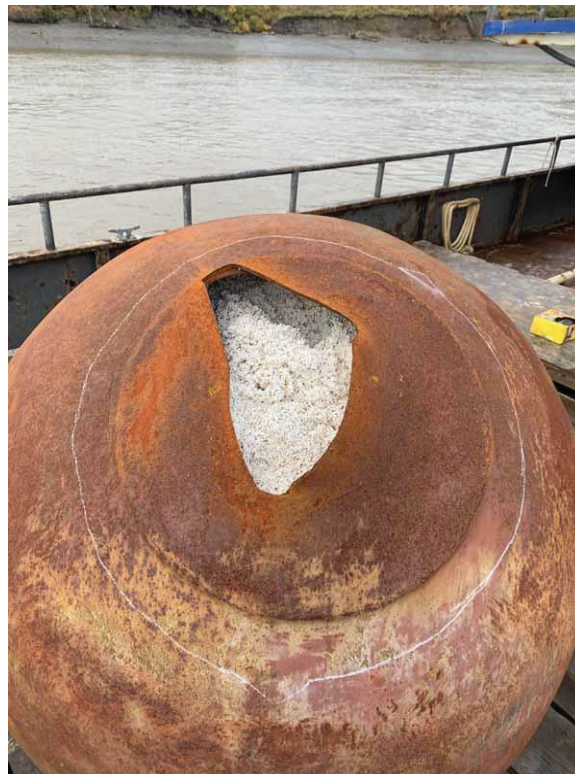
Attachment 3

- The topside of the buoy consists of a padeye (1¼” thick plate) that had been fillet welded to the shell (5/16” thick curved sheet metal) of the buoy.
- The **buoy has functionally failed**, i.e. a **separating crack** had formed at the **fillet weld** of the **topside padeye** thus **allowing the uncontrolled separation of the padeye**, see Fig. 1-4.
- Three (3) shackles used in the mooring operation were found to be marked as follows:
 - 1) **Campbell 1 WLL 8’/2T**, measurements confirmed a shackle diameter of 1” (25mm), see Fig. 4-6 and 8.
 - 2) **Campbell 1 WLL 8’/2T**, measurements confirmed a shackle diameter of 1” (25mm), see Fig. 4-6 and 8.
 - 3) **Crosby WLL 1.5T**, 1 1/8 1251, Fig. 4-7.

View of the subject buoy (top side). Image courtesy of Mr. McFarland.

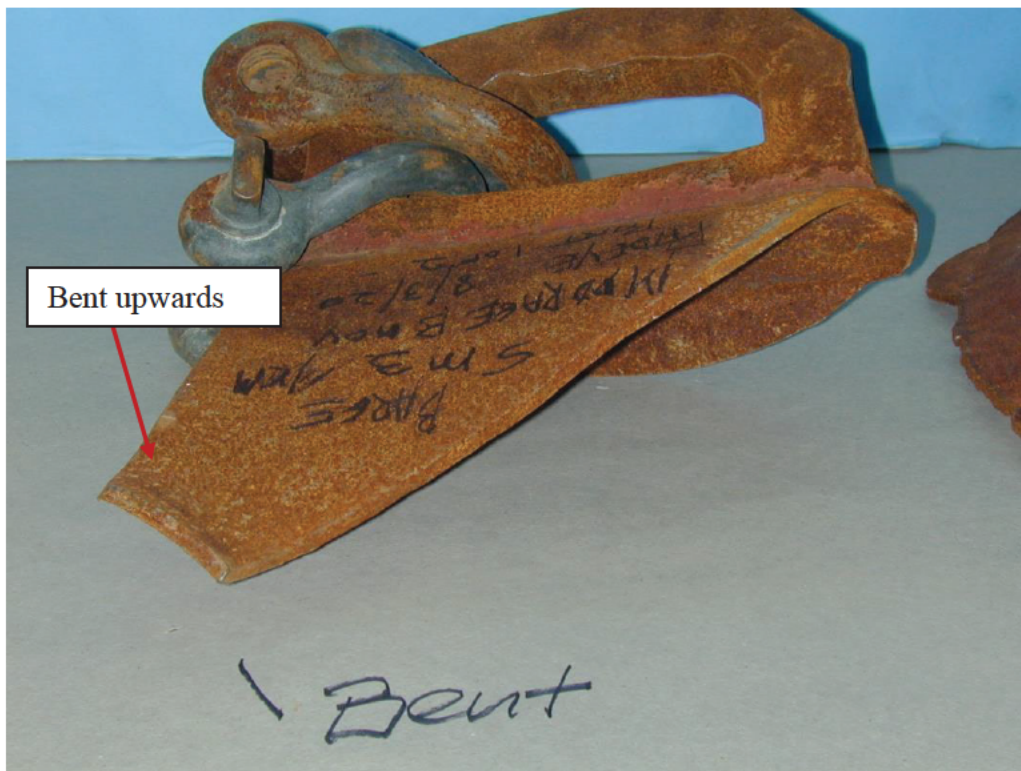
None of the shackles had failed, i.e. **no plastic deformation or cracking** was observed.

Fig. 4: Same as Fig. 3, but viewed from and different angle.

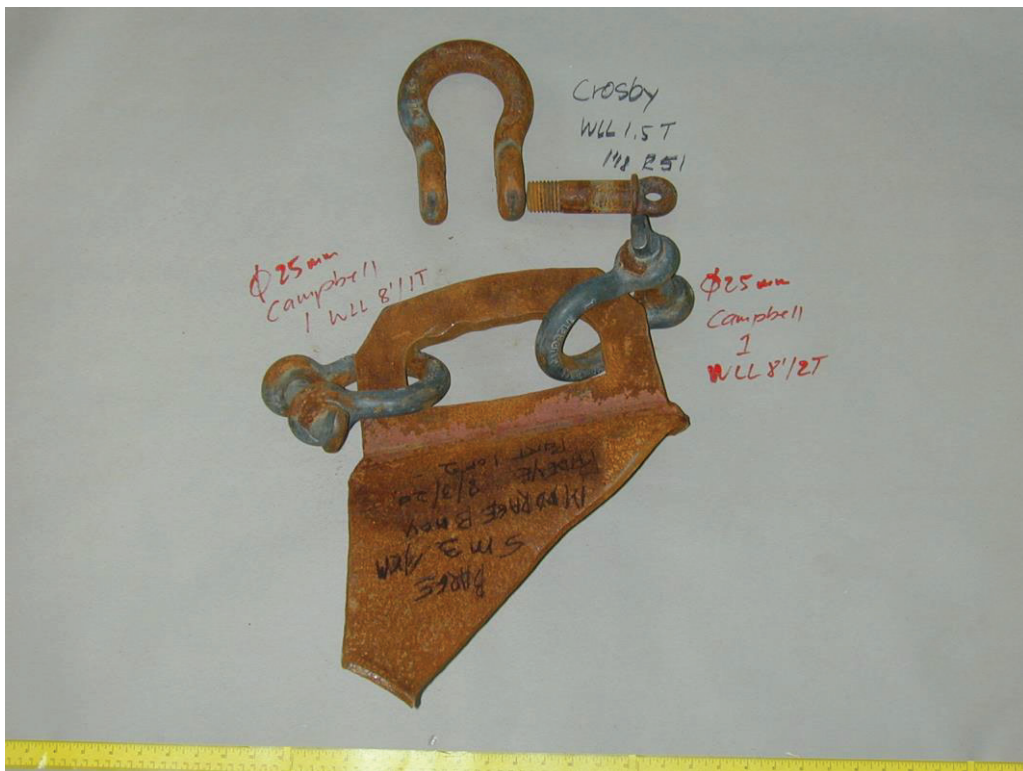
Fig. 6: Same as Fig. 5, but the Crosby shackle has been removed.

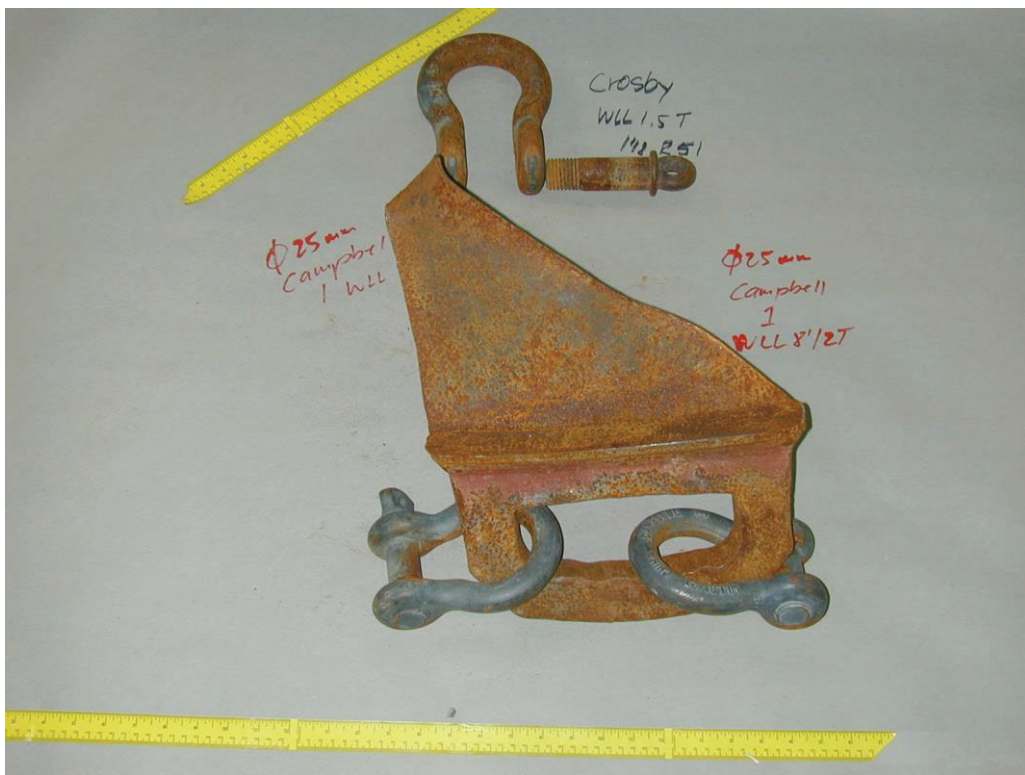
Fig. 10: Same as Fig. 6, but the padeye shown from a different angle.

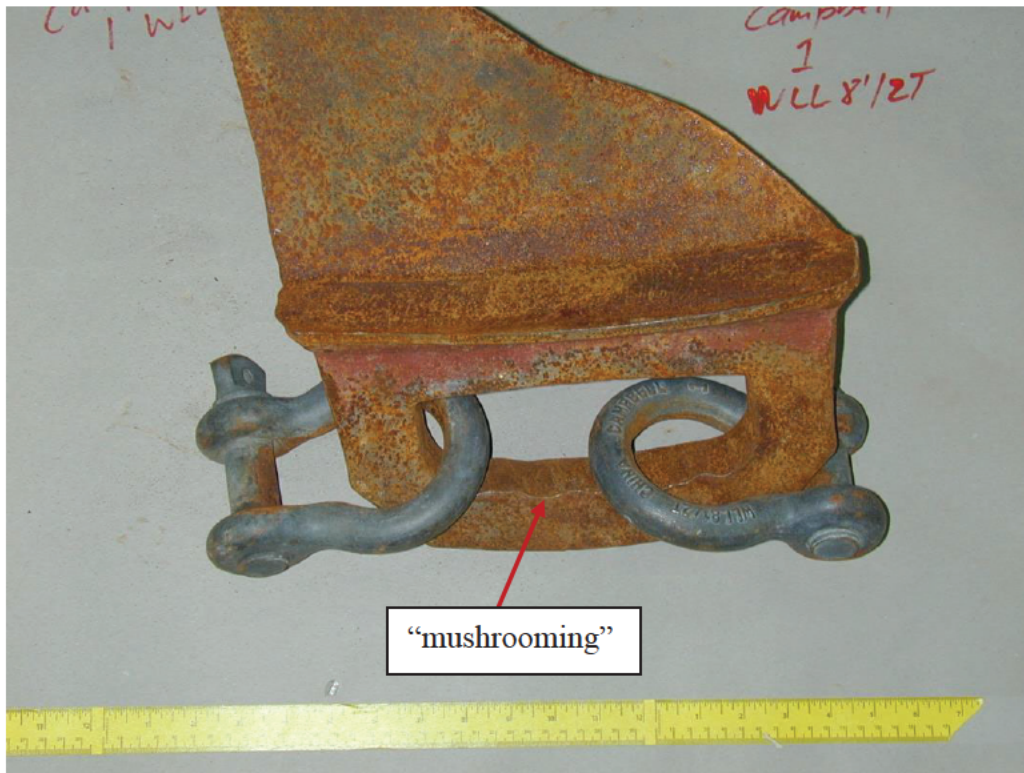
Fig. 11: Close up view of Fig. 5.

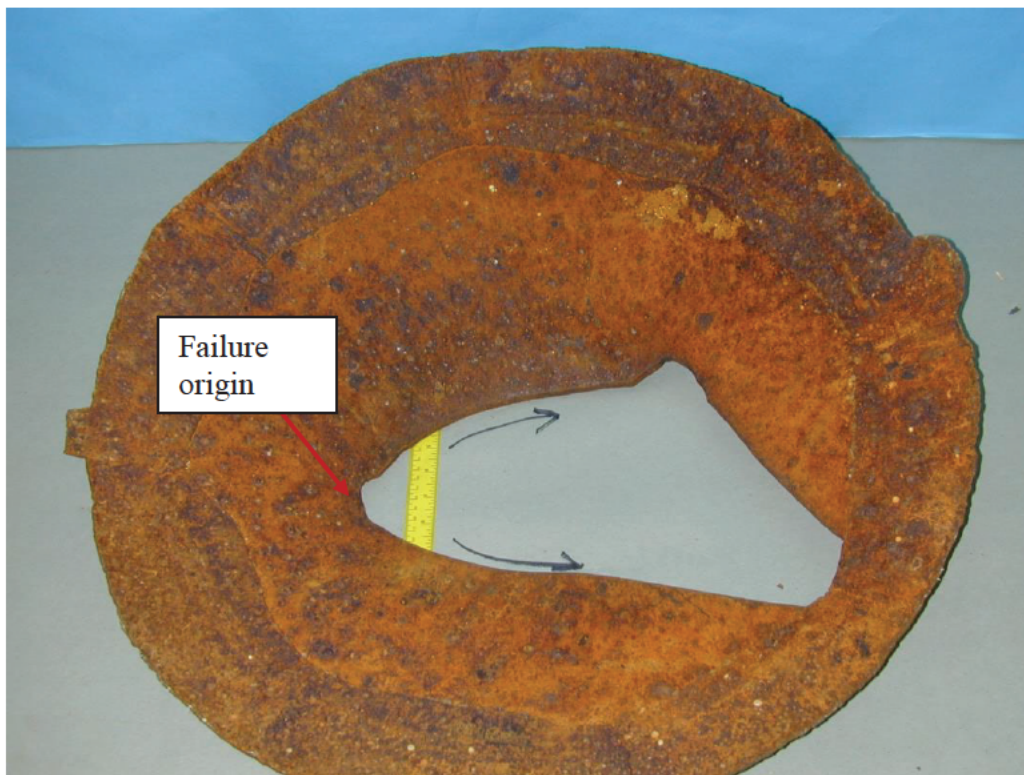
Fig. 14: Same as Fig. 13, but the inside surface is shown.

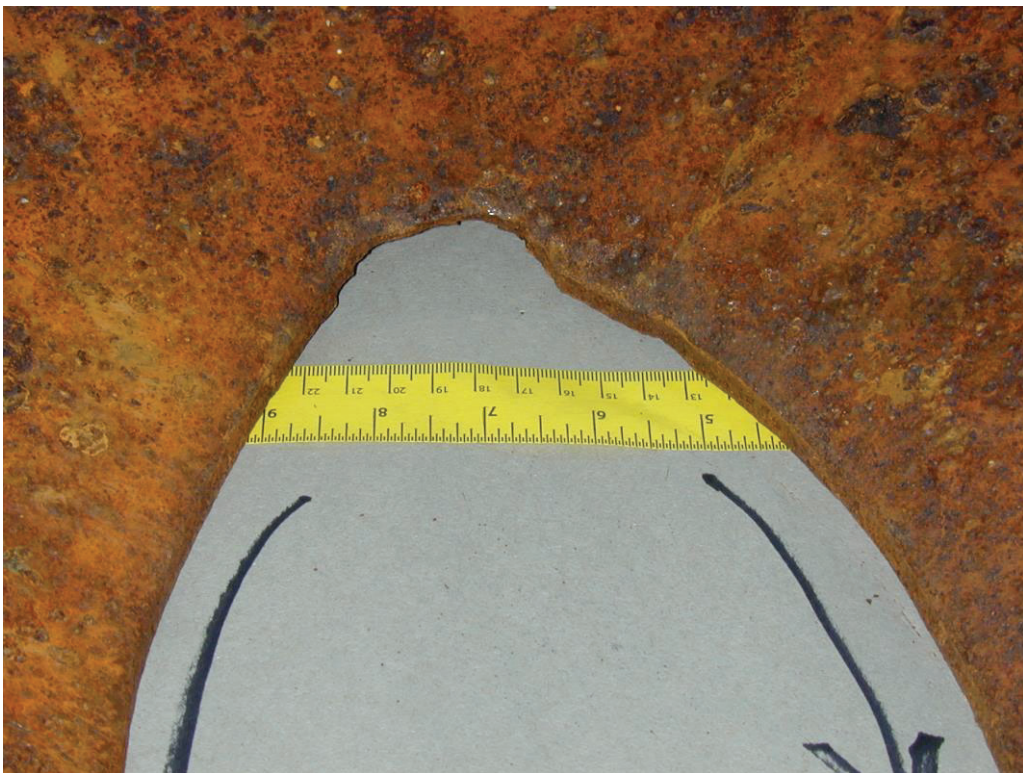
Fig. 16: Close up view of Fig. 15.

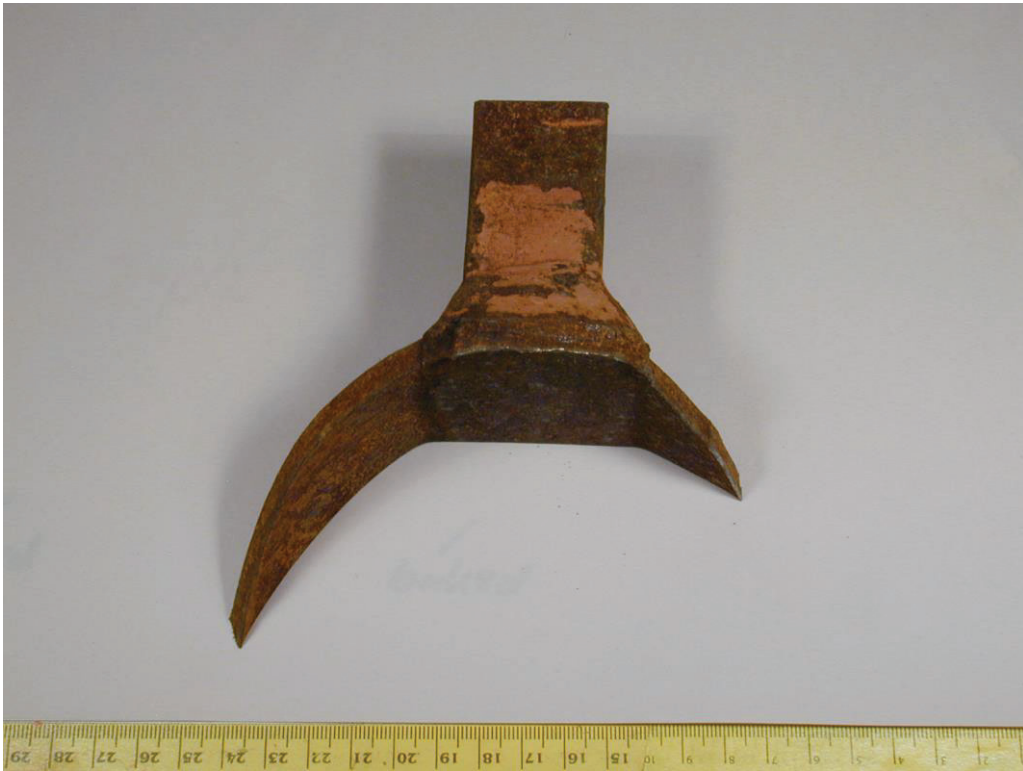
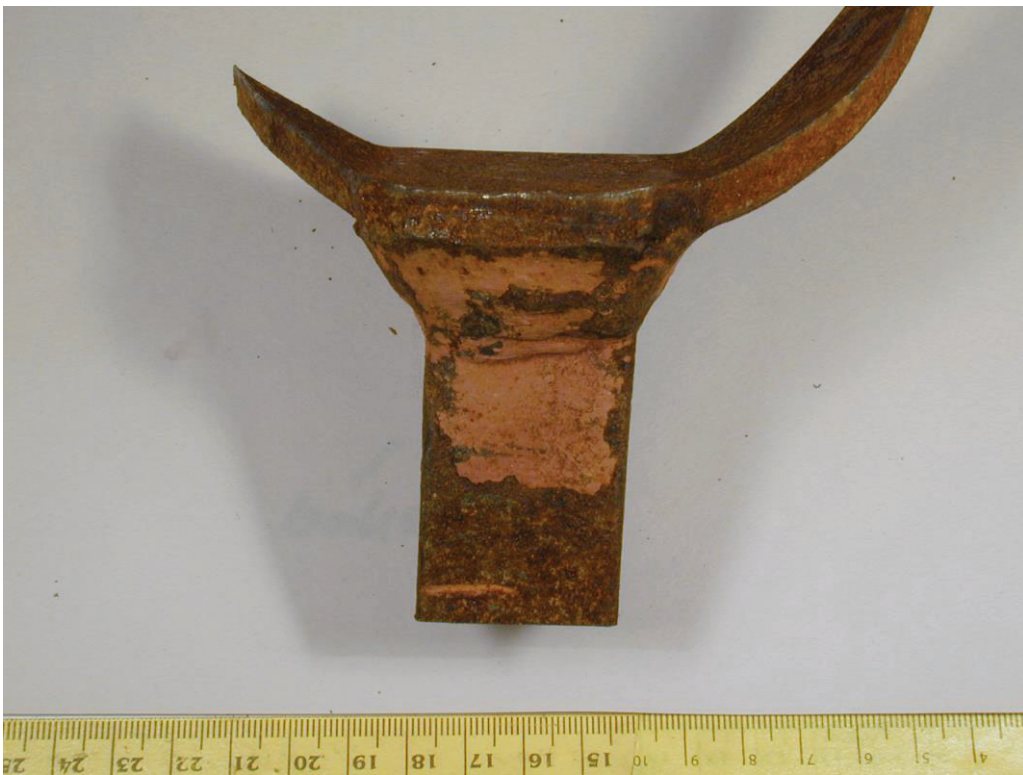
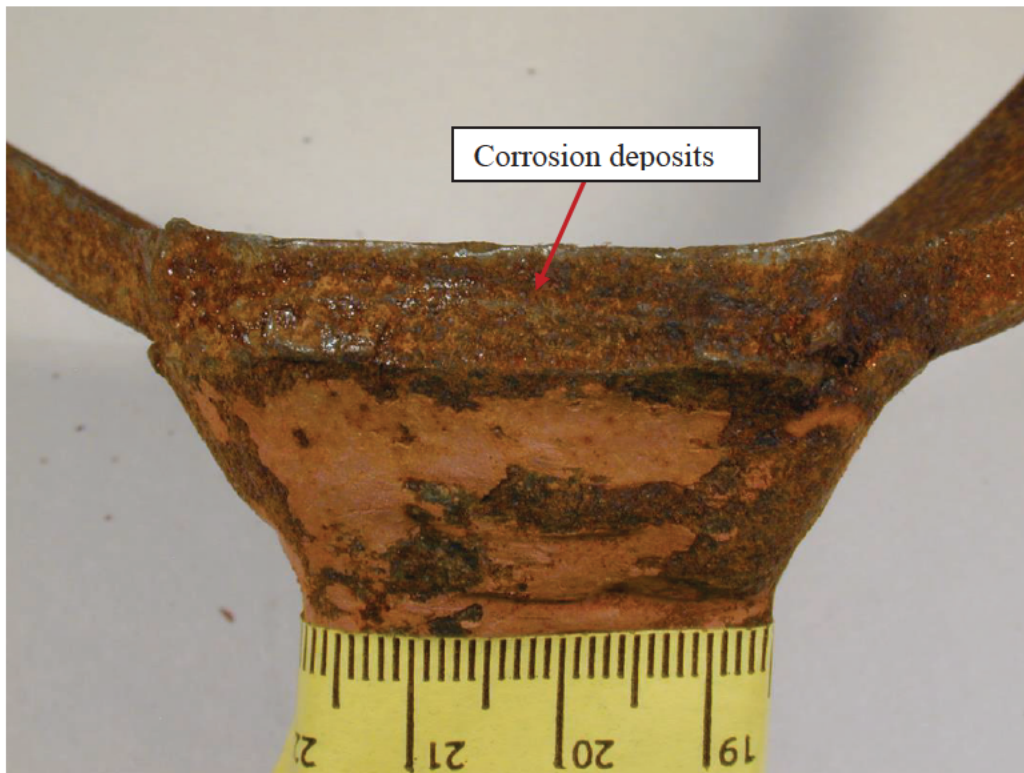
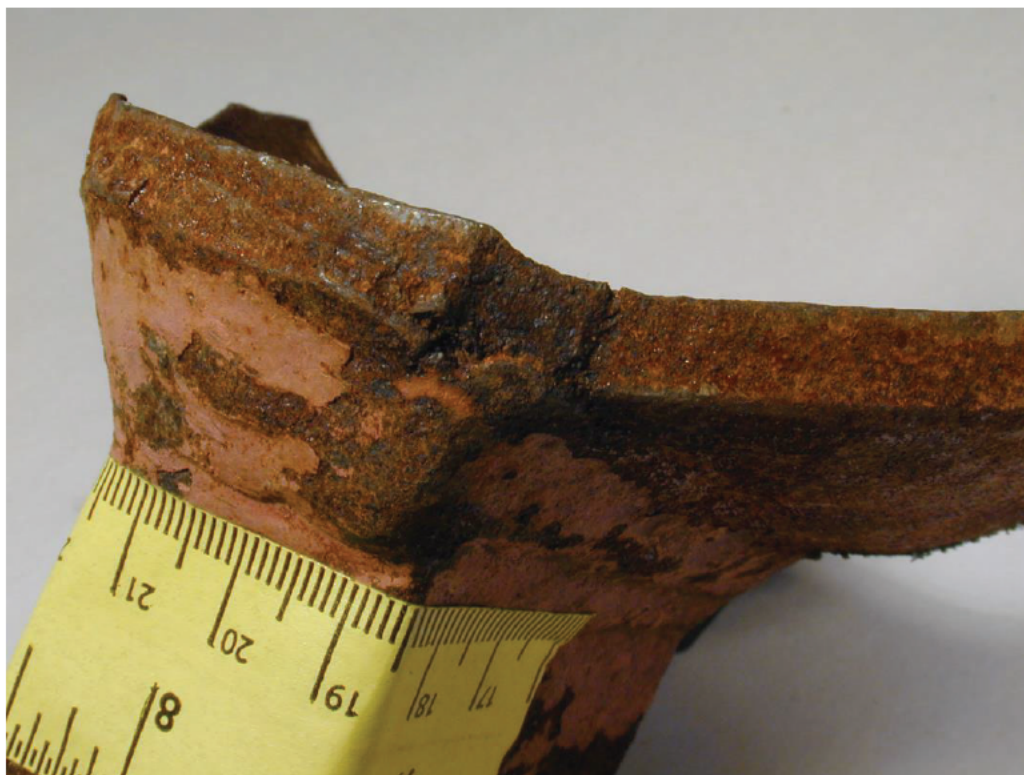
- A light layer of corrosion products was found to cover the fracture face thus masking the finer fractographic details, see Fig. 12-13.
- The **fracture initiated at the fillet weld** (plate side) at the **end face of the padeye**, see Fig. 17-18.
- A section containing the crack origin was removed (see Fig. 19-23) and ultrasonically cleaned, see Fig. 30.

Fig. 19: Overall view of the liberated failure origin.

Fig. 20: Same as Fig. 19, but viewed from a different angle.

Fig. 21: Close up view of Fig. 20.

Fig. 22: Same as Fig. 21, but viewed from a different angle.

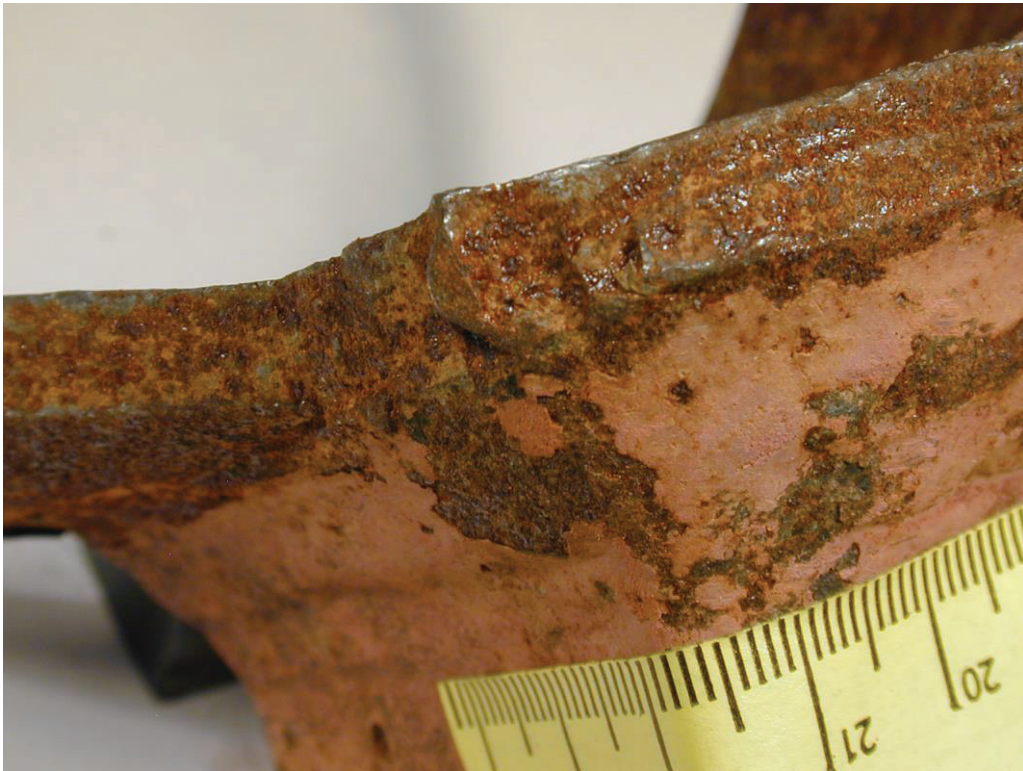
Fig. 23: Same as Fig. 22, but viewed from the opposite side.

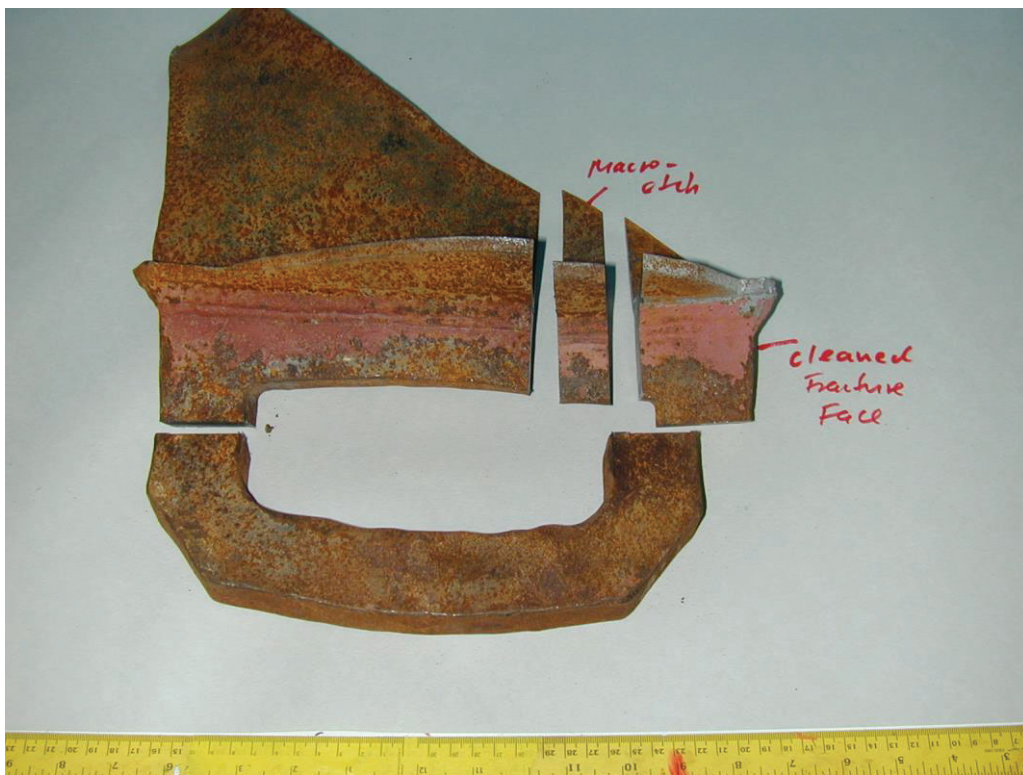
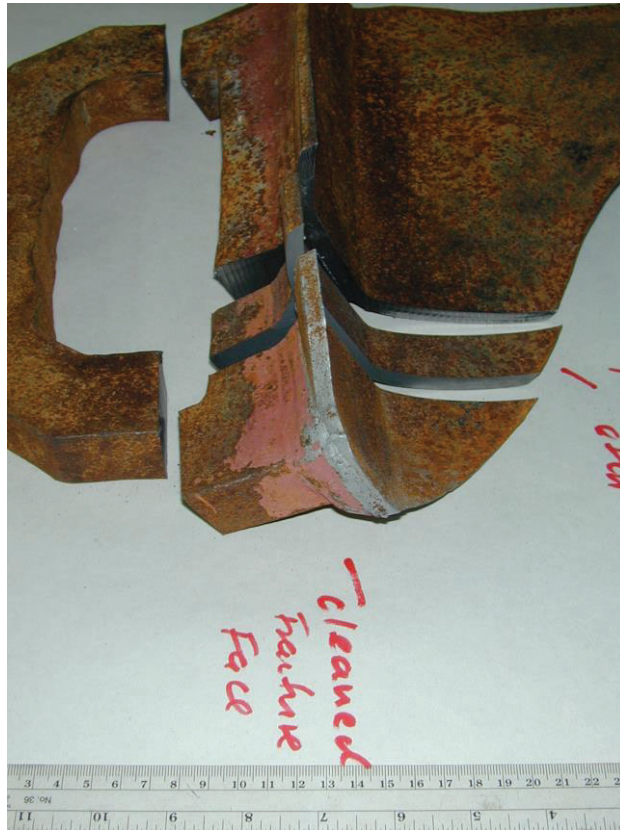
A cross-section was removed across the weld adjacent to the failure origin (see Fig. 24-25) and macro-etched, see Fig. 26.

Fig. 24: Same as Fig. 11, but the padeye has been removed and an x-section removed from the weld and macro-etched.

Fig. 25: Same as Fig. 24, but viewed from a different angle.

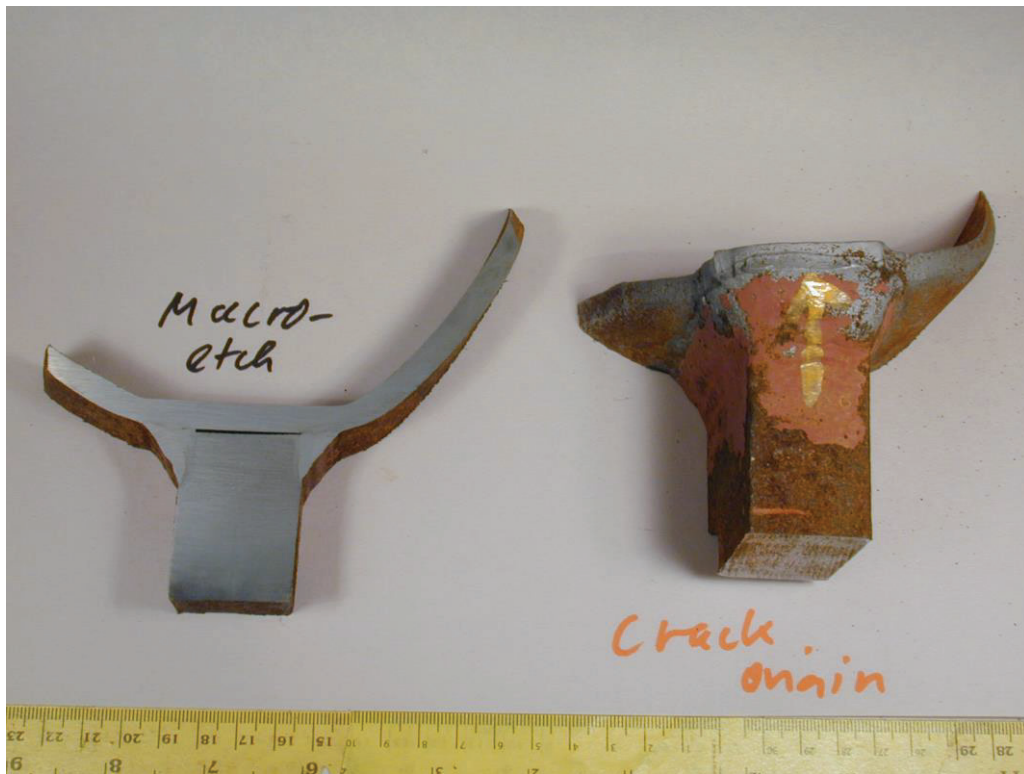
Fig. 26: Close up view of the macro-etched weld x-section and ultrasonically cleaned failure origin.

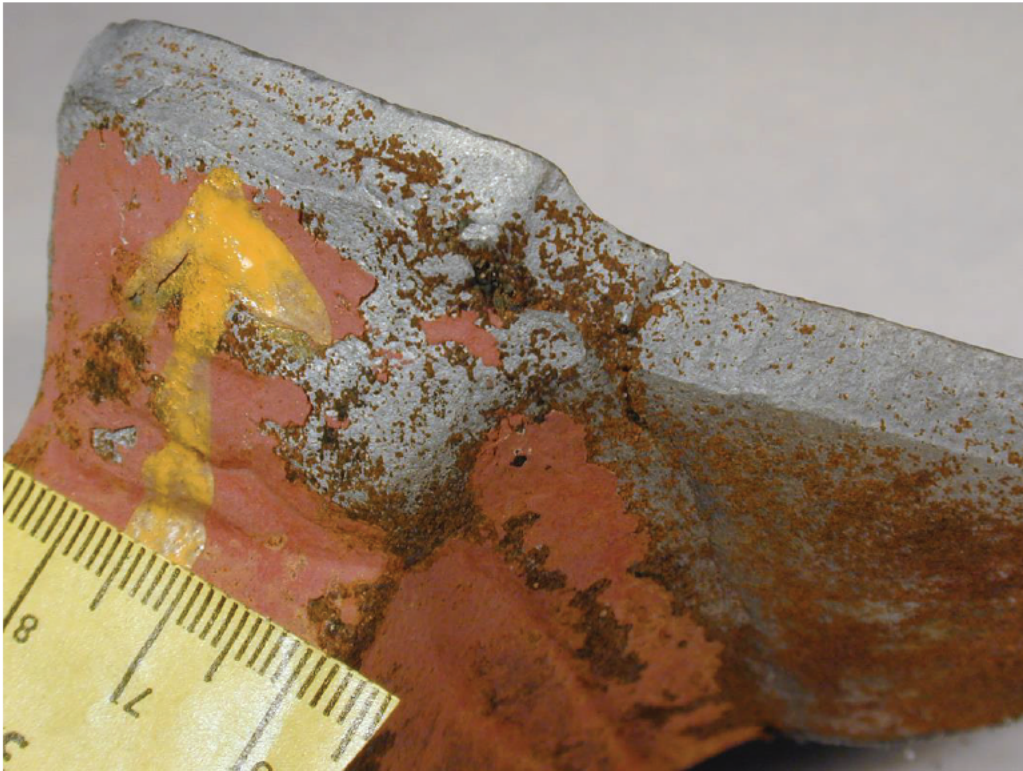
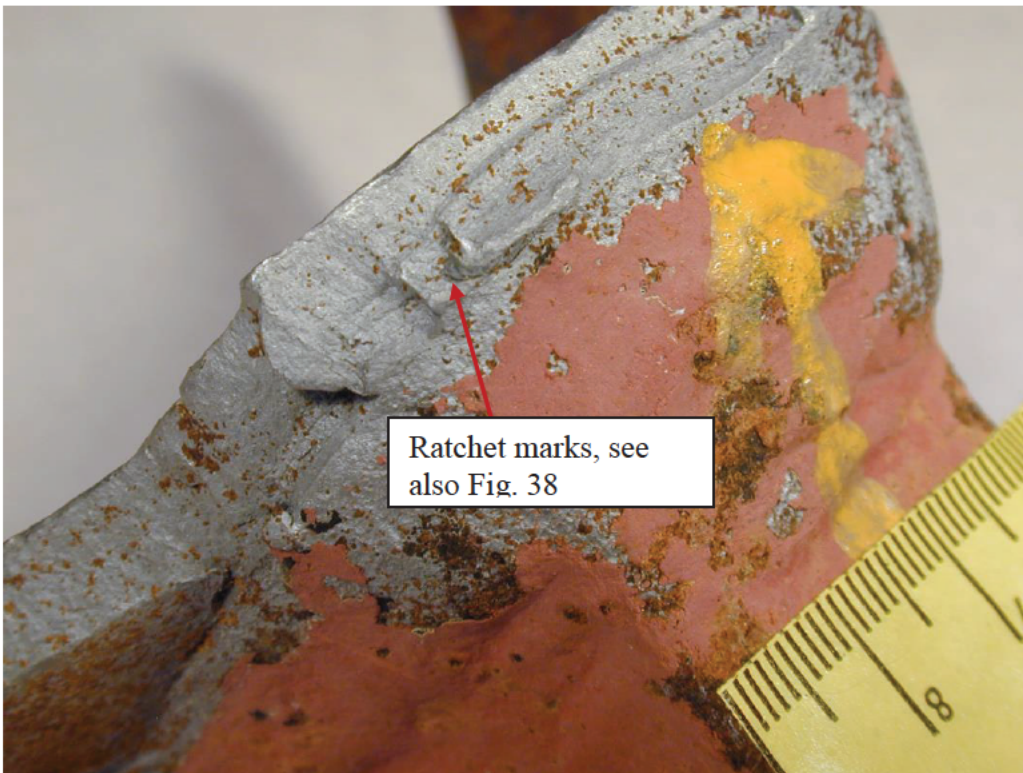
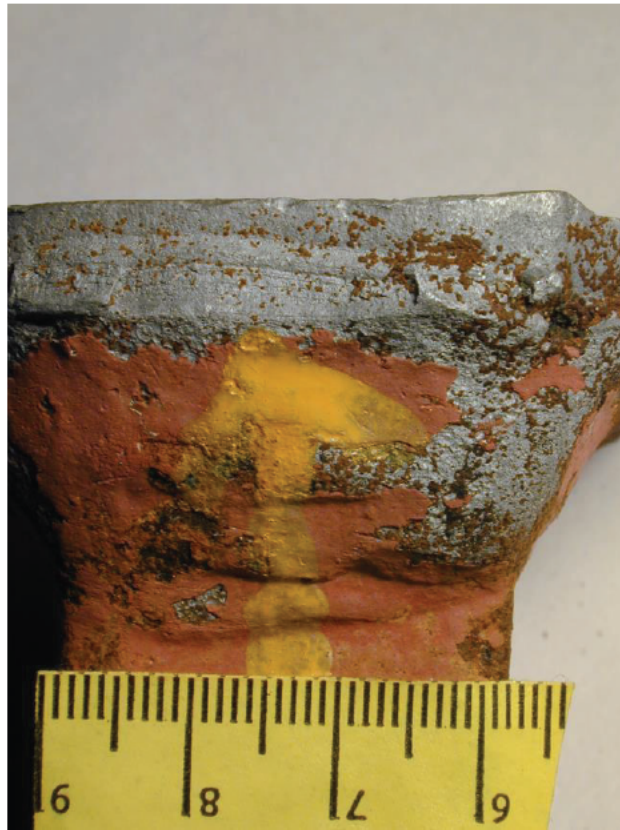
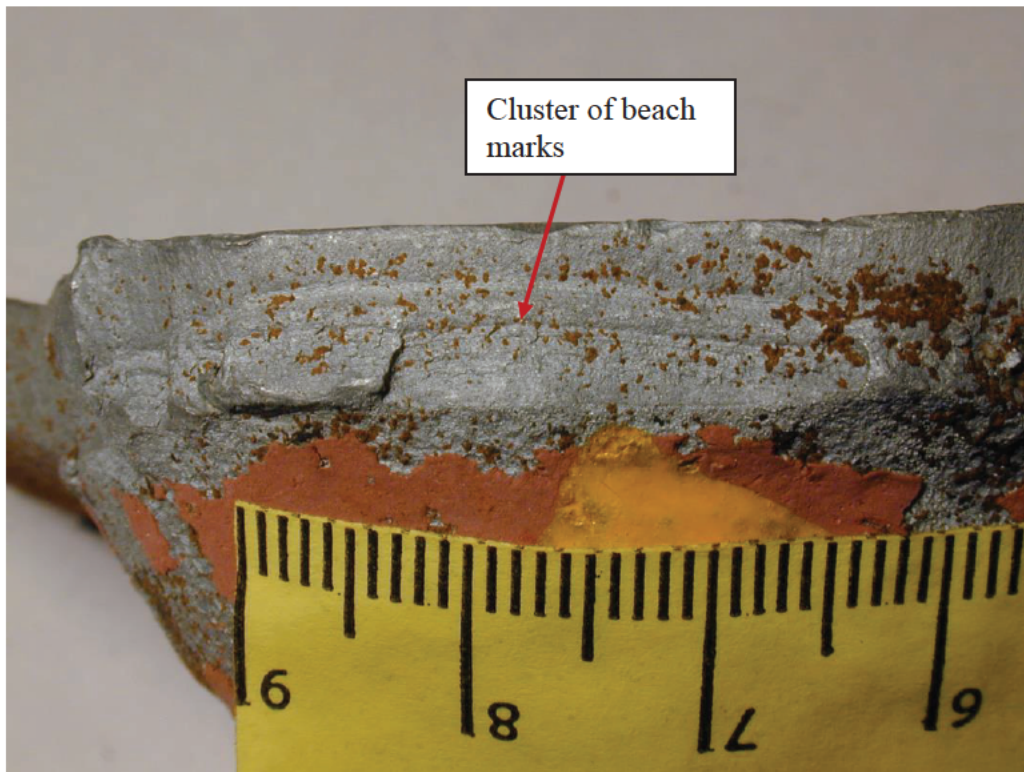
A closer examination revealed a **small fatigue zone** (approximately 5mm deep and extending over the width of the padeye), i.e. beach marks (witness marks of stage II fatigue) were observed, see Fig. 30-37.

Fig. 31: Same as Fig. 30, but viewed from a different angle.

Fig. 32: Same as Fig. 31, but viewed from the opposite side.

Fig. 33: Close up view of Fig. 30.

Fig. 34: Close up view of Fig. 33.

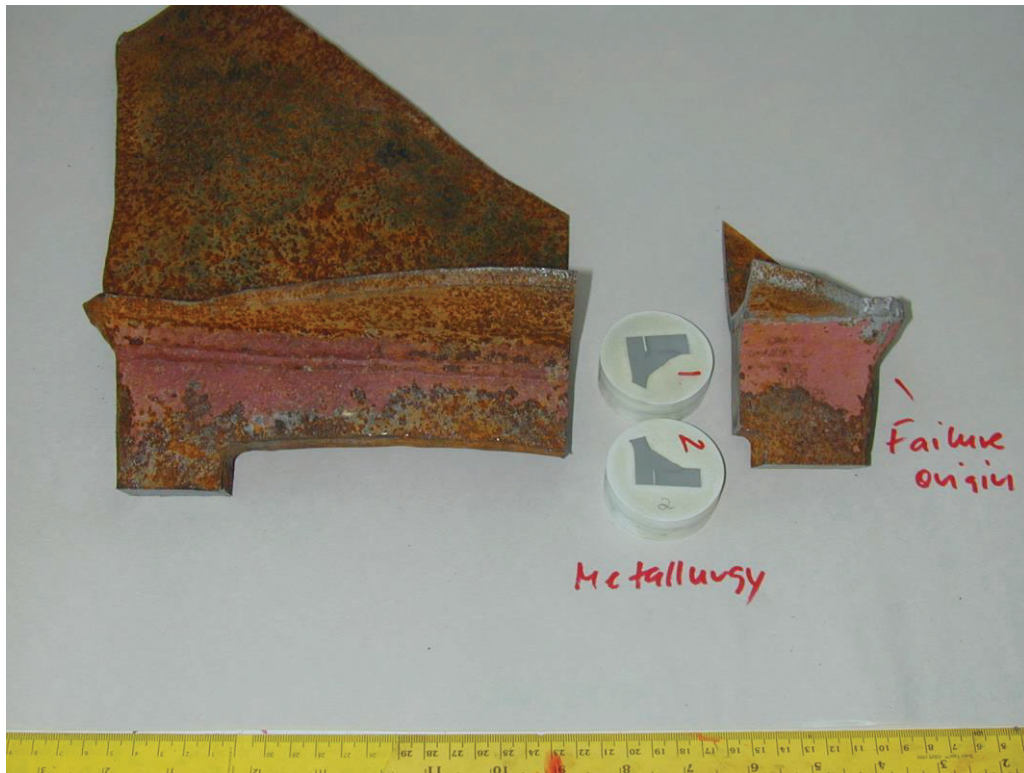
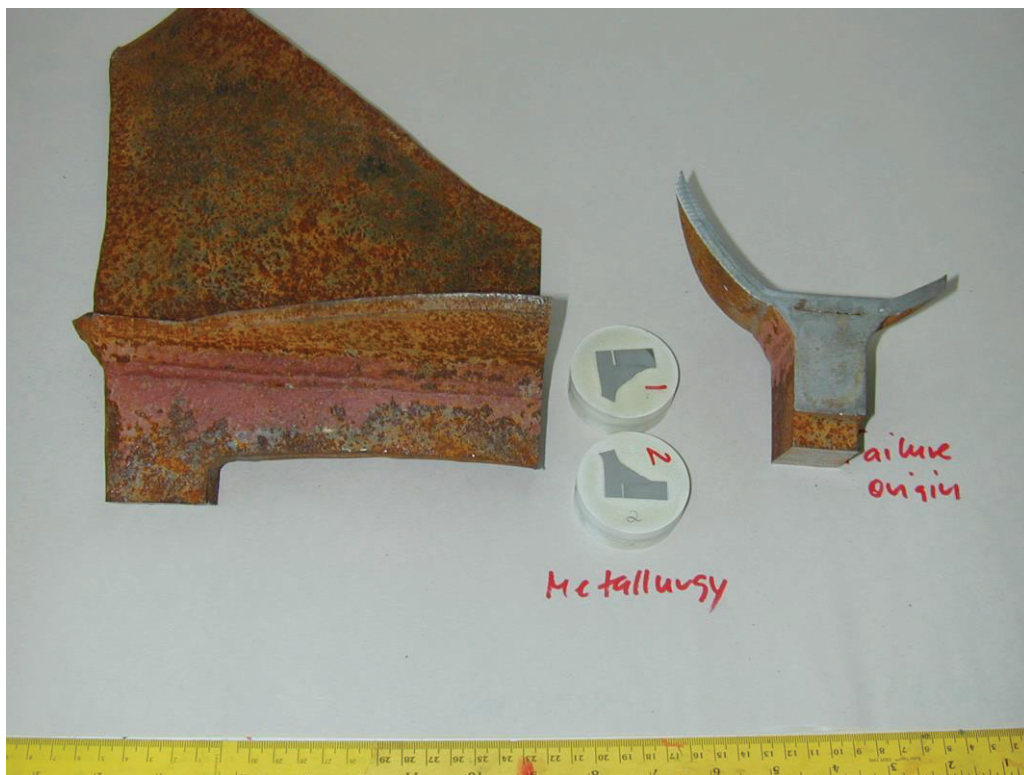
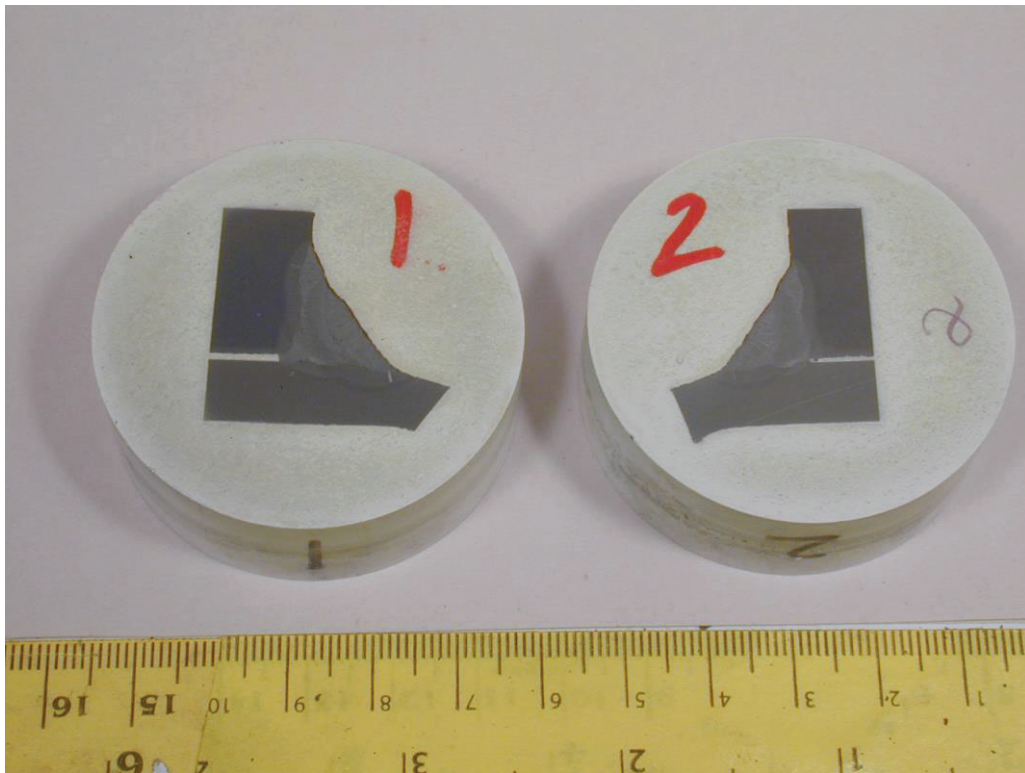
Fig. 39: Overall view of the metallographically prepared sections.

Fig. 40: Same as Fig. 39, but the cleaned failure origin is shown from the end.

Fig. 41: Close up view of Fig. 40.

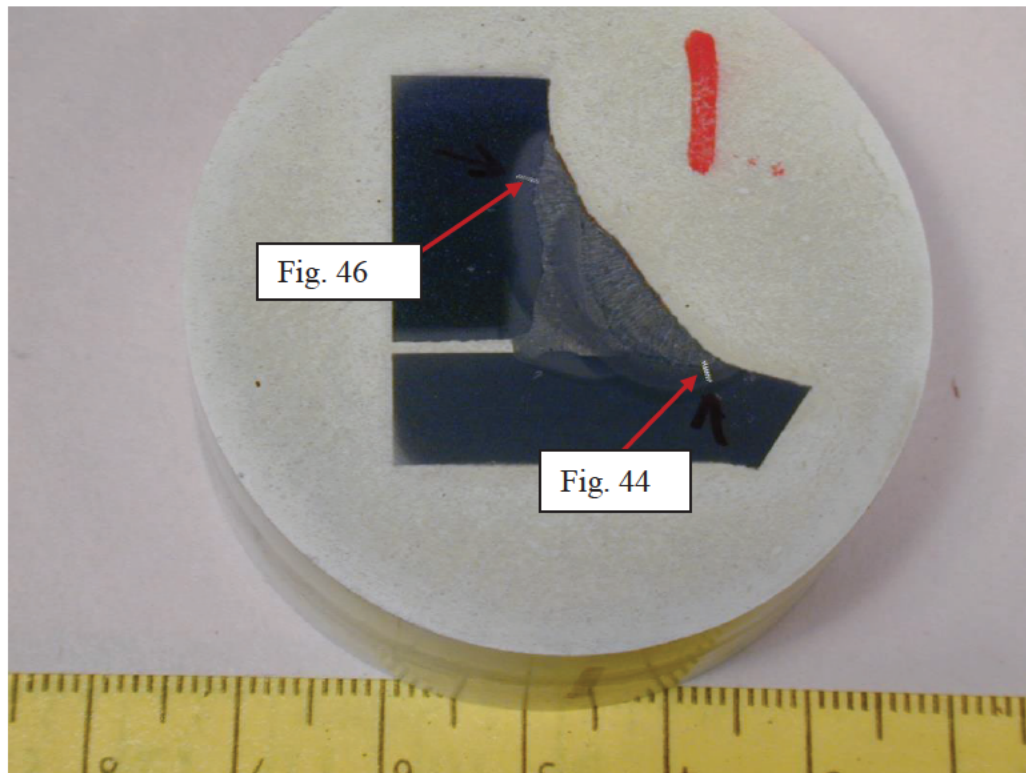
Fig. 43: Same as Fig. 42, but differently illuminated.

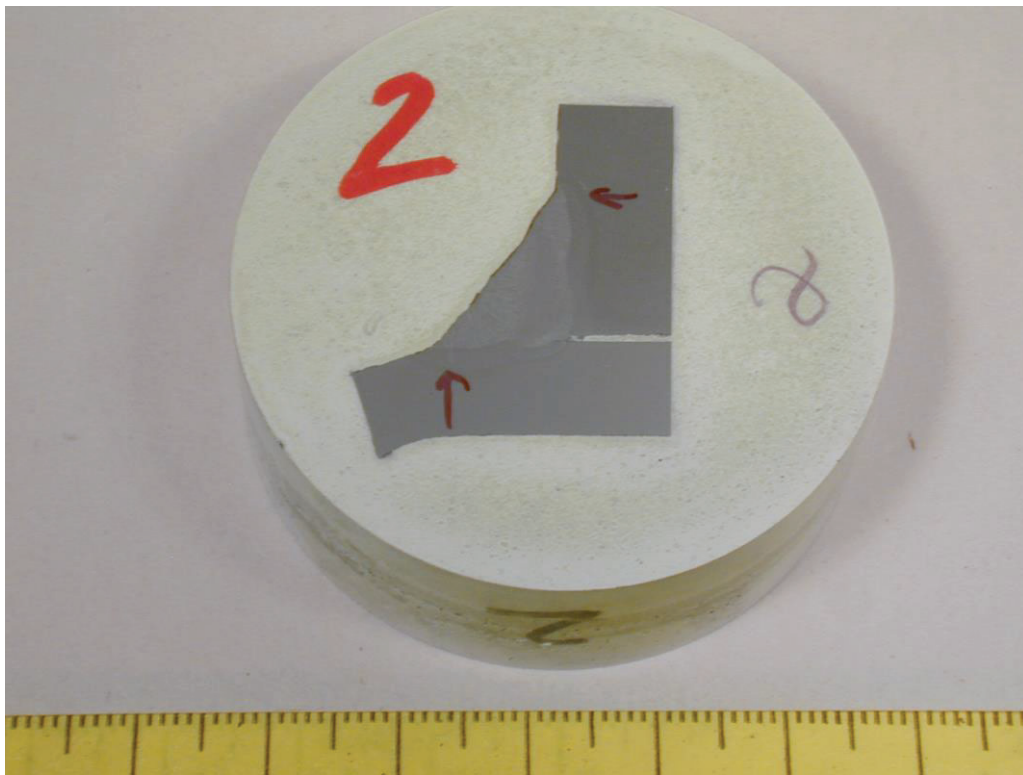
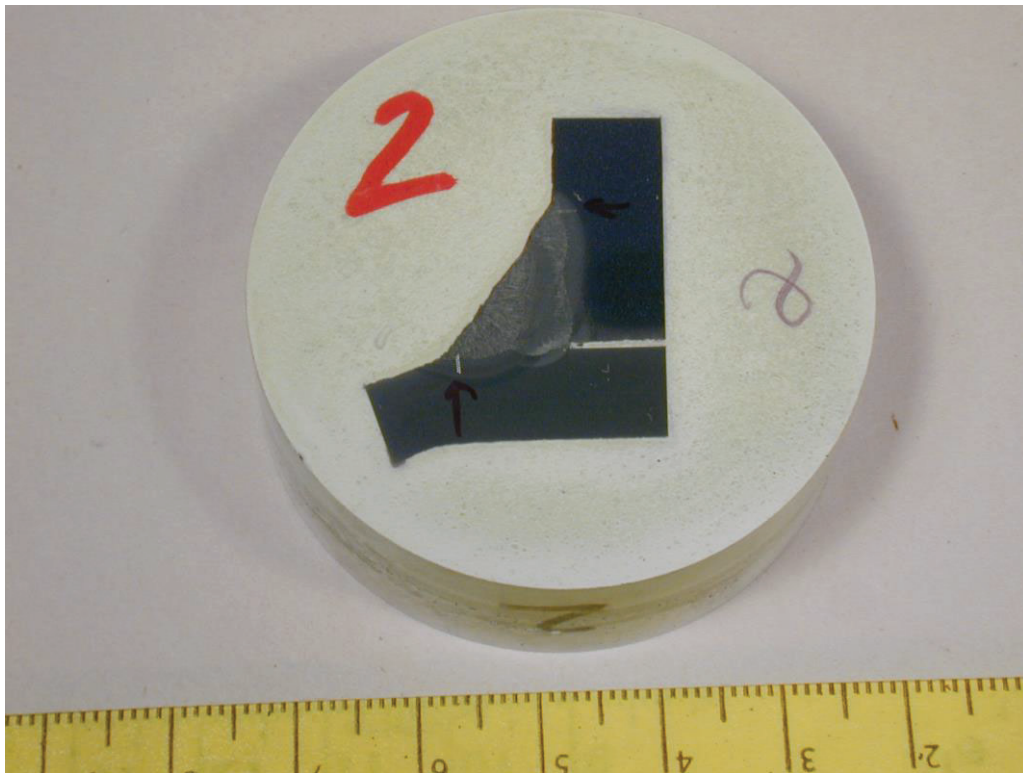
Fig. 48: View of weld section #2.

Fig. 49: Same as Fig. 48, but differently illuminated.

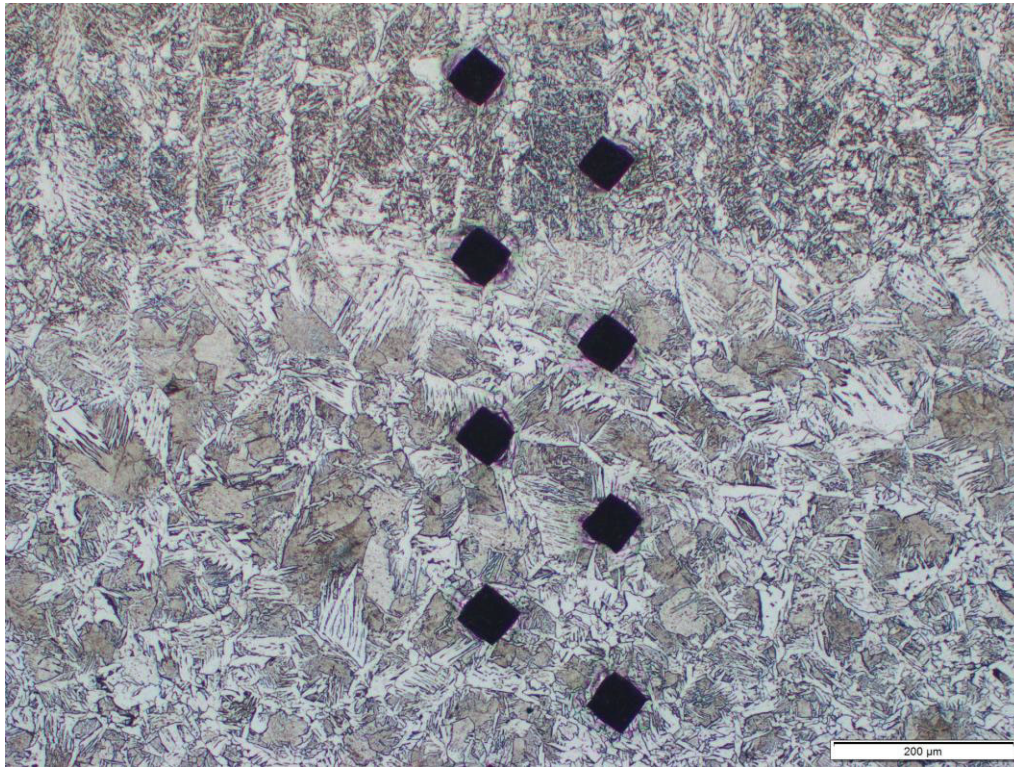
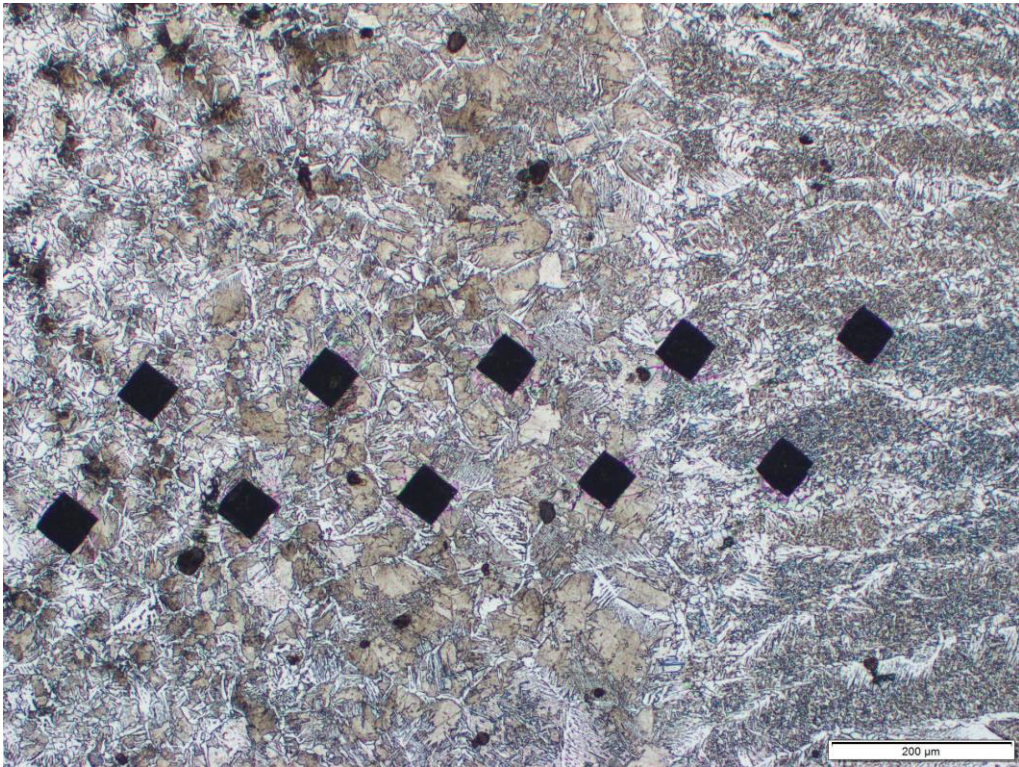
- The padeye is made from a mild carbon steel, i.e. a ferritic/pearlitic microstructure was observed, see Fig. 47.
- The buoy shell is made from a low carbon steel, i.e. a primarily ferritic microstructure was observed, see Fig. 45.
- No undesirable phase transformation products were observed in any of the examined HAZ’s suggesting that a proper temperature control had been maintained at the time of welding, see Fig. 44, 46 and 50-53.
- **No weld defects were found to have encouraged the failure.**

Fig. 51: Close up view of Fig. 50 at 100x.

Fig. 53: Close up view of Fig. 52 at 100x.
