Simon Forensic, LLC

Re: Moorage System Failure
Barge SM3
Your File No. DV 3148
S.F. Report No. 4132

2. Visual Examination

3. Fractographic Examination

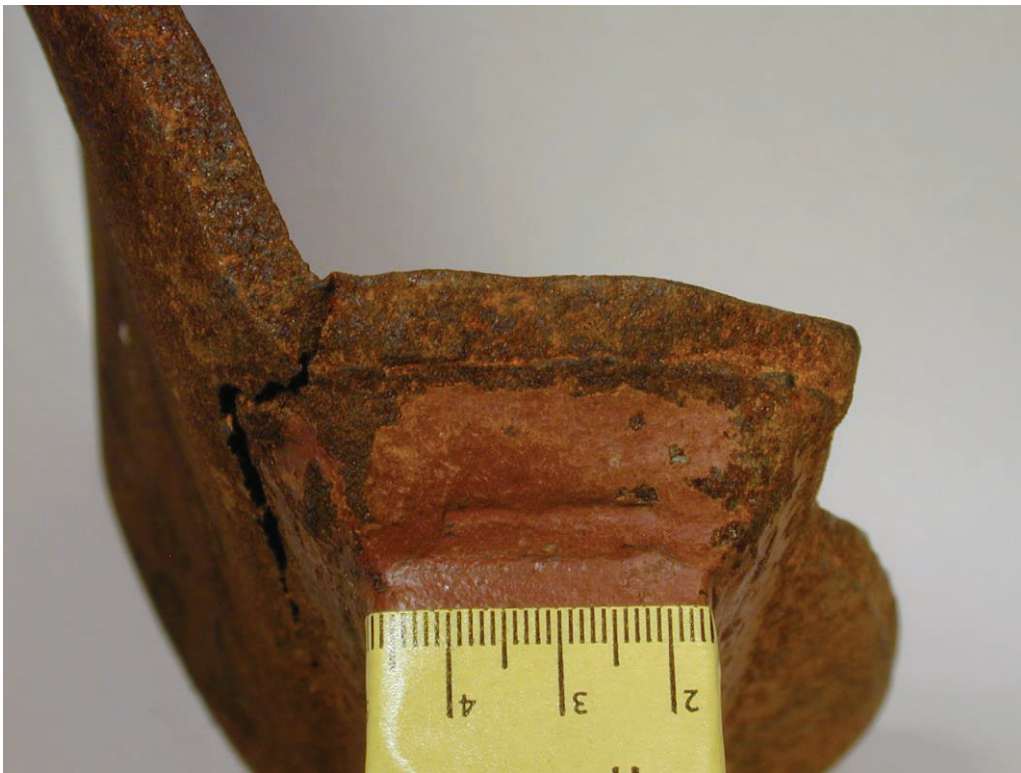
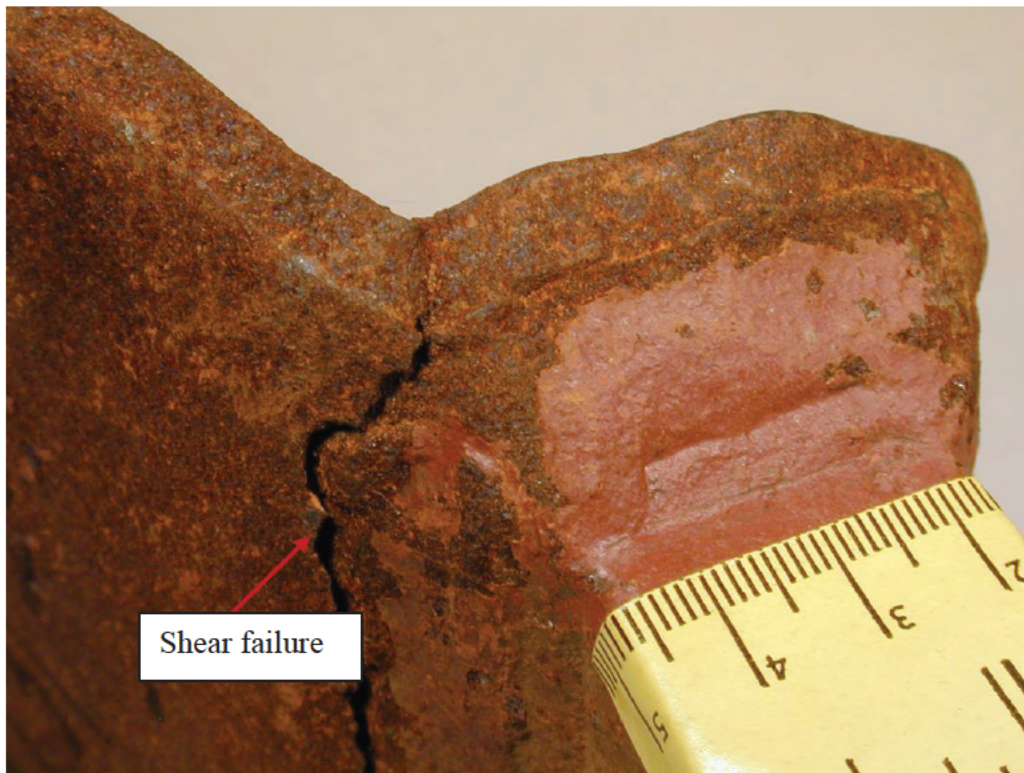
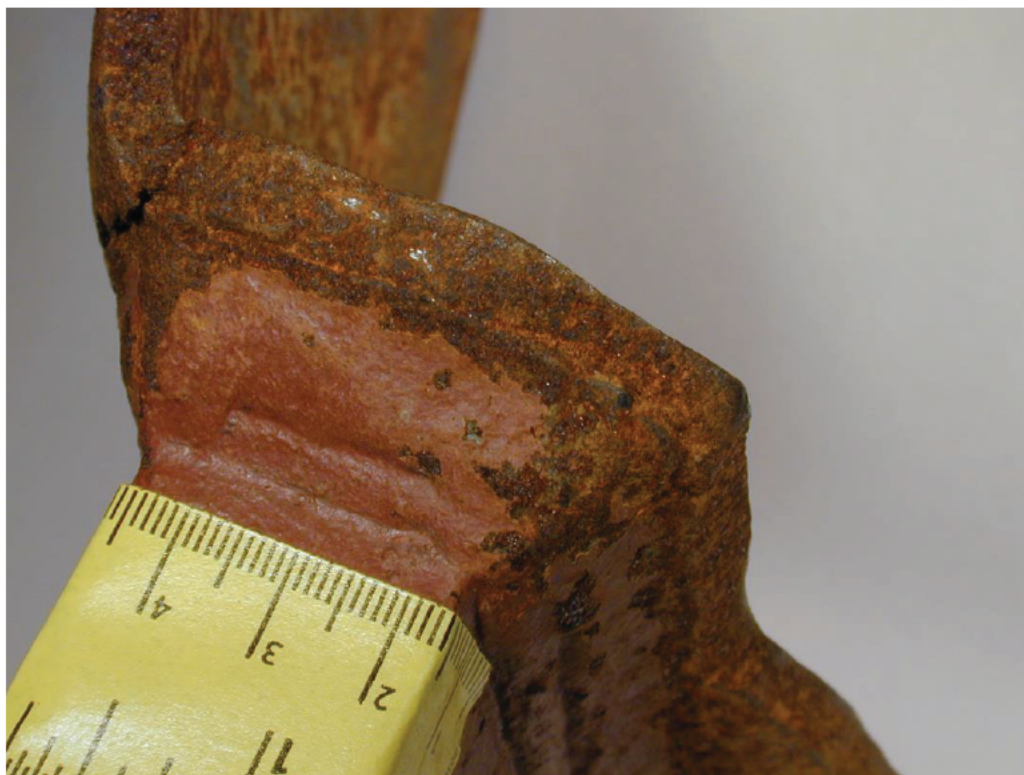
Fig. 54: Same as Fig. 20, but the other end of the padeye is shown.

Fig. 55: Close up view of Fig. 54.

Fig. 56: Same as Fig. 55, but the other side of the padeye end is shown.
