National Transportation Safety Board

HWY24MH005

VEHICLE FACTORS

Group Chair's Factual Report

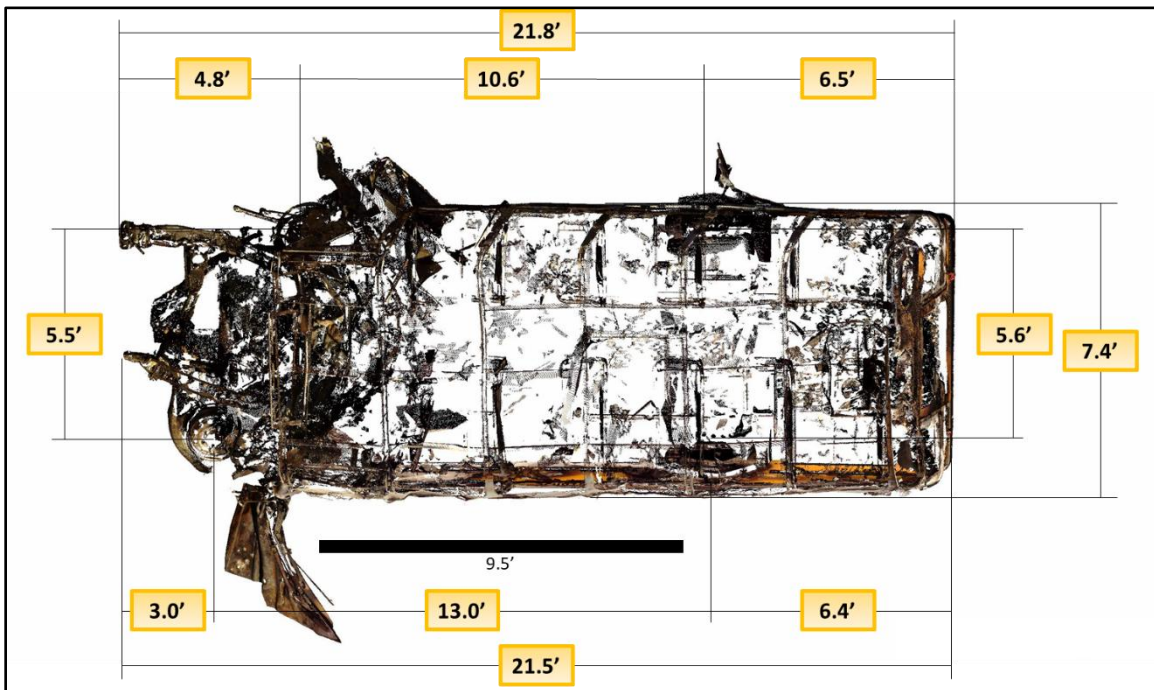
Figure 3. Three-dimensional laser scan of the Micro Bird.

The crash-involved Micro Bird and an exemplar 2021 Micro Bird MB-II were scanned by NTSB investigators using a three-dimensional terrestrial laser scanner and point clouds were created for each vehicle. Refer to the docket for additional information regarding the three-dimensional laser scans. Vehicle dimensions were determined by measuring three-dimensional points in the point clouds using CloudCompare software (Figure 3). According to specifications for Micro Bird T-Series (Ford Transit 350 cutaway) school buses, the undamaged Micro Bird MB-II had an overall length of 274 inches (22 feet 8 inches) and overall width of 86 inches (7 feet 2 inches) and wheelbase of 156 inches (13 feet).⁵

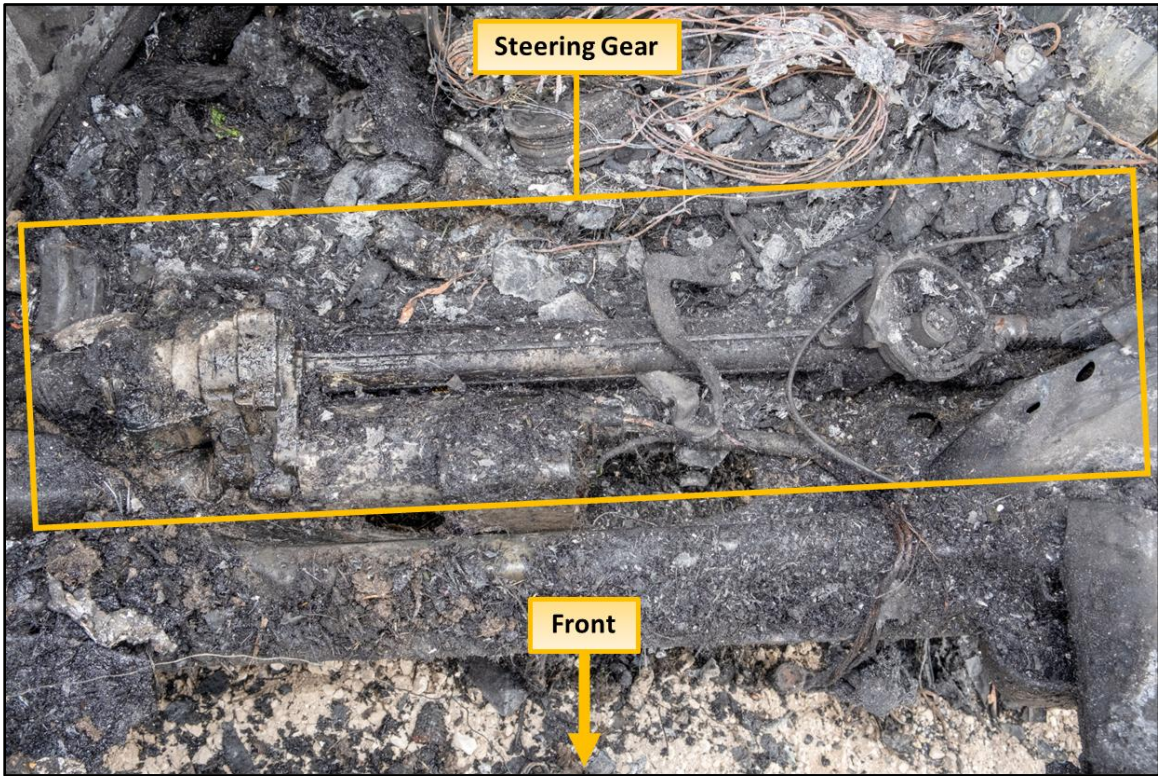
Figure 9. The steering gear mounted near the front of the Micro Bird subframe.

The Micro Bird was equipped with an electric rack-and-pinion steering system. The steering wheel was not found during inspection by NTSB Investigators. The tilt/telescoping steering column was in an undetermined adjusted position and had been displaced rearward and upward due to damage sustained by the bulkhead and dash (Figure 4). A section of the multi-piece intermediate shaft, which was normally connected with u-joints, was detached and found within the vehicle debris in the driver's area of the vehicle (Figure 8). The steering gear was intact and securely mounted near the front of the sub frame (Figure 9). The steering gear was normally connected to the left and right spindles through tie rods, which were bent and had sustained thermal damage as a result of the impact and the post-crash fire (Figure 10 and Figure 11). The right spindle was fractured at the tie rod end. The steering gear was removed and stored as evidence by ISP investigators.

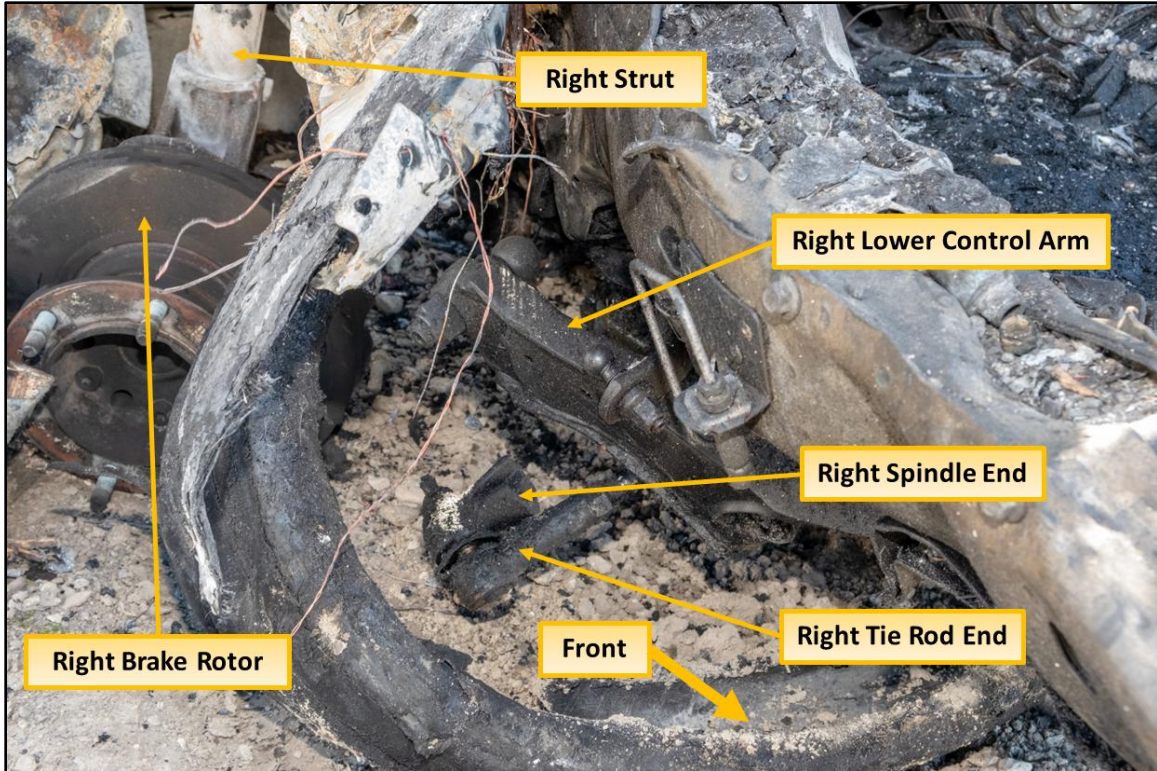
Figure 11. The right-side steering, axle 1 suspension, and brake components of the Micro Bird.

The left strut was detached from its upper mount and the coil spring was missing. The left spindle was detached from the ball joint on the lower control arm and the end link was detached from the stabilizer bar and strut (Figure 10). The top of the right strut remained attached to its upper mount, which was displaced rearward from its pre-crash location. The right spindle was detached from the ball joint on the lower control arm and the end link was detached from the stabilizer bar and strut. The right-side lower control arm was bent and displaced rearward (Figure 11). Combustible components of the axle 1 suspension, such as rubber bushings, were destroyed during the post-cash fire.

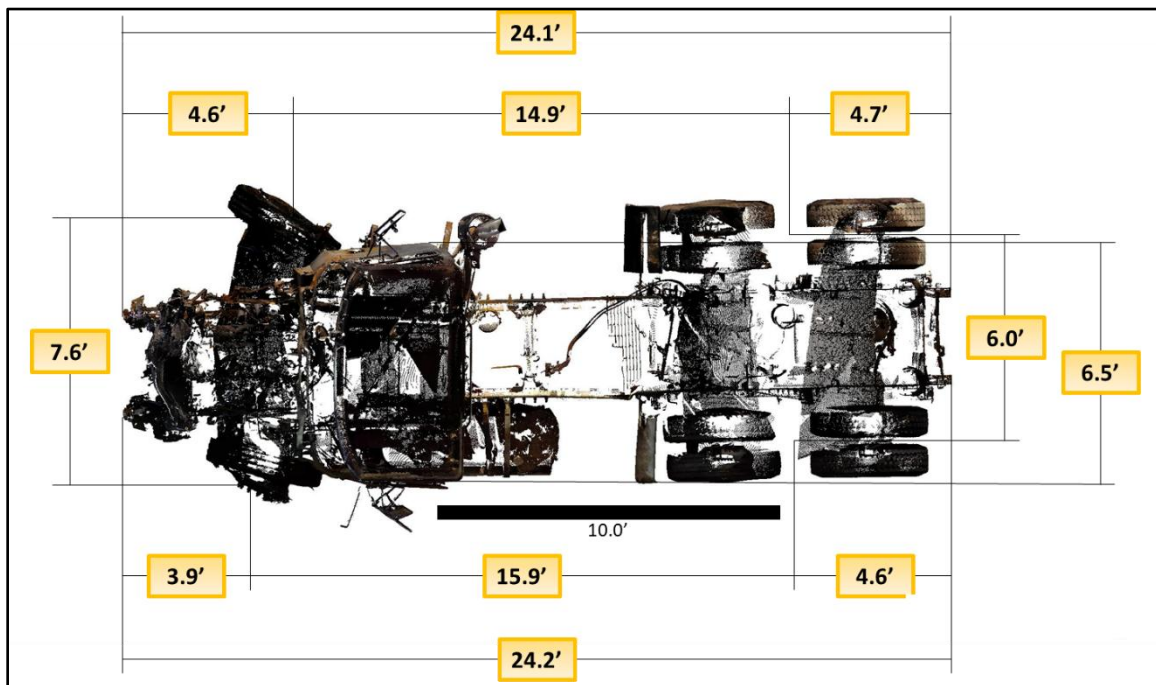
Figure 17. Three-dimensional laser scan of the Mack.

The crash-involved Mack and an exemplar 2002 Mack CH613 were scanned using a three-dimensional terrestrial laser scanner and point clouds were created for each vehicle. Refer to the docket for additional information regarding the three-dimensional laser scans. Vehicle dimensions were determined by measuring three-dimensional points in the point clouds using CloudCompare software (Figure 17). According to the invoice and vehicle specification report for the Mack, the undamaged vehicle had a wheelbase of 205 inches (17.1 feet).²²

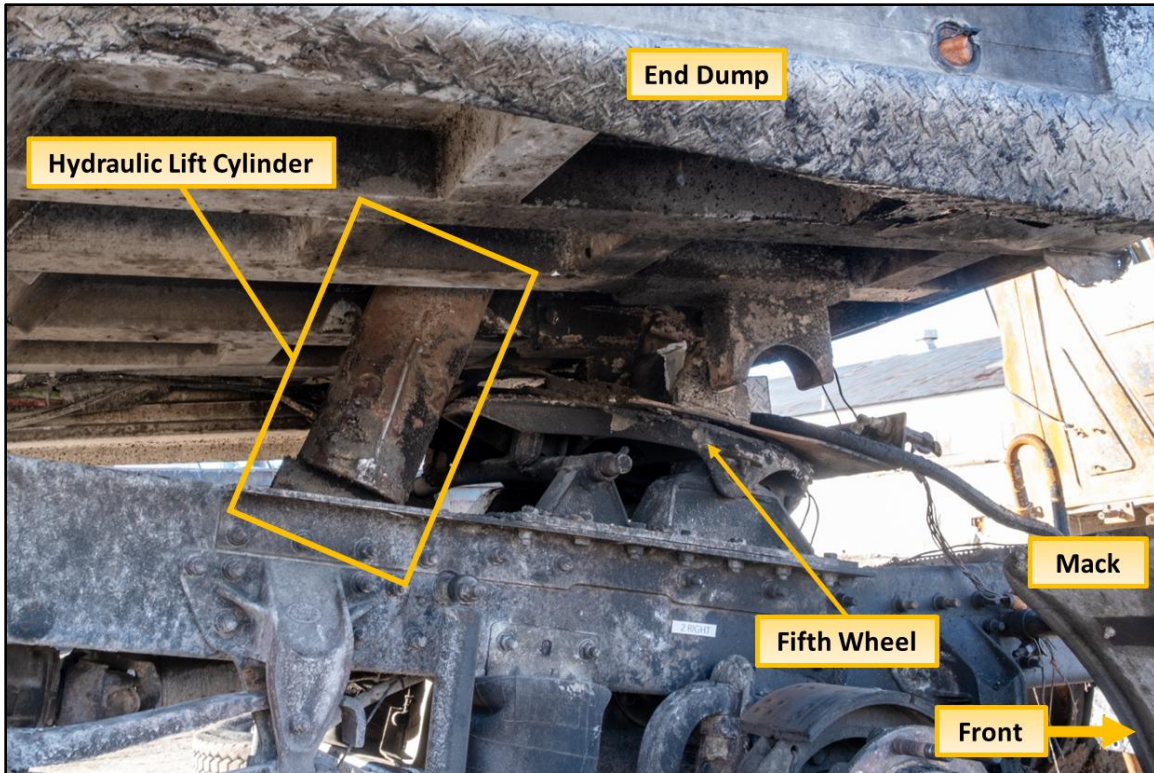
Figure 28. Hydraulic dump trailer ram and fifth wheel/kingpin coupling of the Mack combination.

The end-dump semitrailer sustained contact damage to its right side in the form of crumpling and tearing of fenders above axles 4 through 5, which was consistent with its orientation at its position of rest (Figure 16). Other damage sustained by the end-dump semitrailer included detachment of parts of the hydraulic dump structure, including the hydraulic ram, at the kingpin (Figure 28), and thermal damage to the front and portions of both sides of the vehicle.
