National Transportation Safety Board

HWY23MH017

TECHNICAL RECONSTRUCTION

Group Chair's Factual Report

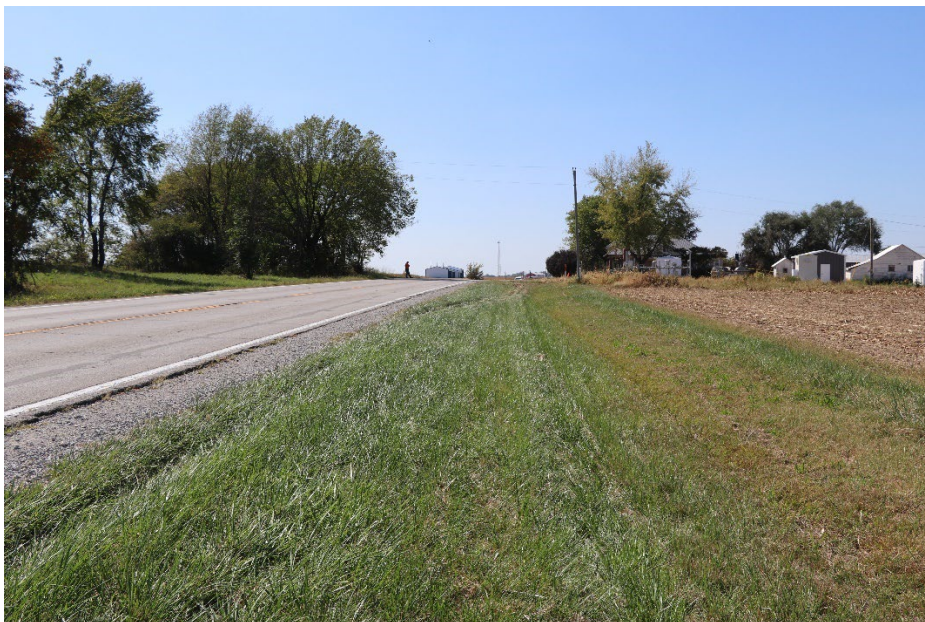
Figure 1. Photograph depicting US Route 40 and drainage channel. Photograph is looking westbound.

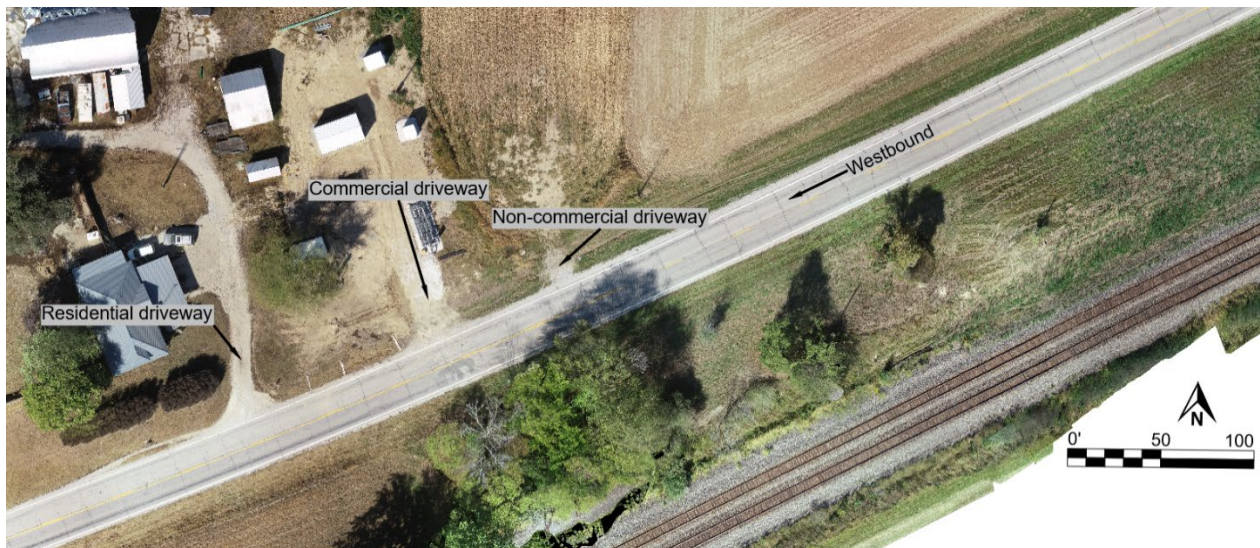
Continuing westward, after the approximate 24-foot-wide non-commercial driveway, was an open area of dirt and grass, ending at a commercial driveway. The commercial driveway was about 24 feet wide, which led to another area of open dirt ending at a residential driveway. Figure 4 is an image from the two-dimensional orthomosaic depicting the layout of the three described driveways.

Figure 4. Cropped image from the two-dimensional orthomosaic depicting the layout of the three driveways.

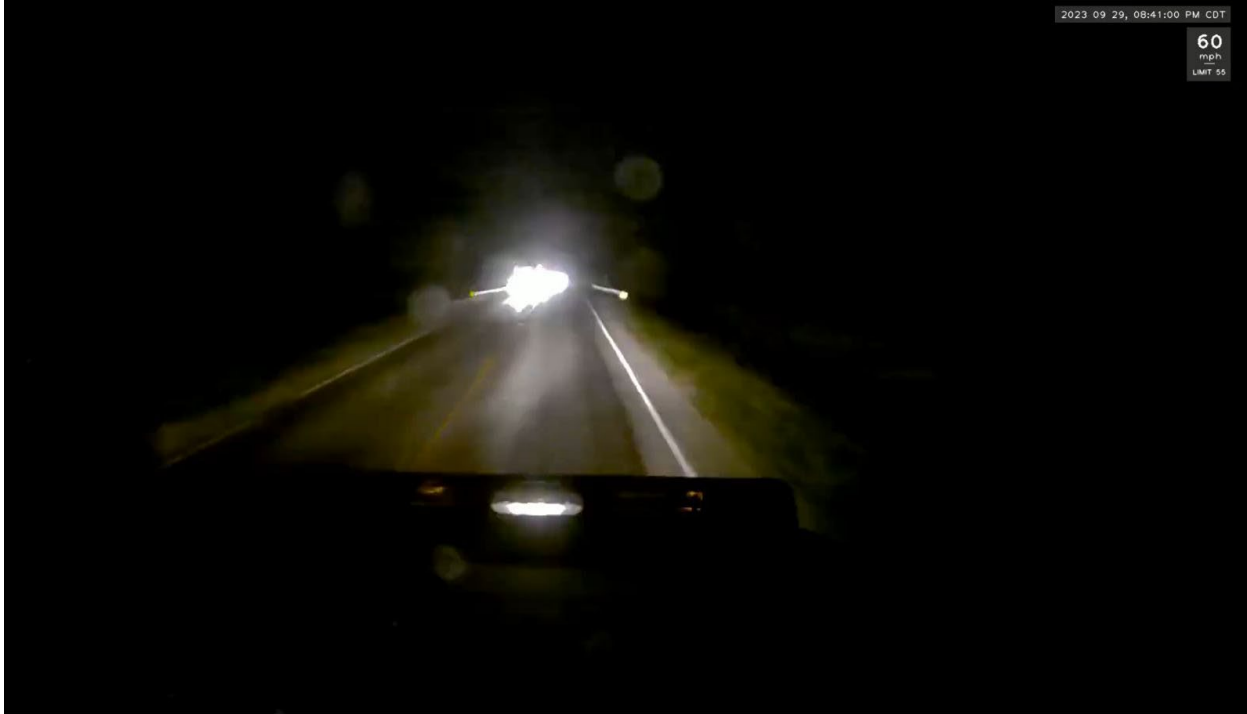
Figure 11. A screen capture from the forward-facing video showing the view from the combination.

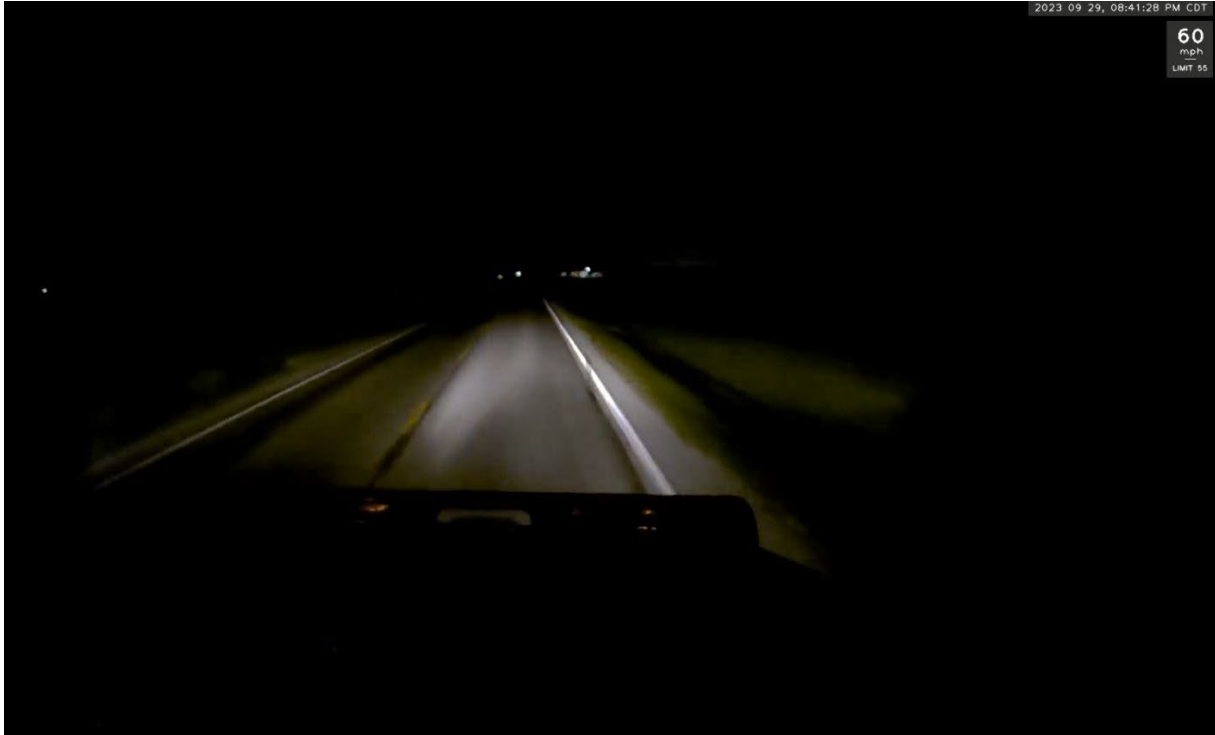
Approximately 8 seconds later (08:41:28) the combination continued westbound, in the distance is the residence and commercial property where the crash event occurred. The speed was reported at approximately 60 mph. Figure 12 below is a screen capture at this time.

Figure 12. A Screen capture at time 08:41:28.

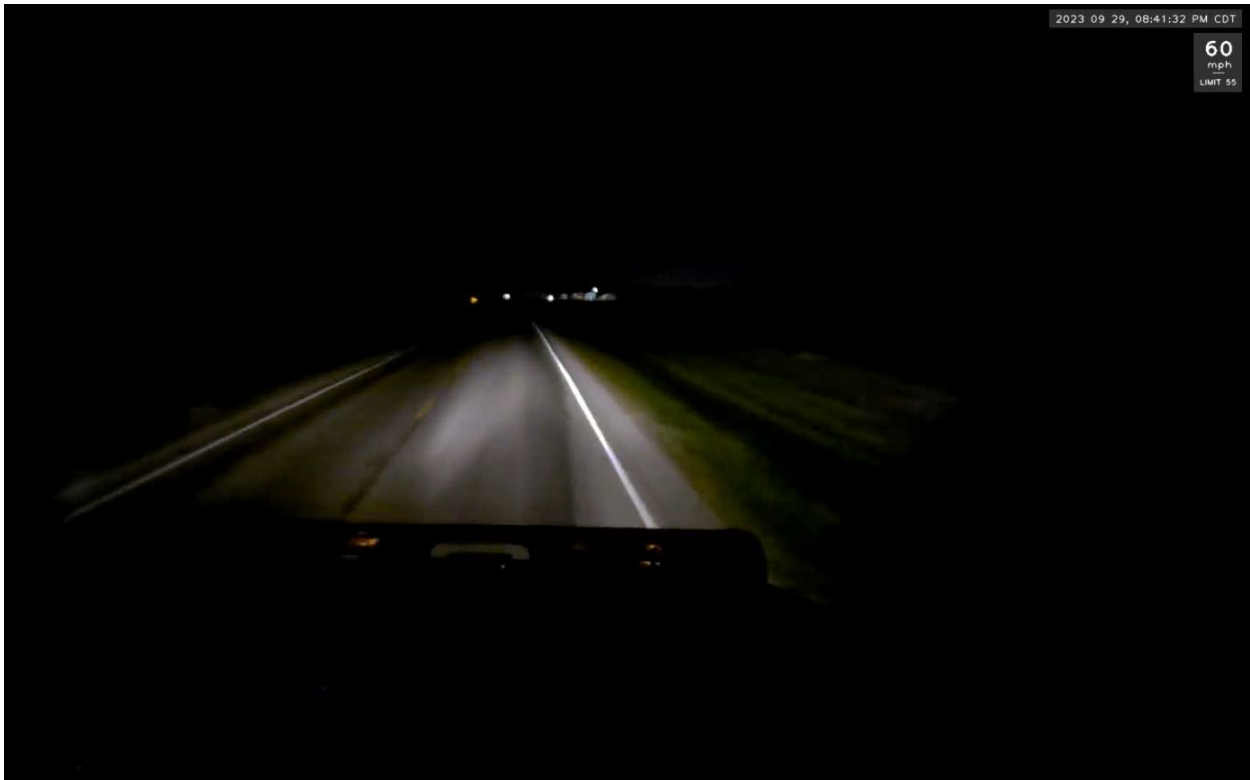
At approximately 08:41:32, as the combination continued westbound, illuminated headlights became visible in the eastbound lane. Also visible is the "No Passing Zone" sign located off the eastbound side of the roadway. The reported speed was approximately 60 mph. Figure 13 is a screen capture at this time.

Figure 13. A screen capture at time 08:41:32.

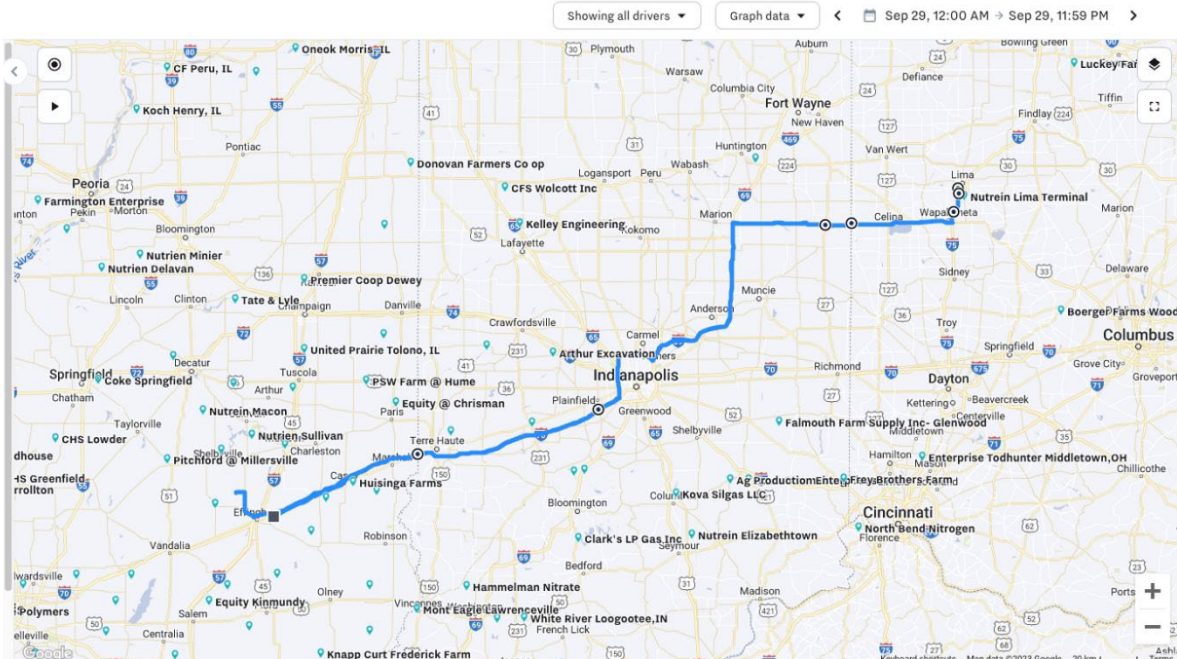
Figure 19. Map image provided by Samsara depicting cargo tank position as derived from the telematic data.

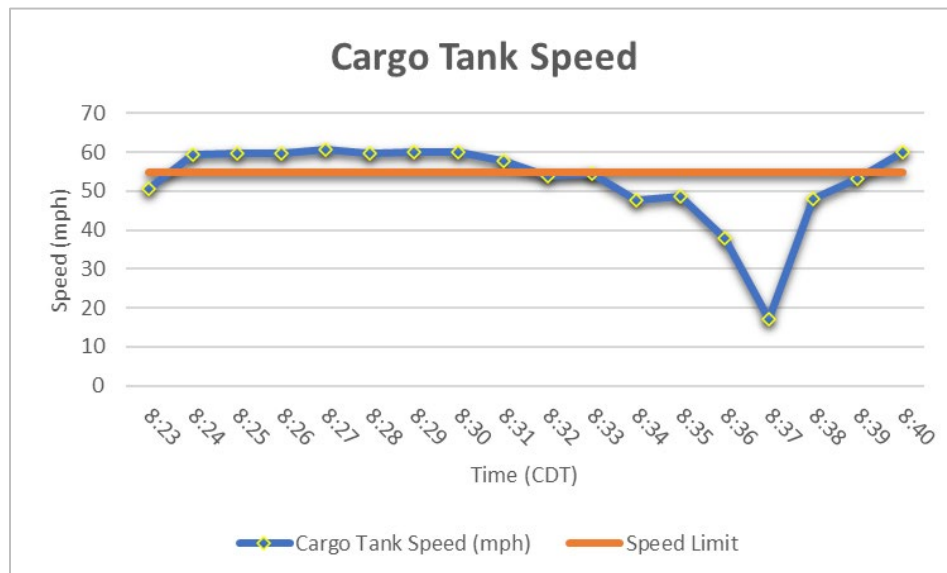
Because the system continuously provides geographic positions (GPS), when integrated with time, the GPS can be utilized to determine an average speed. Figure 12 is a graph showing the reported speed of the cargo tank as well as the reported speed limit for the 16-minutes leading up to the collision event.¹²

Figure 20. Graph representing the average cargo tank speed and roadway speed limit.
