NATIONAL TRANSPORTATION SAFETY BOARD
Office of Aviation Safety
Washington, D.C. 20594

POWERPLANT GROUP CHAIRMAN'S FACTUAL REPORT

NTSB No: DCA17FA021

Aircraft: American Airlines, Boeing 767-323, registration number N345AN, flight number 383

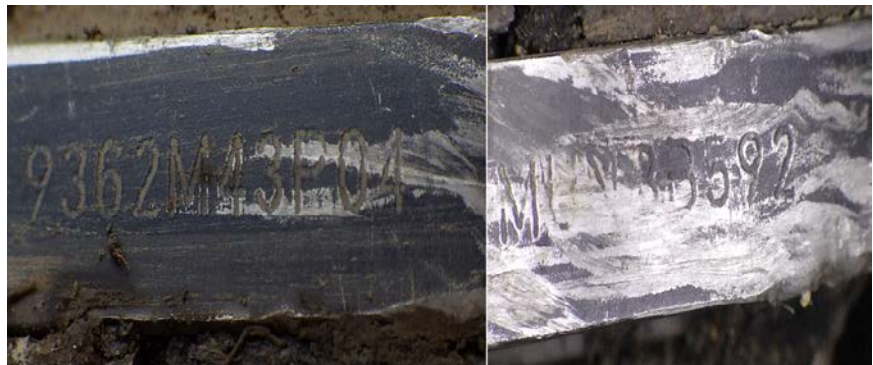
According to the AA maintenance records, the HPT stage 2 disk installed on the event engine ESN 690-373 was part number (PN) 9362M43P04 and serial number (SN) MUNBB592. This was confirmed when disk fragment identified as “B” (See Section 2.7 *HPT Stage 2 Disk Fragment Documentation* for details) was recovered (**PHOTO 2**). At the time of accident, the HPT stage 2 disk had accumulated 68,785 hours TSN and 10,984 CSN. See **TABLE 1** for timeline history.

PHOTO 2: PART MARKING ON THE HPT STAGE 2 DISK LOCATED ON TOP OF DISK POST FRAGMENT ‘B’ – PN ON LEFT AND SN ON RIGHT

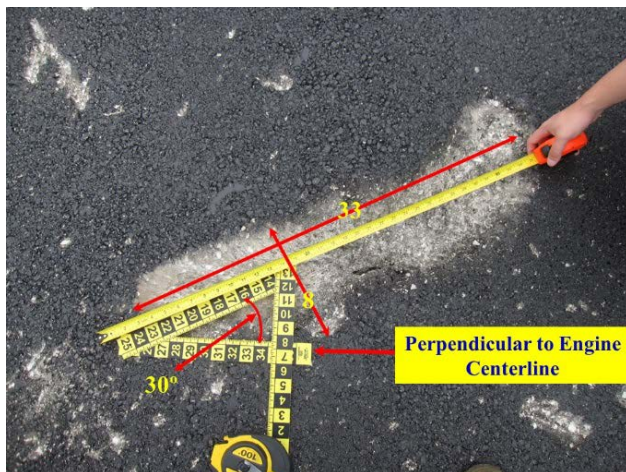
Runway 28R, about 31.5-feet to the right of the runway centerline (midpoint of gouge to midpoint of centerline) just east of the intersection of runway 28R and taxiway 'T', exhibited an impact ground scar/gouge consistent with impact from exiting HPT stage 2 disk fragment(s). The gouge was oriented about 30° forward (direction of airplane travel) relative to the HPT stage 2 plane of rotation (**PHOTO 4**) and in the general direction where three separate fragments of the HPT stage 2 disk were discovered north (right) of runway 28R. The gouge measured approximately 33-inches lengthwise, 8-inches at its widest, and 2-inches at its deepest. Additional smaller runway impacts marks were observed forward and aft of the initial impact scar (**PHOTO 5**).

PHOTO 4: HPT STAGE 2 DISK GROUND IMPACT

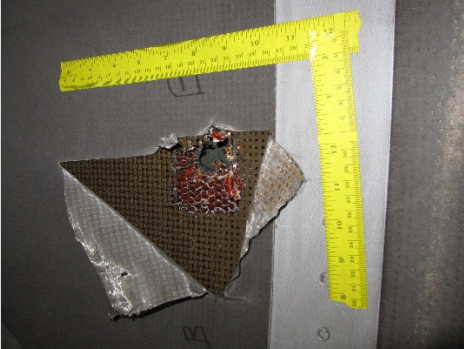
<p>PHOTO 9: BLADE FRAGMENT THRU-HOLE 'B' (OUTBOARD)</p>
B (fan flow path side) (PHOTO 10)	TR Transcowl	5:00 o'clock 31-inches aft of the transcowl LE	2.25-inches axial x 1.00-inches circumferential	Puncture thru-hole

<p>PHOTO 10: BLADE FRAGMENT THRU-HOLE 'B'(INBOARD)</p>
B1 (PHOTOS 11 and 12)	TR Lower Bifurcation Side Wall	6:00 o'clock	3.0-inches axial x 1.25-inches radially Blade fragment weighed 5.455 ounces	HPT stage 2 blade fragment embedded in the structure

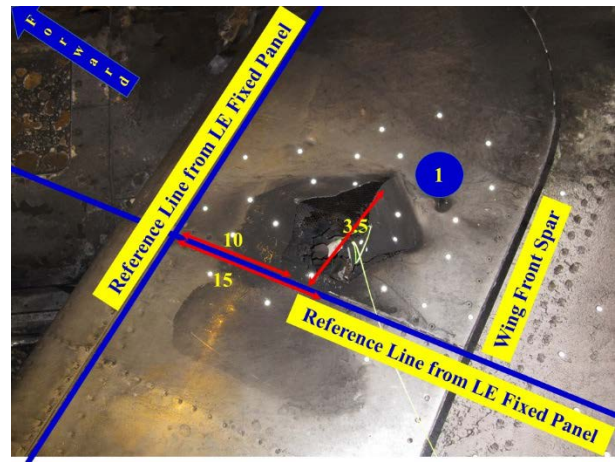
No airplane impact damage was observed outboard of the right engine pylon from exiting HPT stage 2 disk or engine debris; all impact damage was located inboard of the pylon. Examination of the bottom of the wing inboard of the right engine pylon revealed two thru-hole penetrations (**PHOTOS 30** and **31**, holes labeled **1** and **2**) through the lower and upper skins of the wing. Hole **1** was located forward of the front spar in the fixed-wing leading edge panel (**PHOTOS 32** and **33**). Hole **2** was located aft of the wing front spar between wing rib No. 6 and 9 (**PHOTOS 30, 32, and 33**).

**PHOTO 31: RIGHT WING INBOARD OF PYLON
UPPER WING SKIN THRU-HOLE PENETRATION –
HOLE ①, ALL MEASUREMENTS ARE IN INCHES**

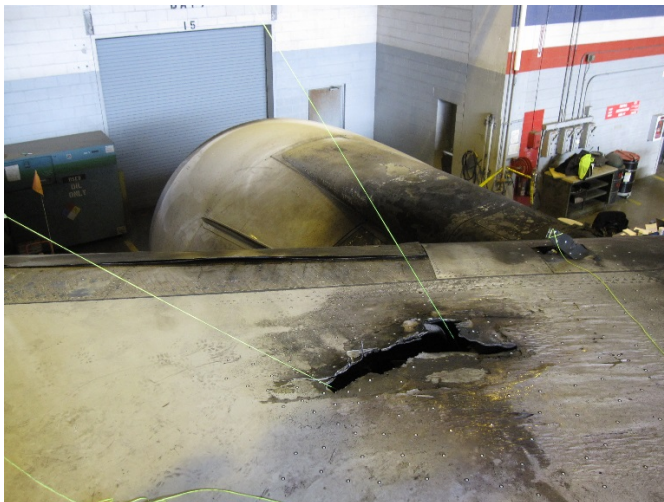
**PHOTO 32: RIGHT WING INBOARD OF PYLON
UPPER WING SKIN THRU-HOLE PENETRATION –
HOLE ②**

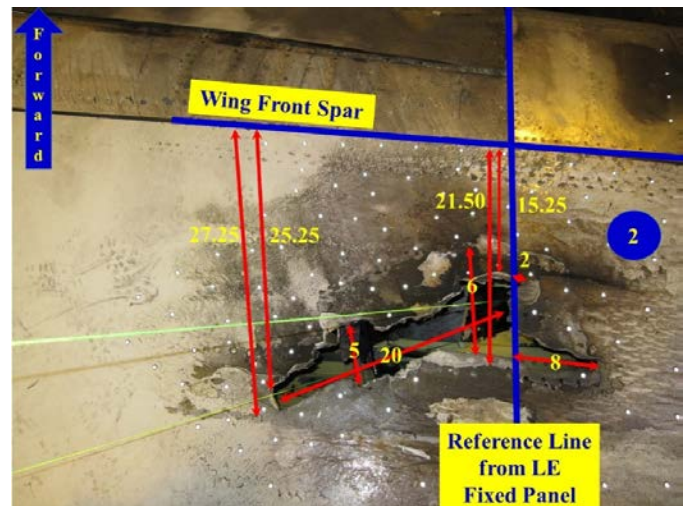
**PHOTO 33: RIGHT WING INBOARD OF PYLON
UPPER WING SKIN THRU-HOLE PENETRATION –
HOLE ②, ALL MEASUREMENTS IN INCHES**

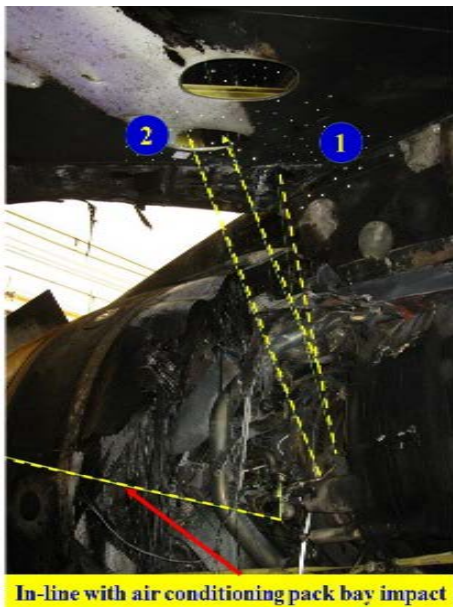
To represent the trajectory area of the exiting HPT stage 2 disk fragments, strings were attached close to the fan mid shaft and on the HPT case representing the inner and outer HPT stage 2 disk diameters and connected to either puncture through holes or ground scar/gouge. Looking through hole ①, the trajectory of the engine debris that passed through the hole did not impact the front spar and continued upward and exited the top of the fixed-wing leading edge panel (PHOTOS 34 and 35). Looking through hole ②, the trajectory of the HPT stage 2 disk fragment first entered the dry bay through the lower wing skin, severed the main engine fuel feed line, severed rib No. 6 (which is part of the inboard dry bay boundary) and continued through the upper wing skin.

**PHOTO 34: INBOARD TRAJECTORY –
LOOKING FORWARD**

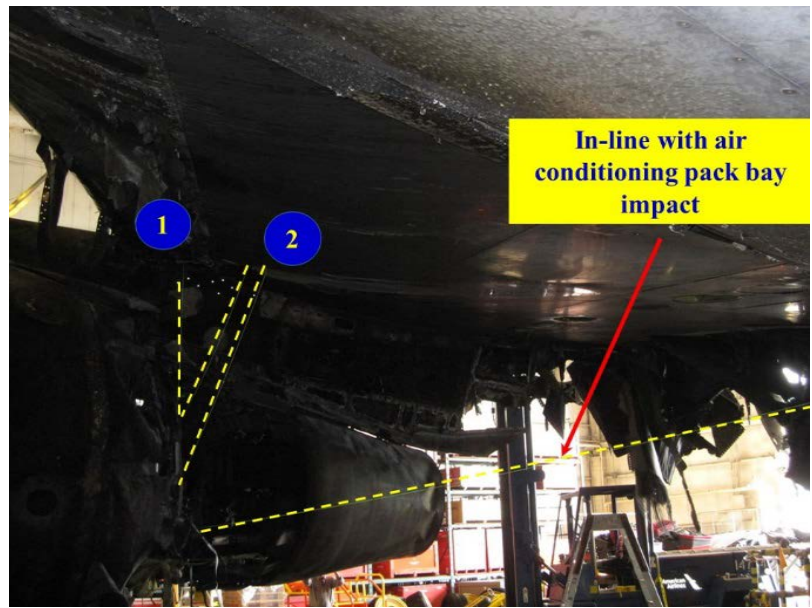
**PHOTO 35: INBOARD TRAJECTORY –
LOOKING AFT**

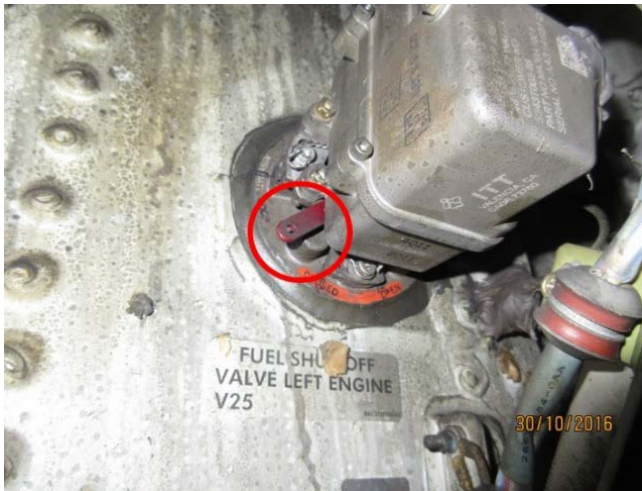
There are two fire suppression bottles for the engine – bottle 1 and bottle 2 – that are shared by both engines. Each fire suppression bottle has a dedicated discharge port for each engine. The engine fire suppression bottles are located in the forward right cargo bay. The part number for both engine fire suppression bottles is Boeing PN S332T011-24 and manufacturer (Pacific Scientific) PN 34600012-24. The SNs for bottle 1 and bottle 2 are 23046F1 and 23044F1, respectively. Visual examination of the discharge ports of each bottle revealed that the detonation device in both discharge ports in each bottle was missing the percussion cap. This is consistent with discharged fire suppression bottles. The left wing (PHOTO 44) and right wing (PHOTO 45) spar fuel shutoff valve actuators were visually confirmed in the CLOSED position as indicated by the mechanical position indicator.

PHOTO 44: LEFT ENGINE FUEL SHUTOFF VALVE IN CLOSED POSITION

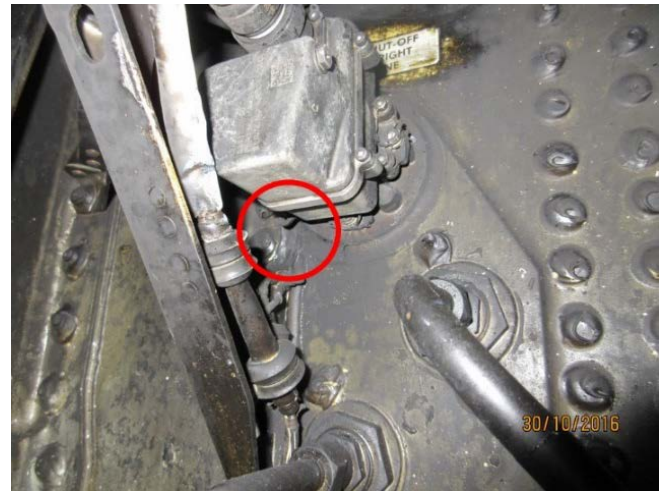
PHOTO 45: RIGHT ENGINE FUEL SHUTOFF VALVE IN CLOSED POSITION

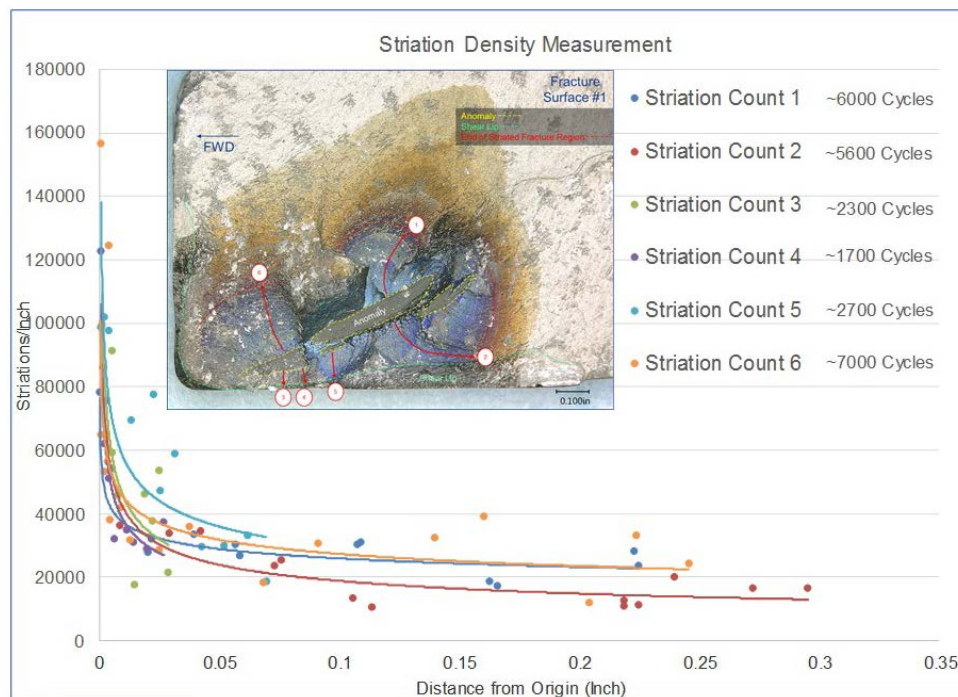
GE concluded that: "The amount of cycles for the crack to breach the disk surface could not be determined due to multiple crack fronts progressing with unknown initiation times." According to GE, the striation density steeply decreased as the crack progressed away from the origin, a behavior consistent with higher alternating stress, low-cycle fatigue (LCF) crack propagation mechanisms. Fracture morphology beyond the striated region had a dimpled morphology, consistent with tensile overload.

FIGURE 9: STRIATION DENSITY CURVES CREATED BY GE

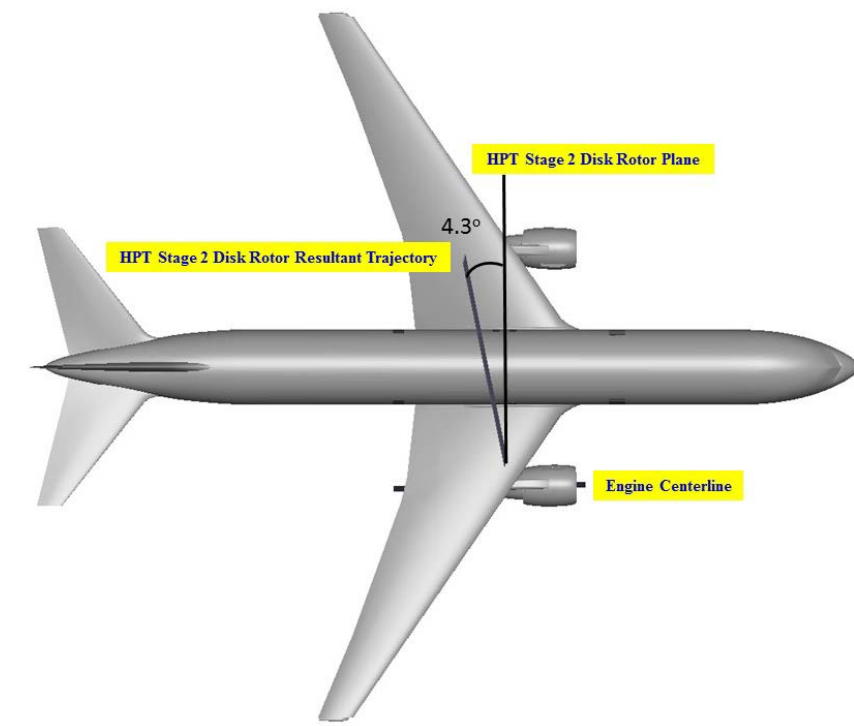
FIGURE 26: HPT STAGE 2 DISK FRAGMENT EXIT TRAJECTORY THROUGH INBOARD RIGHT WING (TOP VIEW)

Boeing performed a trajectory analysis to estimate the exit angle for the disk fragment that departed the engine inboard and penetrated through the right wing (FIGURES 26 and 27). The result of the analysis estimated that the disk fragment exited the engine at about 4.3° aft of the HPT stage 2 disk rotation plane and that the fragment passed over the fuselage.
